# TEST REPORT

1. No : CT13-80138

4. Test Sample : Network Camera (Model : SNF-7010V\* (N:NTSC/ P:PAL))

(1) EN 61373 : 1999

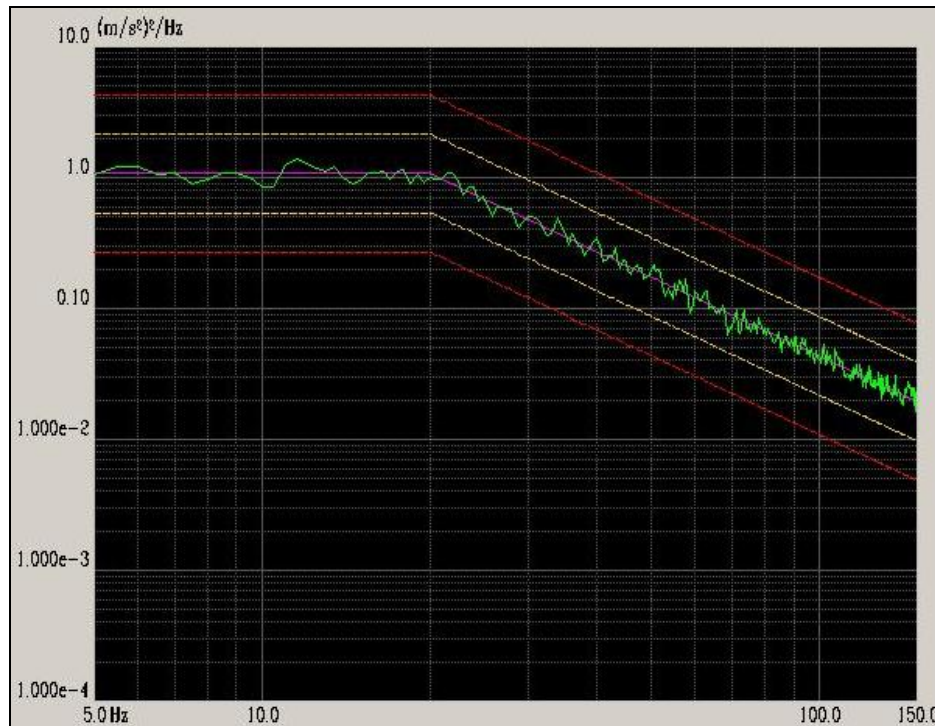
[Graph 1. Longlife Test - Vertical]

| Test Conditions | | | | | | Test Results |
|---|---|---|---|---|---|---|
| Vertical | 5 | 1.034 | – | 5.90 | 5.0 | No Defects<br>& Working Normally. |

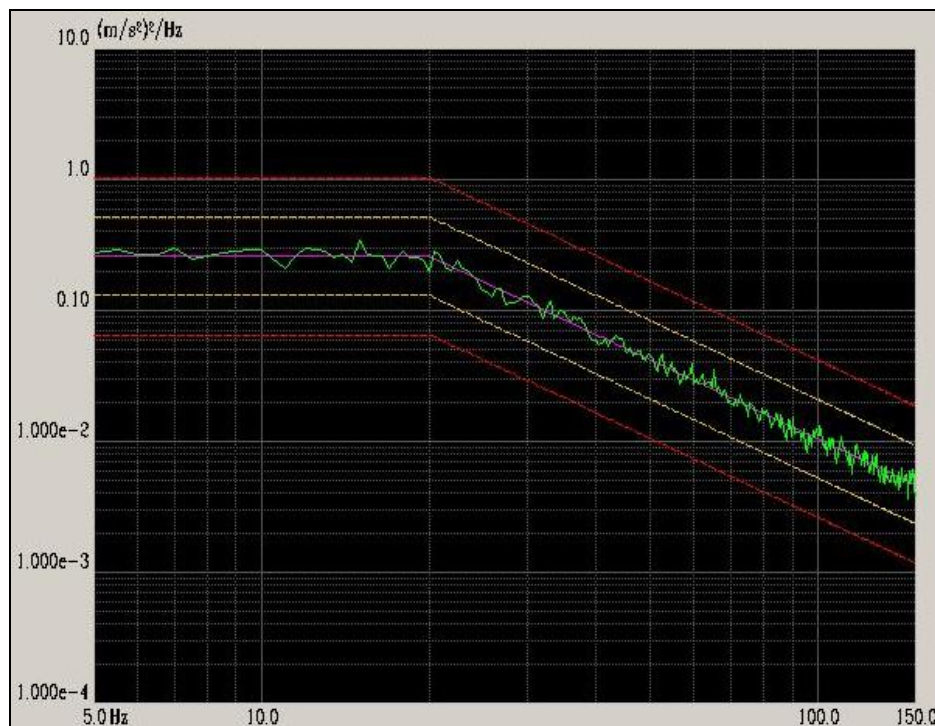
[Graph 2. Longlife Test - Transverse]

| Test Conditions | | | | | | Test Results |
|---|---|---|---|---|---|---|
| Transverse | 5 | 0.250 | – | 2.90 | 5.0 | No Defects<br>& Working Normally. |

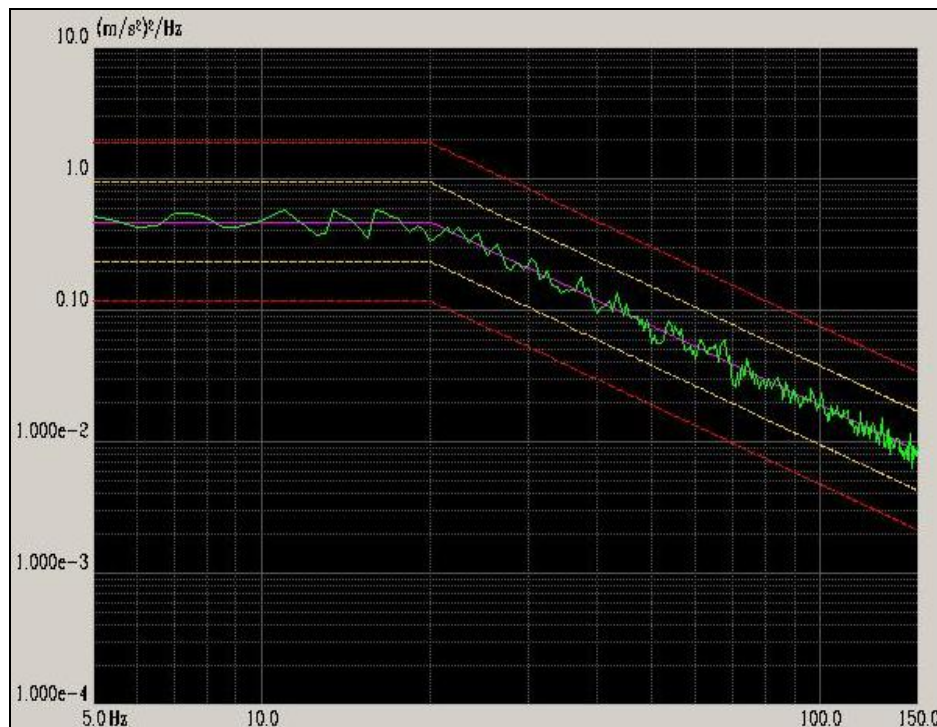
[Graph 3. Longlife Test -Longitudinal]

| Test Conditions | | | | | | Test Results |
|---|---|---|---|---|---|---|
| Longitudinal | 5 | 0.452 | – | 3.90 | 5.0 | No Defects<br>& Working Normally. |

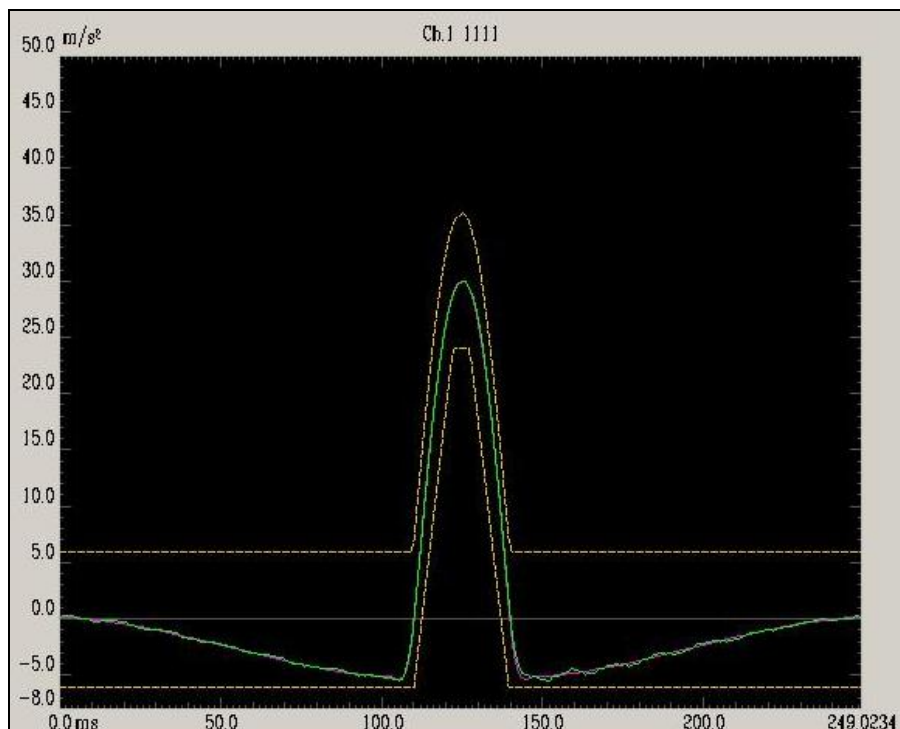
[Graph 4. Shock Test - Vertical(+)]

| Test Conditions | | | | | | Test Results |
|---|---|---|---|---|---|---|
| Vertical | + | 30 | 30 | Half Sine | 3 | No Defects & Working Normally. |

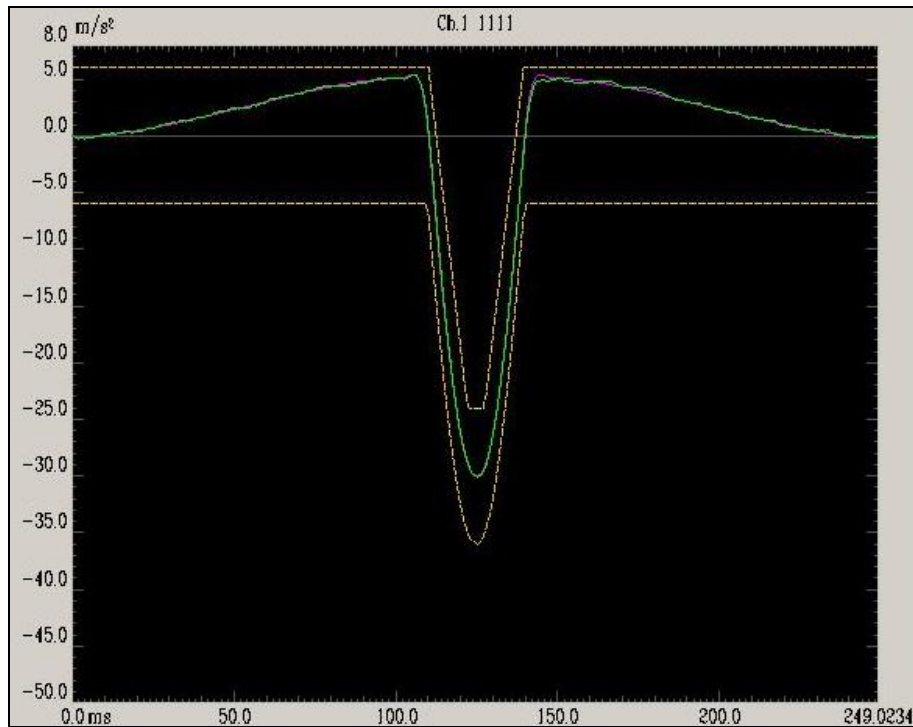
[Graph 5. Shock Test - Vertical(-)]

| Test Conditions | | | | | | Test Results |
|---|---|---|---|---|---|---|
| | – | | | | 3 | No Defects & Working Normally. |

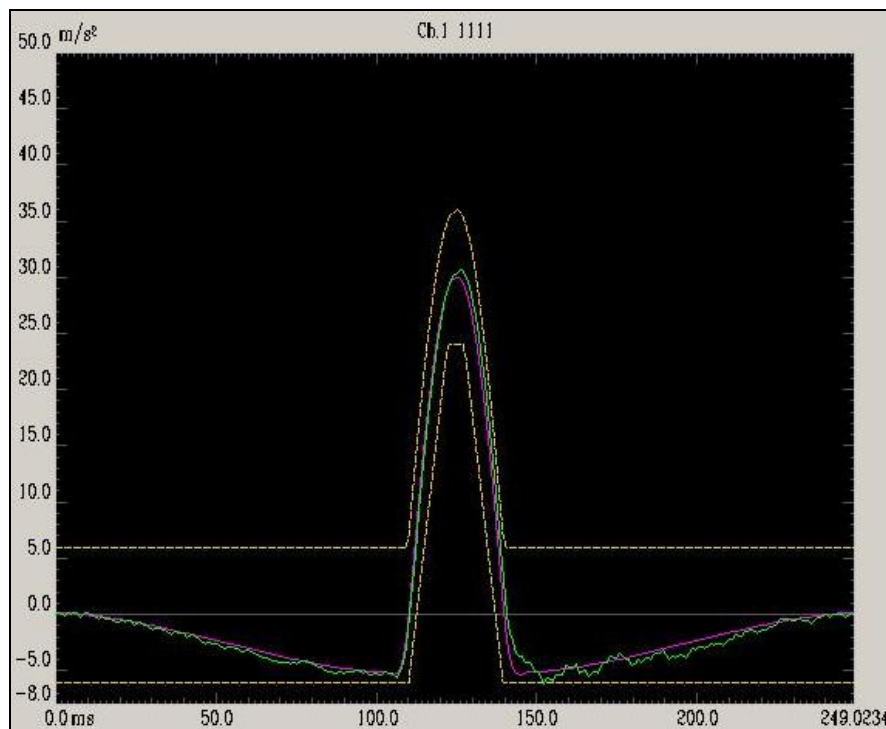
[Graph 6. Shock Test - Transverse(+)]

| Test Conditions | | | | | | Test Results |
|---|---|---|---|---|---|---|
| Transverse | + | 30 | 30 | Half Sine | 3 | No Defects & Working Normally. |

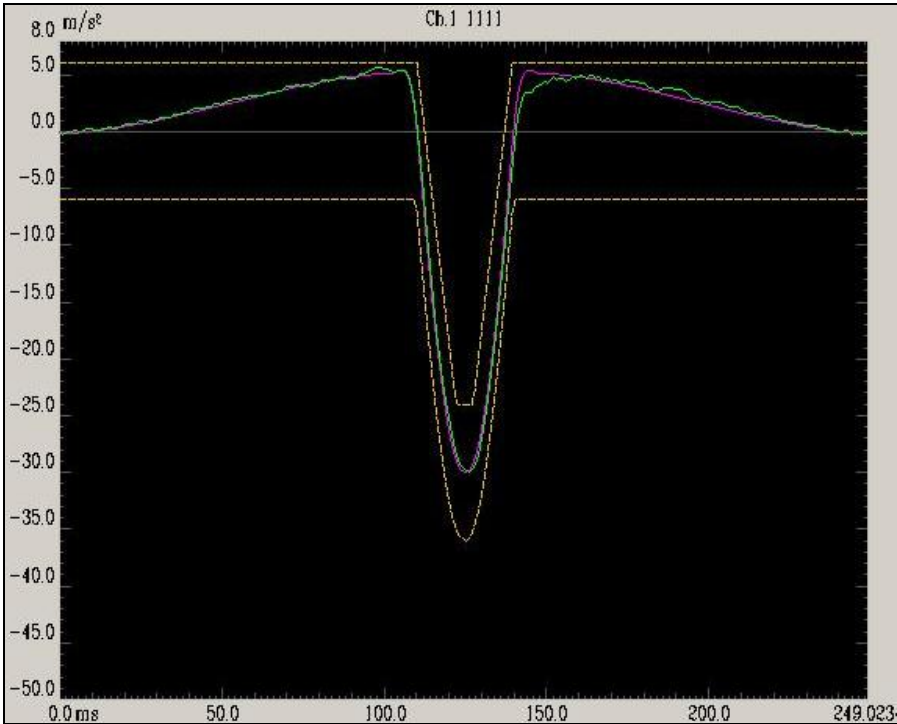
[Graph 7. Shock Test - Transverse(-)]

| Test Conditions | | | | | | Test Results |
|---|---|---|---|---|---|---|
| | – | | | | 3 | No Defects & Working Normally. |

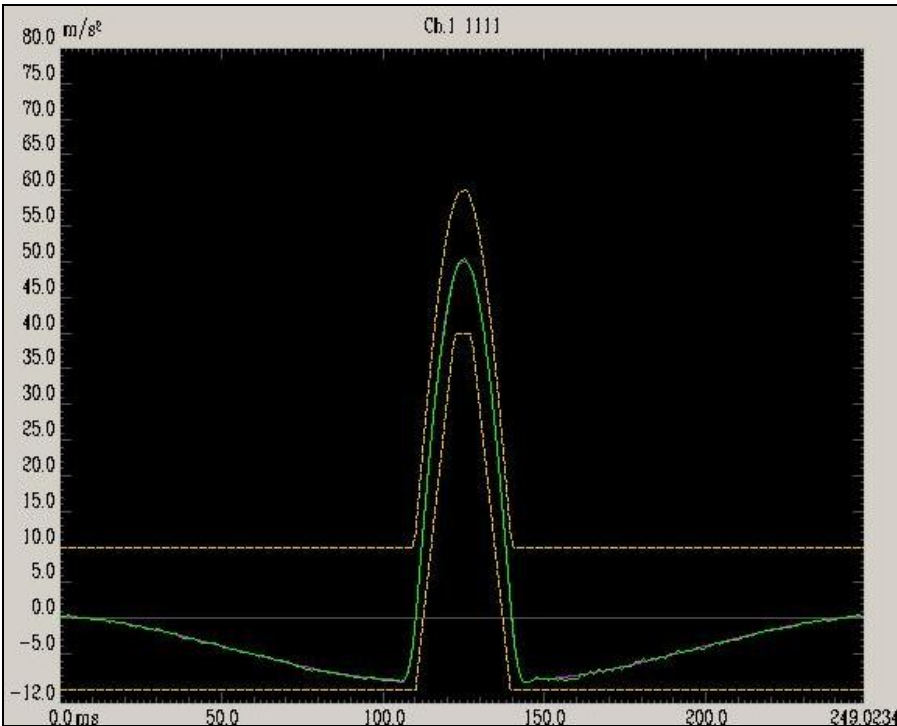
[Graph 8. Shock Test - Longitudinal(+)]

| Test Conditions | | | | | | Test Results |
|---|---|---|---|---|---|---|
| Longitudinal | + | 50 | 30 | Half Sine | 3 | No Defects & Working Normally. |

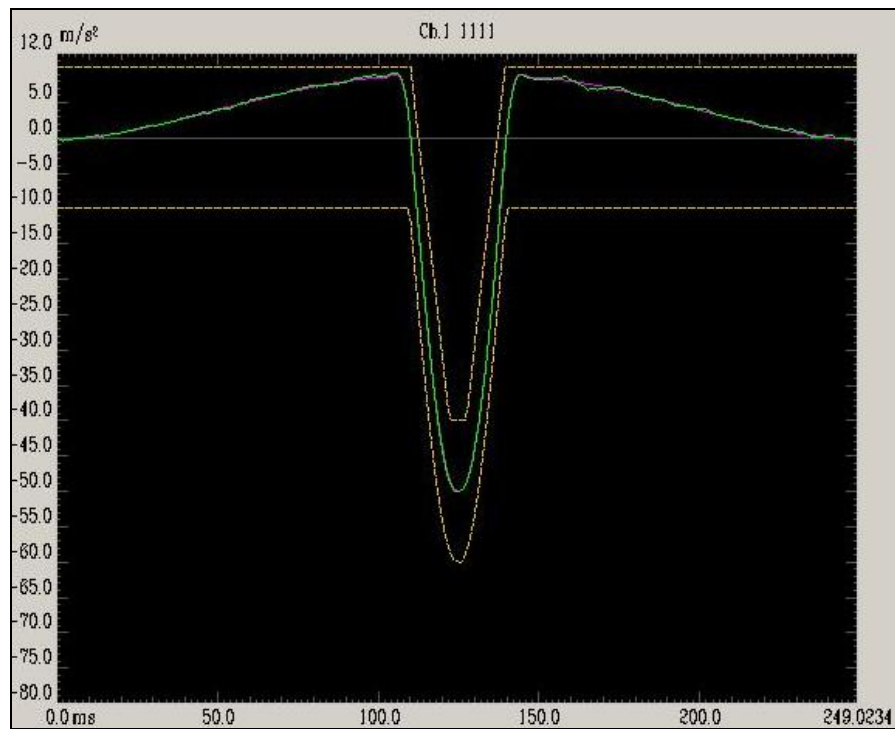
[Graph 9. Shock Test - Longitudinal(-)]

| Test Conditions | | | | | | Test Results |
|---|---|---|---|---|---|---|
| | – | | | | 3 | No Defects & Working Normally. |

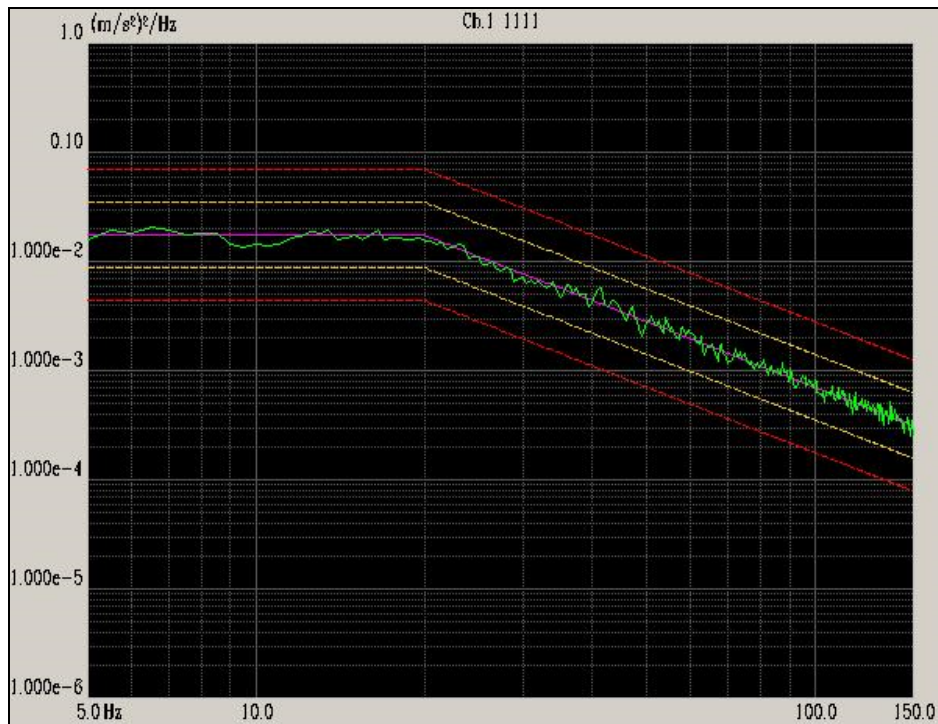
[Graph 10. Functional Test - Vertical]

| Test Conditions | | | | | | Test Results |
|---|---|---|---|---|---|---|
| Vertical | 5 | 0.0164 | – | 0.75 | 0.5 | No Defects<br>& Working Normally. |

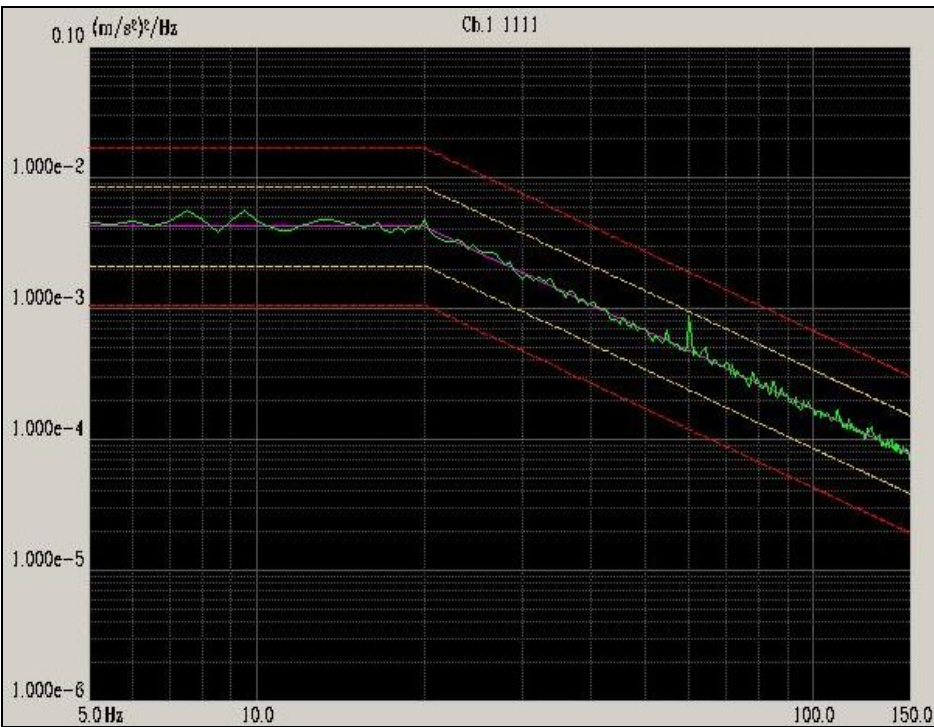
[Graph 11. Functional Test - Transverse]

| Test Conditions | | | | | | Test Results |
|---|---|---|---|---|---|---|
| Transverse | 5 | 0.0041 | – | 0.37 | 0.5 | No Defects<br>& Working Normally. |

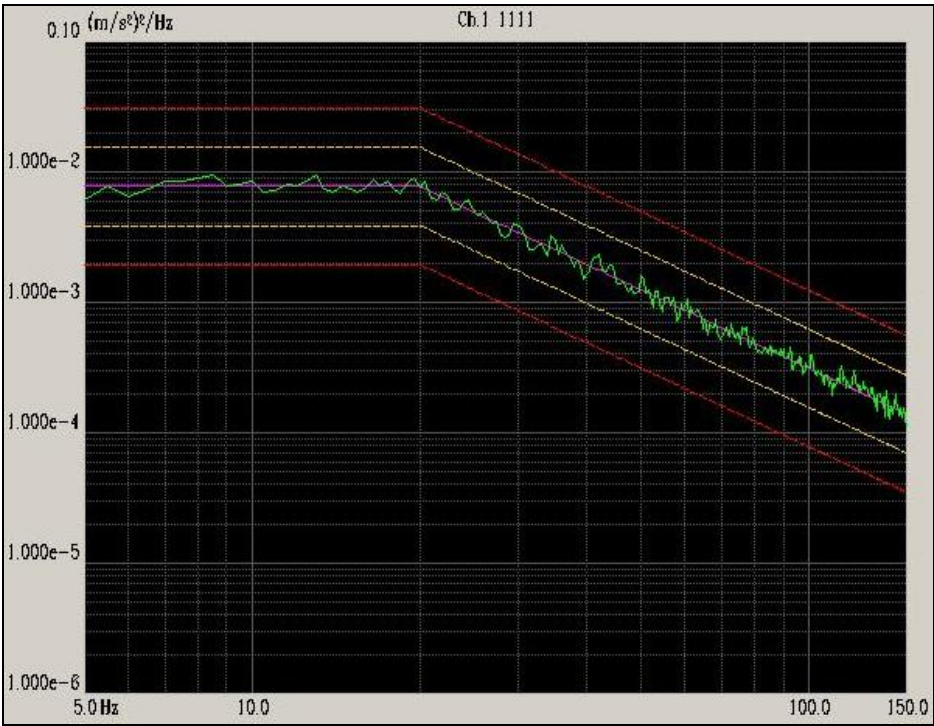
[Graph 12. Functional Test - Longitudinal]

| Test Conditions | | | | | | Test Results |
|---|---|---|---|---|---|---|
| Longitudinal | 5 | 0.0073 | – | 0.50 | 0.5 | No Defects<br>& Working Normally. |
