# ***ENVIRONMENTAL TEST REPORT***

**Product: Bio Entry W 2**

## TEST REPORT

| <b>Standard</b> ..... | | KS C IEC 60529:2006 / IP67 | |

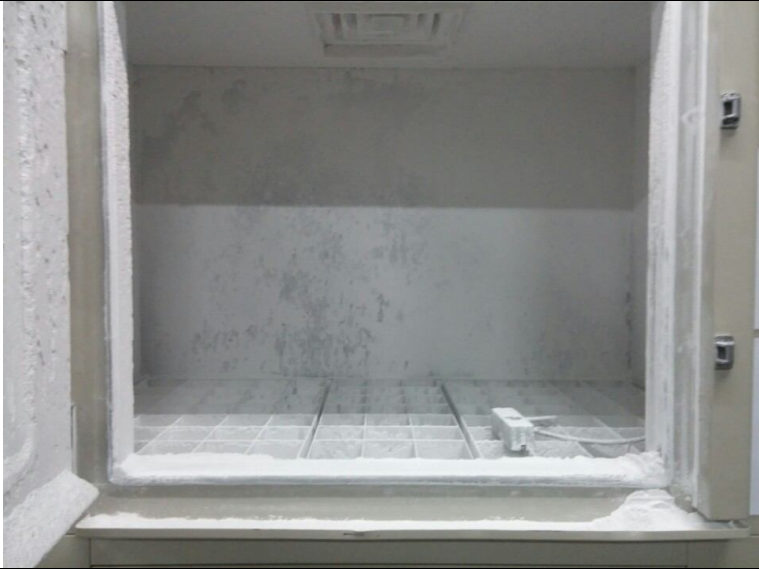
| Item | IP Code | Result |
|---|---|---|
| | IP6X | No traces of dust deposits were found at any point within the enclosure. |

| | IP6X (Tests for protection against solid foreign objects indicated by the first characteristic numeral) | |
