# TEST REPORT

REPORT No.:  
CTK-2024-01359  
Page (1) / (13) pages

NETWORK CAMERA / ANE-L8082R

IEC 60529:1989 +A1:1999+A2:2013

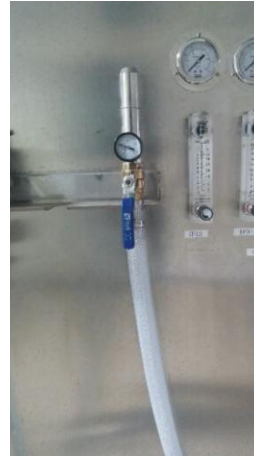
Hose Nozzle (12.5 mm)

| Second characteristic numeral | Degrees of protection | Application |
|---|---|---|
| 6 | <p>The product must not be harmed in any direction even strong jet water.</p> <p>Water jet hose nozzle Fig.6, Nozzle 12.5 mm diameter</p> <p>Water flow rate: 100 l/min ± 5 % : <b>100 LPM</b></p> <p>Distance: 2.5 m to 3 m: <b>2.5 m</b></p> <p>Duration of test: 1 min/m<sup>2</sup> at least 3 min: <b>3 min</b></p> | <input checked="" type="checkbox"/> |

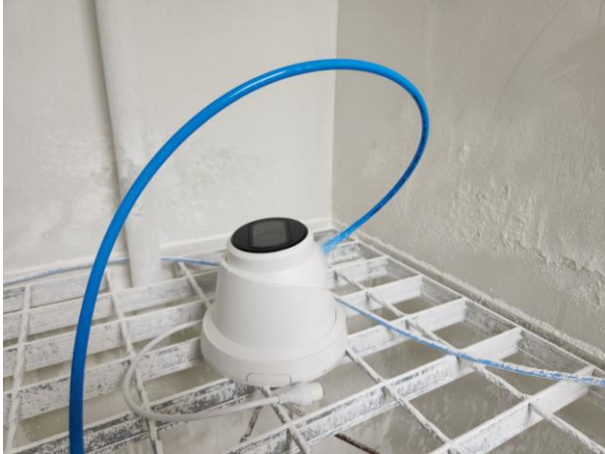
Dust test

| First characteristic numeral | Degree of protection | Application |
|---|---|---|
| 6 | <p>In Dust Testing Equipment, the test sample has to have no ingress of dust after testing atmospheric pressure present condition for 8 hr.</p> <p>(Talcum powder have to go through the measured sieve by <math>\Phi</math> 50 um wire that are spacing 75 um in squared, per volume and union Talcum powder have to be 2 kg/m<sup>3</sup>)</p> <p>Products in volume .....: <b>3 072 cm<sup>3</sup> → 3.07 L</b></p> <p>Target intake volume (Products in volume 80) .....: <b>245.76 L</b></p> <p>Suction volume (Max product in volume 60) .....: <b>184.32 LPH → 3.07 LPM</b></p> <p>Actual Suction volume .....: <b>3.07 L</b></p> <p>Suction pressure (Up to 2 kPa) .....: <b>1.77 kPa</b></p> <p>Test time (Up to 8 time) .....: <b>8 hr</b></p> | <input checked="" type="checkbox"/> |

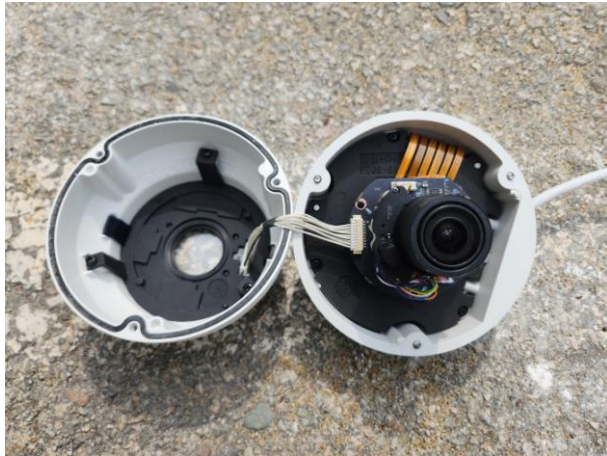
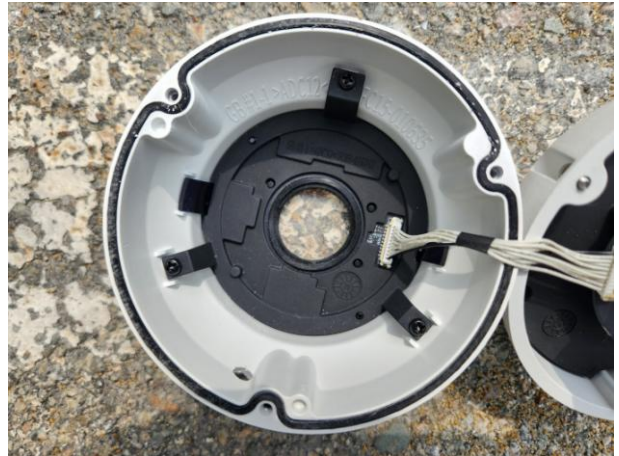
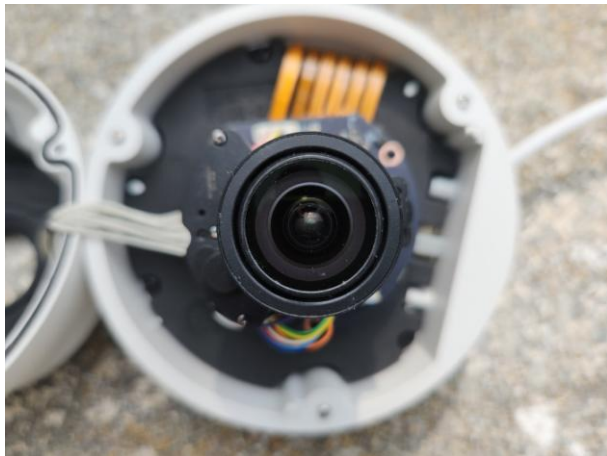
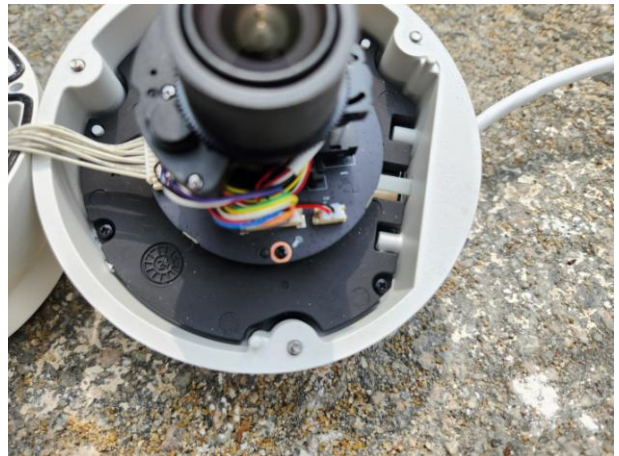
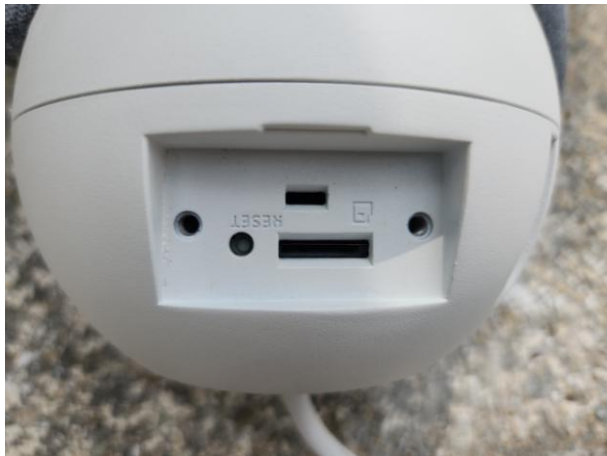
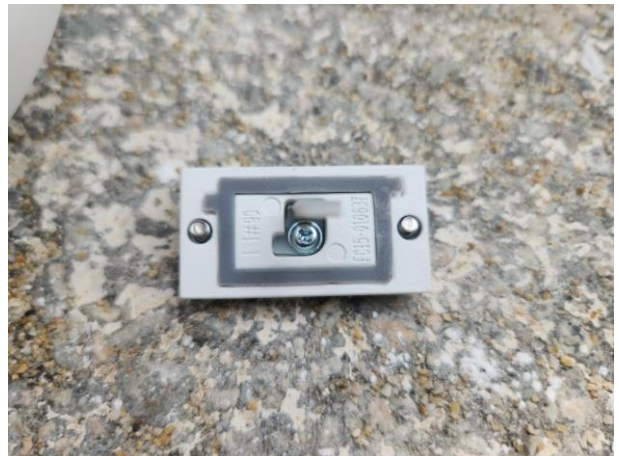
### 4.2.1 Product internal images after test [The First characteristic Numeral Test]

| IP code | Evaluation Criteria | Test Results | Remark |
|---|---|---|---|
| | No ingress of dust. | Normal | - |

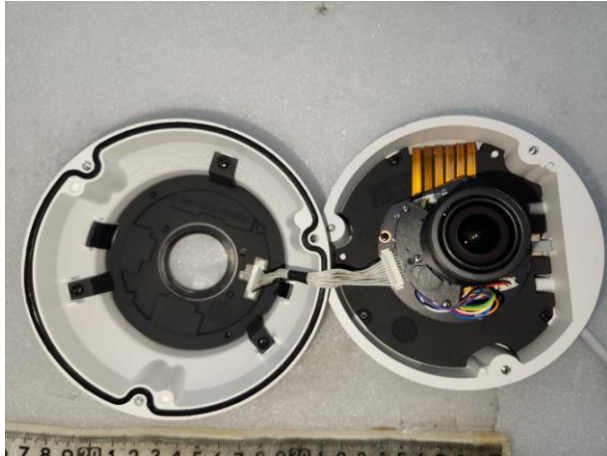
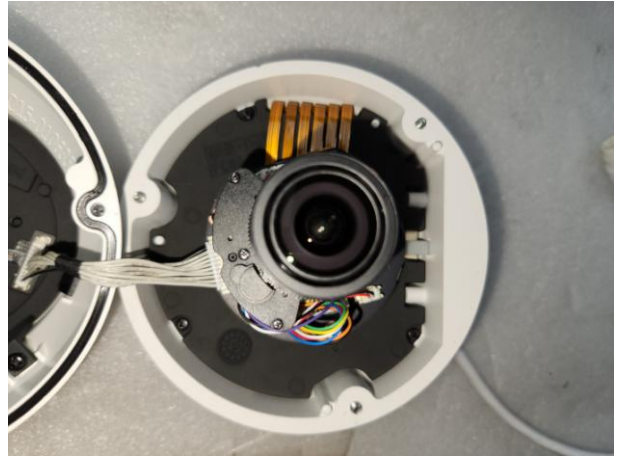
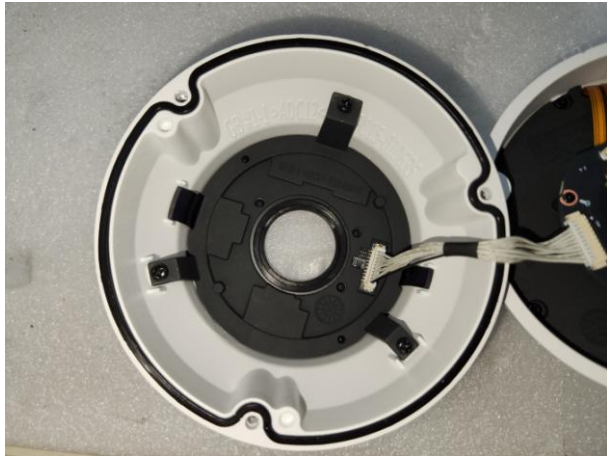
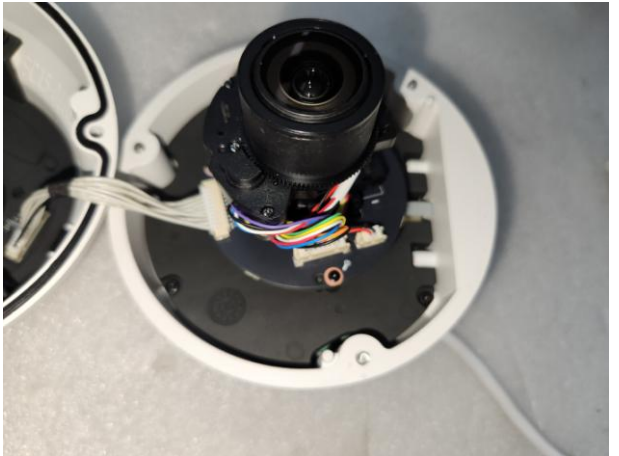
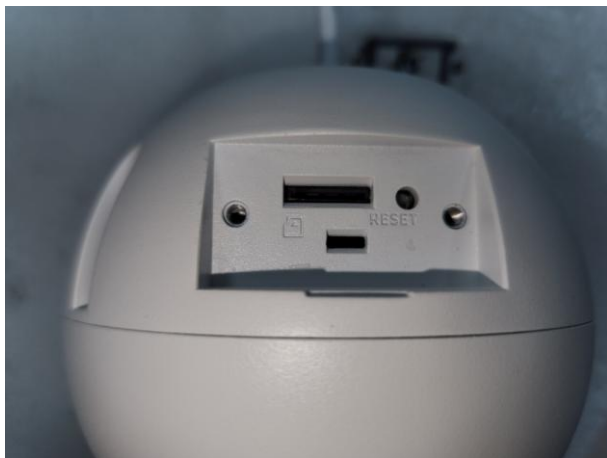
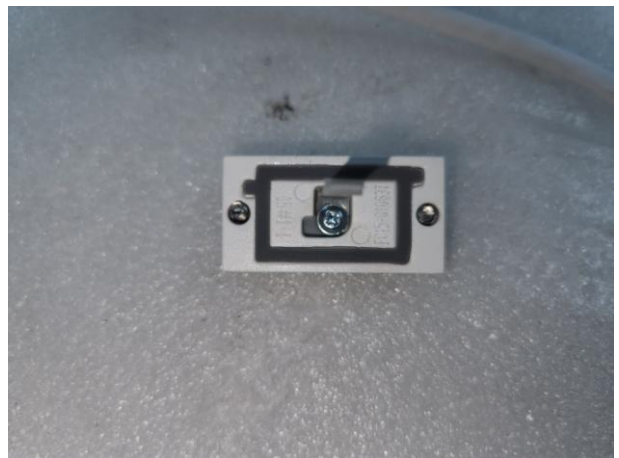
#### 4.2.2 Product internal images after test [The Second characteristic Numeral Test]

| IP code | Evaluation Criteria | Test Results | Remark |
|---|---|---|---|
| IP X6 | No ingress of water. | Normal | - |
