# TEST REPORT

REPORT No.:  
CTK-2024-01360  
Page (1) / (14) pages

NETWORK CAMERA / ANE-L8082R

IEC 60529:1989 +A1:1999+A2:2013

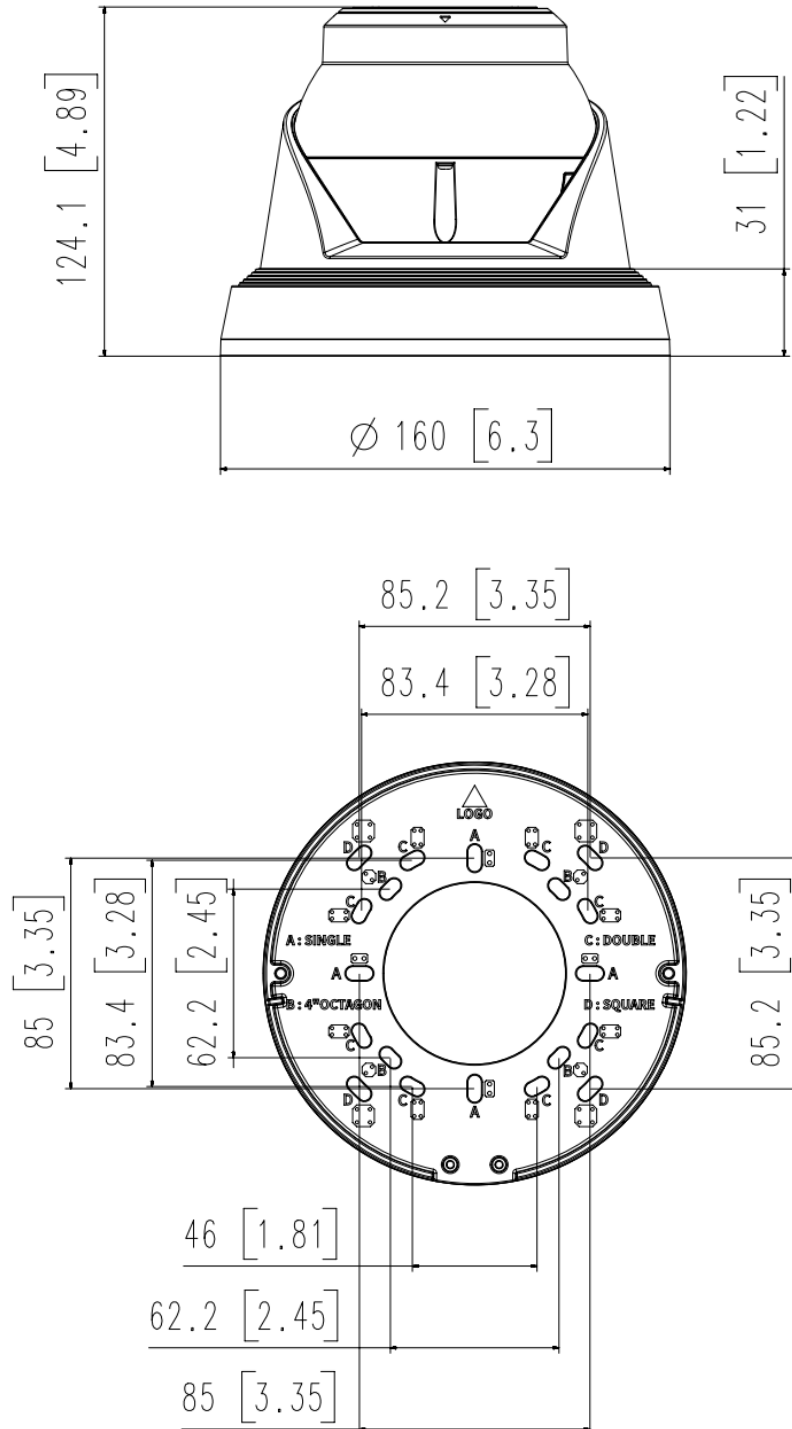
Enclosure Dimensions [Unit : mm]

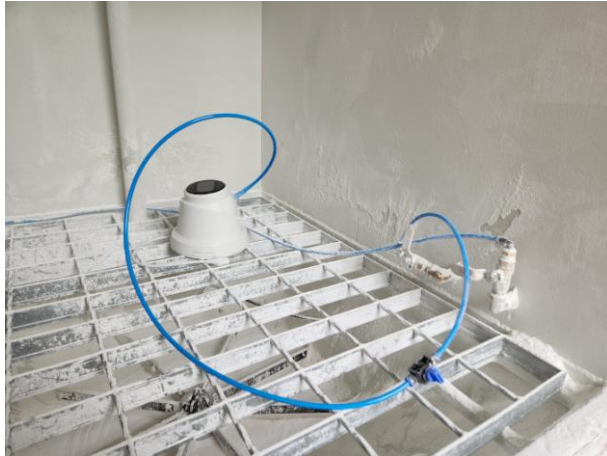
Dust test

| First characteristic numeral | Degree of protection | Application |
|---|---|---|
| 6 | <p>In Dust Testing Equipment, the test sample has to have no ingress of dust after testing atmospheric pressure present condition for 8 hr.</p> <p>(Talcum powder have to go through the measured sieve by <math>\Phi</math> 50 <math>\mu</math>m wire that are spacing 75 <math>\mu</math>m in squared, per volume and union Talcum powder have to be 2 kg/m<sup>3</sup>)</p> <p>Products in volume .....: <b>3 072 cm<sup>3</sup> → 3.07 L</b></p> <p>Target intake volume (Products in volume 80) .....: <b>245.76 L</b></p> <p>Suction volume (Max product in volume 60) .....: <b>184.32 LPH → 3.07 LPM</b></p> <p>Actual Suction volume .....: <b>3.07 L</b></p> <p>Suction pressure (Up to 2 kPa) .....: <b>1.77 kPa</b></p> <p>Test time (Up to 8 time) .....: <b>8 hr</b></p> | <input checked="" type="checkbox"/> |

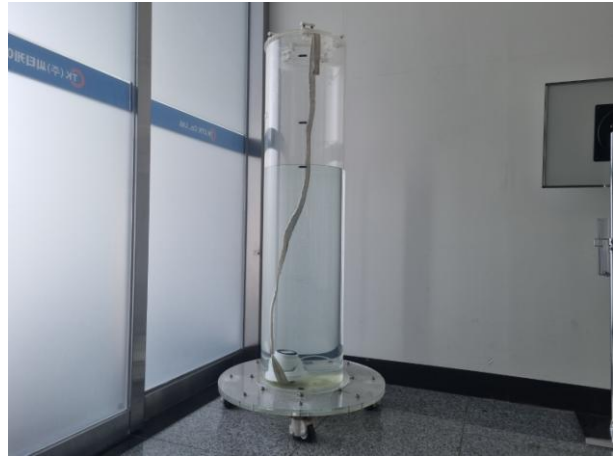
Water test

| Second characteristic numeral | Degrees of protection | Application |
|---|---|---|
| 7 | <p>Sink the product in the water by the Pressure and Time according to regulation and the product must not be harmed.</p> <p>Immersion tank water-level on enclosure with:</p> <p><input type="checkbox"/> height equal to or greater than 850 mm: the highest point of enclosures located 0.15 m below the surface of the water</p> <p><input checked="" type="checkbox"/> height less than 850 mm: the lowest point of enclosures located 1 m below the surface of the water</p> <p>Duration of test: 30 min</p> | <input checked="" type="checkbox"/> |

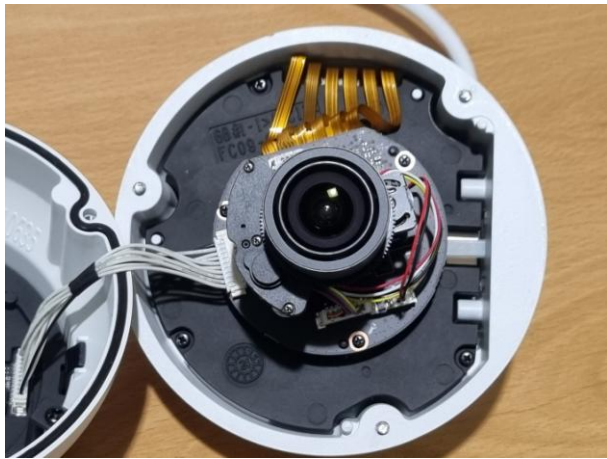
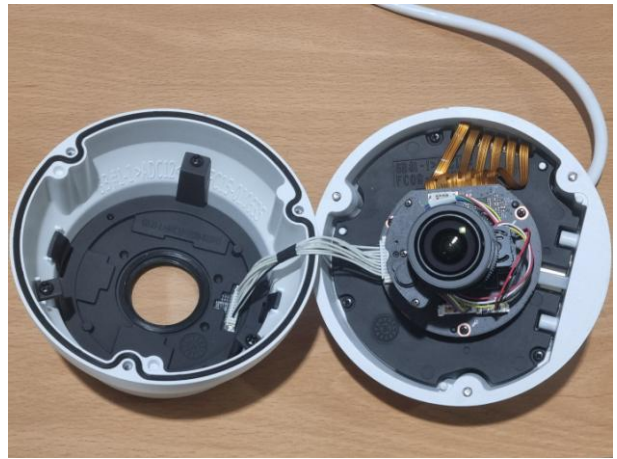
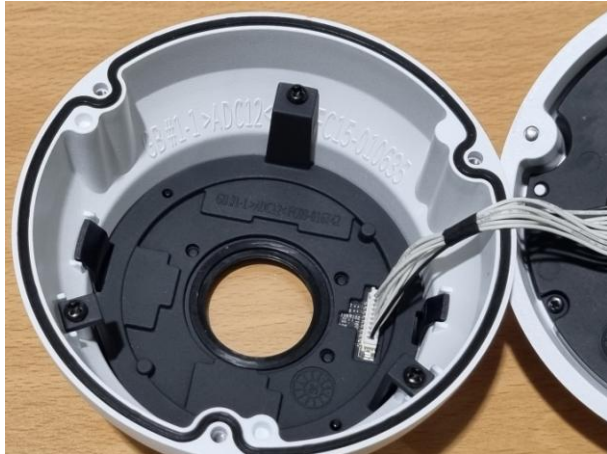
#### 4.2.2 Product internal images after test [The Second characteristic Numeral Test]

| IP code | Evaluation Criteria | Test Results | Remark |
|---|---|---|---|
| IP X7 | No ingress of water. | Normal | - |
