# TEST REPORT

| <br>CTK Co., Ltd.<br>The Power Leader of Global Regulatory Compliance | <b>CTK Co., Ltd.</b><br>5 Dongbu-ro 221beon-gil, Cheoin-gu, Yongin-si,<br>Gyeonggi-do, Republic of Korea<br>Tel: +82-31-339-9970<br>Fax: +82-31-624-9501 | REPORT No.:<br>CTK-2024-01391<br>Page (1) / (14) pages | |

NETWORK CAMERA / ANE-L8082R

KS C IEC 62262: 2005

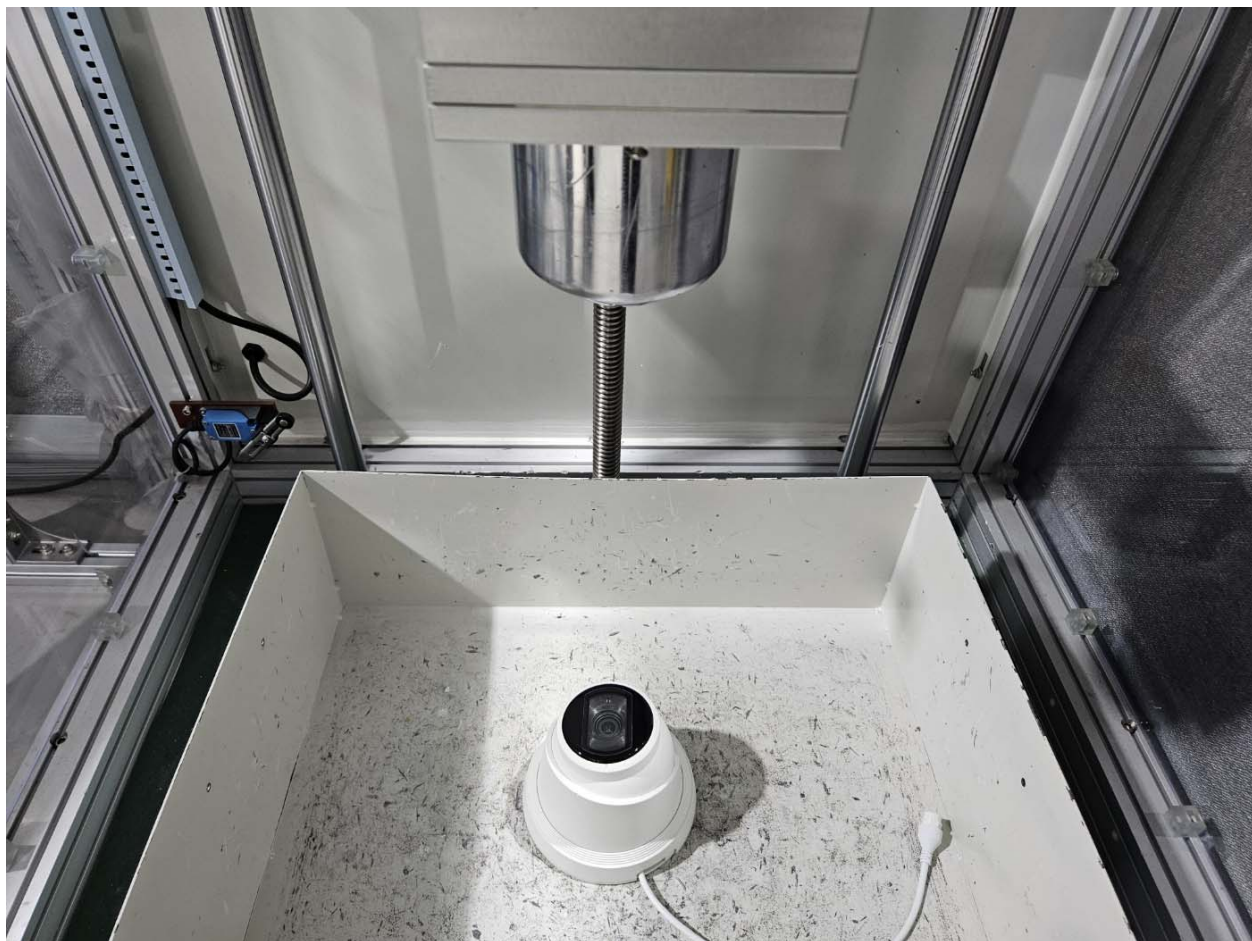
Test environment setup image\_1

| IK code | Impact Energy (J) | Equivalent mass (kg) | Drop height (mm ± 1%) | Application |
|---|---|---|---|---|
| 10 | 20.00 | 5.00 | 400 | <input checked="" type="checkbox"/> |
| - Impact times: five times for each of the exposed surface. (Do not impact more than 3 times in the same spot) | | | | |

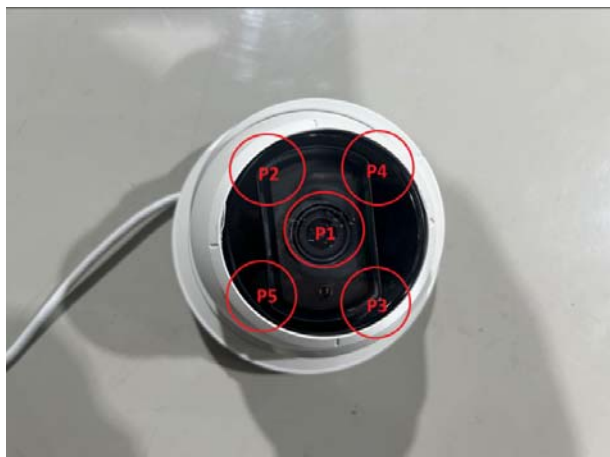
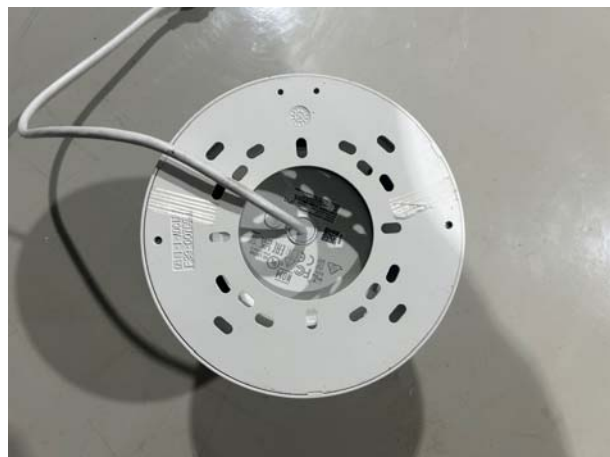
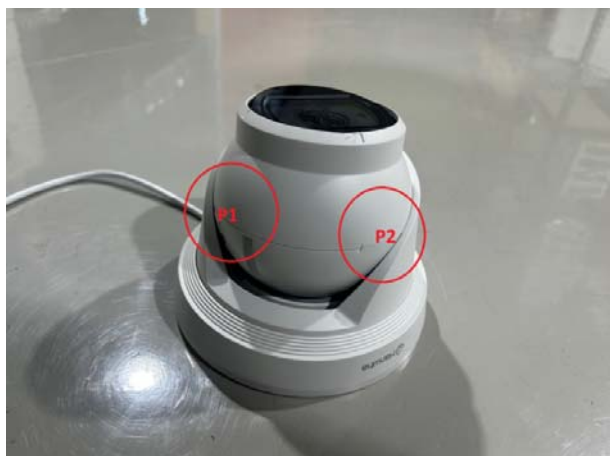
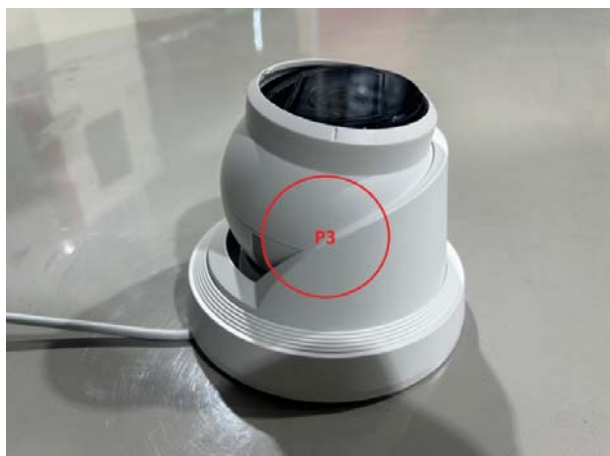
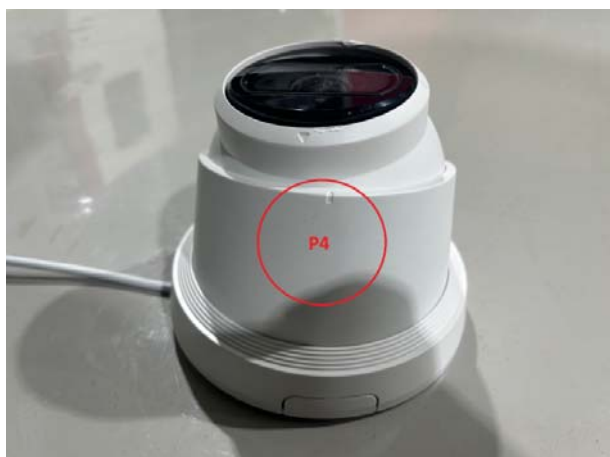
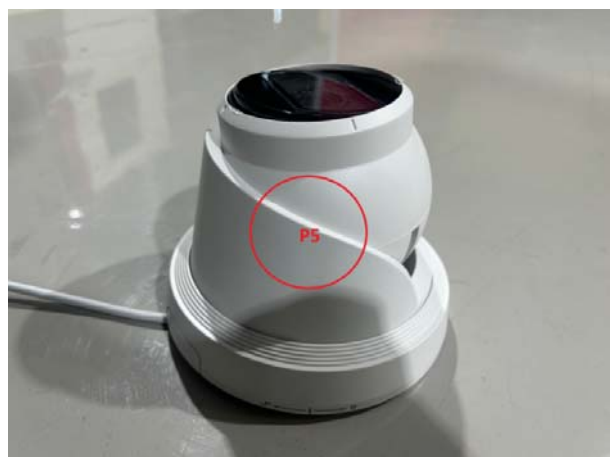
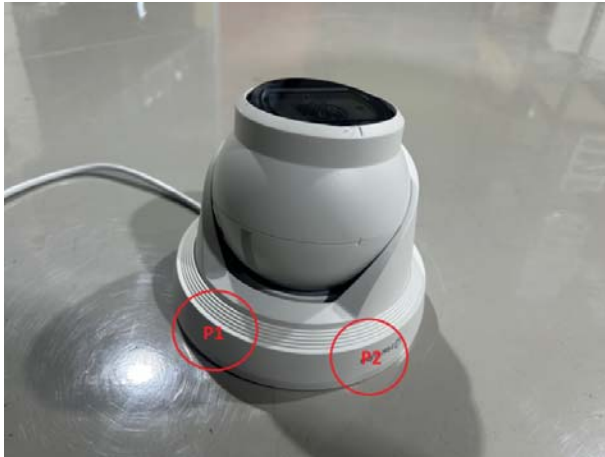
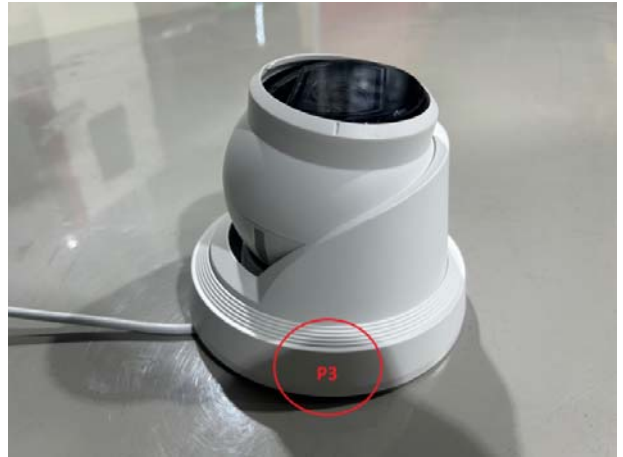
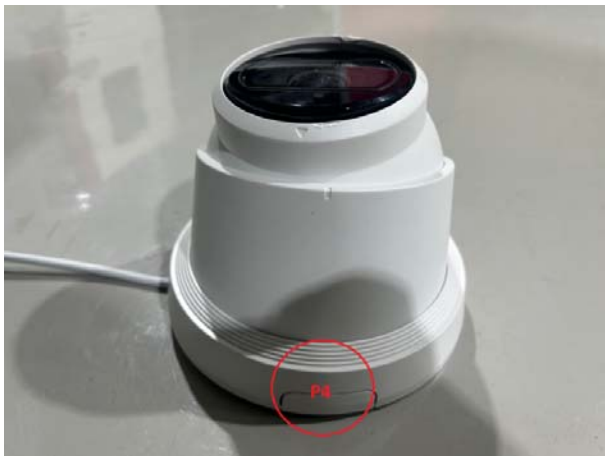
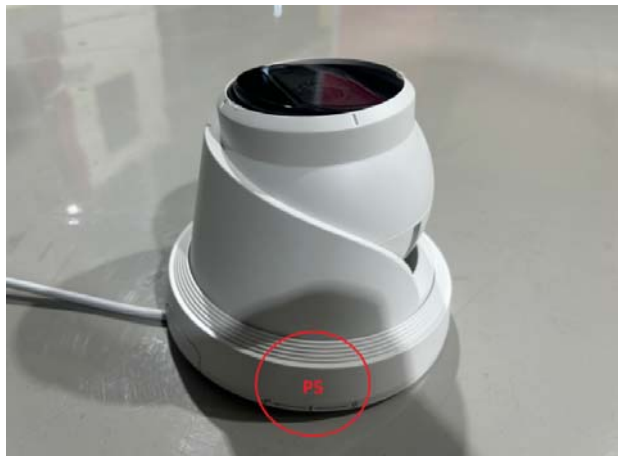
### 4.2.1 Check the hit area during the test

| Evaluation Criteria | | Test Results |
|---|---|---|
| | Post-test | Some scratches were generated on the outside of the product. |
