# TEST REPORT

REPORT No.:  
CTK-2025-00970  
Page (1) / (15) pages

NETWORK CAMERA / PND-A9082RV

IEC 60529:1989 +A1:1999+A2:2013

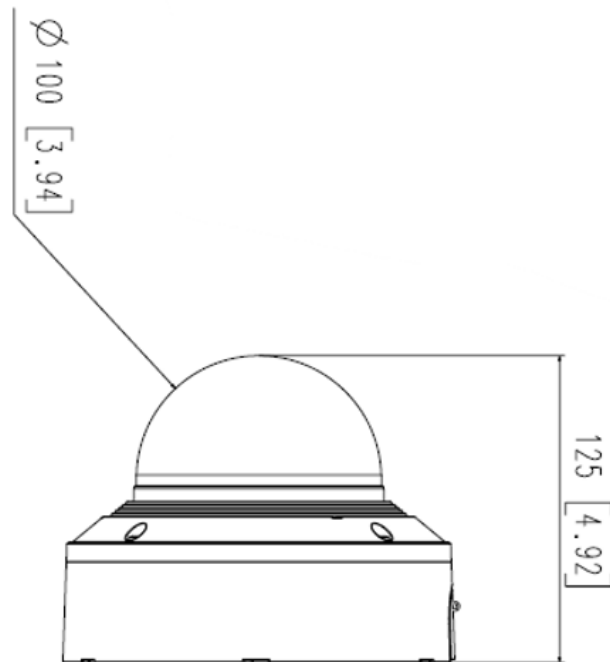
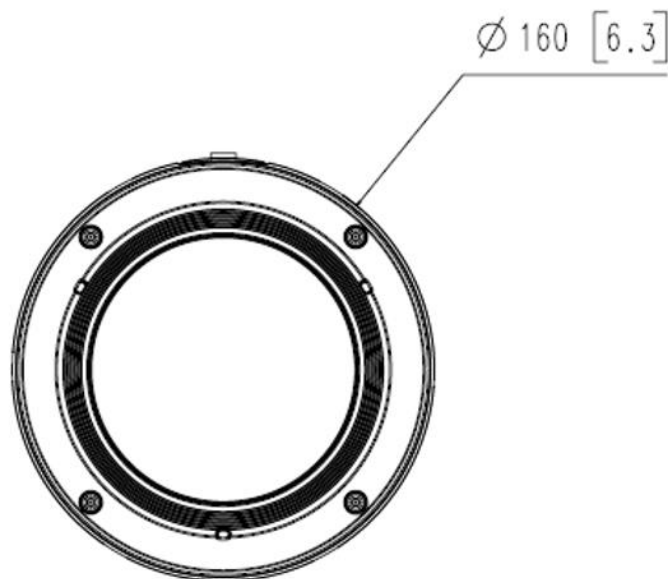
Enclosure dimensions [unit : mm]

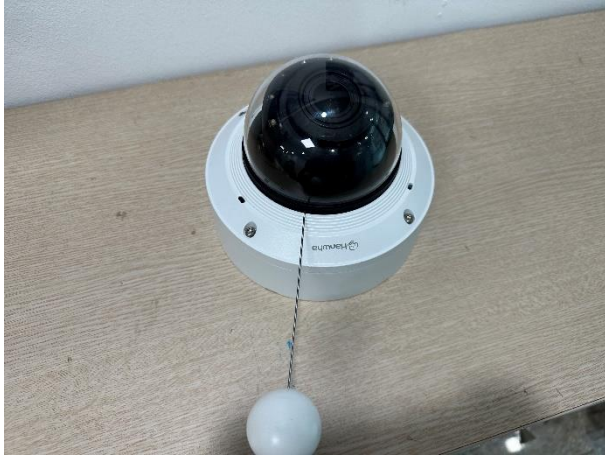
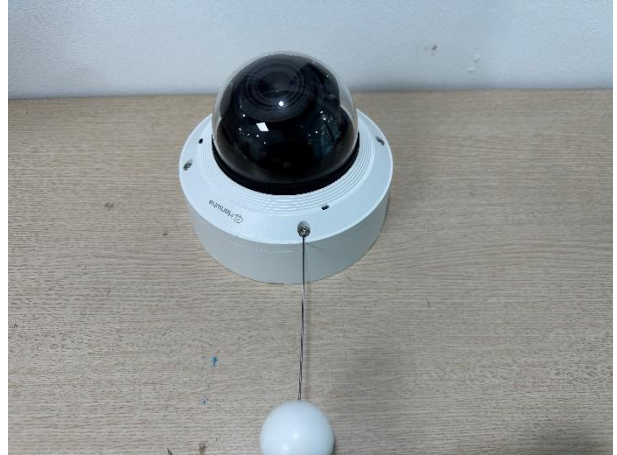
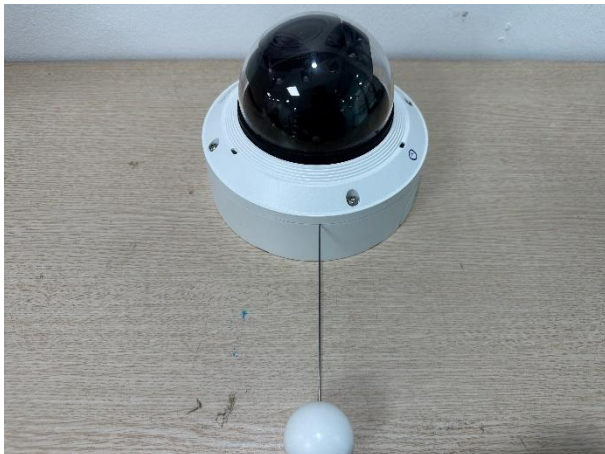
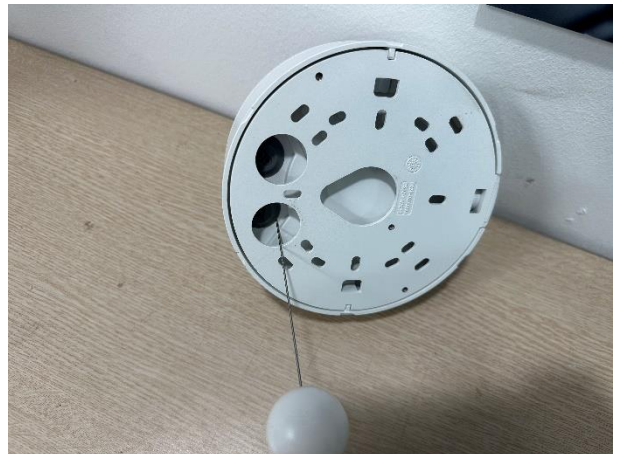
| First characteristic numeral | Degree of protection | Application |
|---|---|---|
| 5 | Protected against access to hazardous parts with a wire.<br>The access probe of 1.0 mmØ, shall not penetrate.<br>Test force: 1 N ± 10 % | <input checked="" type="checkbox"/> |

Probe test

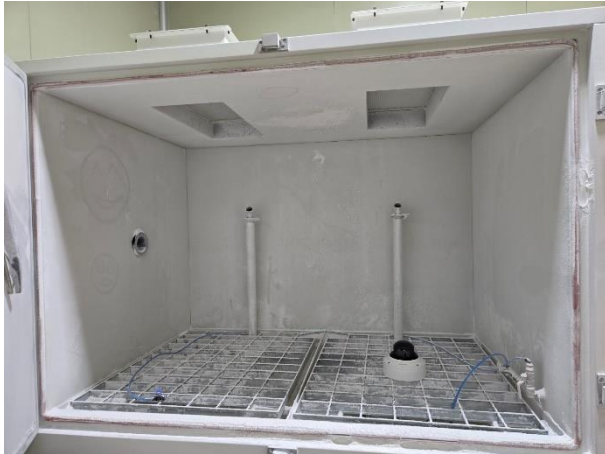
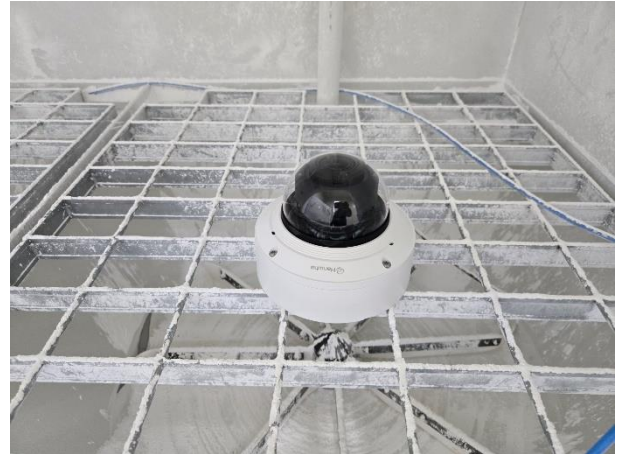
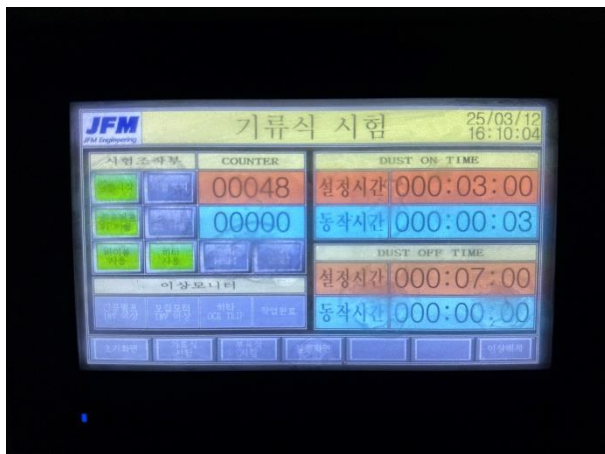
| First characteristic numeral | Degree of protection | Application |
|---|---|---|
| | <p><b>Category 2:</b> Enclosures where no pressure difference relative to the surrounding air is present.</p> | <input checked="" type="checkbox"/> |

Dust test

Dust test Monitor

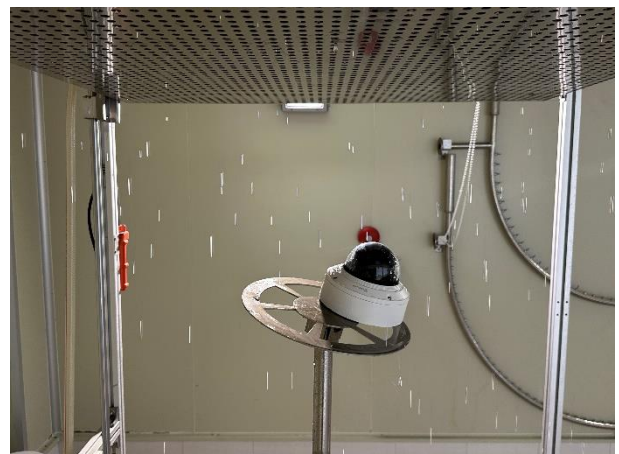
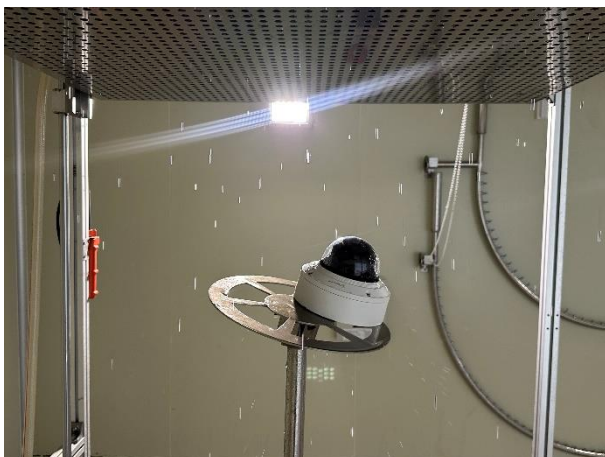
| Second characteristic numeral | Degrees of protection | Application |
|---|---|---|
| 2 | <p>When outskirts of the product have been tilted by 15° Water that drops verticality has to be harmless.</p> <p>Drip box Fig.3, Enclosure in 4 fixed positions of 15° tilt</p> <p>Water flow rate: 3 mm/min</p> <p>Duration of test: 2.5 min for each position of tilt</p> | <input checked="" type="checkbox"/> |

Water test

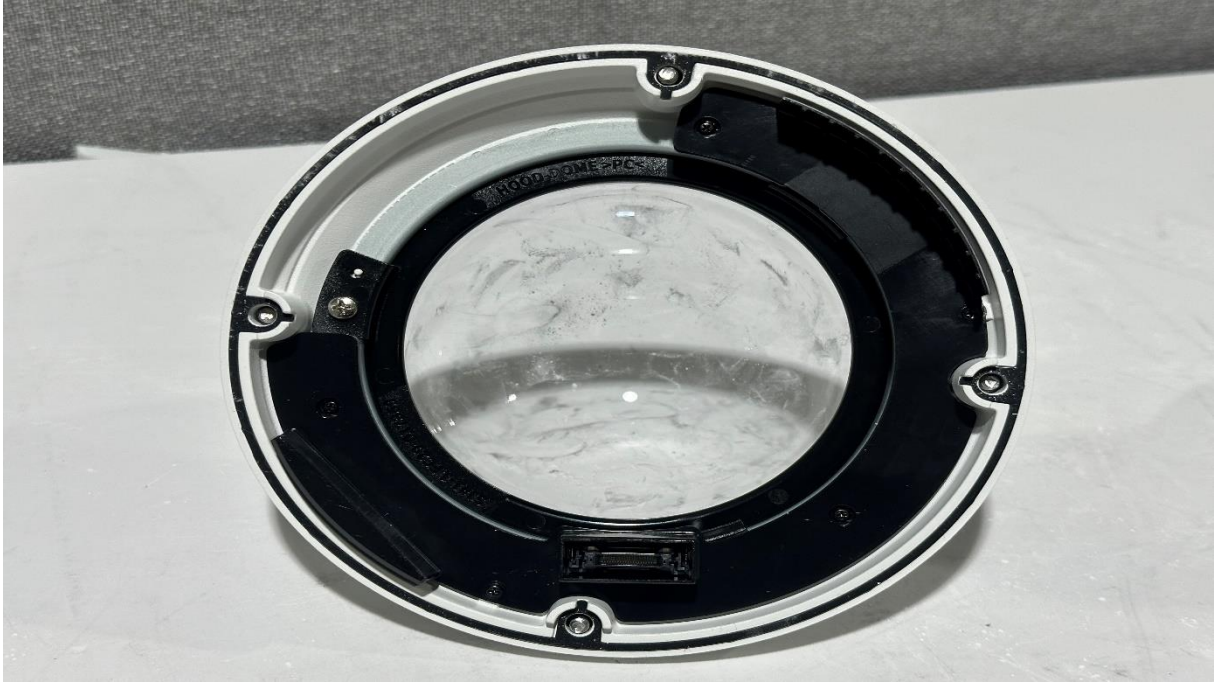
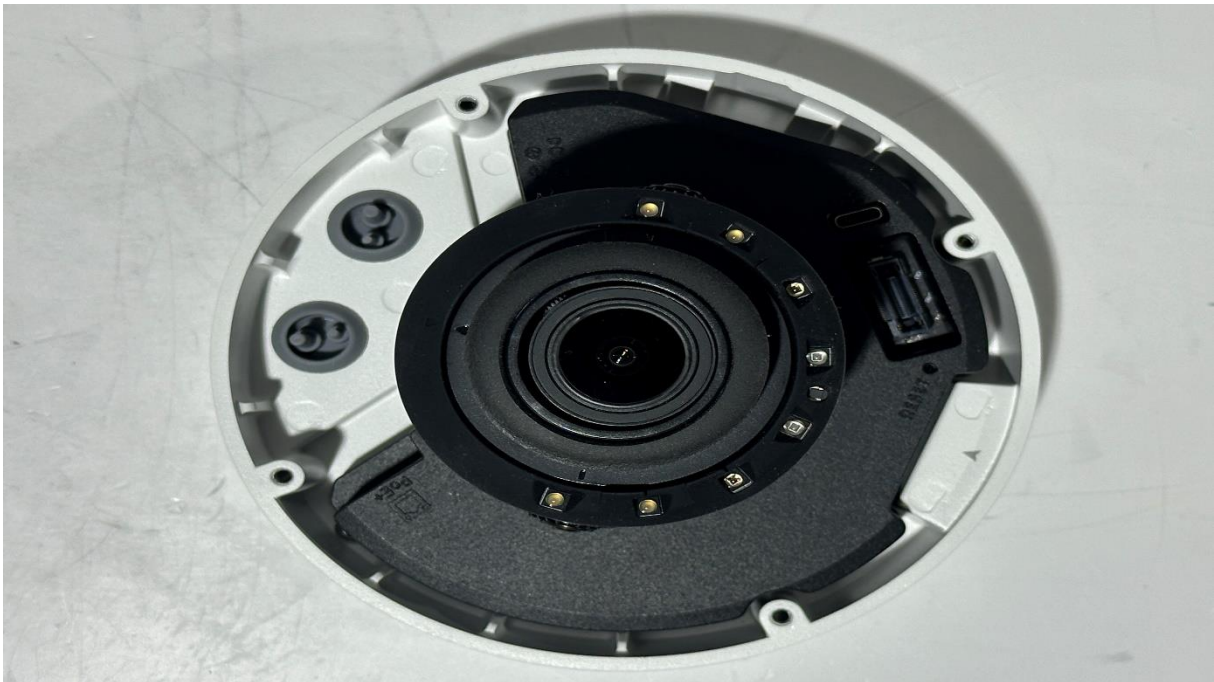
#### 3.5.1 Product internal images after test [The first characteristic numeral test]

| IP code | Evaluation Criteria | Test Results | Remark |
|---|---|---|---|
| IP 5X | No ingress of Probe | Normal | - |
| | No ingress of dust | Normal | |

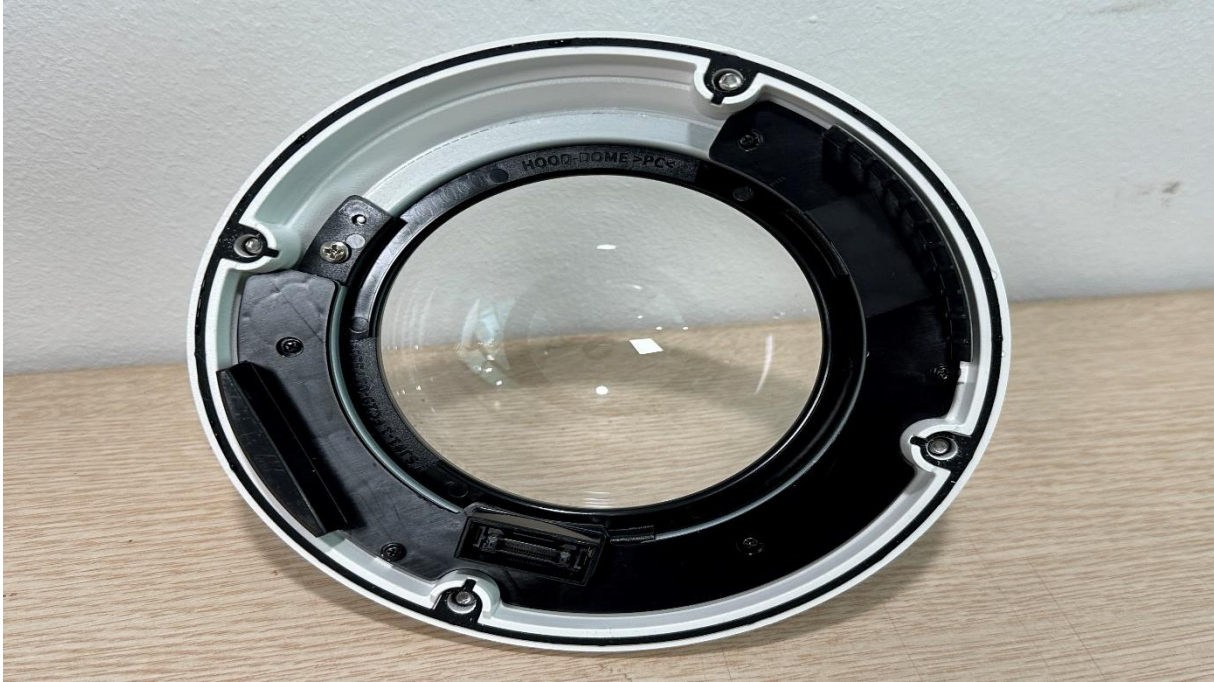
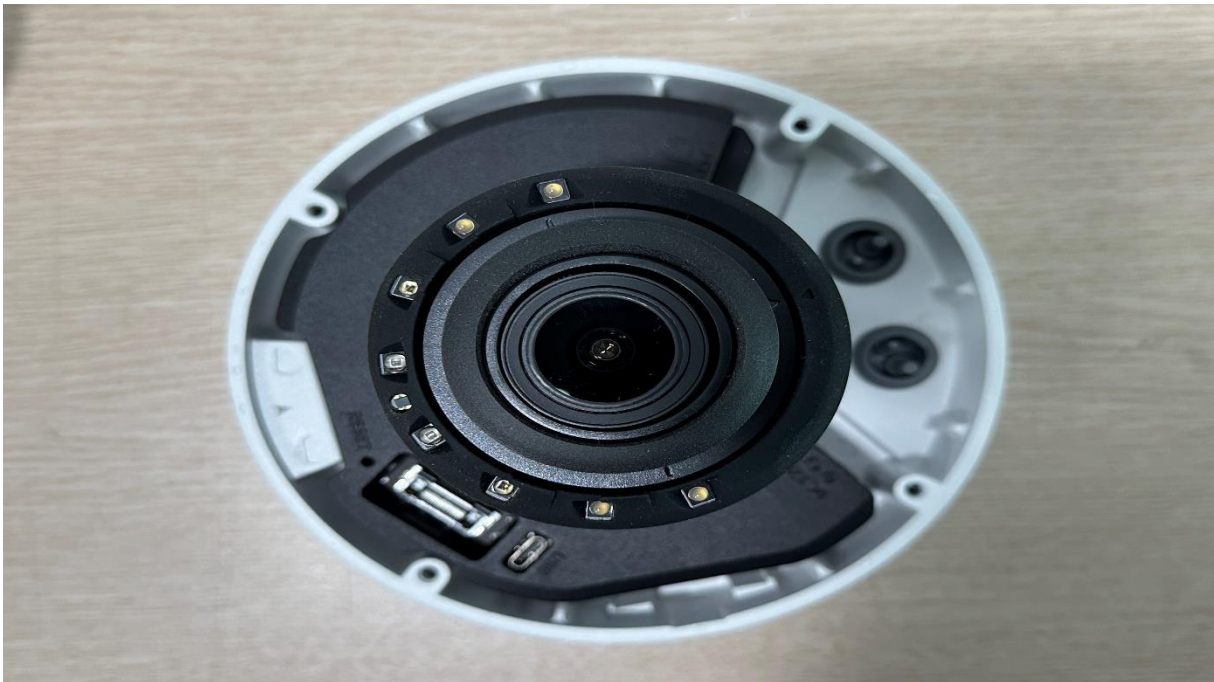
### 3.5.2 Product internal images after test [The second characteristic numeral test]

| IP code | Evaluation Criteria | Test Results | Remark |
|---|---|---|---|
| IP X2 | No ingress of water | Normal | |
