# TEST REPORT

REPORT No.:  
CTK-2019-0161-1  
Page (1) / (9) pages

**3. Use of Report :** Quality control**4. Test Sample / Model:** Network Camera /

PNM-9084RQZ\*(\* is Blank or N or P : P=PAL, N=NTSC )

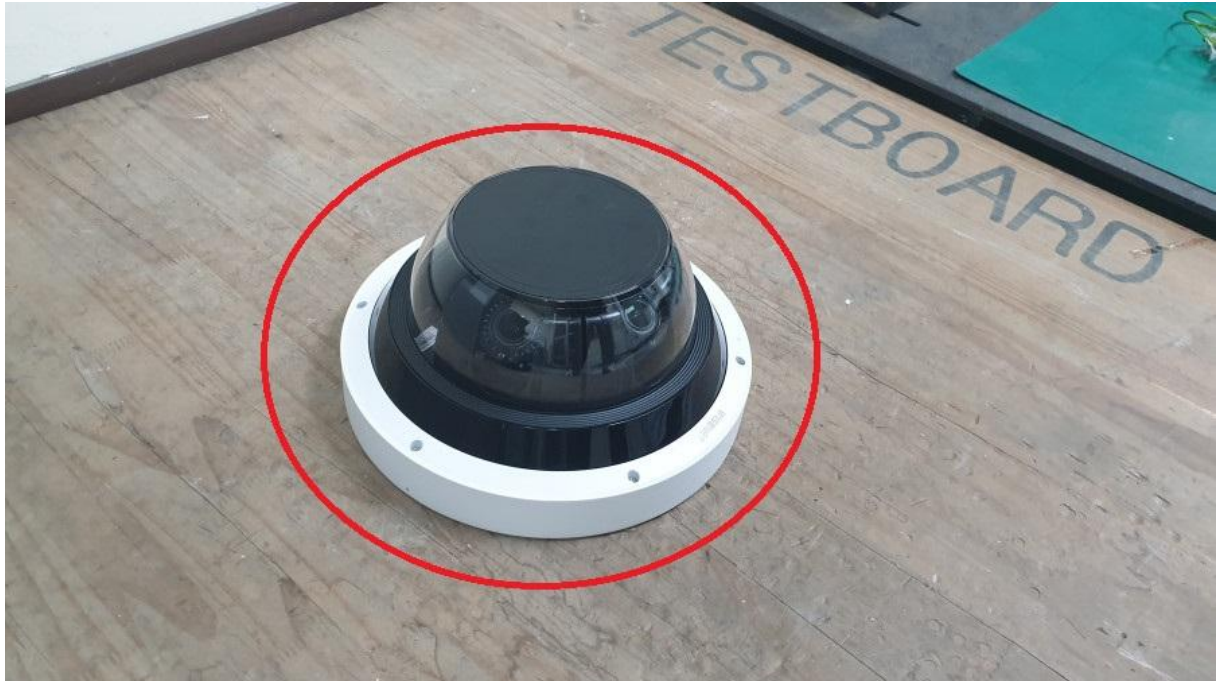
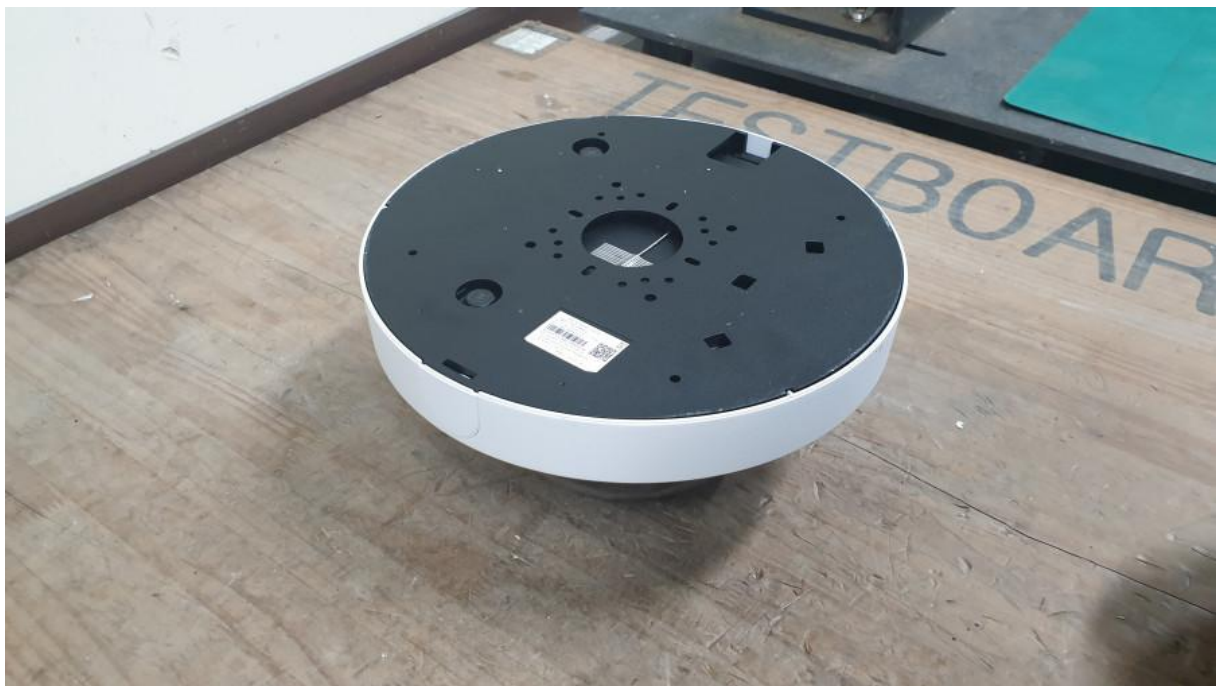
## 2.3 Photos after test

| Item | Contents | Result |
|---|---|---|
| External protection Enclosure | No damage | Pass |
| Comment<br><br>Some scratches were generated on the outside of the product. | | |
