# TEST REPORT

REPORT No.:  
CTK-2024-01573  
Page (1) / (13) pages

NETWORK CAMERA / PNM-C32083RQZ

IEC 60529:1989 +A1:1999+A2:2013

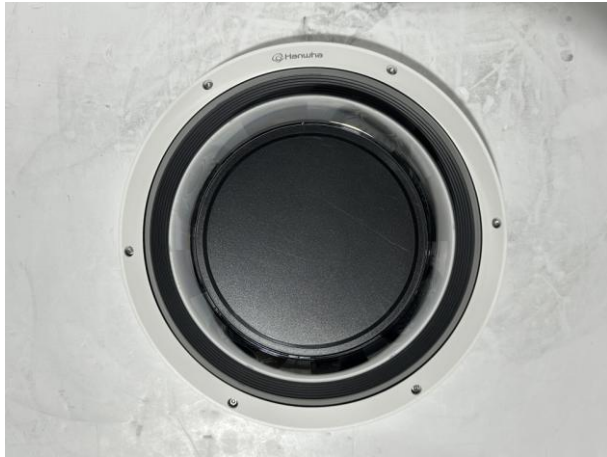
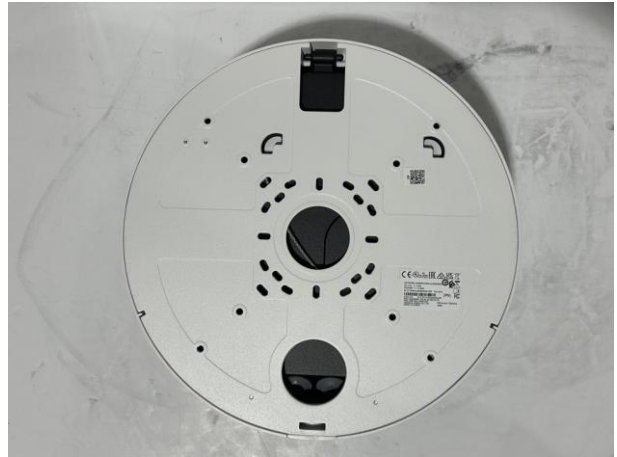
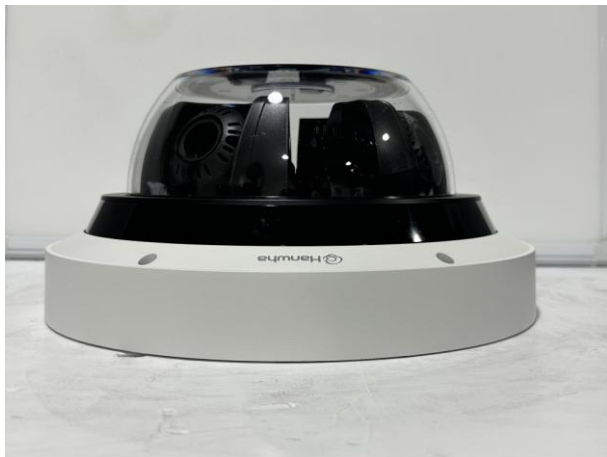
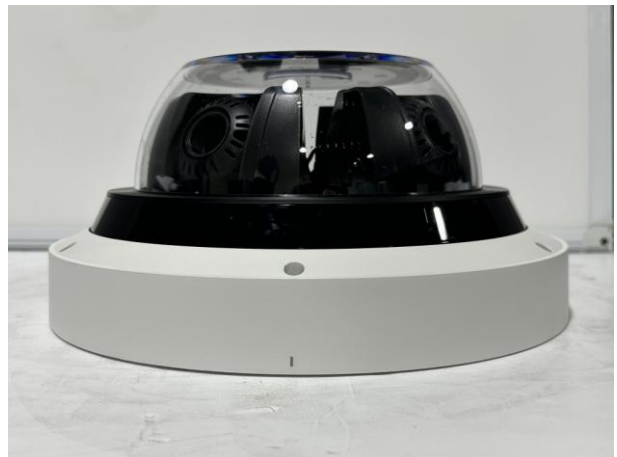
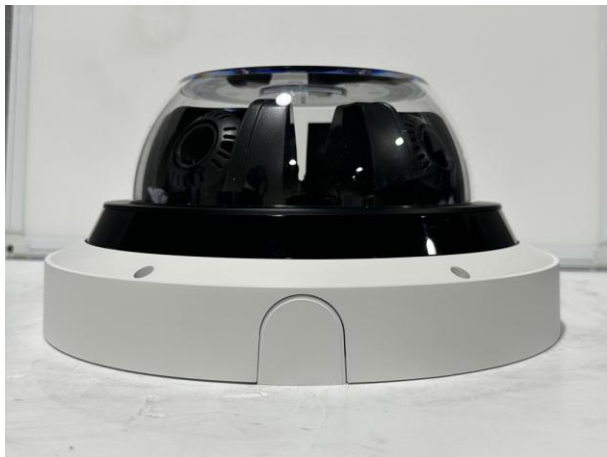
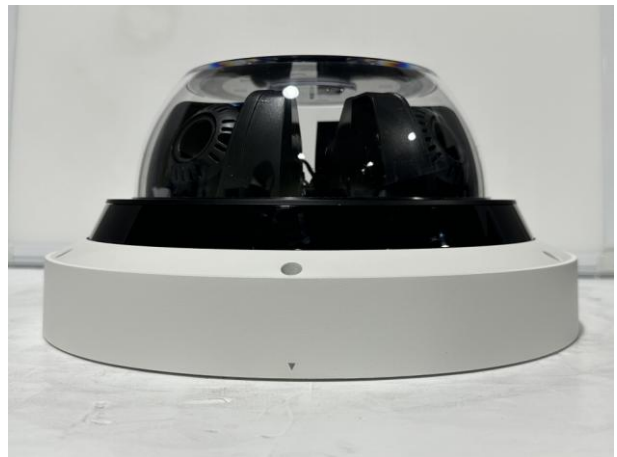
Top

Bottom

Front

Rear

Left side

Right side

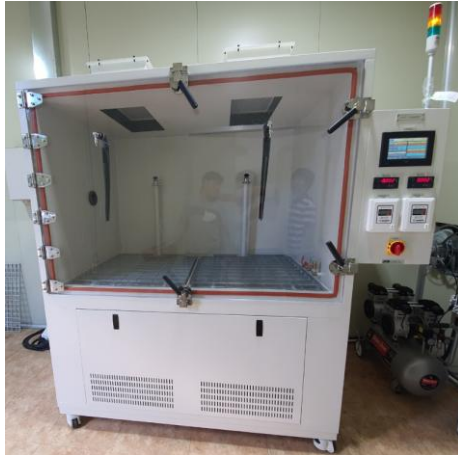
Dust Chamber

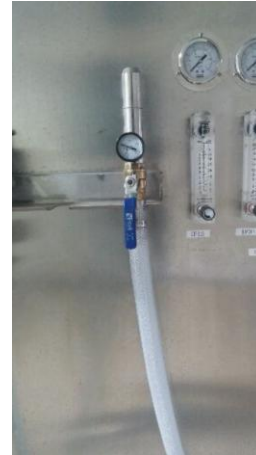
Hose Nozzle (12.5 mm)

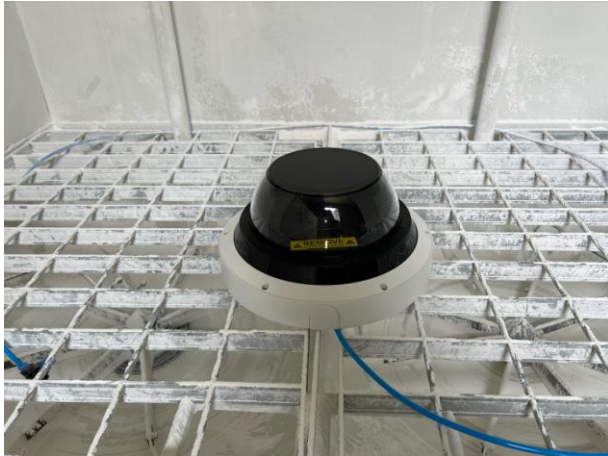
| First characteristic numeral | Degree of protection | Application |
|---|---|---|
| 6 | <p>In Dust Testing Equipment, the test sample has to have no ingress of dust after testing atmospheric pressure present condition for 8 hr.</p> <p>(Talcum powder have to go through the measured sieve by <math>\Phi</math> 50 <math>\mu</math>m wire that are spacing 75 <math>\mu</math>m in squared, per volume and union Talcum powder have to be 2 kg/m<sup>3</sup>)</p> <p>Products in volume .....: <b>2 016 cm<sup>3</sup> → 2.02 L</b></p> <p>Target intake volume (Products in volume 80) .....: <b>161.28 L</b></p> <p>Suction volume (Max product in volume 60) .....: <b>120.96 LPH → 2.02 LPM</b></p> <p>Actual Suction volume .....: <b>2.02 L</b></p> <p>Suction pressure (Up to 2 kPa) .....: <b>2 kPa</b></p> <p>Test time (Up to 8 time) .....: <b>8 hr</b></p> | <input checked="" type="checkbox"/> |

Dust test

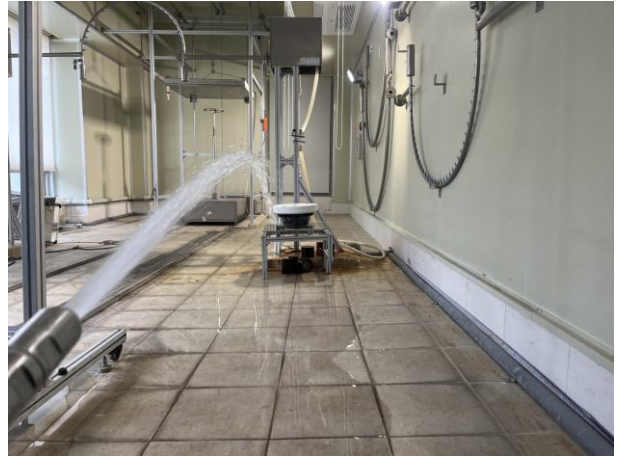
| Second characteristic numeral | Degrees of protection | Application |
|---|---|---|
| 6 | <p>The product must not be harmed in any direction even strong jet water.</p> <p>Water jet hose nozzle Fig.6, Nozzle 12.5 mm diameter</p> <p>Water flow rate: 100 l/min <math>\pm</math> 5 % : <b>100 LPM</b></p> <p>Distance: 2.5 m to 3 m: <b>2.5 m</b></p> <p>Duration of test: 1 min/m<sup>2</sup> at least 3 min: <b>3 min</b></p> | <input checked="" type="checkbox"/> |

Water test

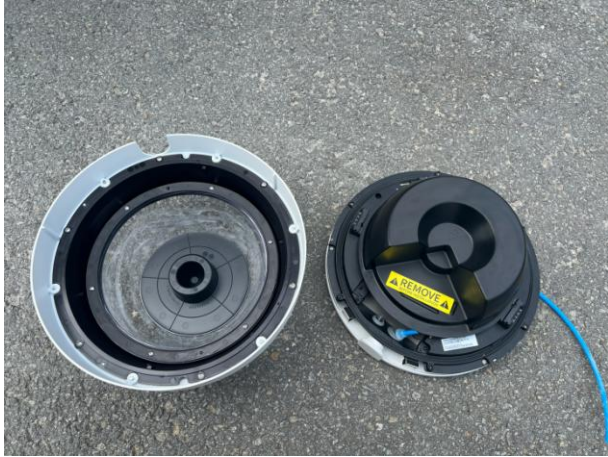
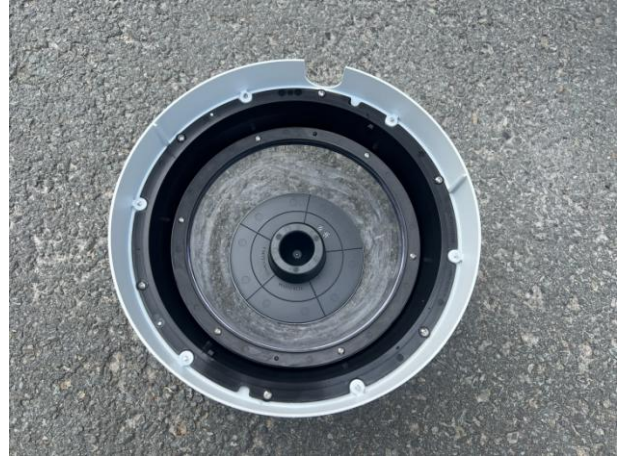
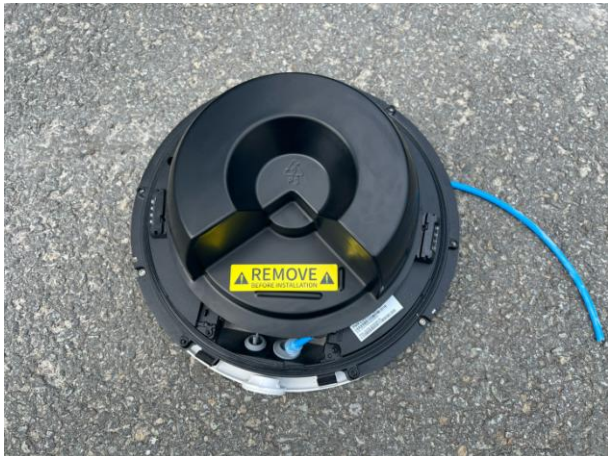
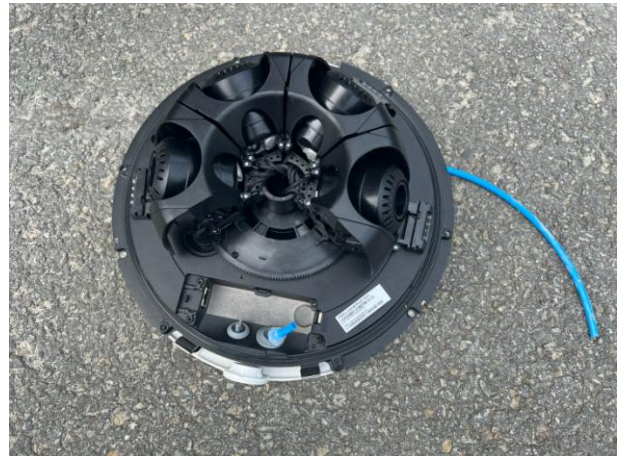
### 4.2.1 Product internal images after test [The First characteristic Numeral Test]

| IP code | Evaluation Criteria | Test Results | Remark |
|---|---|---|---|
| | No ingress of dust. | Normal | - |

Dust test\_1

Dust test\_2

Dust test\_3

Dust test\_4

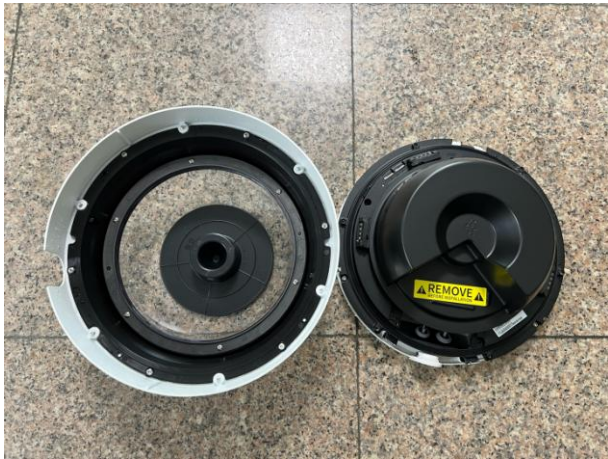
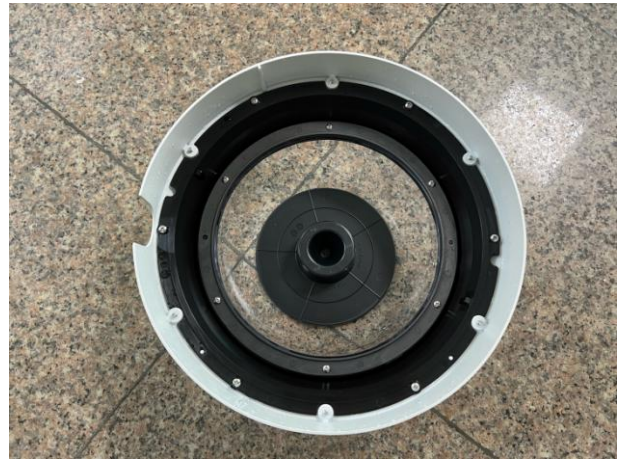
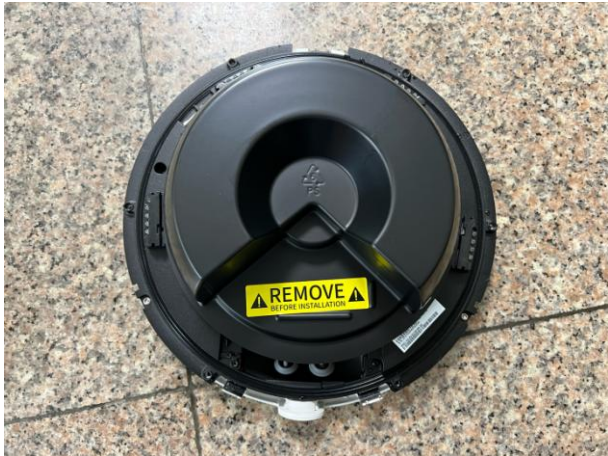
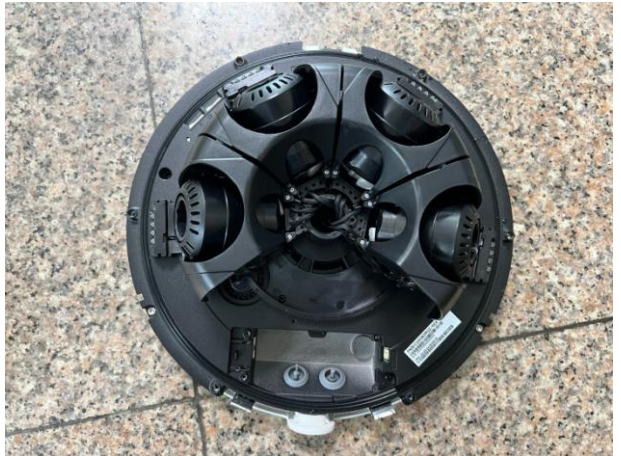
#### 4.2.2 Product internal images after test [The Second characteristic Numeral Test]

| IP code | Evaluation Criteria | Test Results | Remark |
|---|---|---|---|
| IP X6 | No ingress of water. | Normal | - |

Water test\_1

Water test\_2

Water test\_3

Water test\_4
