# TEST REPORT

REPORT No.:  
CTK-2025-01427  
Page (1) / (24) pages

NETWORK CAMERA / PNO-A7082R

NEMA TS 2-2013 2.2.7.2 Test B ~ 2.2.7.8, NEMA TS 2.2.8,  
NEMA TS 2.2.9

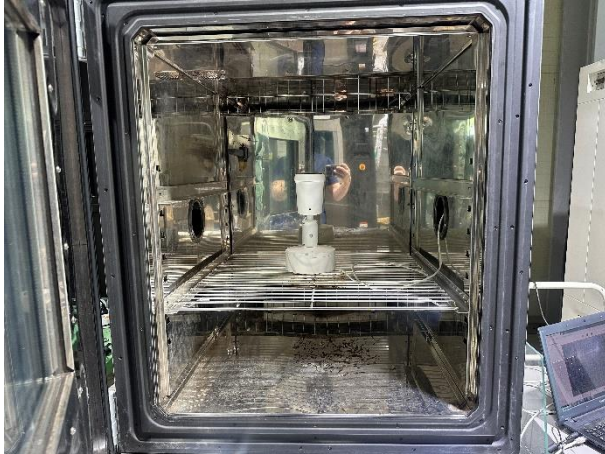
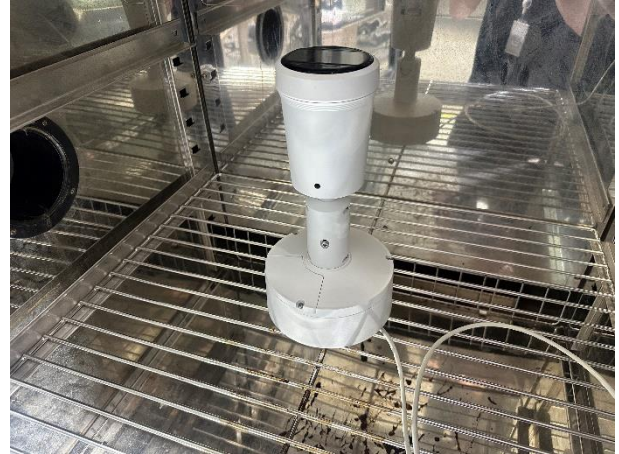
Transient Tests

#### 3.3.1 Evidence of test setting (2.2.7.2 Test B ~ 2.2.7.8 Transient Test)

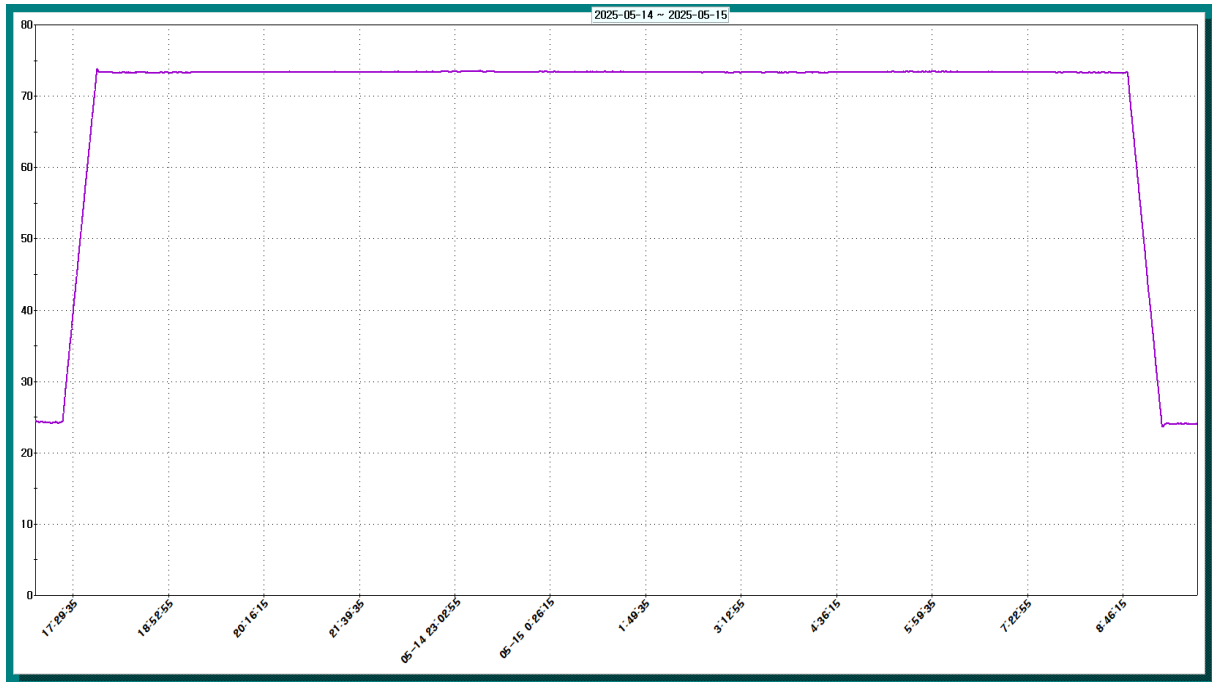
Temperature Data

#### 3.5.1 Power Service [NEMA TS 2-2013 2.2.7.2 Test B ~ 2.2.7.8 – 13. C]

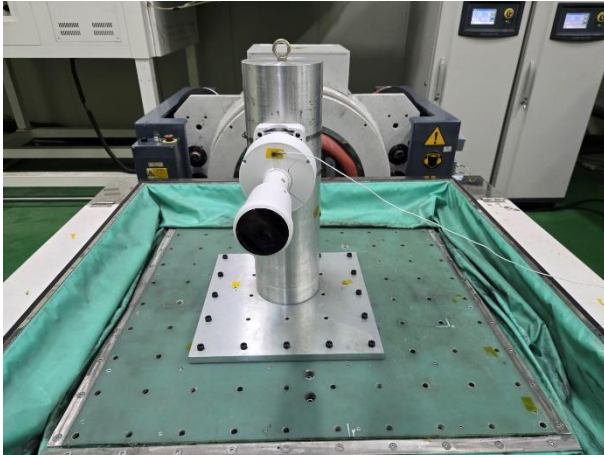
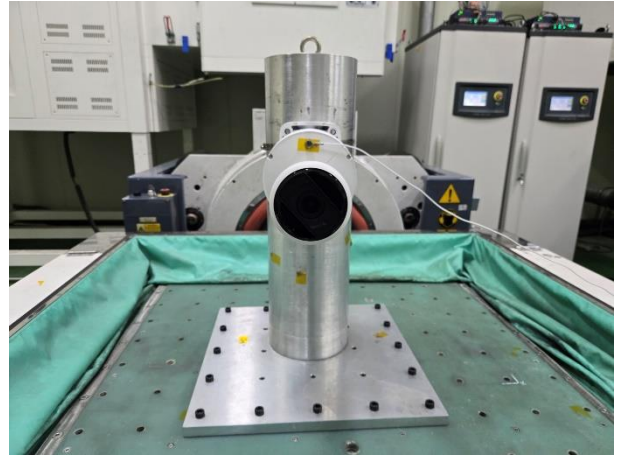
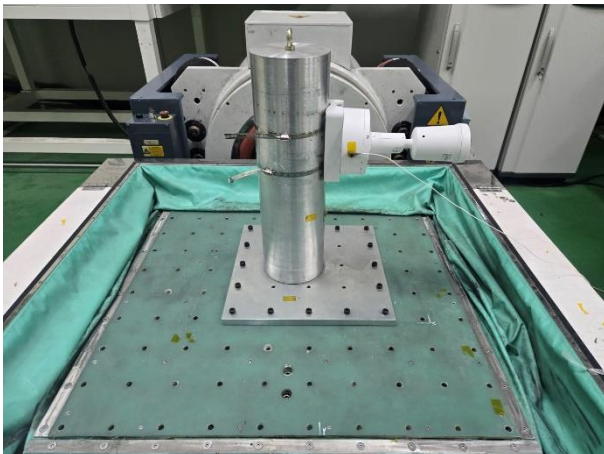
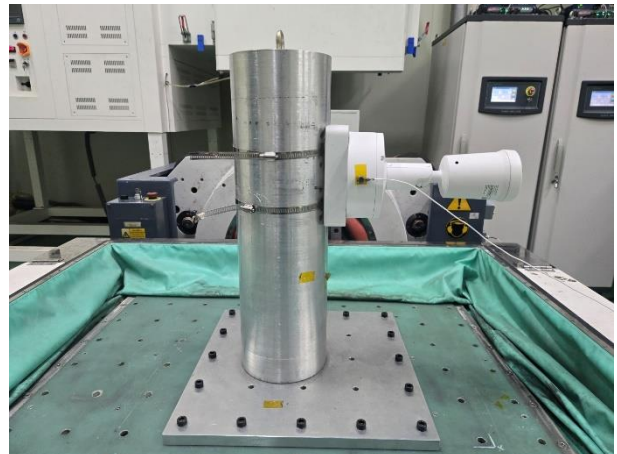
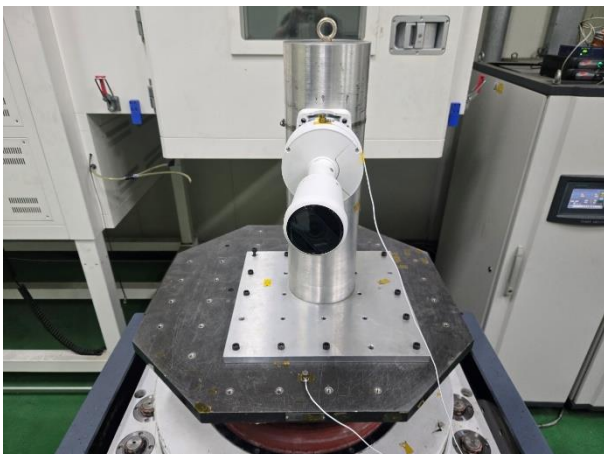
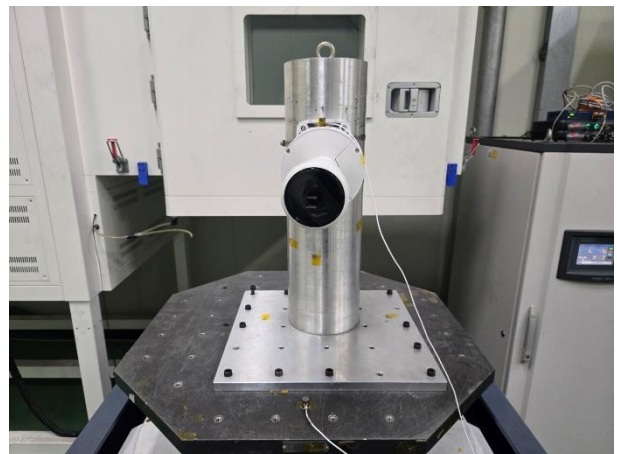
#### 4.3.1 Evidence of test setting (NEMA TS 2-2013 2.2.8)

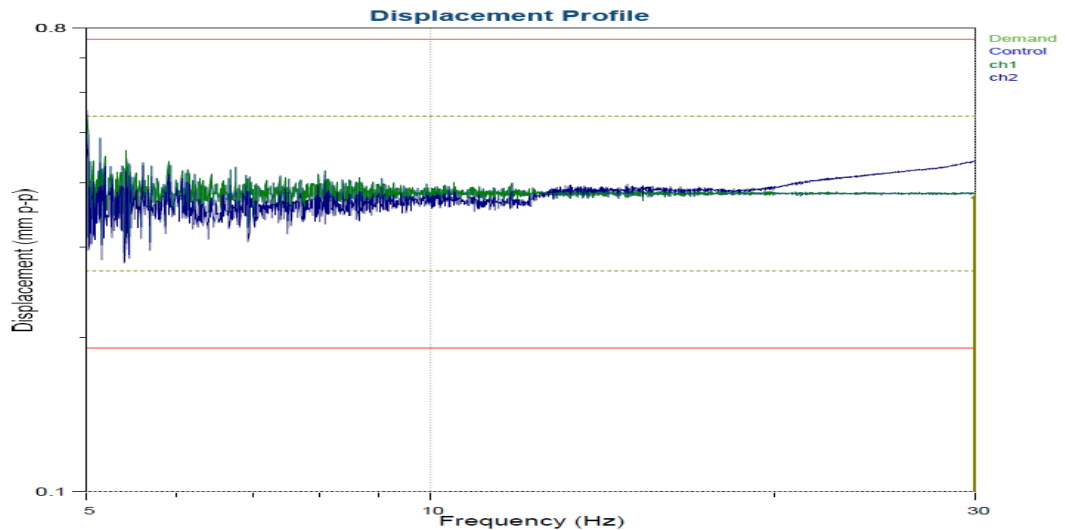
#### Resonant search Test ( X Axis )

5 05, 2025 11:00:01 Level 1) 100 % Output: 0 Volts peak NEMA TS-2 2.2.8 - search.  
Demand: 0.381 mm Level Time: 0:12:3 Frequency: 30 Hz:  
Control: 0.0008803 mm Total Time: 0:12:3 End of Sweep Test

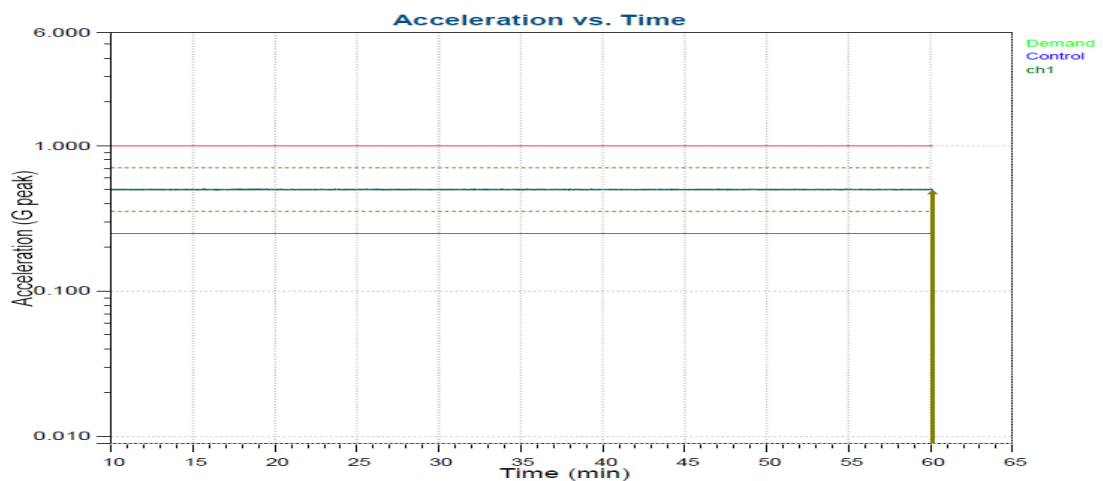
#### Endurance Test ( X Axis )

5 05, 2025 12:01:00 Level 1) 100 % Output: 0 Volts peak 한화비전 공진 L  
Demand: 0.5 G Level Time: 1:00:00 Frequency: 30 Hz  
Control: 0.0004358 G Total Time: 1:00:07 End of Timed Test

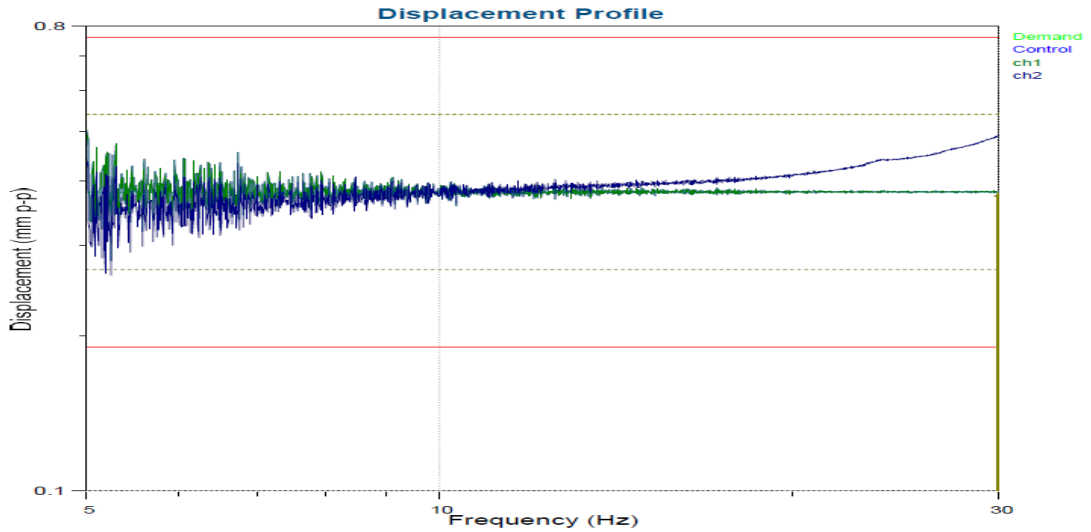
### Resonant search Test ( Y Axis )

5 05, 2025 12:20:1 Level 1) 100 % Output: 0.000293 Volts pea NEMA TS-2 2.2.8 - search.  
Demand: 0.381 mm Level Time: 0:12:3 Frequency: 30 H:  
Control: 0.001627 mm Total Time: 0:12:3 End of Sweep Test

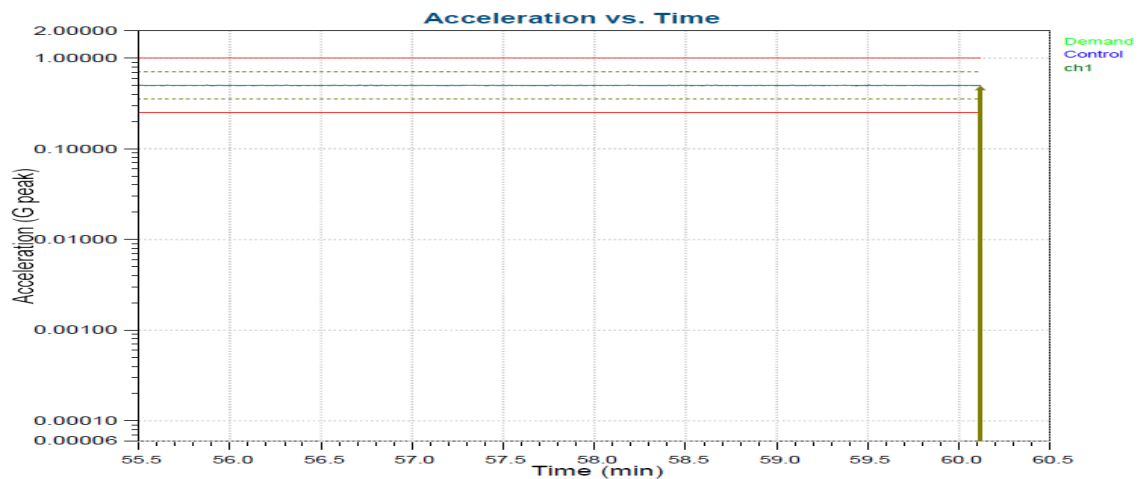
### Endurance Test ( Y Axis )

5 05, 2025 13:39:26 Level 1) 100 % Output: 0 Volts peak 한화비전 공진 L  
Demand: 0.5 G Level Time: 1:00:00 Frequency: 30 Hz  
Control: 0.004027 G Total Time: 1:00:07 End of Timed Test

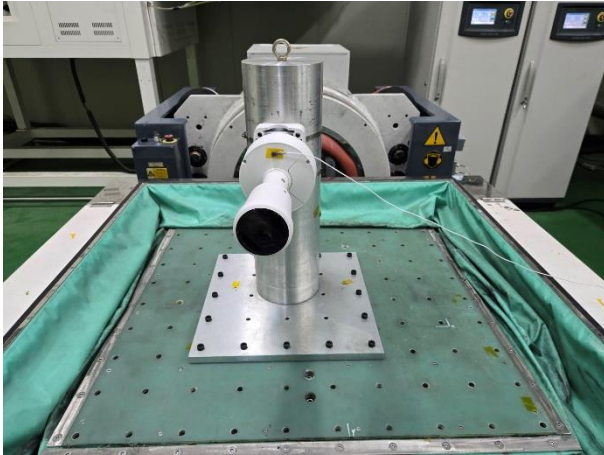
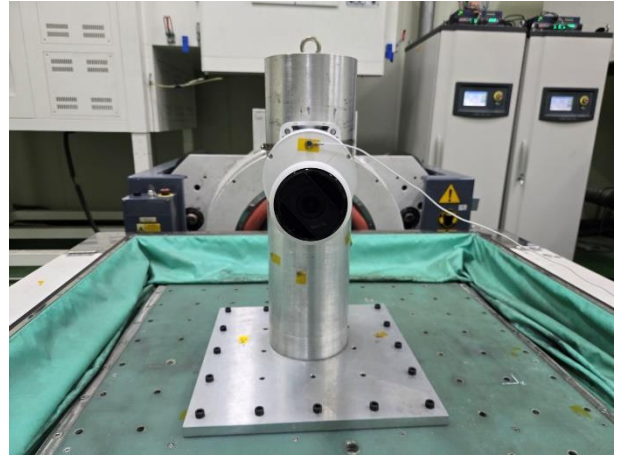
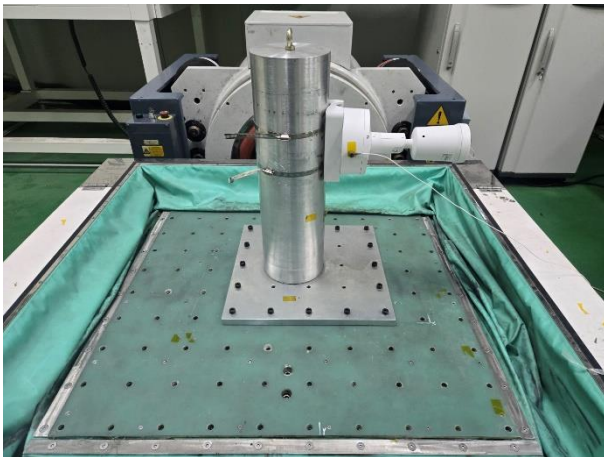
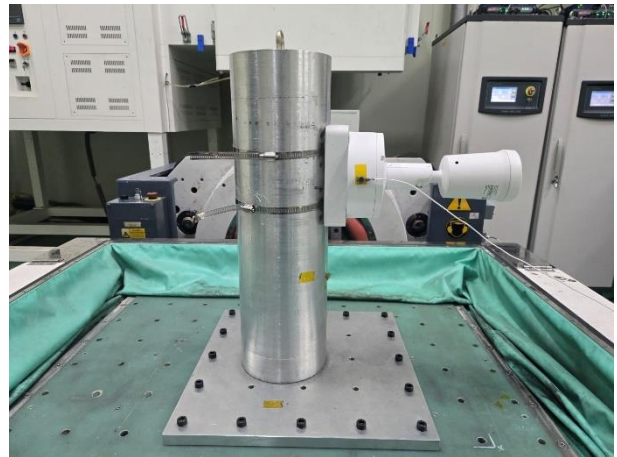
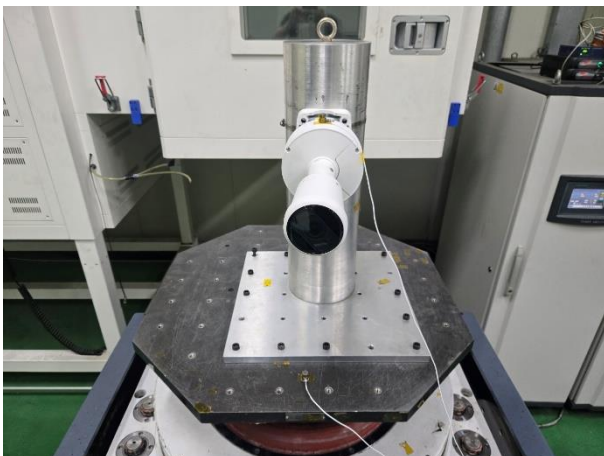
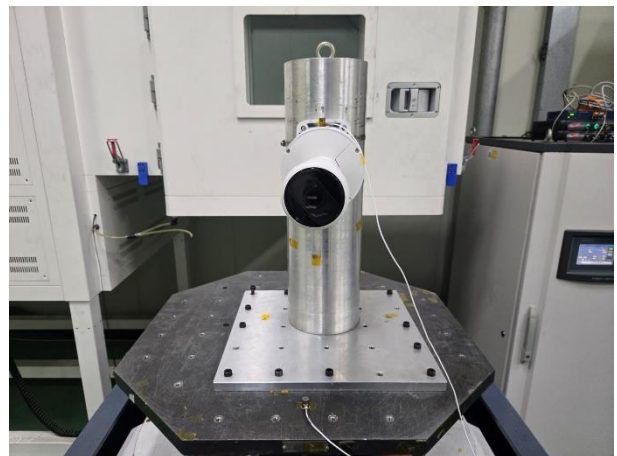
#### 5.3.1 Evidence of test setting (NEMA TS 2-2013 2.2.9)

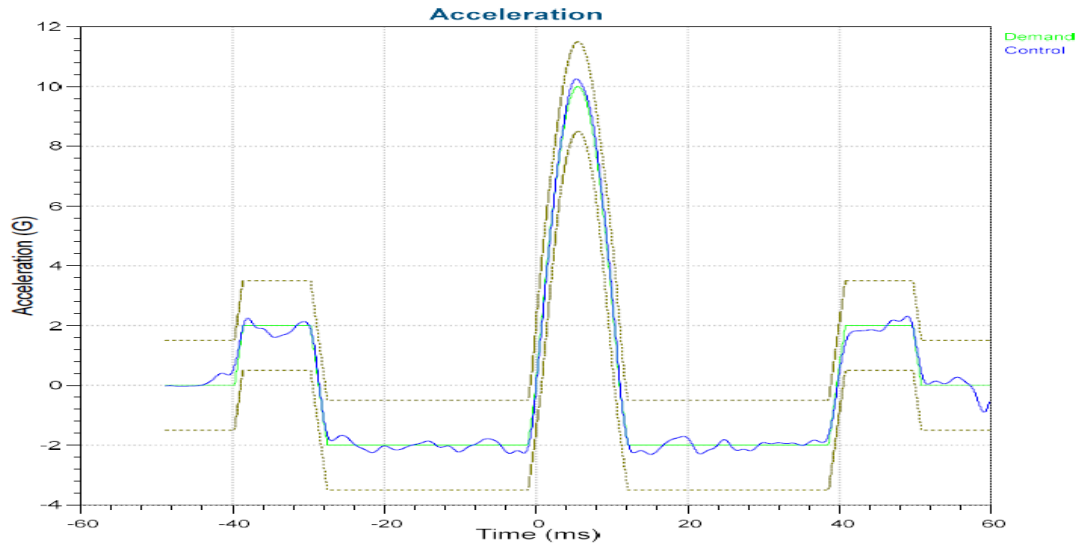
X+

5 05, 2025 12:06:16 Level 1) 100 % Output: 0.7921 Volts peak NEMA TS-2 2.2.9 ...

Demand: 10 G

Control: 10.26 G Pulse: 1 of 1 Running

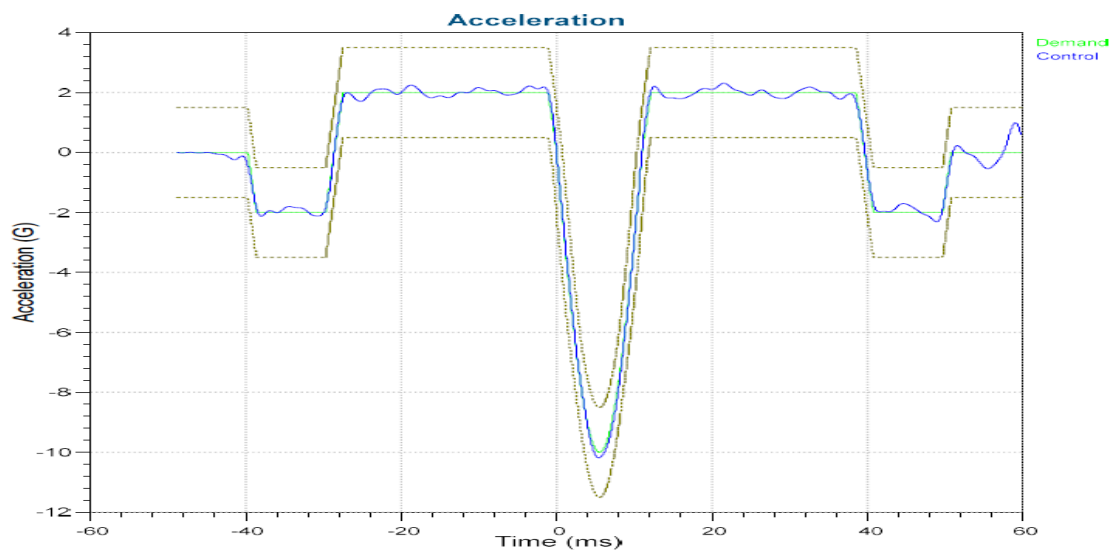
X-

5 05, 2025 12:06:19 Level 2) 100 % Output: 0.7836 Volts peak NEMA TS-2 2.2.9 ...

Demand: 10 G

Control: 10.19 G Pulse: 1 of 1 End of Test

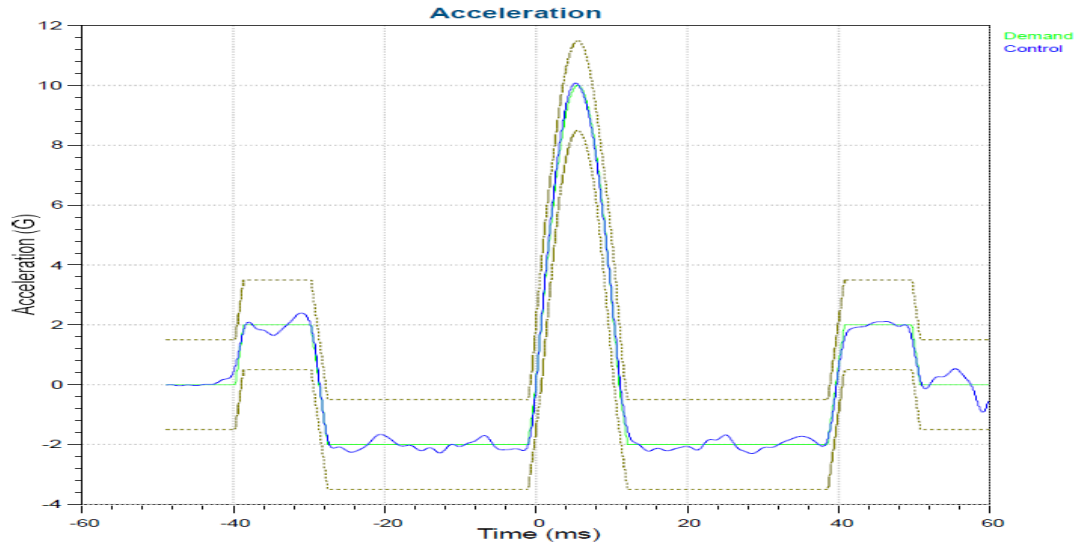
Y+

5 05, 2025 13:39:59 Level 1) 100 % Output: 0.767 Volts peak NEMA TS-2 2.2.9 ...

Demand: 10 G

Control: 10.08 G Pulse: 1 of 1 Running

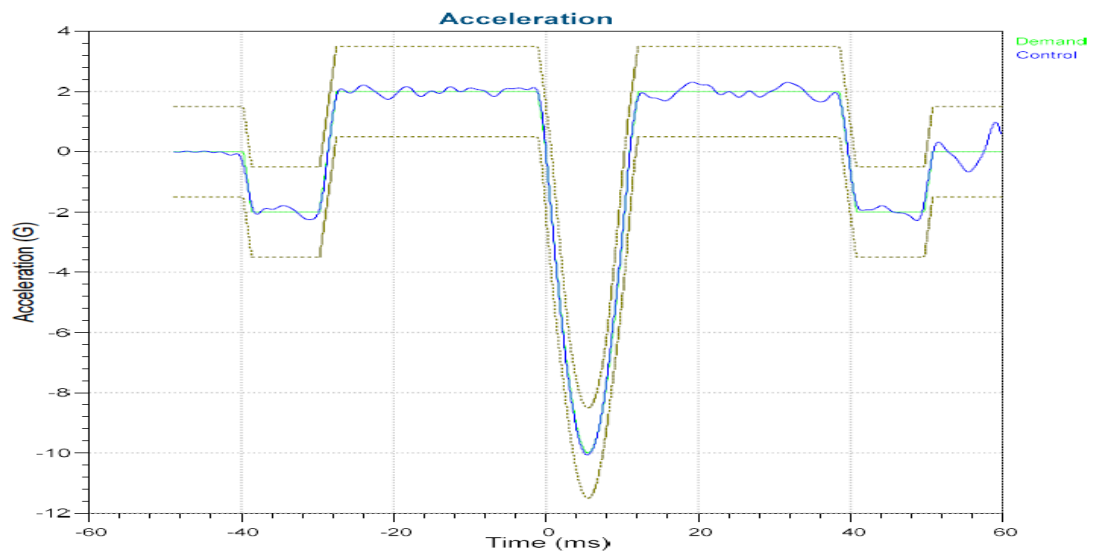
Y-

5 05, 2025 13:40:04 Level 2) 100 % Output: 0.7643 Volts peak NEMA TS-2 2.2.9 ...

Demand: 10 G

Control: 10.06 G Pulse: 1 of 1 End of Test

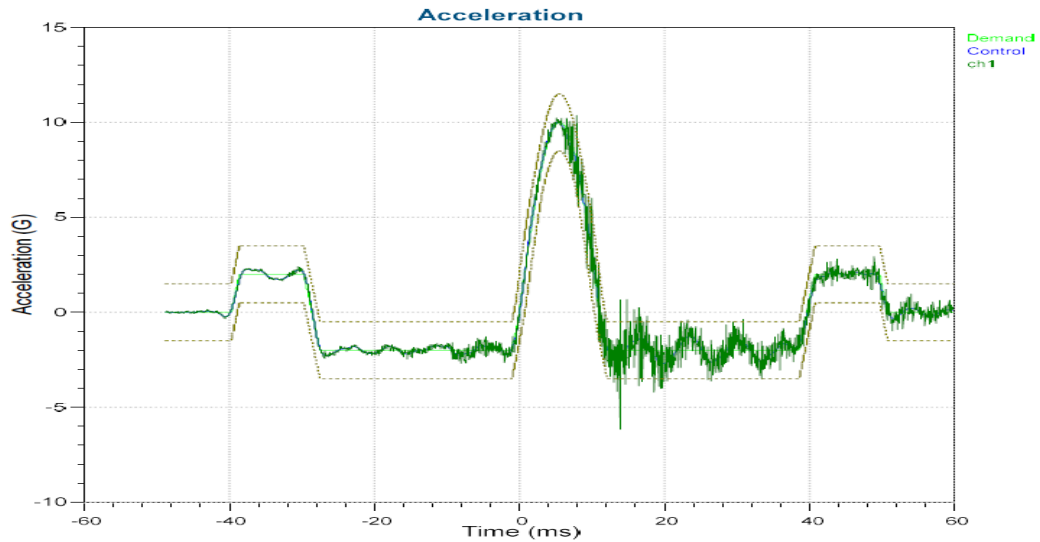
Z+

5 05, 2025 16:46:54 Level 1) 100 % Output: 0.6866 Volts peak 2025-05-02 NEMA TS-2 2.2.5

Demand: 10 G

Control: 10.03 G Pulse: 1 of 1 Running

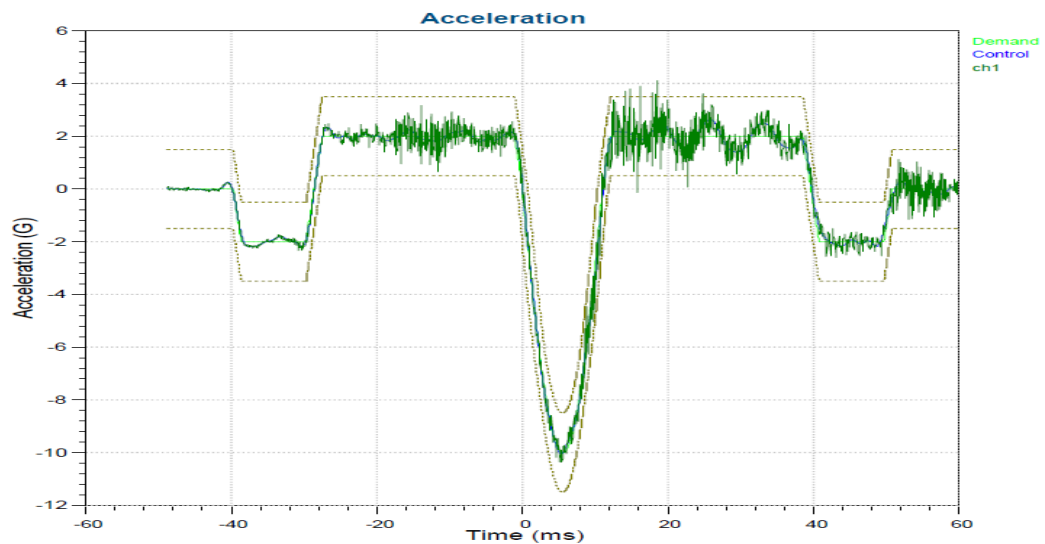
Z-

5 05, 2025 16:47:00 Level 2) 100 % Output: 0.682 Volts peak 2025-05-02 NEMA TS-2 2.2.5

Demand: 10 G

Control: 10.05 G Pulse: 1 of 1 End of Test
