# TEST REPORT

REPORT No.:  
CTK-2025-00982  
Page (1) / (14) pages

NETWORK CAMERA / PNO-A9092R

IEC 62262:2002+AMD1:2021

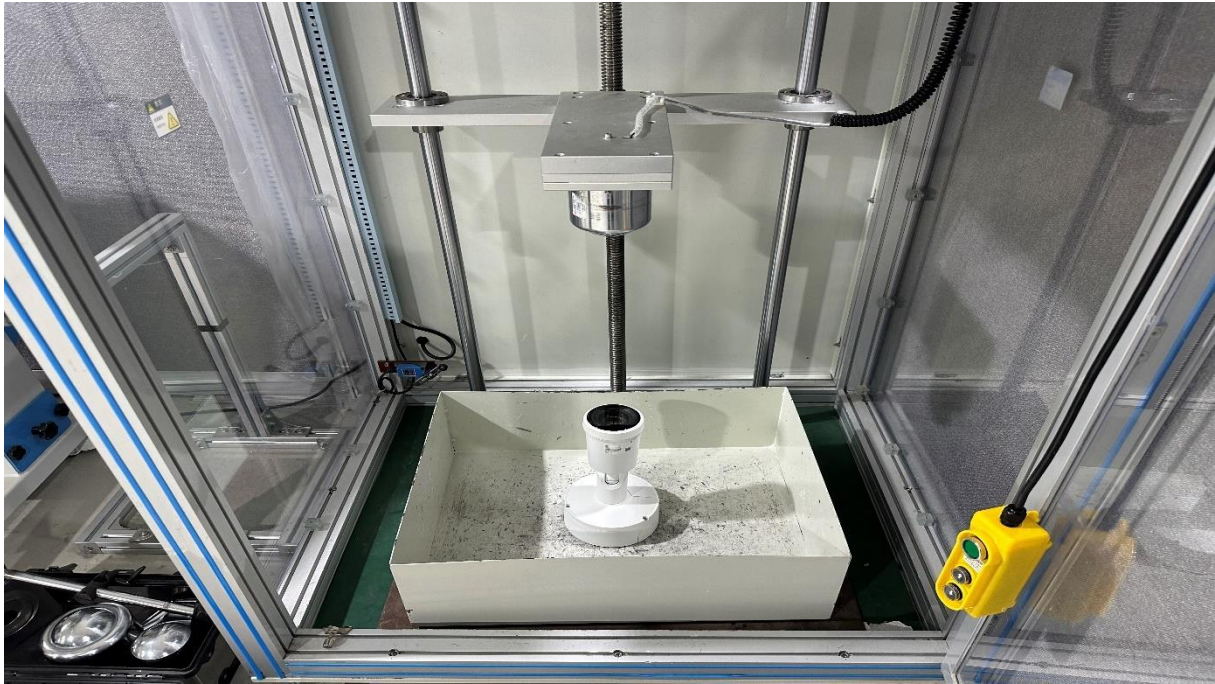
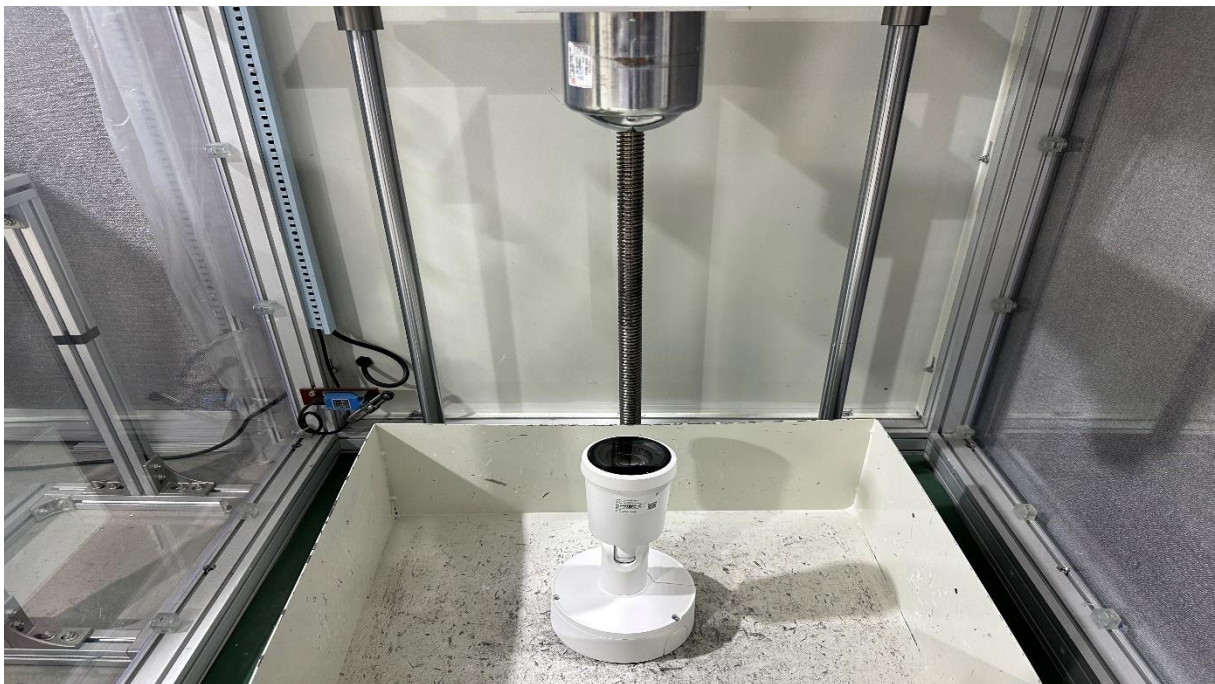
#### 3.3.1 Evidence of test setting

3.2.1 Test standard: IEC 62262:2002+AMD1:2021

| IK code | Impact Energy (J) | Equivalent mass (kg) | Drop height (mm $\pm$ 1%) | Application |
|---|---|---|---|---|
| 10 | 20.00 | 5.00 | 400 | <input checked="" type="checkbox"/> |

Impact times: five times for each of the exposed surface. (Do not impact more than 3 times in the same spot)

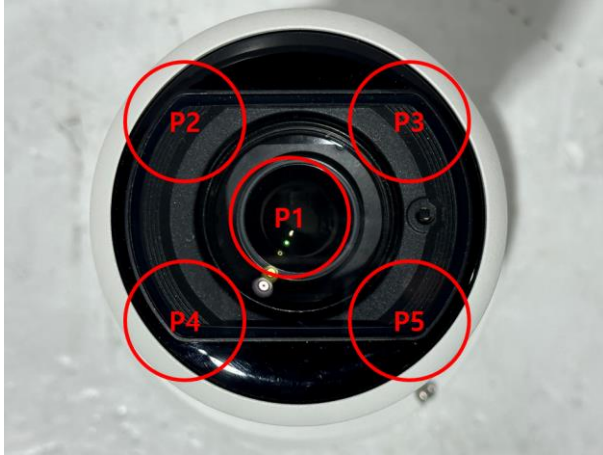
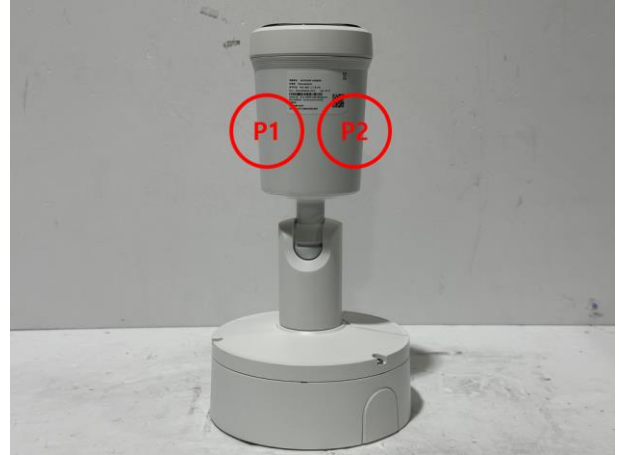
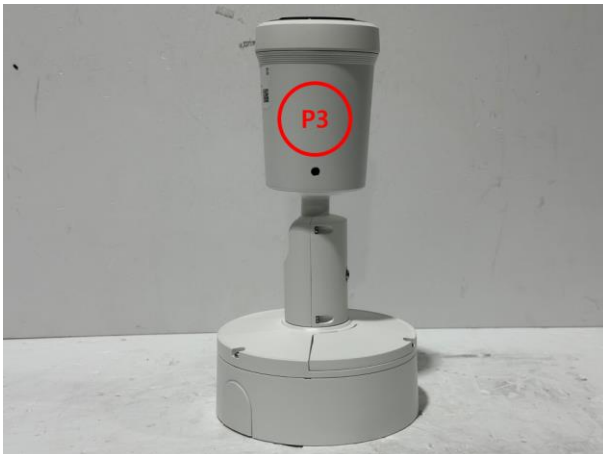
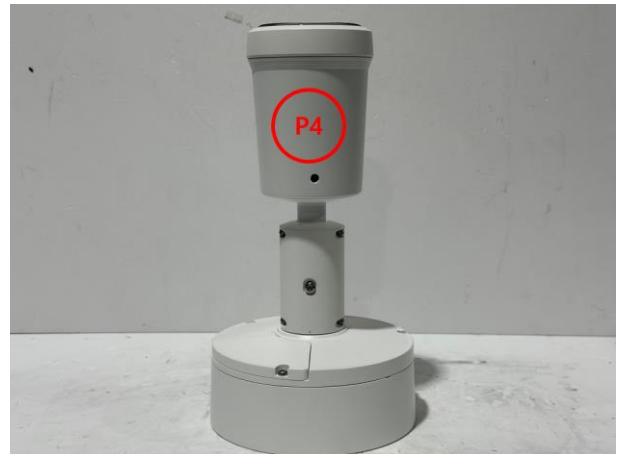
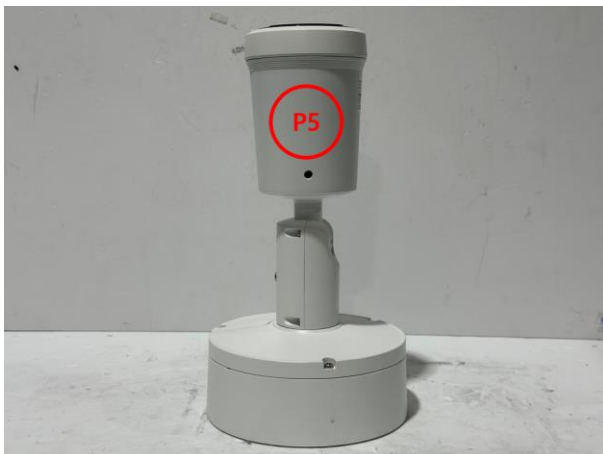
#### 3.5.1 Check the hit area during the test (1)

Check the hit area the test\_1

Check the hit area the test\_2

Check the hit area the test\_3

Check the hit area the test\_4

Check the hit area the test\_5

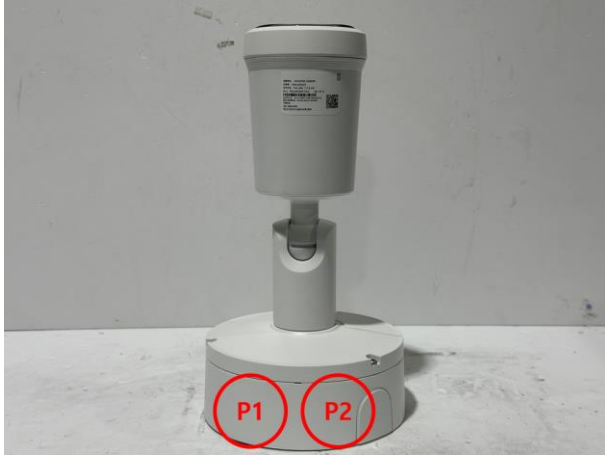
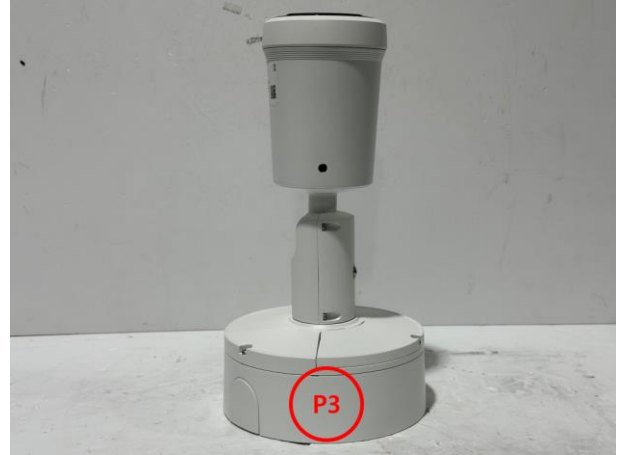
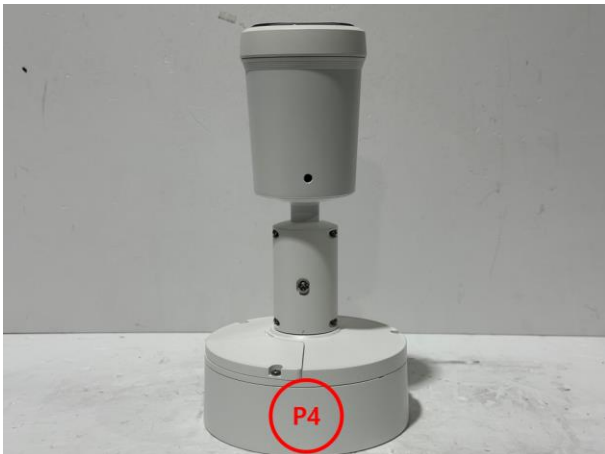
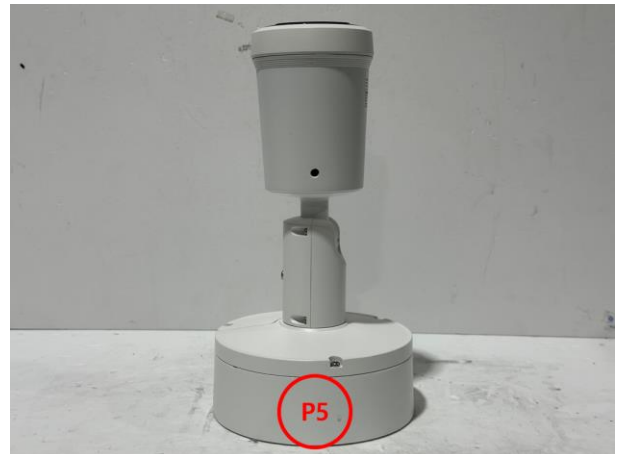
### 3.5.2 Check the hit area during the test (2)

Check the hit area the test\_6

Check the hit area the test\_7

Check the hit area the test\_8

Check the hit area the test\_9

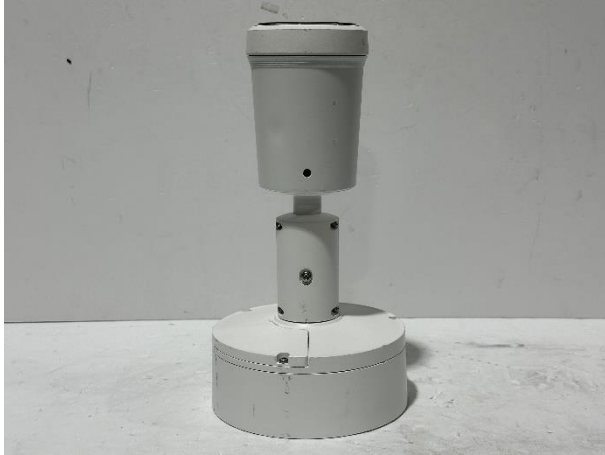
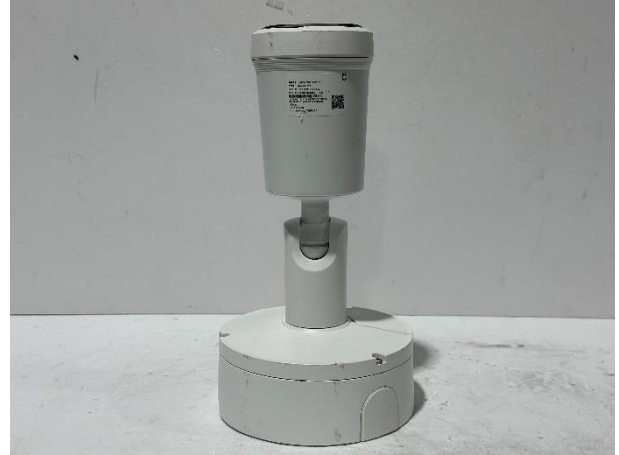
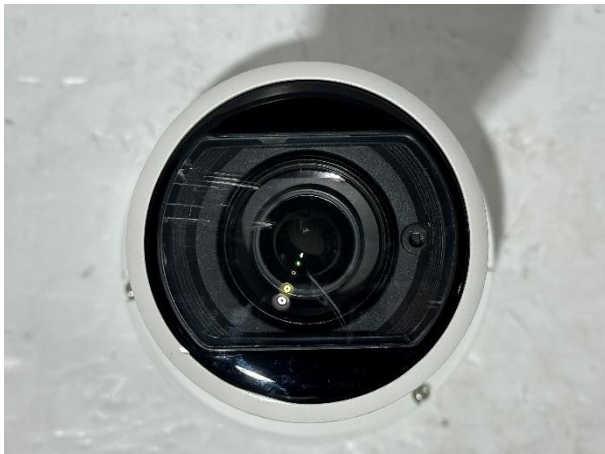
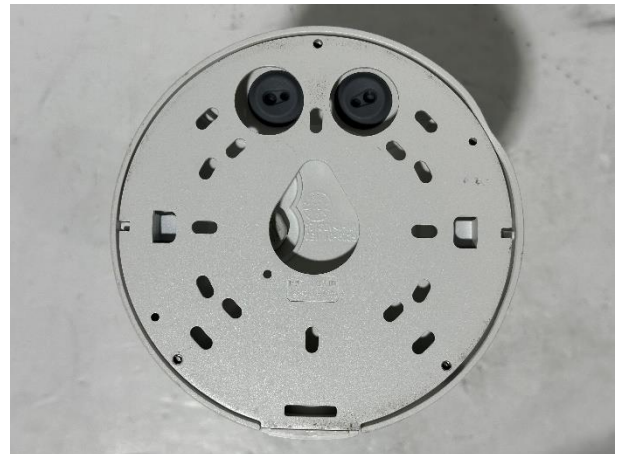
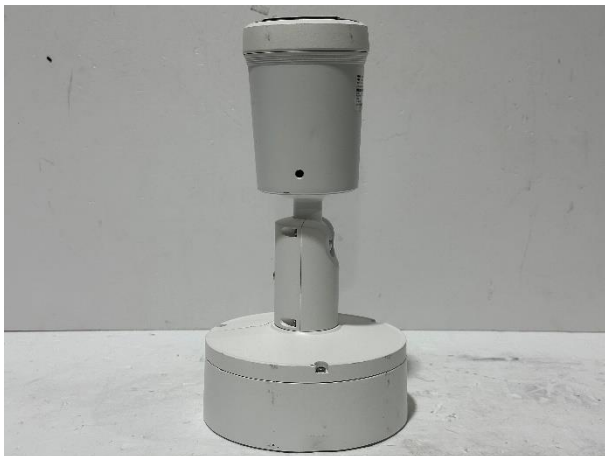
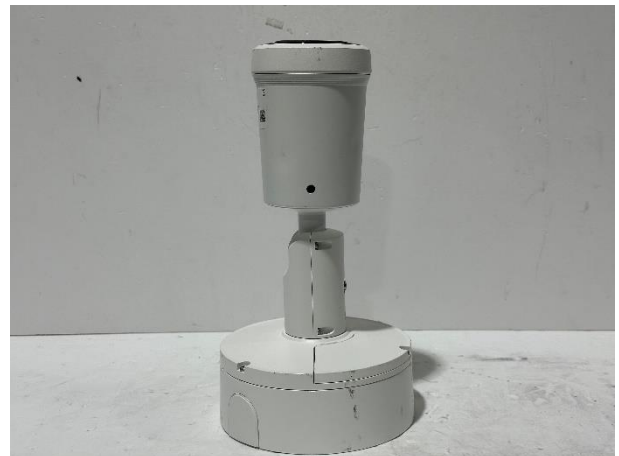
### 3.5.3 Post-test product images

| Evaluation Criteria | Test Results | Remark |
|---|---|---|
| Visual Inspection | Some scratches were generated on the outside of the product. | - |

※ Refer to the product photos after the completion of testing in section 3.5.2
