# TEST REPORT

CTK-2025-01428

NETWORK CAMERA / PNV-A7082RZ

EN 60068-2-1, EN 60068-2-2, EN 60068-2-14, EN 60068-2-6, EN  
60068-2-27, EN 60068-2-78, IEC 60068-2-1, IEC 60068-2-2, IEC  
60068-2-14, IEC 60068-2-6, IEC 60068-2-27, IEC 60068-2-78

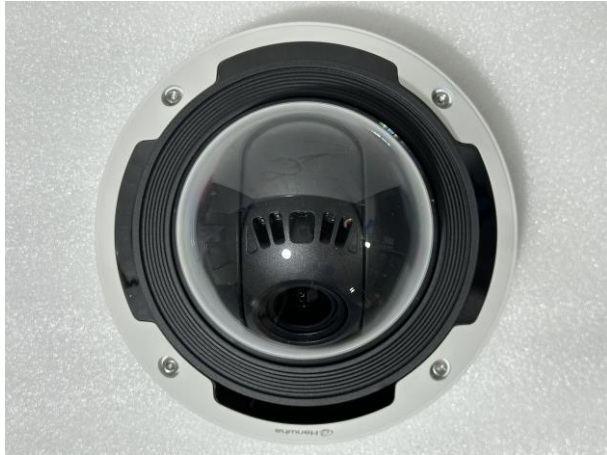
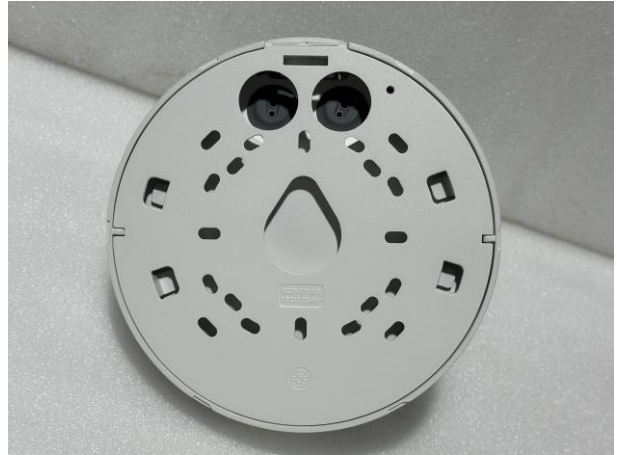
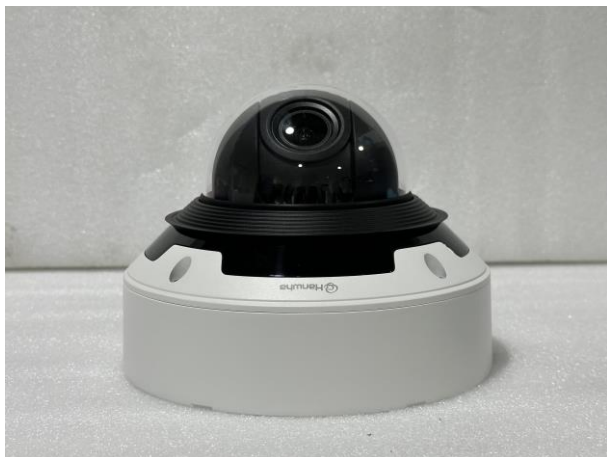
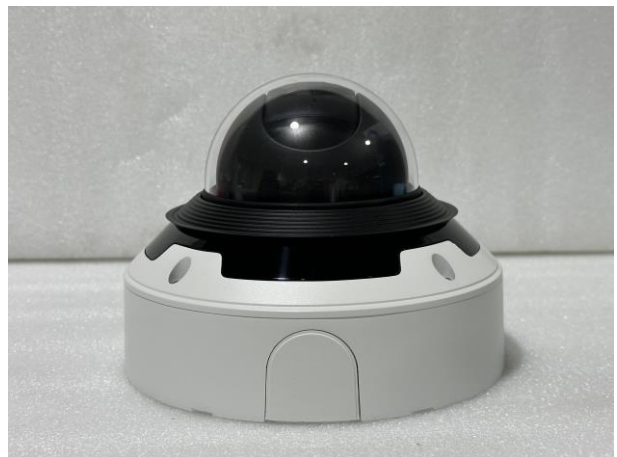
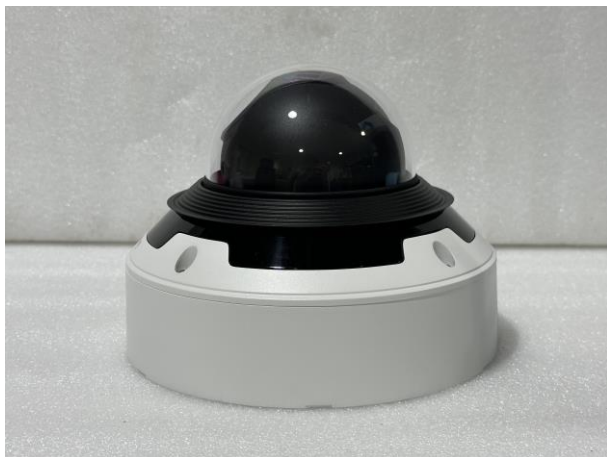
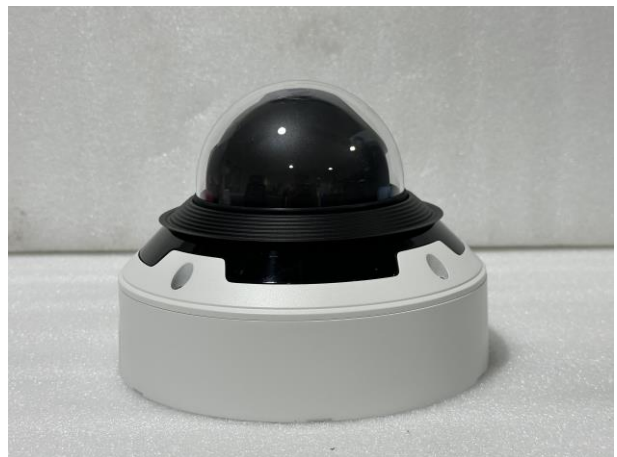
### 2.3.1 Test sample

## 2.3 Pre-test product images

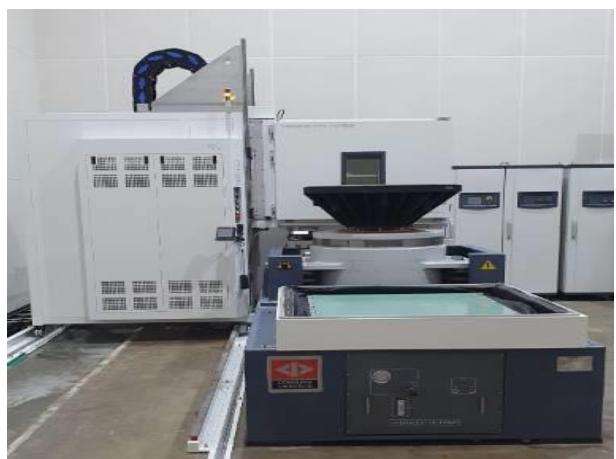
| Testing equipment | Model Name | Manufacturer | Manufacturing Number | Calibration Date |
|---|---|---|---|---|
| VIBRATION TESTING SYSTEM | LT1010 | FAMTECH | D2012335 | N/A |

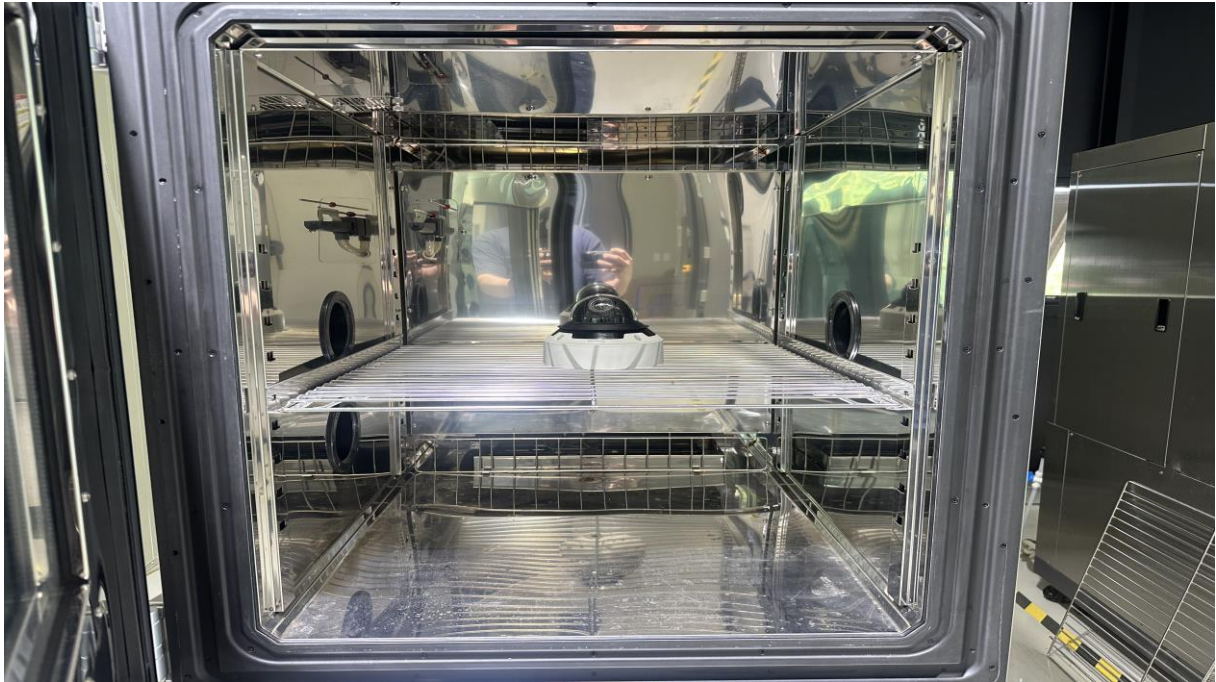
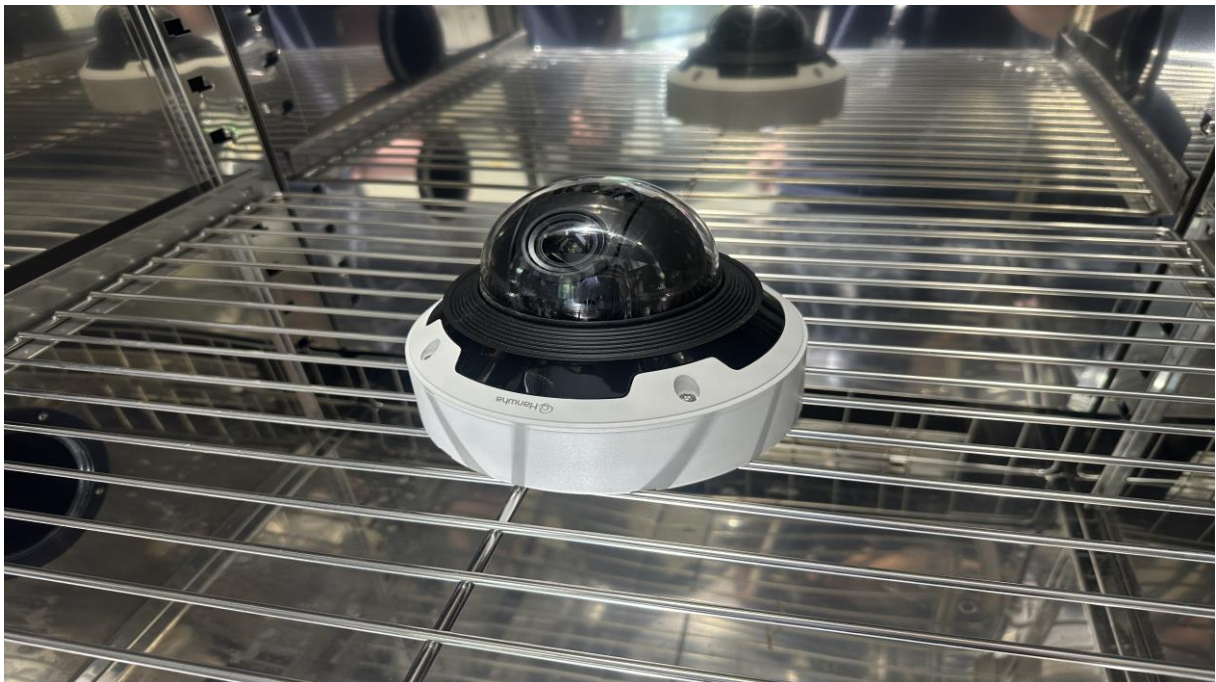
#### 3.3.1 Evidence of test setting

3.2.1 Sample status: Non-operation

3.2.2 Test temperature: -50 °C

3.2.3 Test time: 16 h

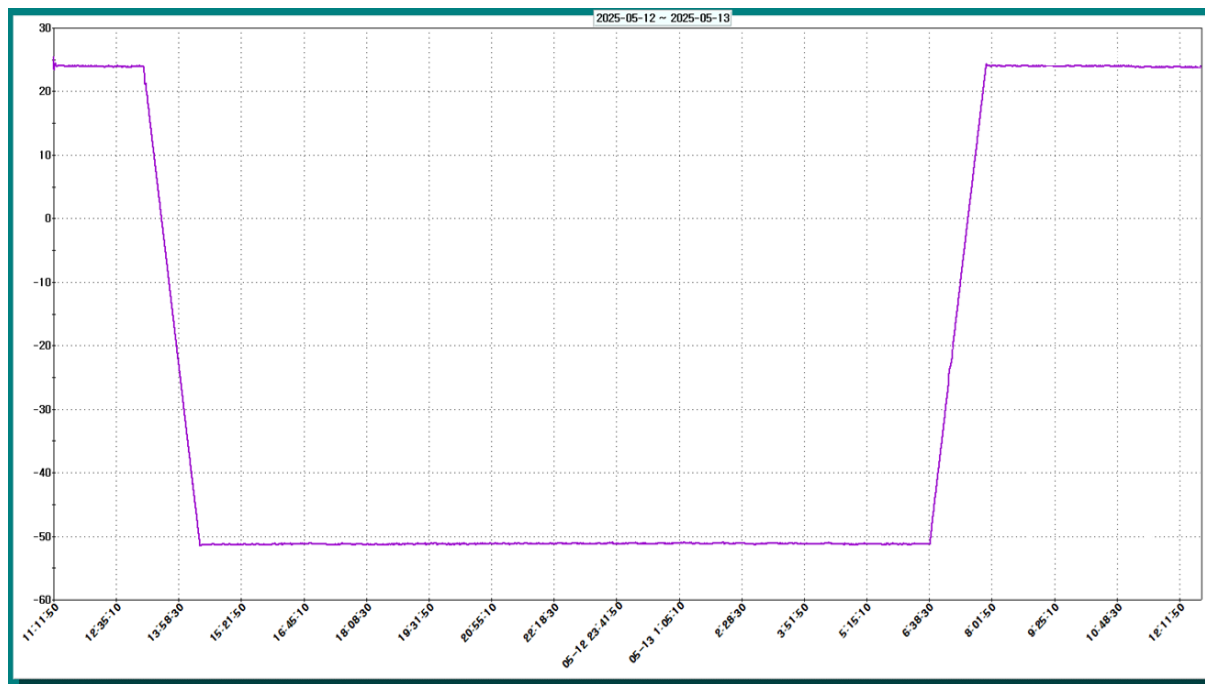
#### 3.5.1 Test data and graph

Temperature Data

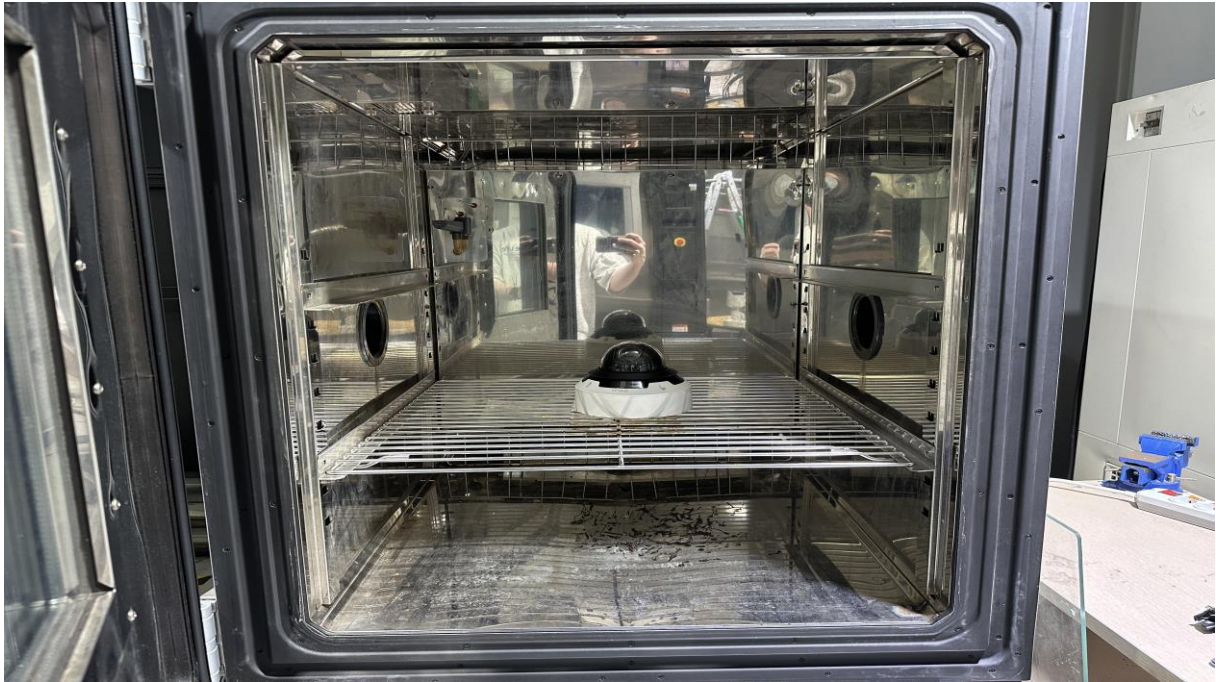
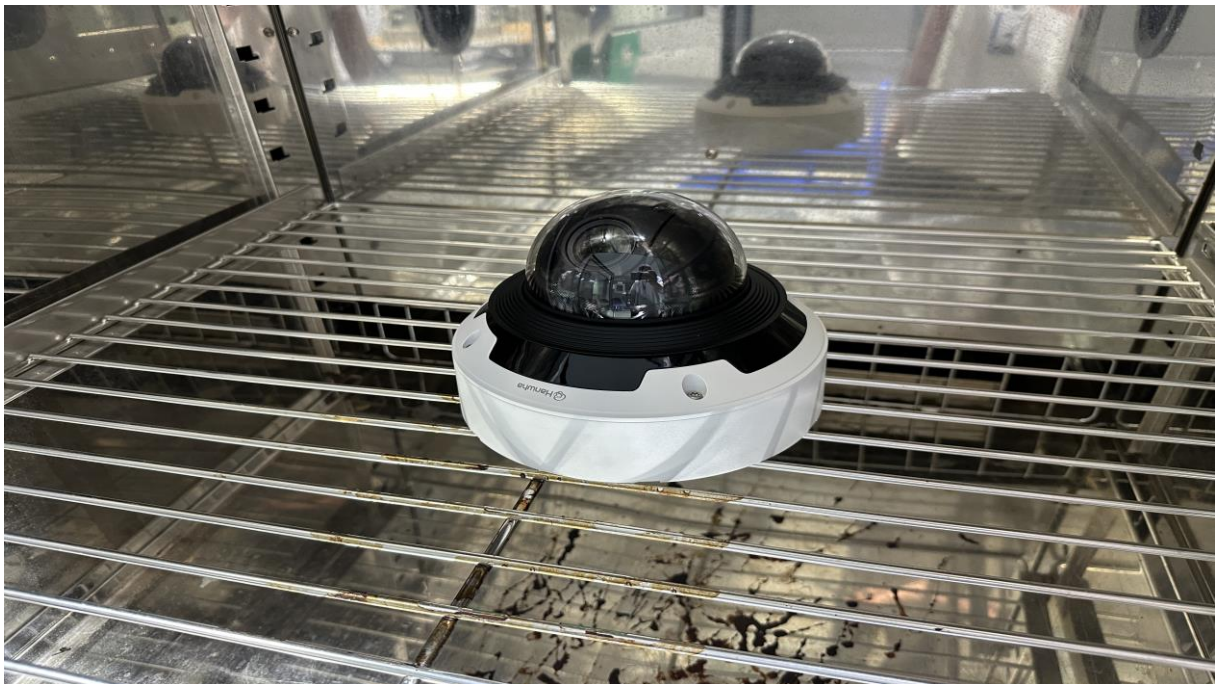
#### 4.3.1 Evidence of test setting

4.2.1 Sample status: Non-operation

4.2.2 Test temperature: 60 °C

4.2.3 Test time: 96 h

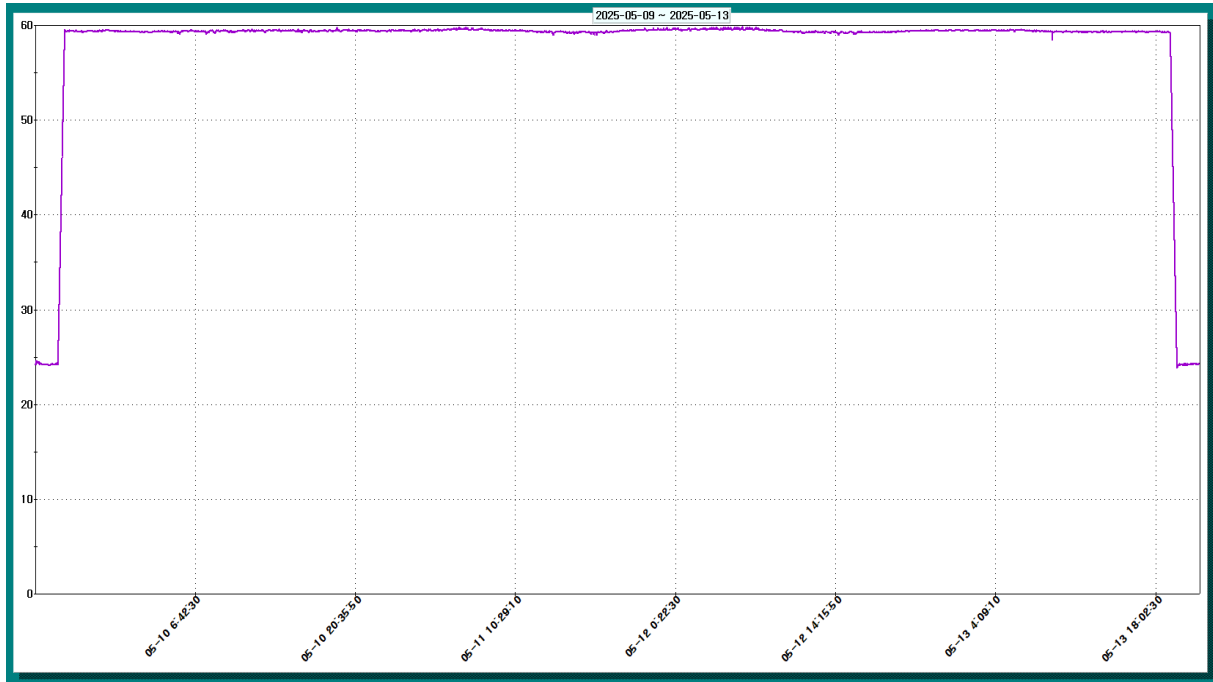
#### 4.5.1 Test data and graph

Temperature Data

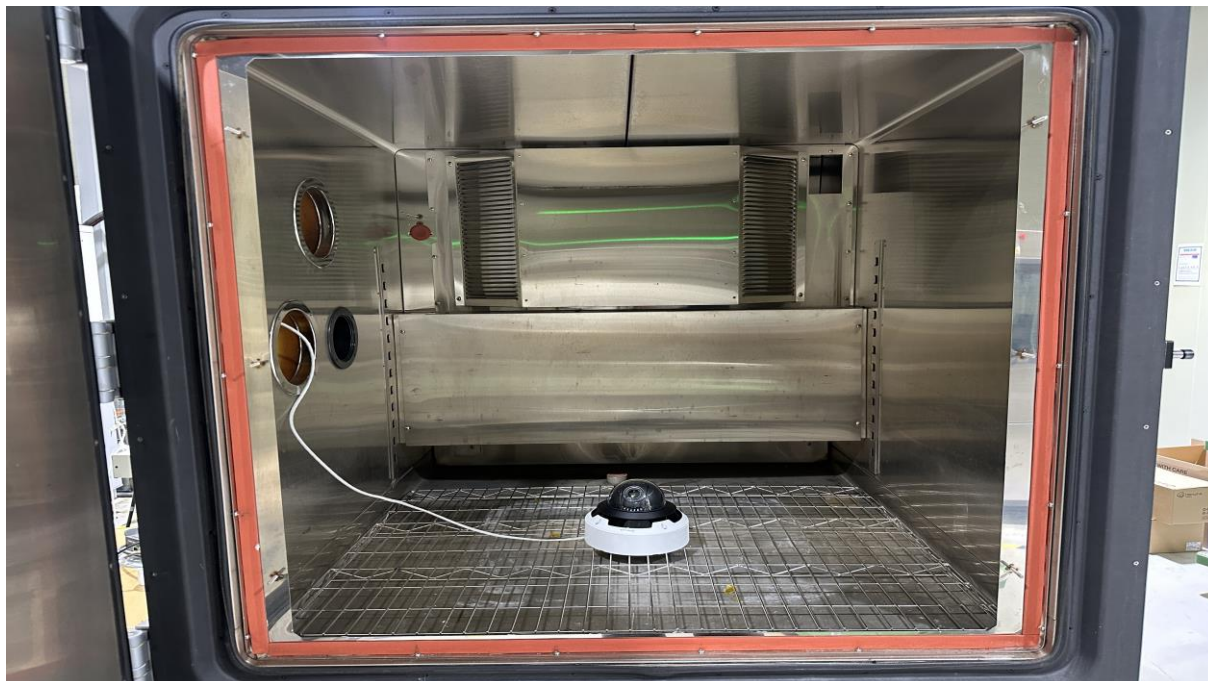
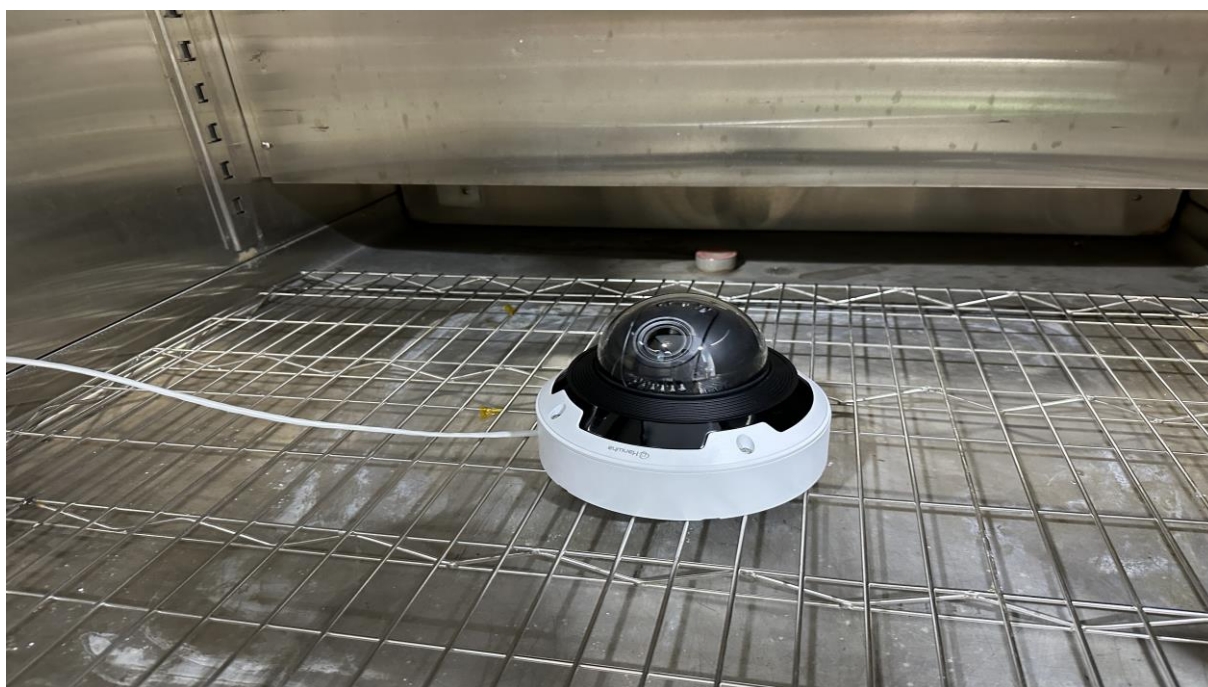
#### 5.3.1 Evidence of test setting

5.2.1 Sample status: operation

5.2.2 Test temperature: -50 °C, 55 °C

5.2.3 Test time: 24 h

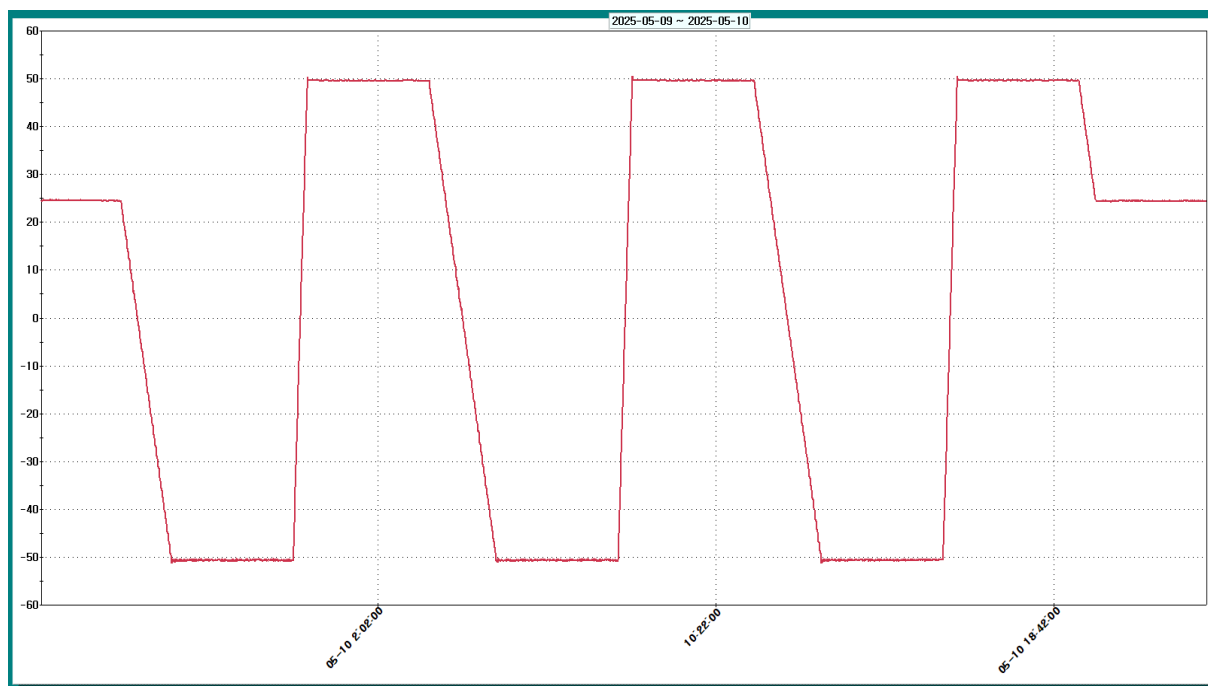
### 5.5.1 Test data and graph

Temperature Data

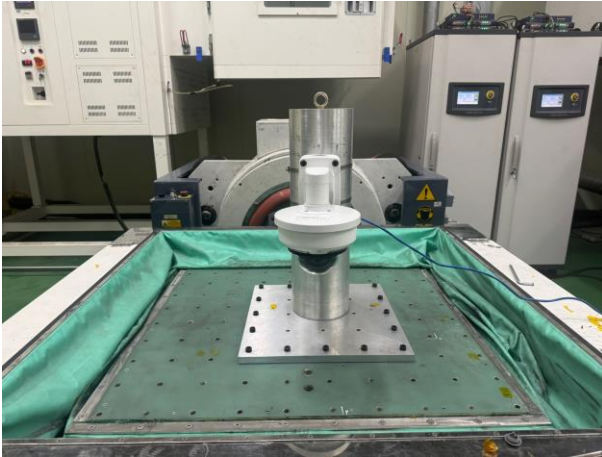
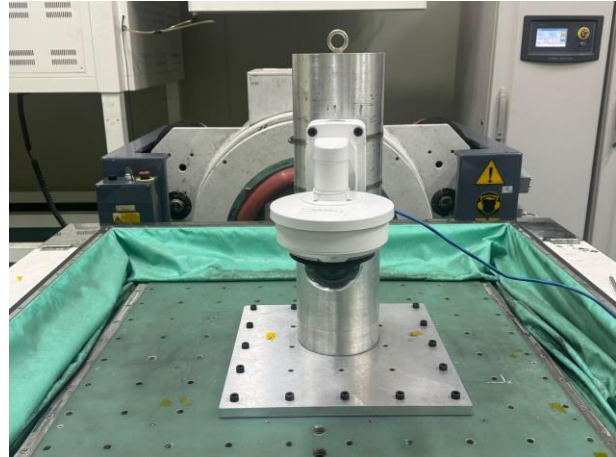
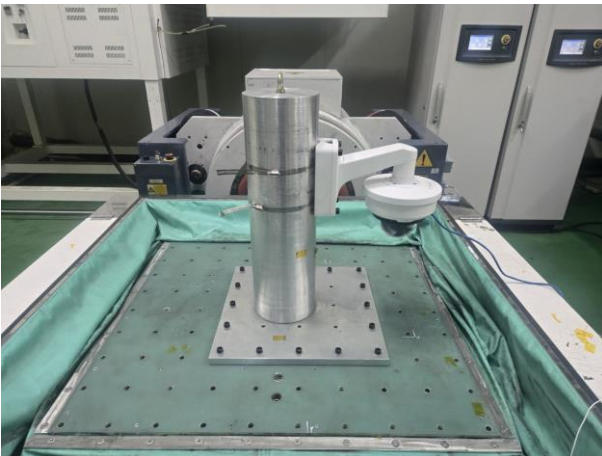
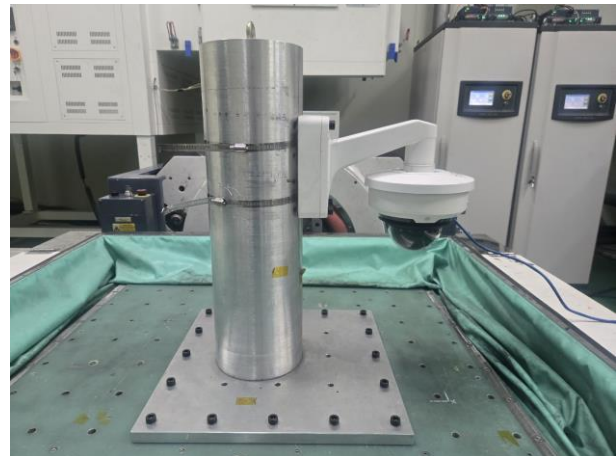
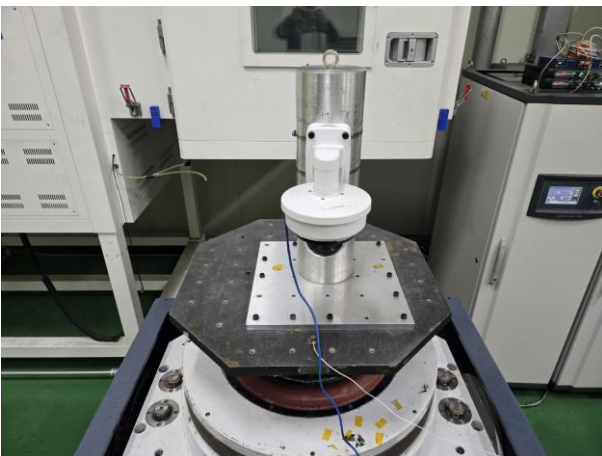
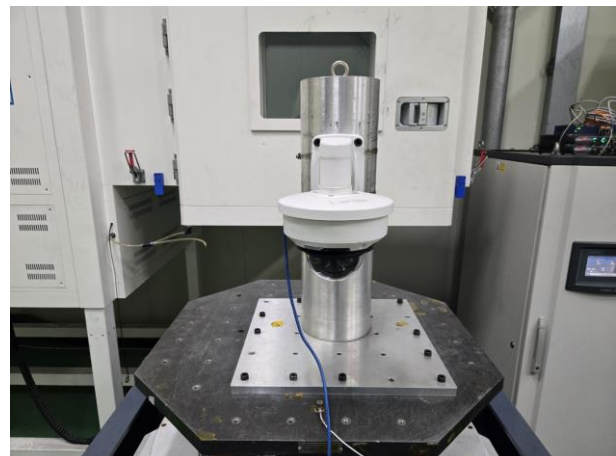
### 6.3.1 Evidence of test setting

- Sample status: operation
- Frequency(Hz): 5 Hz ~ 200 Hz
- Acceleration(G): 1 G
- Sweep rate: 1 oct/min
- Test Axis: X, Y, Z
- Test time(h): Total 30 min (10 min. per each axis)

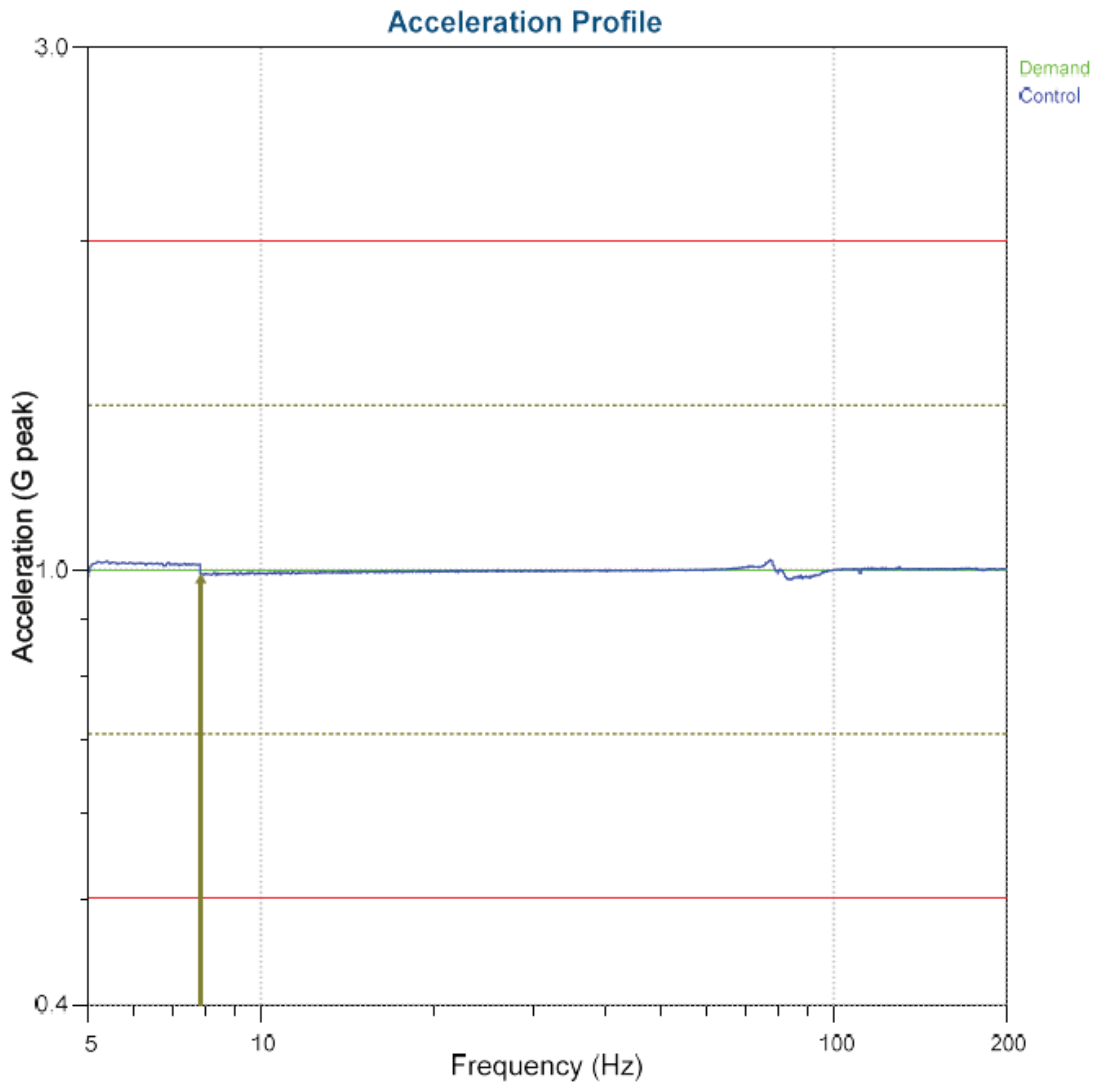
#### 6.5.1 Test data and graph (Vibration Test X Axis)

Demand: 1 G Level Time: 0:10:00 Frequency: 7.858 Hz

Control: 0.0006623 G Total Time: 0:10:11 End of Timed Test

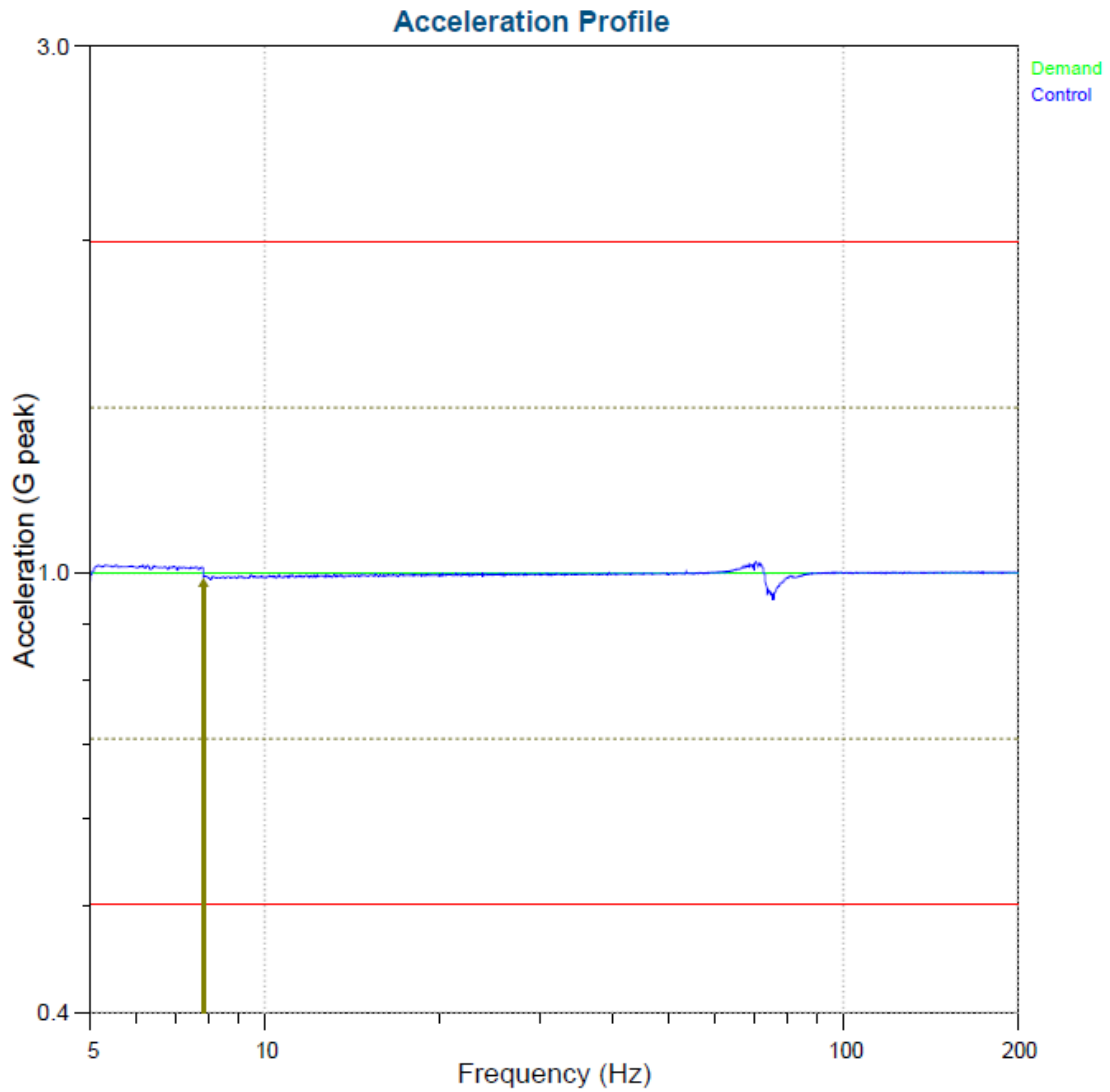
### 6.5.2 Test data and graph (Vibration Test Y Axis)

Demand: 1 G Level Time: 0:10:0 Frequency: 7.841 Hz

Control: 0.001586 G Total Time: 0:10:1 End of Timed Test

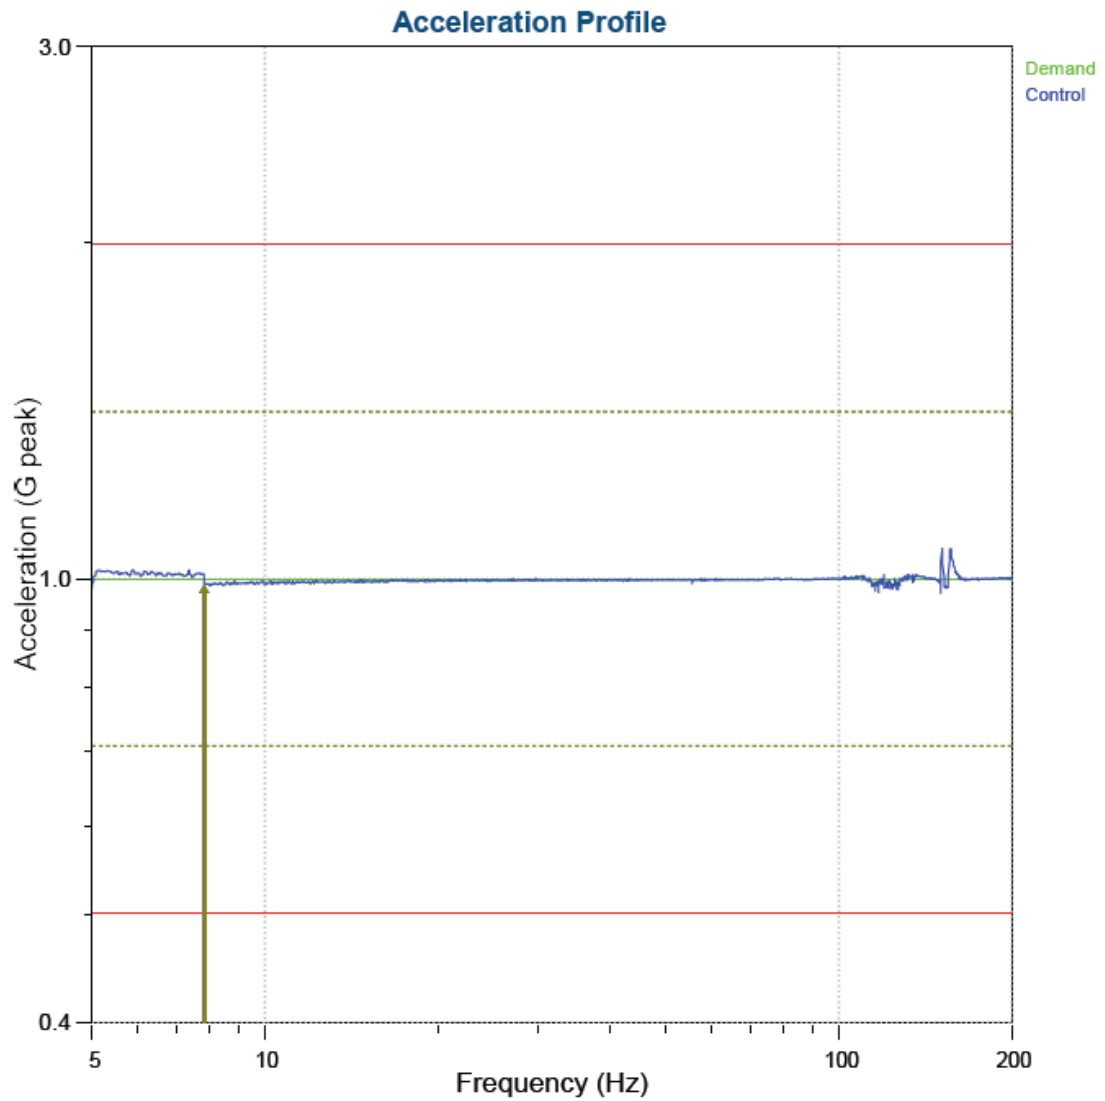
### 6.5.3 Test data and graph (Vibration Test Z Axis)

Demand: 1 G Level Time: 0:10:0 Frequency: 7.841 Hz

Control: 0.001931 G Total Time: 0:10:1 End of Timed Test

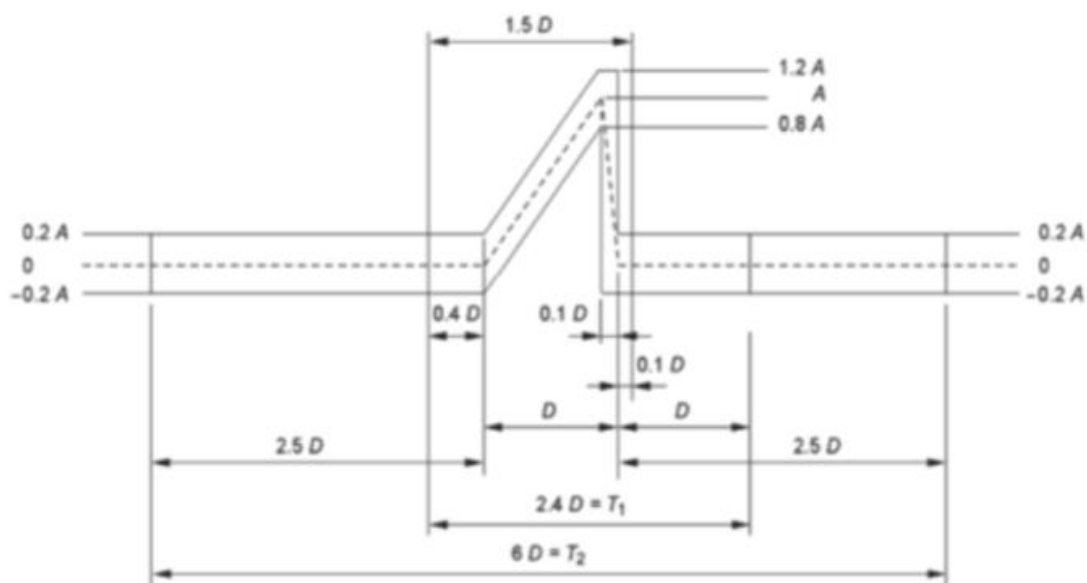
7.2.6 Profile

7.2.2 Acceleration(G): 10 G

7.2.3 Number of impacts: 10 per direction (total 60)

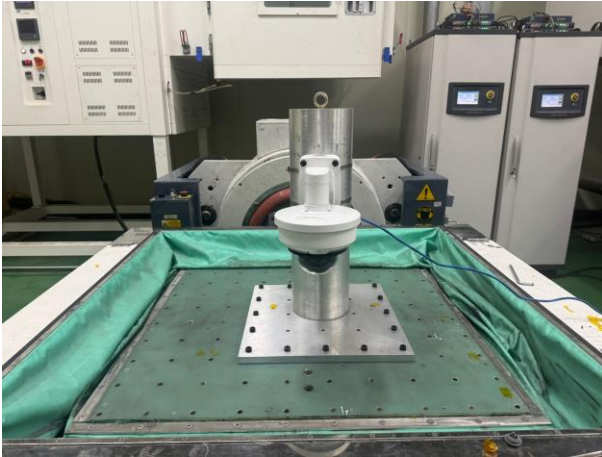
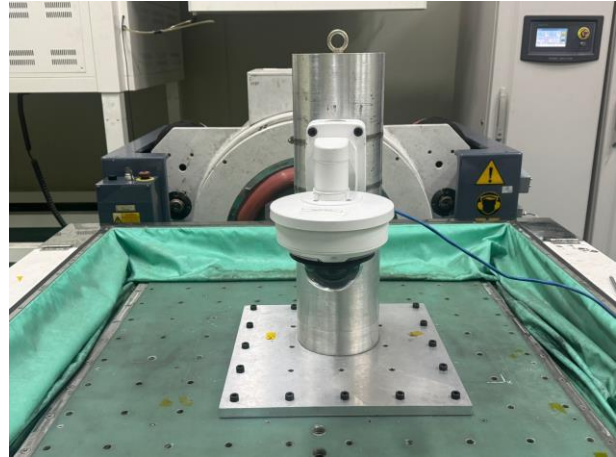
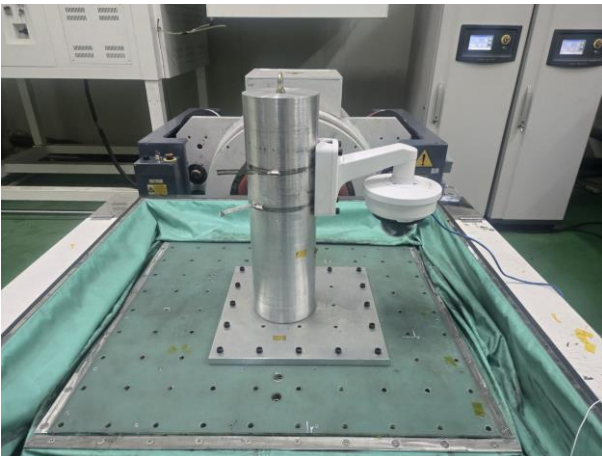
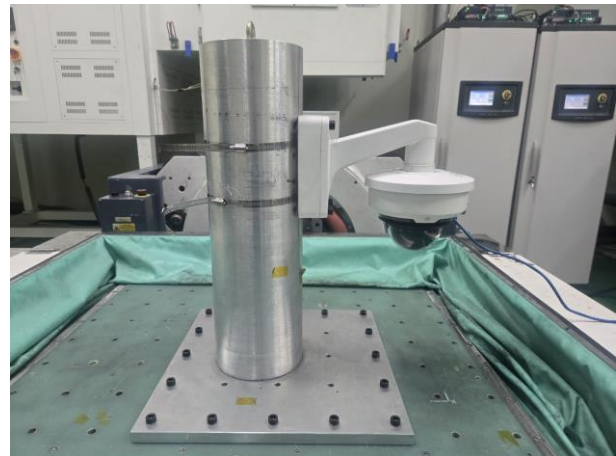
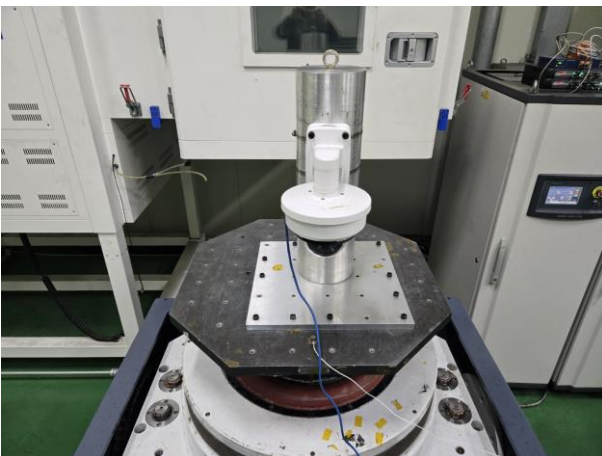
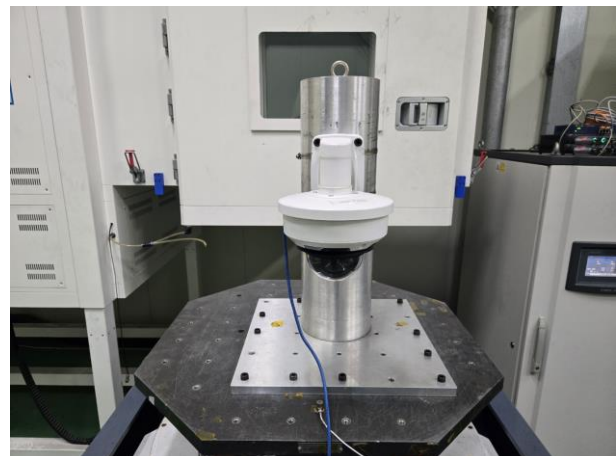
### 7.3.1 Evidence of test setting

7.2.4 Test Axis: X, Y, Z

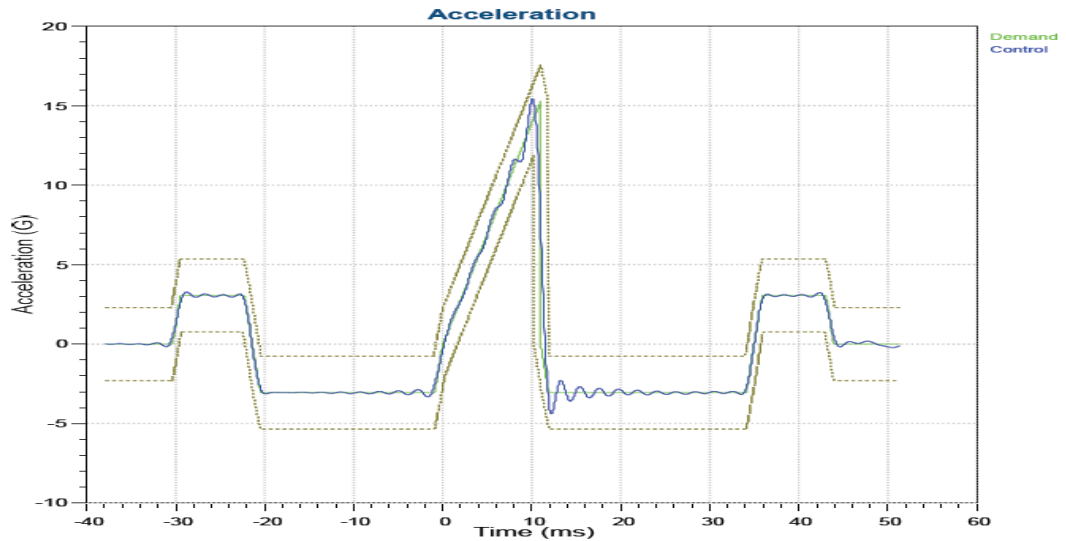
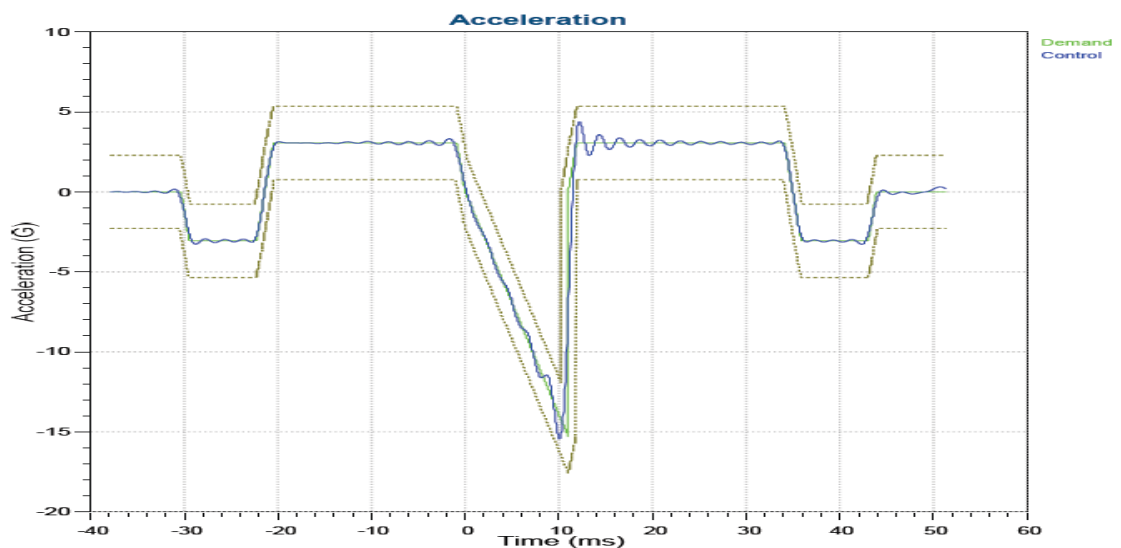
### 7.5.1 Test data and graph (Shock Test X Axis)

Demand: 15.3 C

Control: 15.44 C Pulse: 10 of 1C

Control: 15.43 C Pulse: 10 of 1C

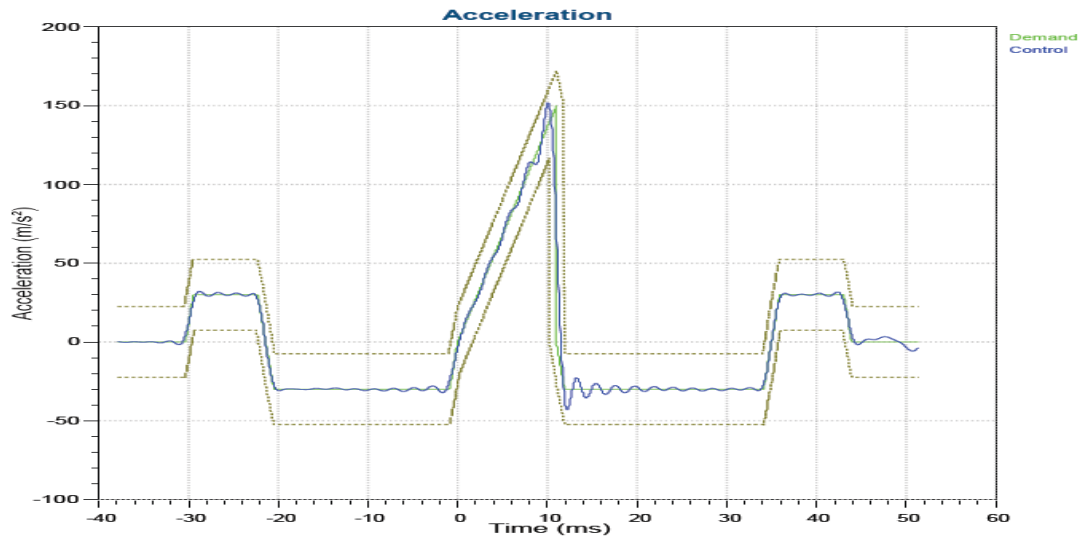
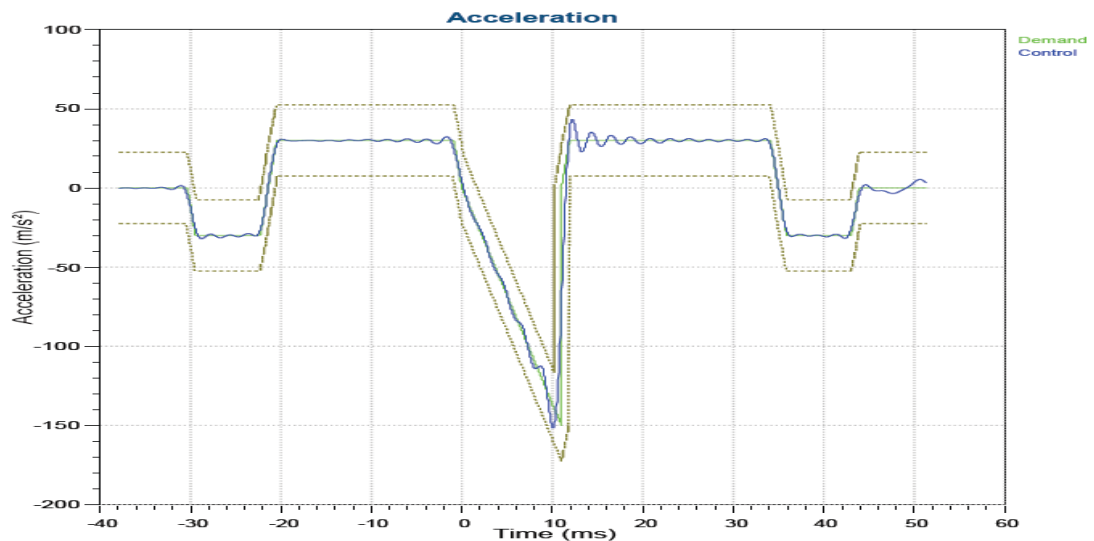
### 7.5.2 Test data and graph (Shock Test Y Axis)

Demand: 150 m/s

Control: 151.6 m/s Pulse: 10 of 10

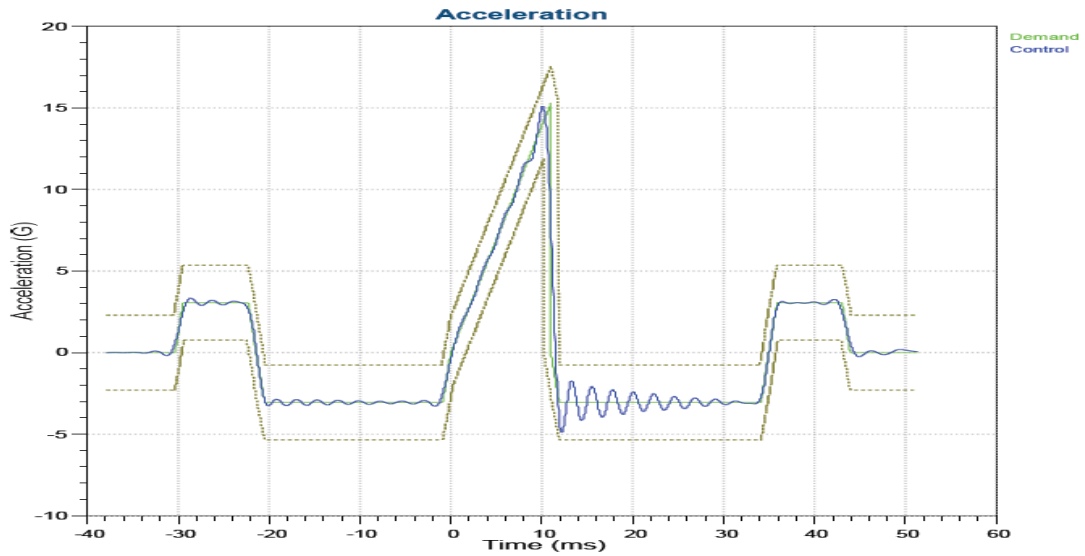
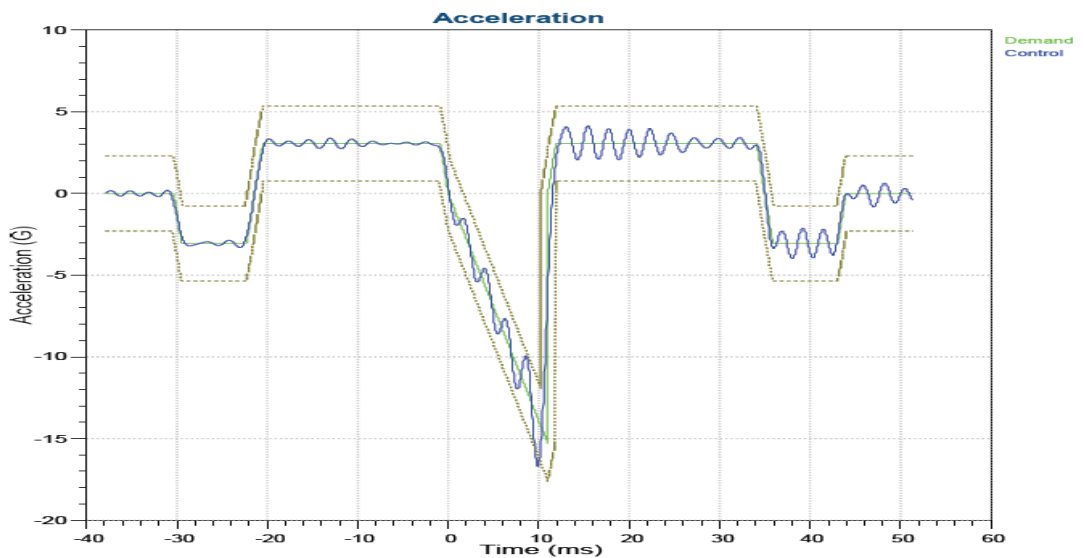
### 7.5.3 Test data and graph (Shock Test Z Axis)

Demand: 15.3 C

Control: 15.1 C

Control: 16.71 C

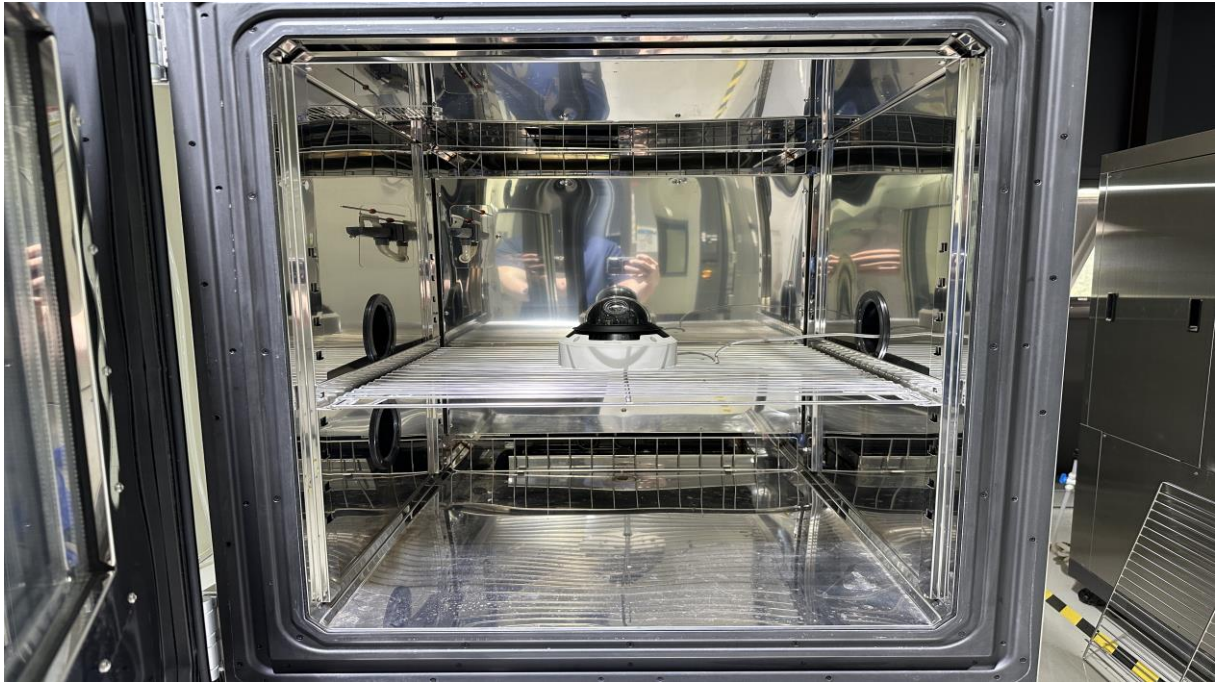
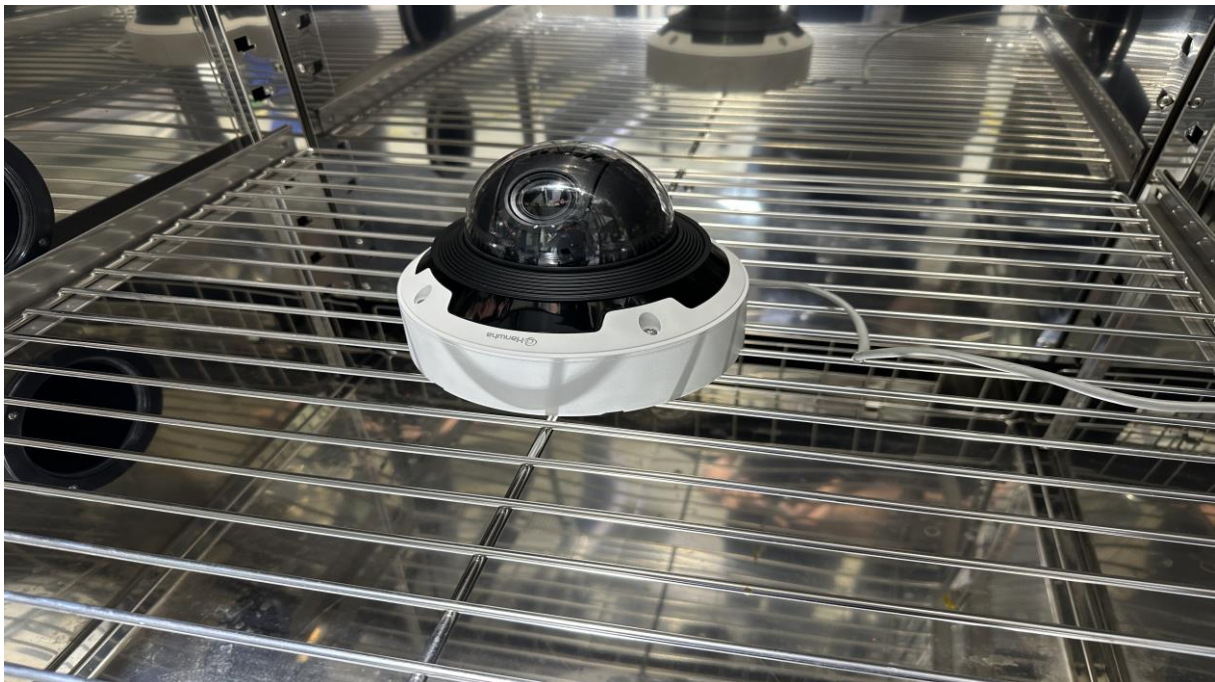
#### 8.3.1 Evidence of test setting

8.2.2 Test temperature:  $40 \pm 2$  °C

8.2.3 Test Humidity:  $93 \pm 3$  % R.H.

8.2.4 Test time: 240 h
