# TEST REPORT

CTK-2025-01428

NETWORK CAMERA / PNV-A7082RZ

EN 60068-2-1, EN 60068-2-2, EN 60068-2-14, EN 60068-2-6, EN  
60068-2-27, EN 60068-2-78, IEC 60068-2-1, IEC 60068-2-2, IEC  
60068-2-14, IEC 60068-2-6, IEC 60068-2-27, IEC 60068-2-78

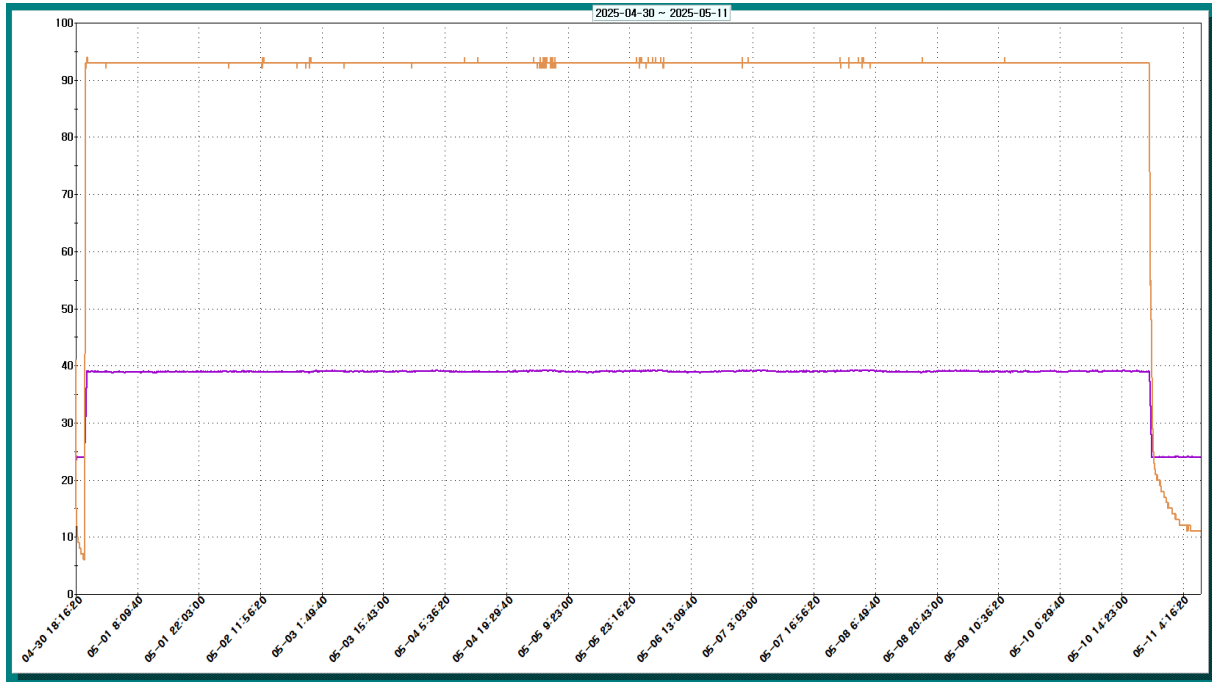
#### 8.5.1 Test data and graph

Temperature Data

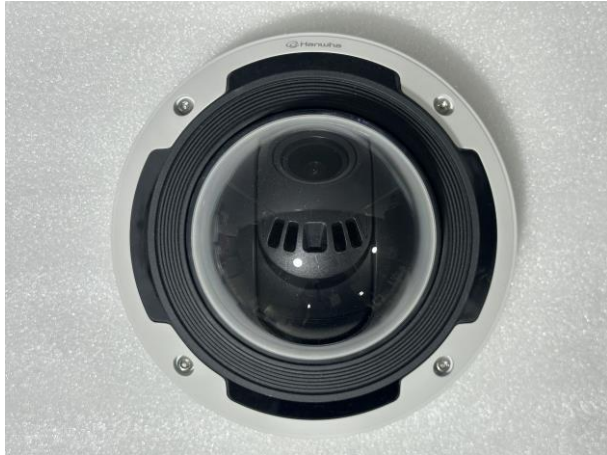
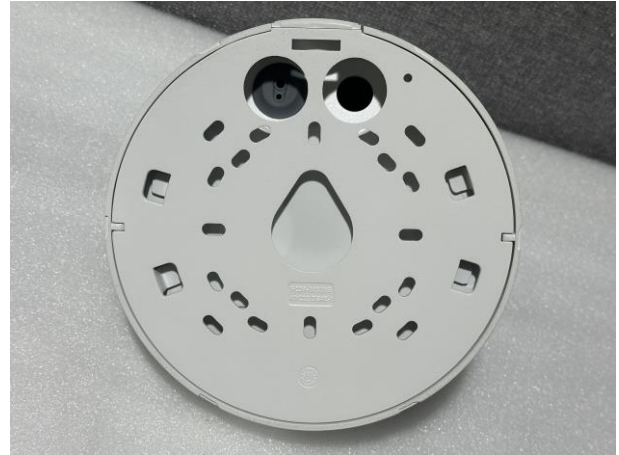
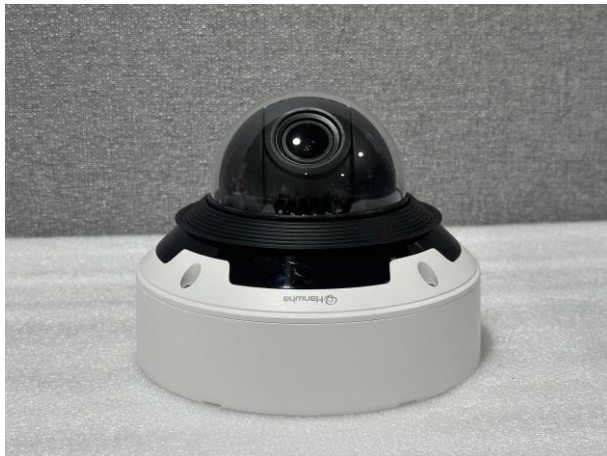
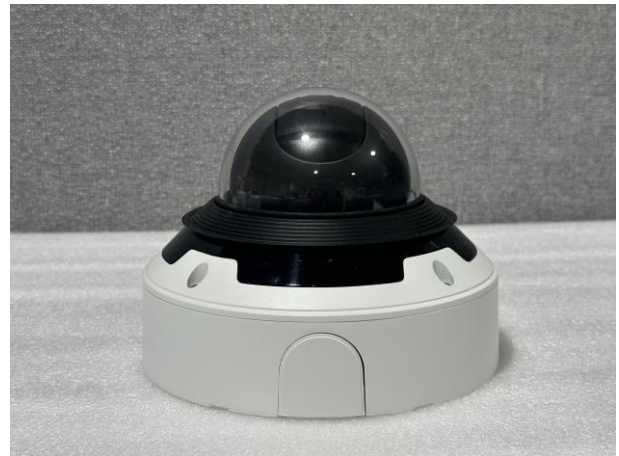
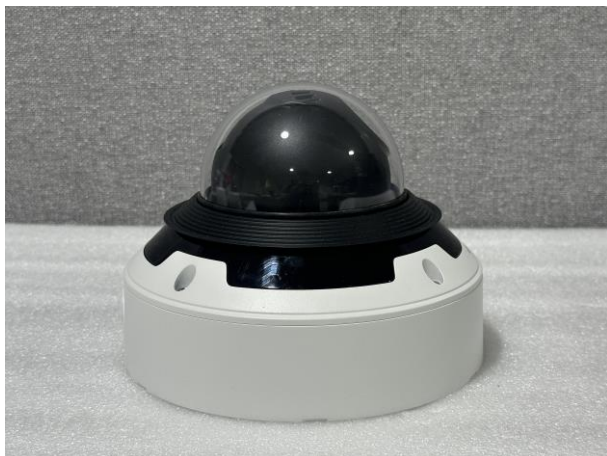
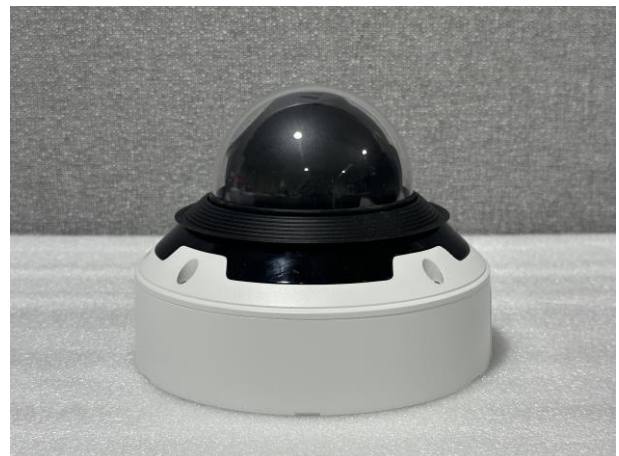
### 8.6.1 Test sample

## 8.6 Post-test product images

| Evaluations Criteria | Test result | | 비고 |
|---|---|---|---|
| Sample | Visual Inspection | Normal | - |
