# TEST REPORT

REPORT No.:  
CTK-2025-01429  
Page (1) / (24) pages

NETWORK CAMERA / PNV-A7082RZ

NEMA TS 2-2013 2.2.7.2 Test B ~ 2.2.7.8, NEMA TS 2.2.8,  
NEMA TS 2.2.9

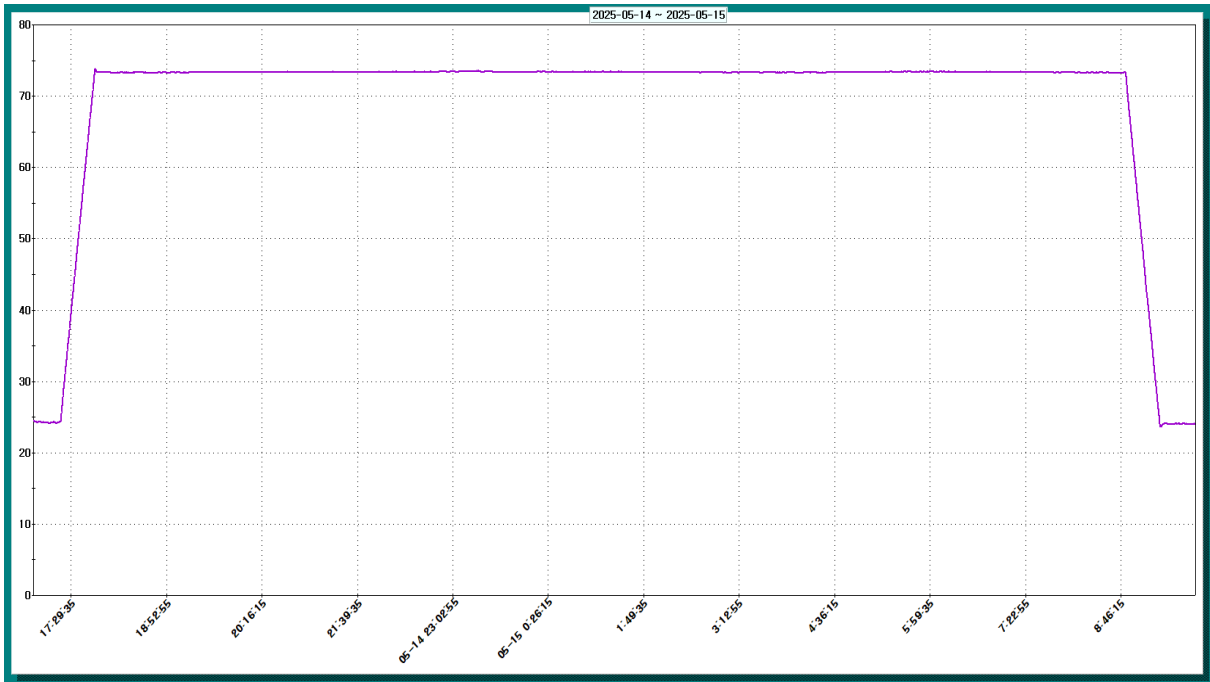
#### 3.5.1 Power Service [NEMA TS 2-2013 2.2.7.2 Test B ~ 2.2.7.8 – 13. C]

Temperature Data

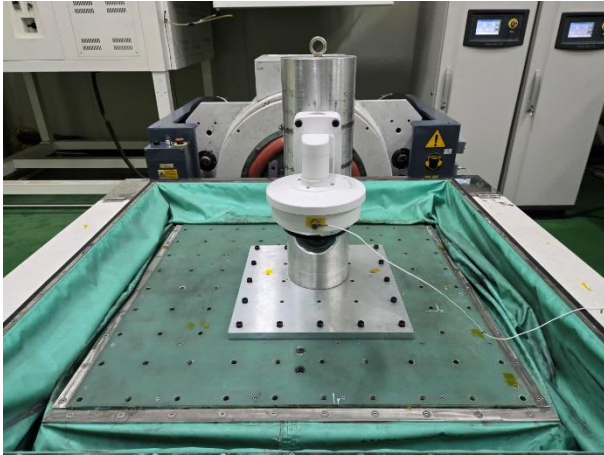
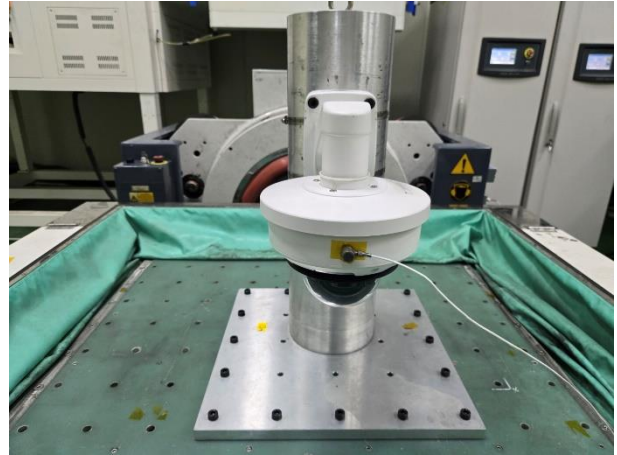
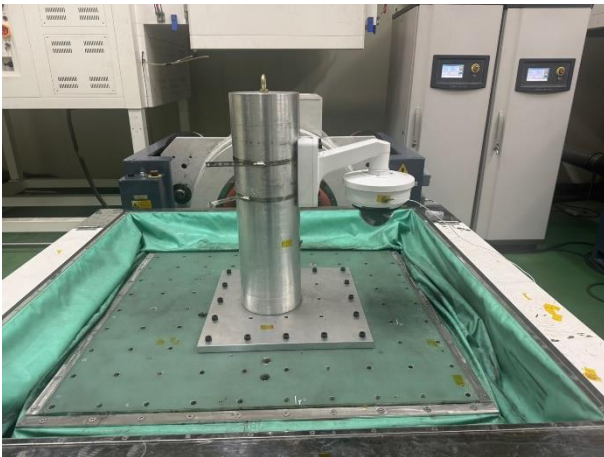
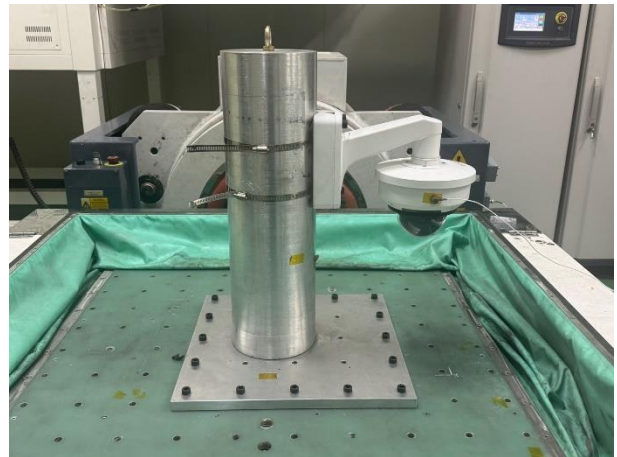
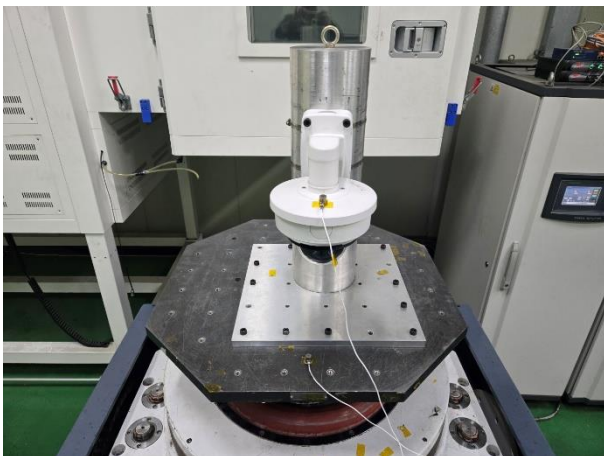
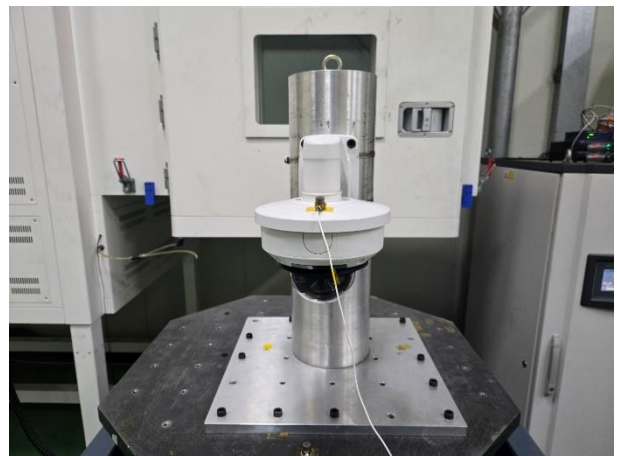
#### 4.3.1 Evidence of test setting (NEMA TS 2-2013 2.2.8)

- Applicable axis : X, Y, Z
- Test time(h) : 12.5
- Evaluation items
  - Check for mechanical damage before and after testing
- Test methods
  - With the test unit securely fastened to the test table, set the test table for a double amplitude displacement of 0.015 inch.

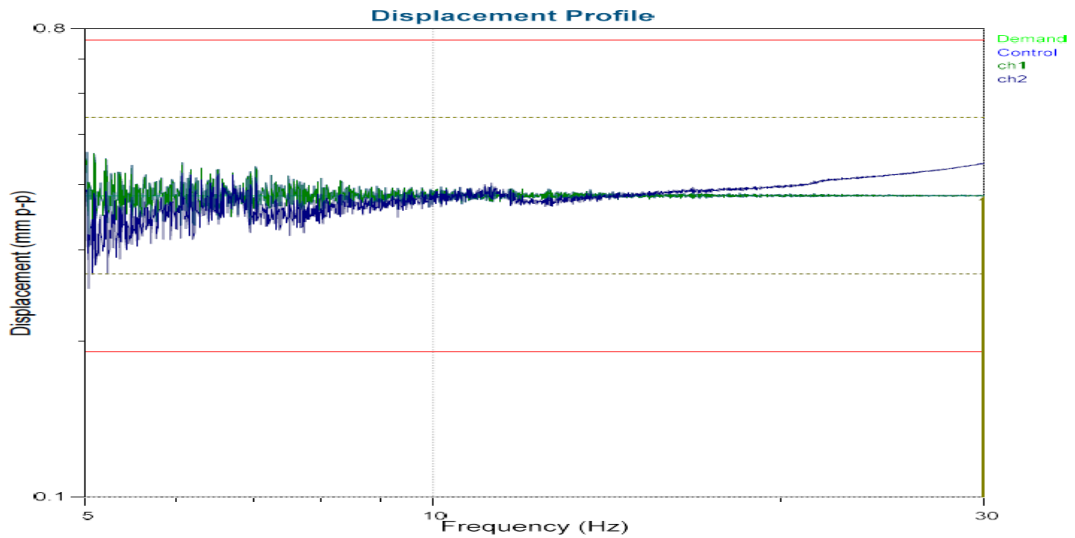
5 02, 2025 13:26:00 Level 1) 100 % Output: 0 Volts peak NEMA TS-2 2.2.8 - search.  
Demand: 0.381 mm Level Time: 0:12:30 Frequency: 30 Hz  
Control: 0.0005562 mm Total Time: 0:12:36 End of Sweep Test

#### Resonant search Test ( X Axis )

- Sample status : unpackaged / not in operation
- Applied waveform : Sine
- Frequency(Hz) : 5 ~ 30
- Double amplitude displacement (inch) : 0.015
- Sweep rate(Sweep/min) : 12.5

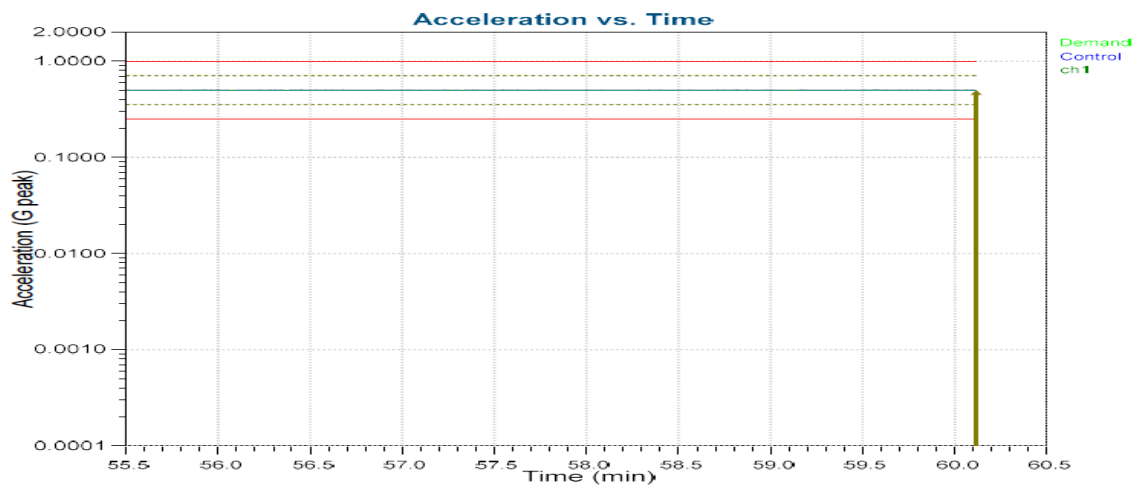
5 02, 2025 14:28:01 Level 1) 100 % Output: 0 Volts peak 한화비전 공진 L  
Demand: 0.5 G Level Time: 1:00:00 Frequency: 30 Hz  
Control: 0.0002145 G Total Time: 1:00:07 End of Timed Test

#### Endurance Test ( X Axis )

- Sample status : unpackaged / not in operation
- Applied waveform : Sine
- Frequency(Hz) : 30 or 3.2.2 Test results
- Acceleration(G) : 0.5
- Applicable axis : X, Y, Z
- Test time(h) : All 3(Each axis 1)
- Evaluation items
  - Check for mechanical damage before and after testing
- Test methods
  - Vibrate the test unit in each plane at its resonant frequency for a period of 1 hour at an amplitude resulting in 0.5 g acceleration. (test profile)
  - When more than one resonant frequency has been recorded in accordance with Section 1.2 Item 4, the test period of 1 hour shall be divided equally between the resonant frequencies.
  - The total time of the endurance test shall be limited to 3 hours, 1 hour in each of three mutually perpendicular planes.

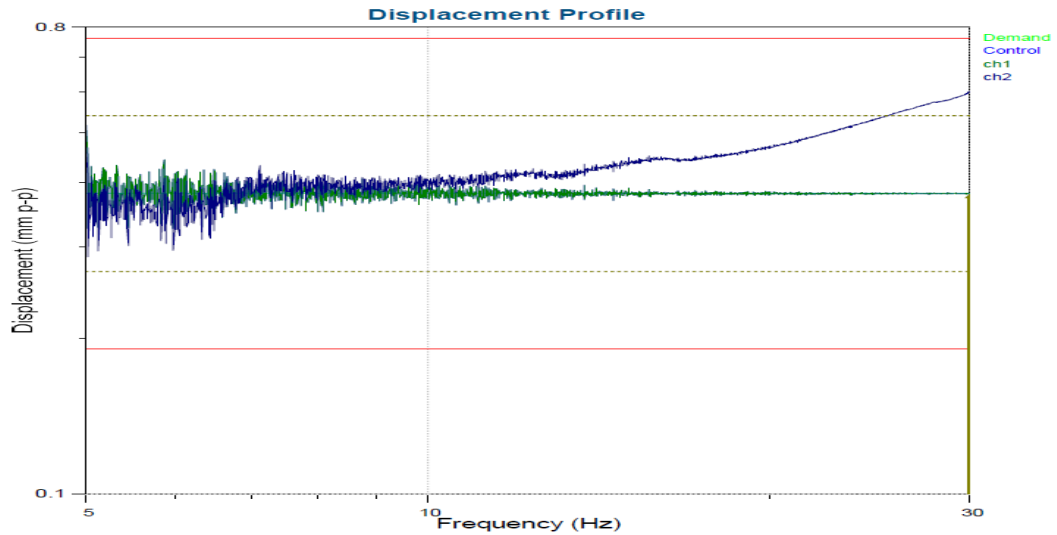
5 02, 2025 14:48:02 Level 1) 100 % Output: 0.06956 Volts peak NEMA TS-2 2.2.8 - search.  
Demand: 0.381 mm Level Time: 0:12:30 Frequency: 30 Hz  
Control: 0.381 mm Total Time: 0:12:37 End of Sweep Test

### Resonant search Test ( Y Axis )

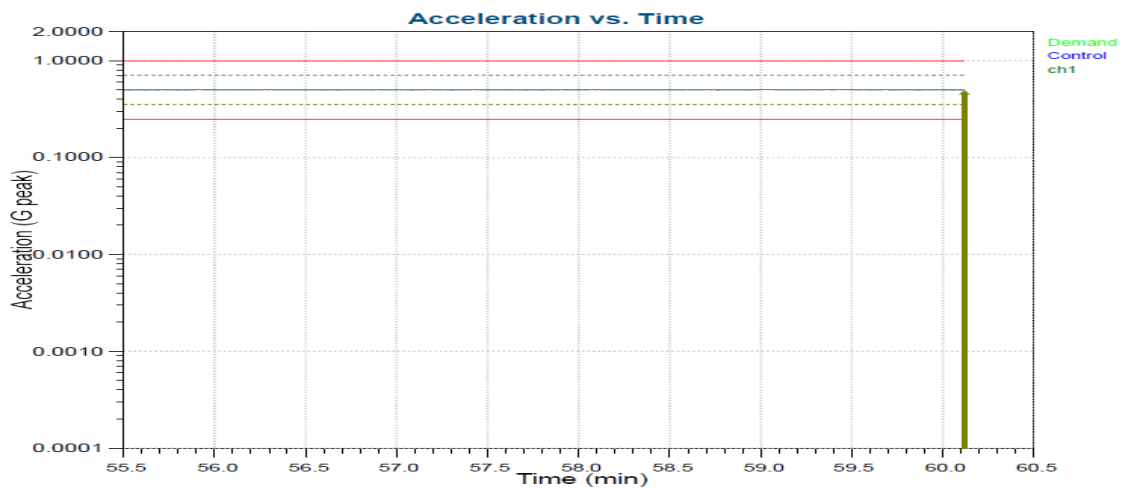
5 02, 2025 15:48:30 Level 1) 100 % Output: 3.281e-05 Volts peak  
Demand: 0.5 G Level Time: 1:00:00 Frequency: 30 Hz  
Control: 0.0007178 G Total Time: 1:00:07 End of Timed Test

### Endurance Test ( Y Axis )

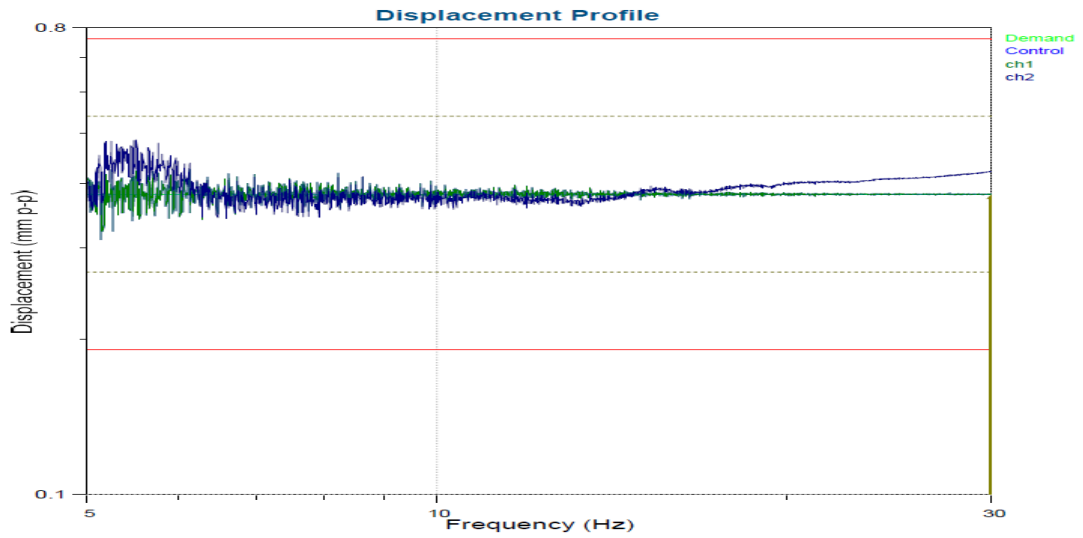
5 05, 2025 17:12:4: Level 1) 100 % Output: 0 Volts peak NEMA TS-2 2.2.8 - search.  
Demand: 0.381 mm Level Time: 0:12:3 Frequency: 30 Hz  
Control: 0.001005 mm Total Time: 0:12:3 End of Sweep Test

### Resonant search Test ( Z Axis )

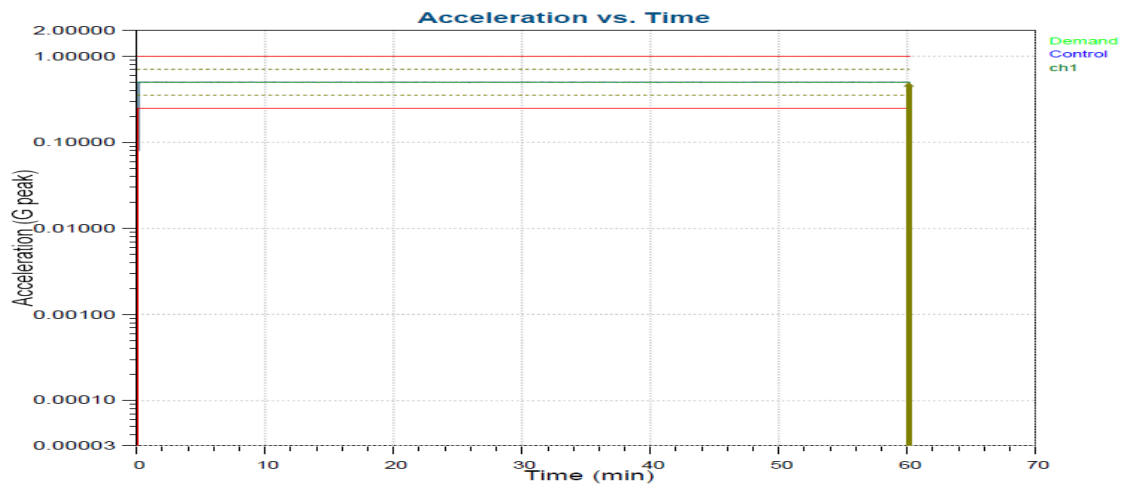
5 06, 2025 08:34:53 Level 1) 100 % Output: 0 Volts peak 한화비전 공진 L  
Demand: 0.5 G Level Time: 1:00:00 Frequency: 30 Hz  
Control: 0.0008318 G Total Time: 1:00:07 End of Timed Test

### Endurance Test ( Z Axis )

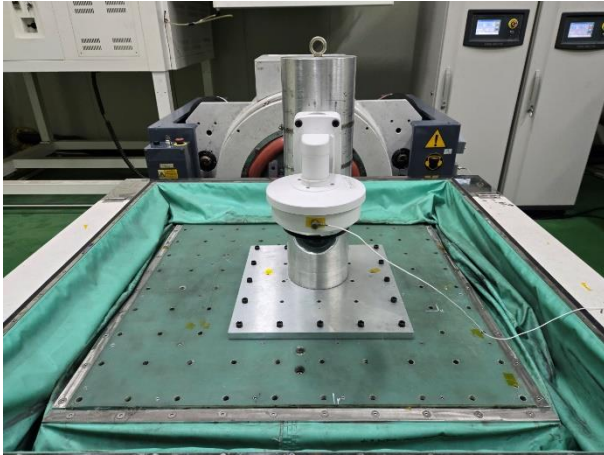
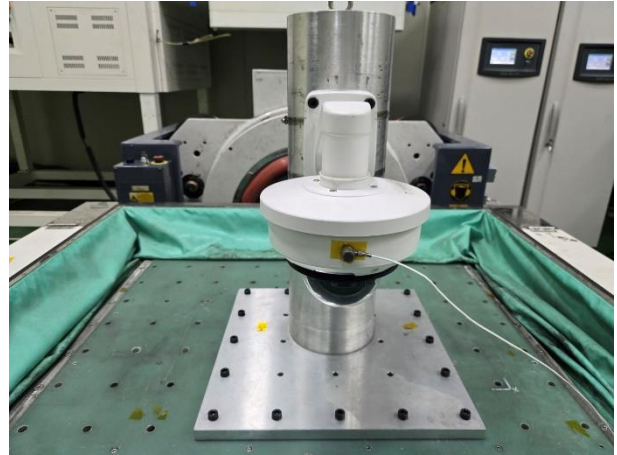
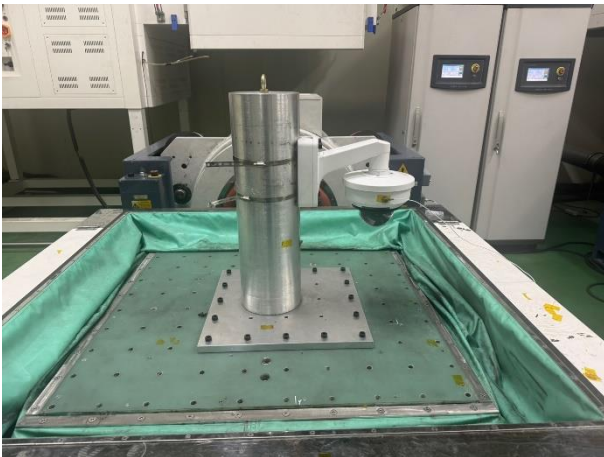
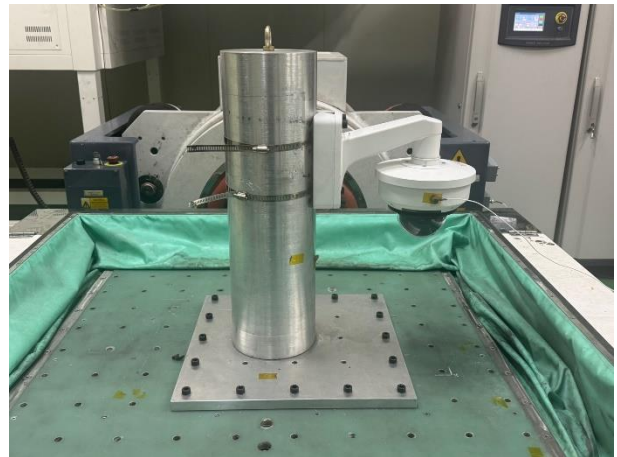
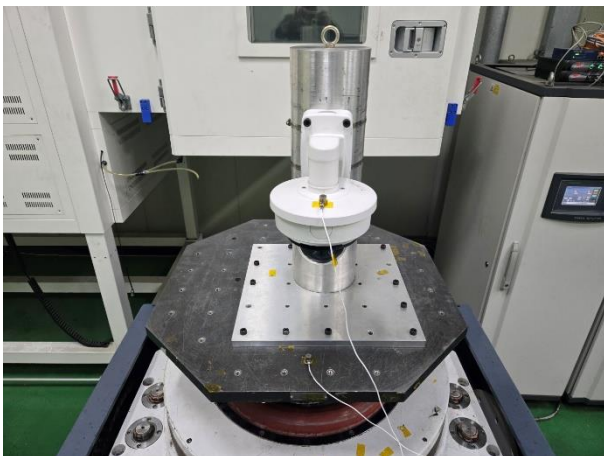
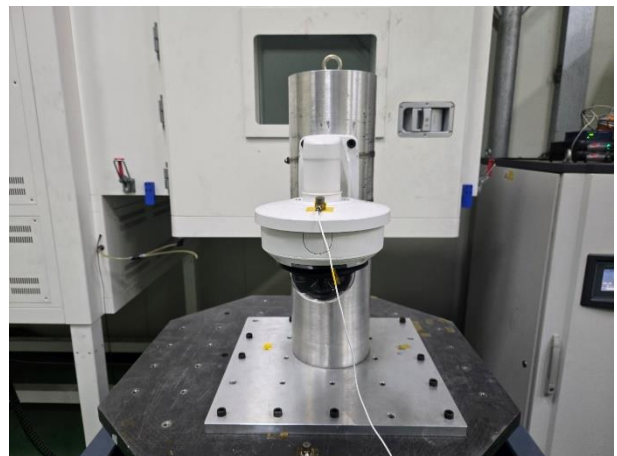
#### 5.3.1 Evidence of test setting (NEMA TS 2-2013 2.2.9)

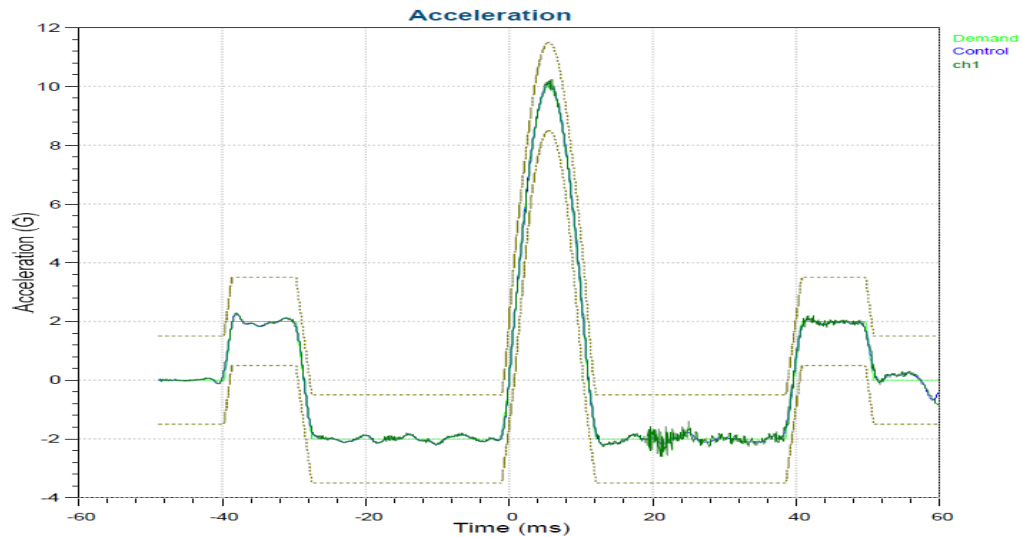
X+

5 02, 2025 14:34:02 Level 1) 100 % Output: 0.7748 Volts peak 2025-05-02 NEMA TS-2 2.2.5

Demand: 10 G

Control: 10.11 G Pulse: 1 of 1 Running

5.2.2 Applied waveform: Half sine

5.2.3 Acceleration(G): 10 G

5.2.4 Nominal duration (ms): 11

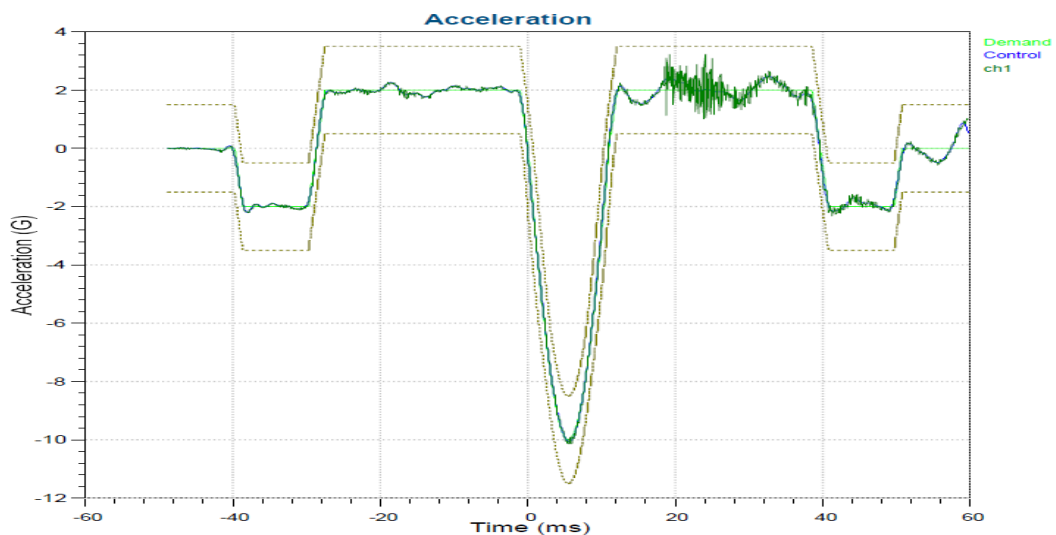
X-

5 02, 2025 14:34:15 Level 2) 100 % Output: 0.7748 Volts peak 2025-05-02 NEMA TS-2 2.2.5

Demand: 10 G

Control: 10.07 G Pulse: 1 of 1 End of Test

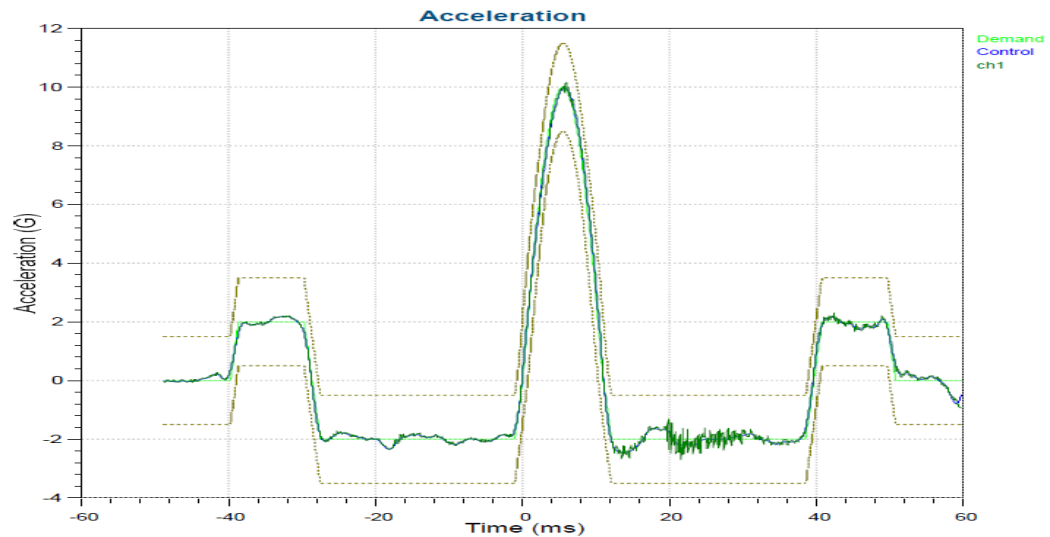
Y+

5 02, 2025 15:49:11 Level 1) 100 % Output: 0.7874 Volts peak 2025-05-02 NEMA TS-2 2.2.5

Demand: 10 G

Control: 9.985 G Pulse: 1 of 1 Running

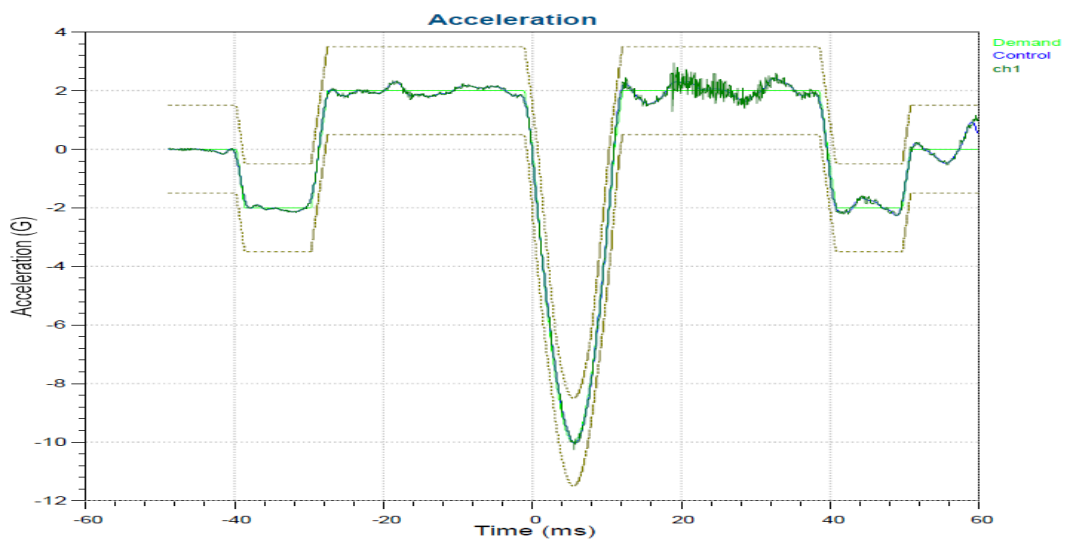
Y-

5 02, 2025 15:49:13 Level 2) 100 % Output: 0.7766 Volts peak 2025-05-02 NEMA TS-2 2.2.5

Demand: 10 G

Control: 10.04 G Pulse: 1 of 1 End of Test

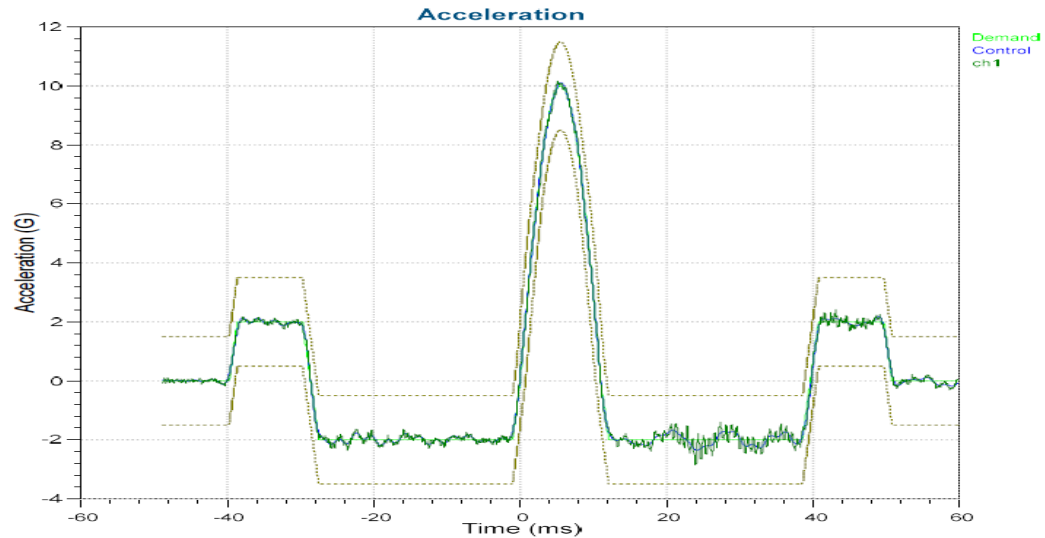
Z+

5 06, 2025 08:35:30 Level 1) 100 % Output: 0.6694 Volts peak 2025-05-02 NEMA TS-2 2.2.5

Demand: 10 G

Control: 10.11 G Pulse: 1 of 1 Running

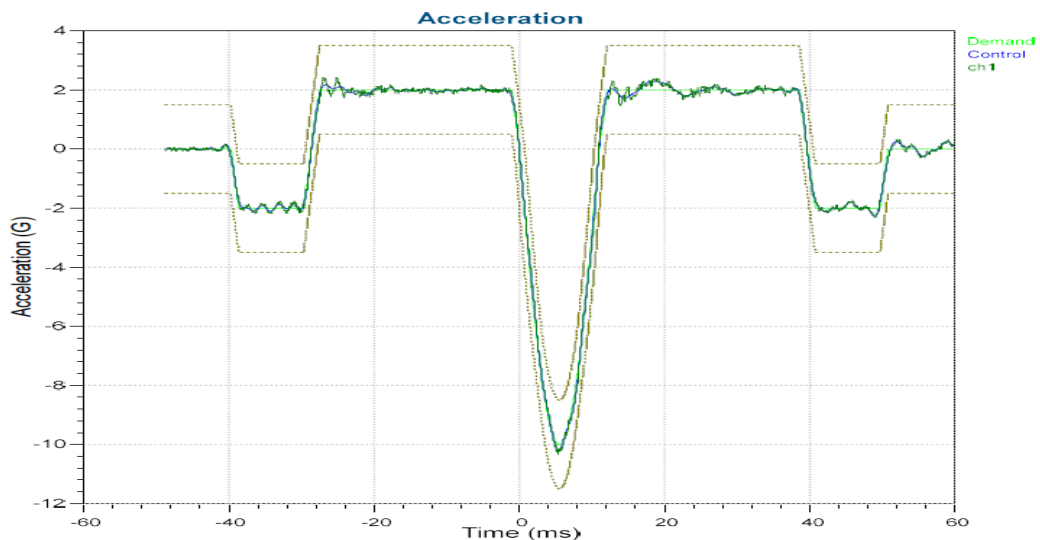
Z-

5 06, 2025 08:36:02 Level 2) 100 % Output: 0.6707 Volts peak 2025-05-02 NEMA TS-2 2.2.5

Demand: 10 G

Control: 10.23 G Pulse: 1 of 1 End of Test
