# TEST REPORT

REPORT No.:  
CTK-2025-00960  
Page (1) / (14) pages

NETWORK CAMERA / PNV-A9082RZ

IEC 60529:1989 +A1:1999+A2:2013

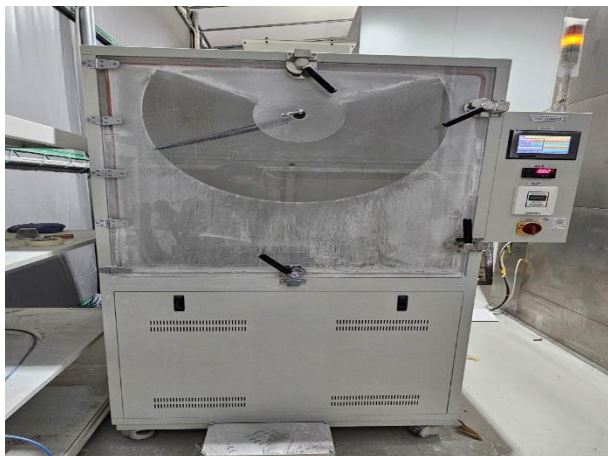
Dust Chamber

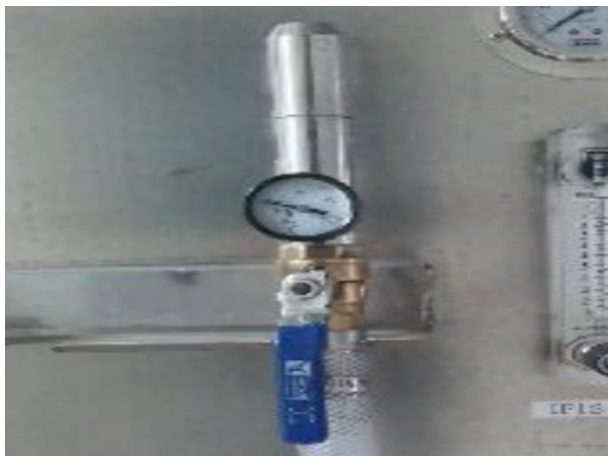
Hose Nozzle (12.5 mm)

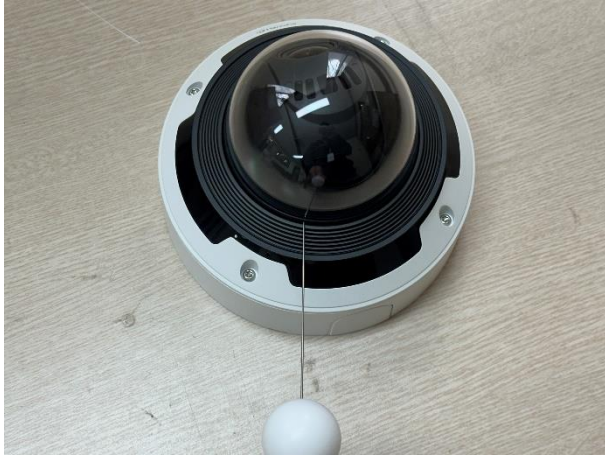
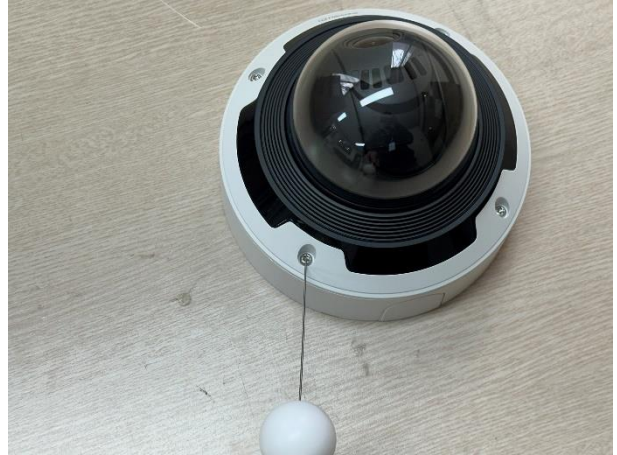
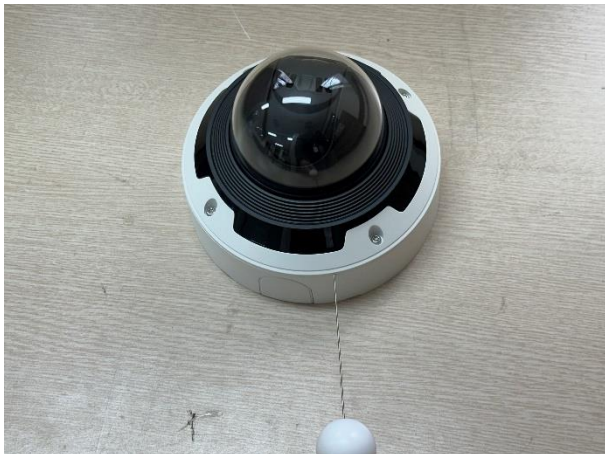
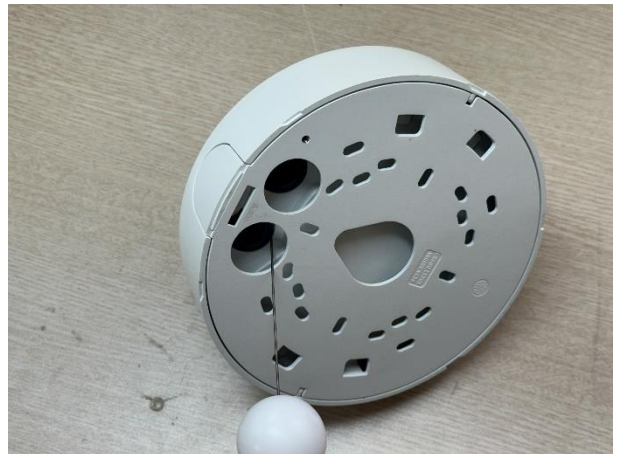
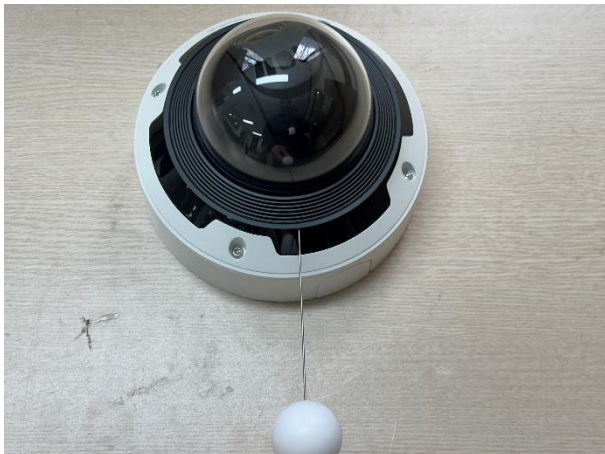
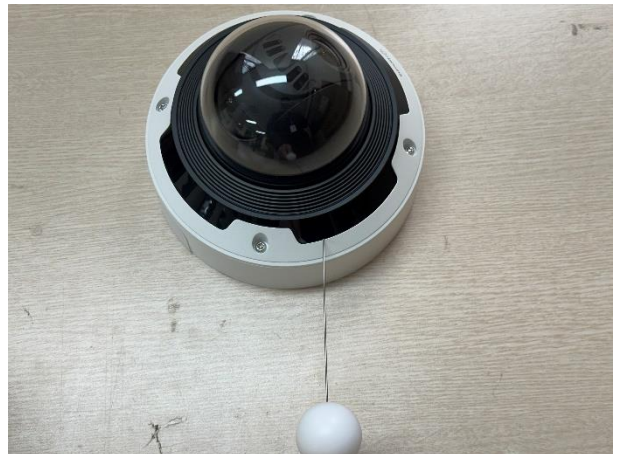
| First characteristic numeral | Degree of protection | Application |
|---|---|---|
| 6 | Protected against access to hazardous parts with a wire.<br>The access probe of 1.0 mmØ, shall not penetrate.<br>Test force: 1 N ± 10 % | <input checked="" type="checkbox"/> |

Probe test

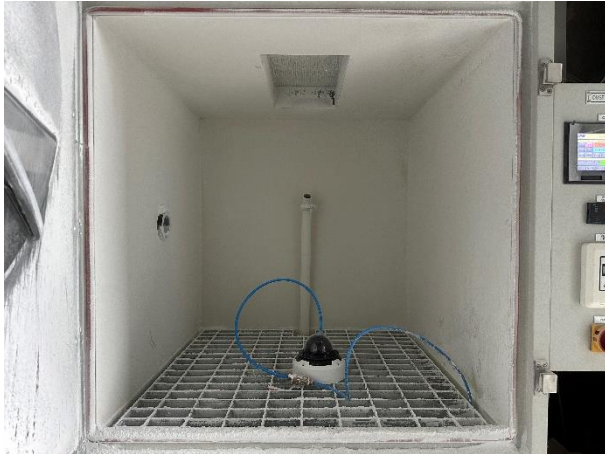
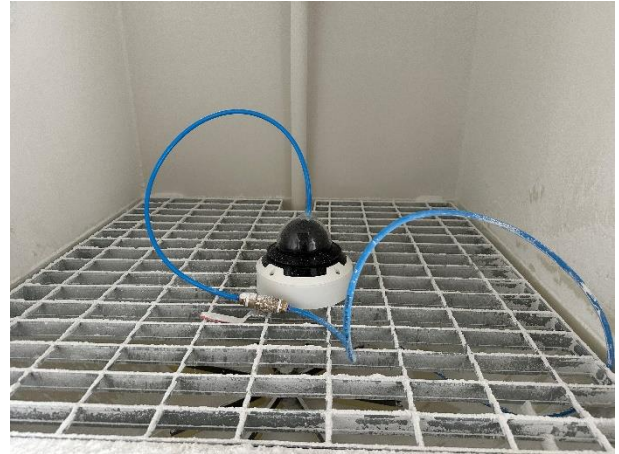
| First characteristic numeral | Degree of protection | Application |
|---|---|---|
| 6 | <p>In Dust Testing Equipment, the test sample must have no ingress of dust after testing atmospheric pressure present condition for 8 h.</p> <p>(The talcum powder must pass through a calibrated sieve with a 50 <math>\mu\text{m}</math> wire mesh, spaced at 75 <math>\mu\text{m}</math> intervals in a square pattern. Additionally, the bulk density of the talcum powder should be 2 kg/m<sup>3</sup>)</p> <p>Products in volume .....: <b>4 374 cm<sup>3</sup> → 4.37 L</b></p> <p>Target intake volume (Products in volume 80) : <b>349.92 L</b></p> <p>Suction volume (Max product in volume 60) ..: <b>262.44 LPH → 4.37 LPM</b></p> <p>Actual Suction volume .....: <b>4.37 L</b></p> <p>Suction pressure (Up to 2 kPa) .....: <b>1.78 kPa</b></p> <p>Test time (Up to 8 time) .....: <b>8 hr</b></p> | <input checked="" type="checkbox"/> |

Dust test

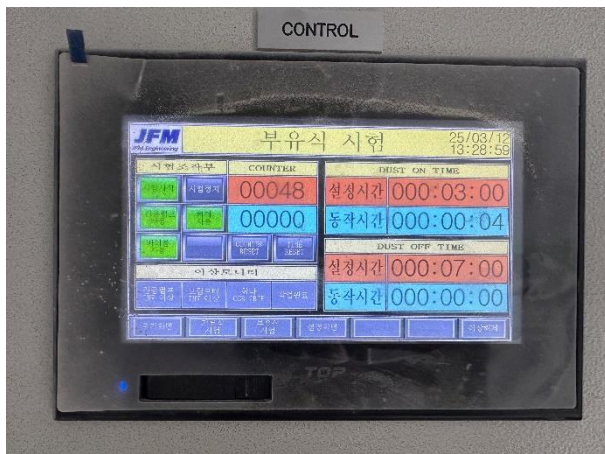
Dust test Monitor

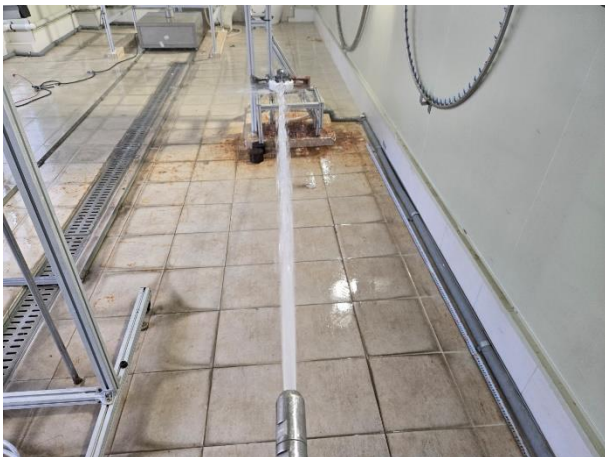
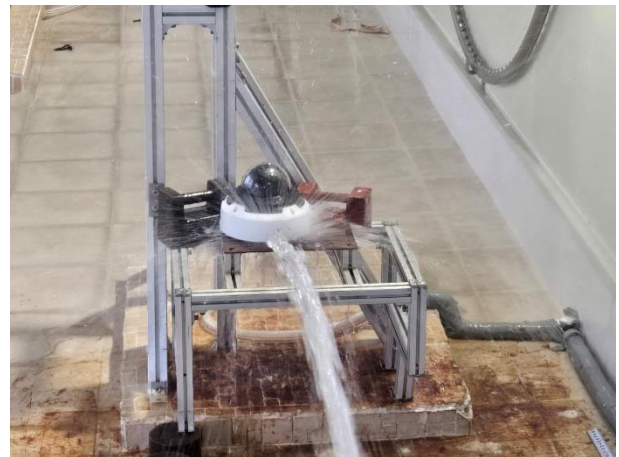
| Second characteristic numeral | Degrees of protection | Application |
|---|---|---|
| 6 | <p>The product must not be harmed in any direction even strong jet water.</p> <p>Water jet hose nozzle Fig.6, Nozzle 12.5 mm diameter</p> <p>Water flow rate: 100 l/min <math>\pm</math> 5 % : <b>100 LPM</b></p> <p>Distance: 2.5 m to 3 m: <b>3 m</b></p> <p>Duration of test: 1 min/m<sup>2</sup> at least 3 min: <b>3 min</b></p> | <input checked="" type="checkbox"/> |

Water test

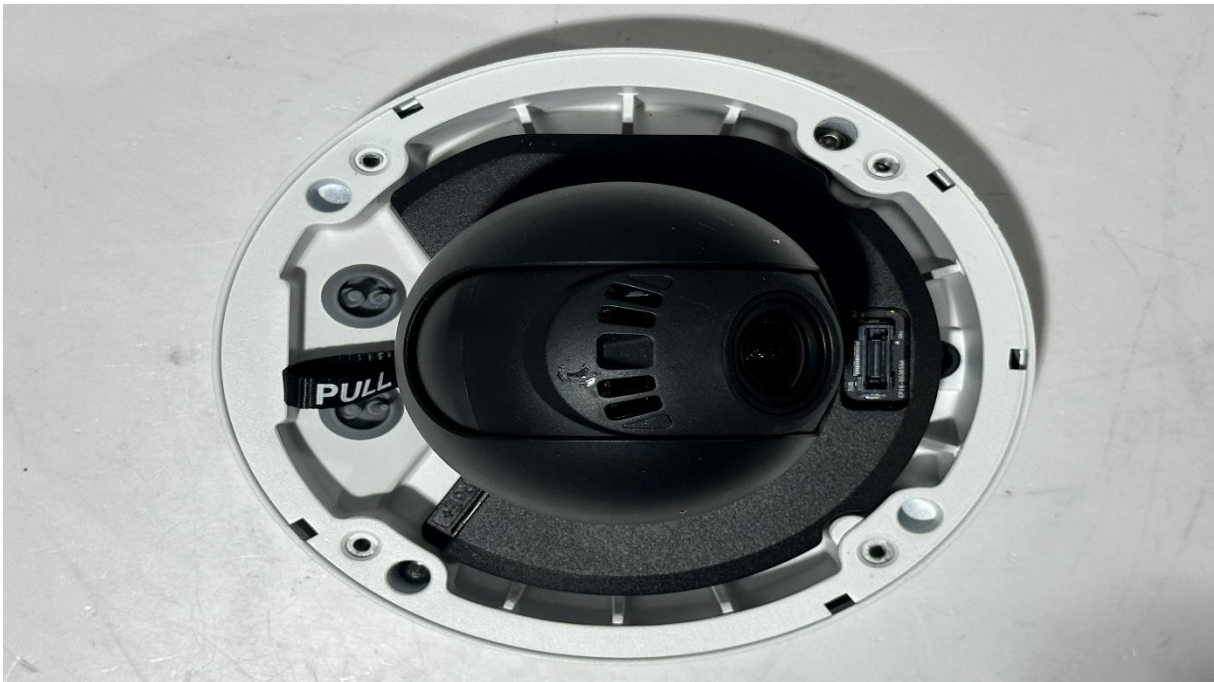
#### 3.5.1 Product internal images after test [The first characteristic numeral test]

| IP code | Evaluation Criteria | Test Results | Remark |
|---|---|---|---|
| IP 6X | No ingress of Probe | Normal | - |
| | No ingress of dust | Normal | - |

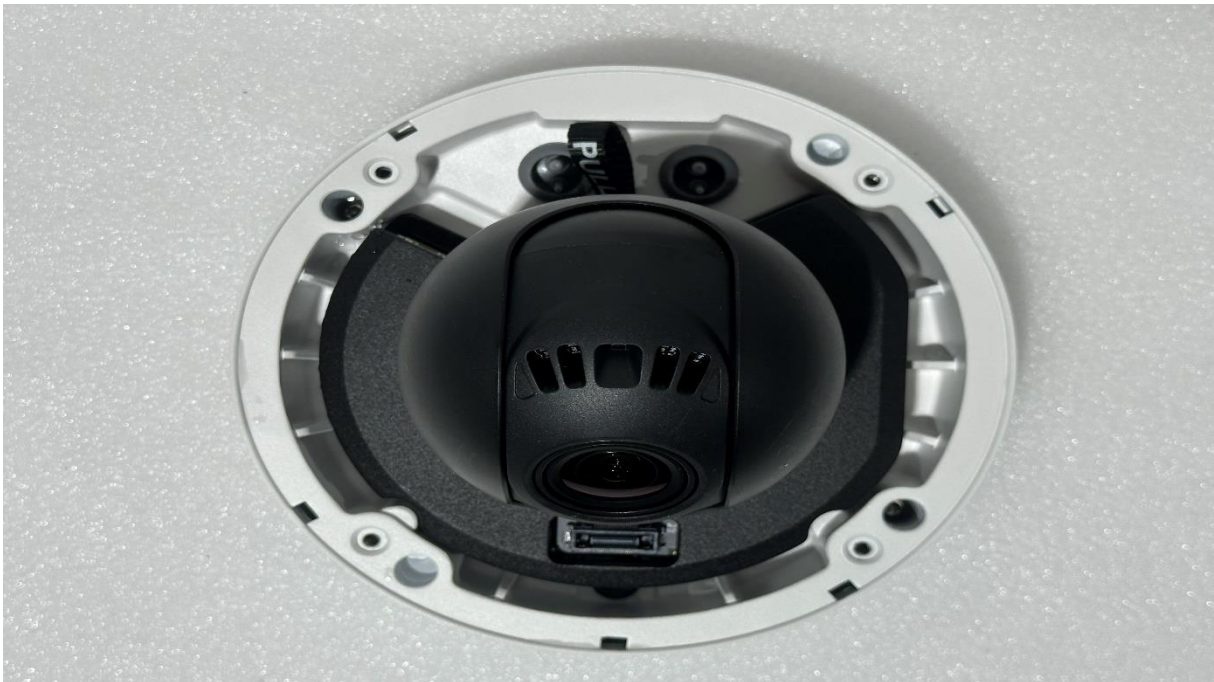
### 3.5.2 Product internal images after test [The second characteristic numeral test]

| IP code | Evaluation Criteria | Test Results | Remark |
|---|---|---|---|
| IP X6 | No ingress of water | Normal | - |
