# TEST REPORT

REPORT No.:  
CTK-2024-00666  
Page (1) / (13) pages

NETWORK CAMERA / QNO-C6083R

KS C IEC 62262: 2002

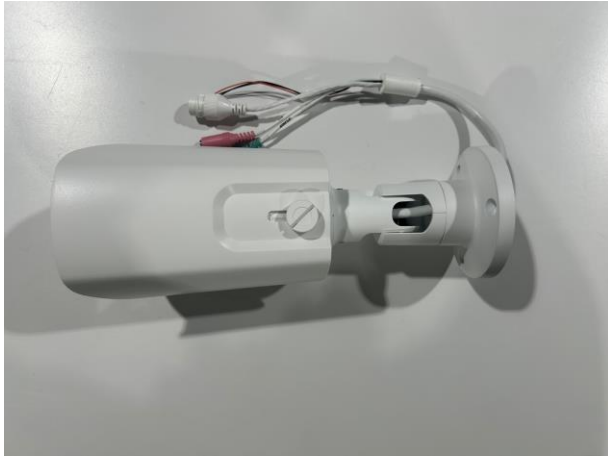
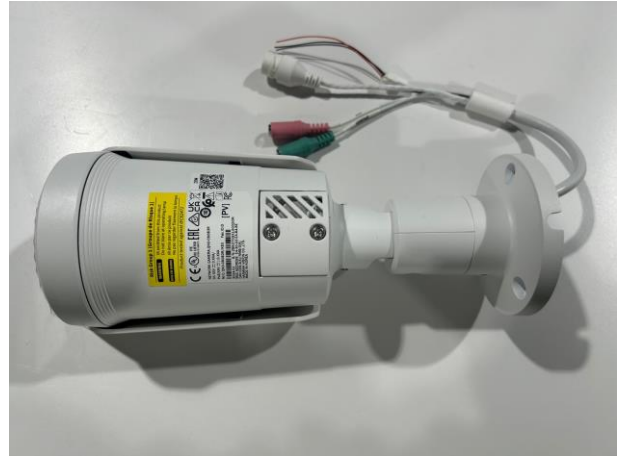
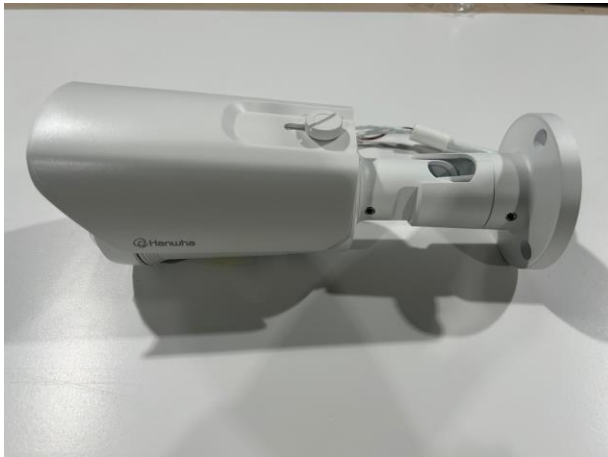
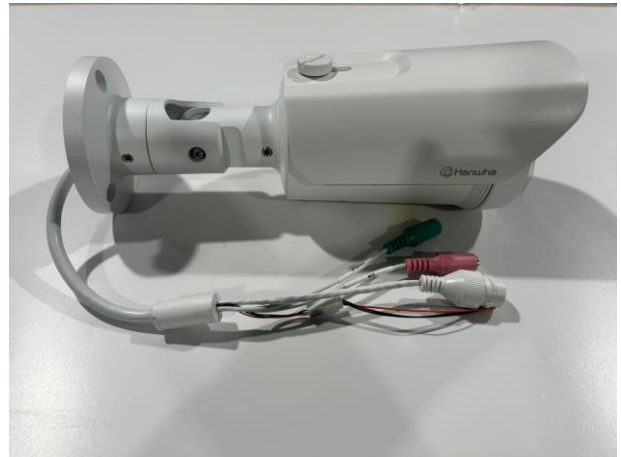
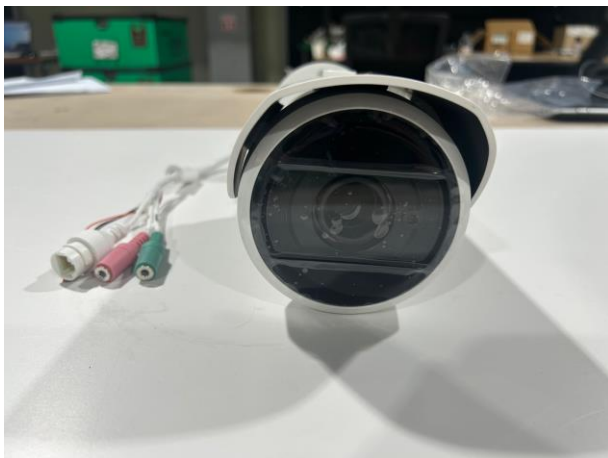
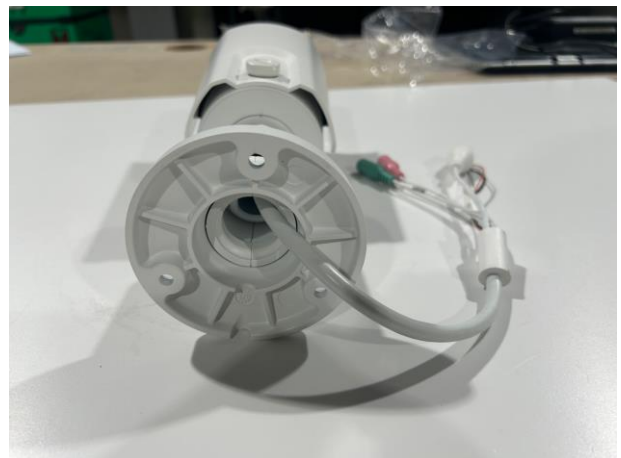
## 2.3 Pre-test product images

| Evaluation Criteria | | Test Results | Comment |
|---|---|---|---|
| Visual Inspection | Pre-test | No problem with the product | - |

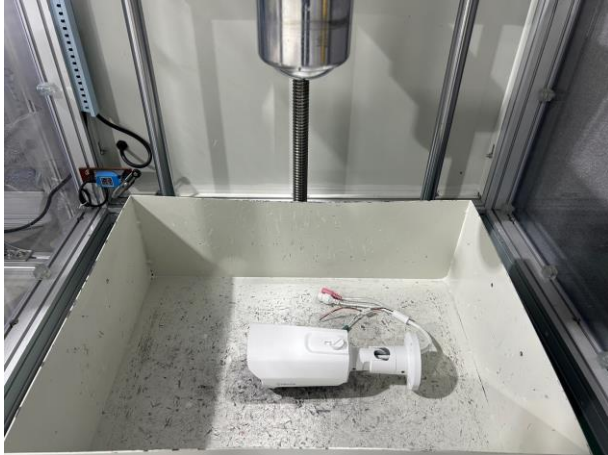
Check the hit area the test \_1

| Evaluation Criteria | | Test Results | Comment |
|---|---|---|---|
| | Post-test | Some scratches were generated on the outside of the product. | - |
