# TEST REPORT

CTK-2025-01263

NETWORK THERMAL CAMERA / TNO-C3050T

EN 60068-2-1, EN 60068-2-2, EN 60068-2-14, EN 60068-2-6, EN  
60068-2-27, EN 60068-2-78, IEC 60068-2-1, IEC 60068-2-2, IEC  
60068-2-14, IEC 60068-2-6, IEC 60068-2-27, IEC 60068-2-78

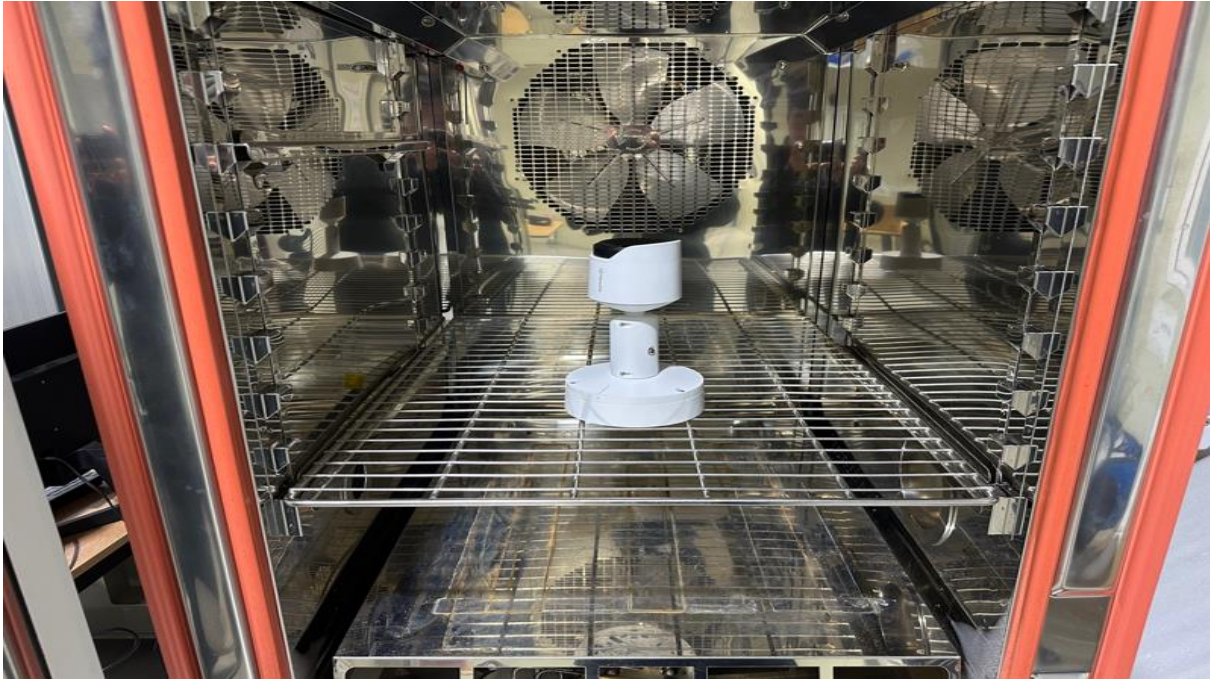
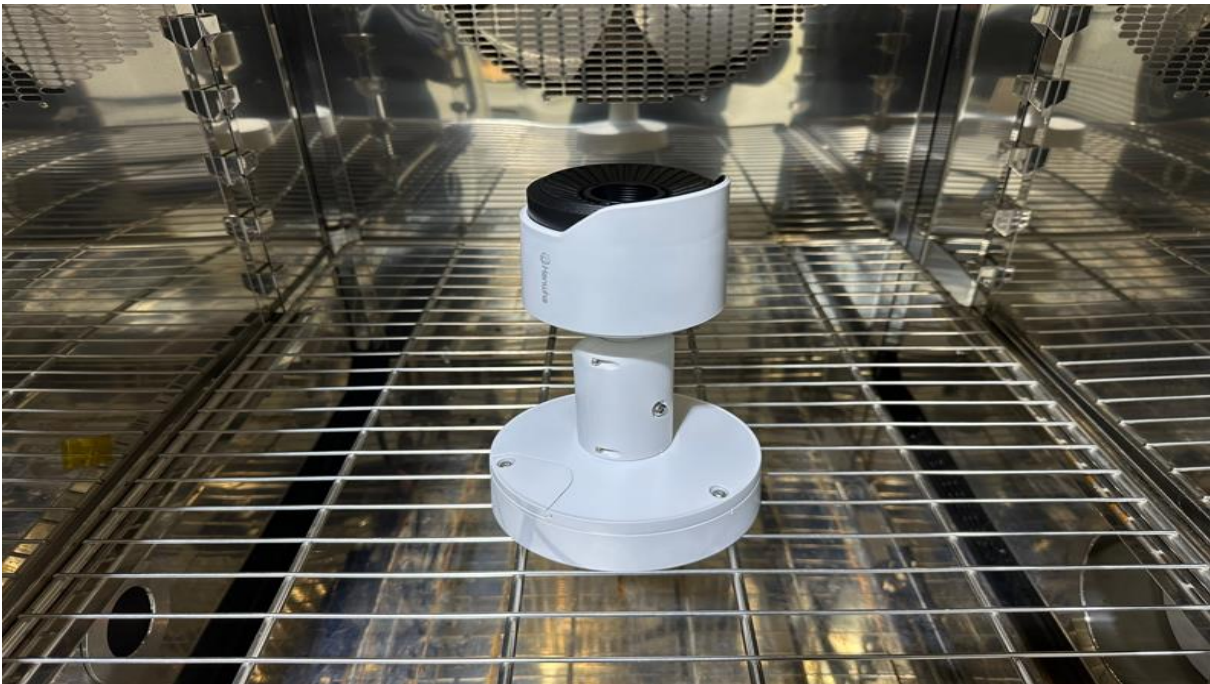
#### 3.3.1 Evidence of test setting

3.2.1 Sample status: Non-operation

3.2.2 Test temperature: -33 °C

3.2.3 Test time: 16 h

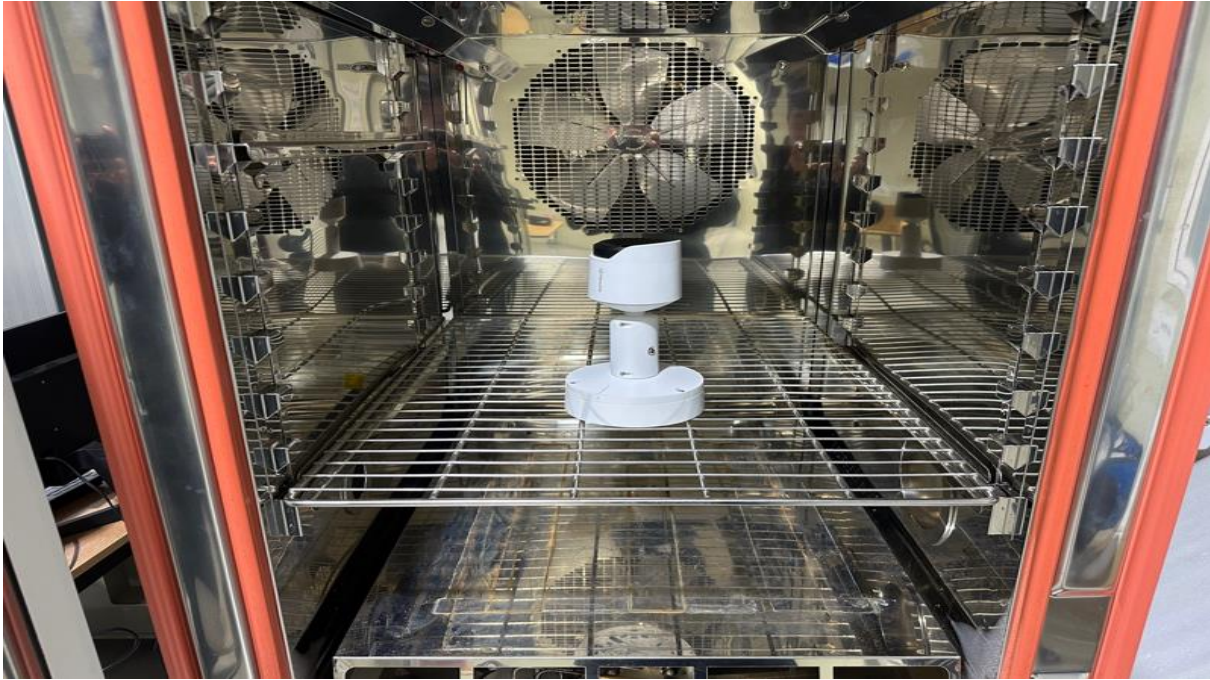
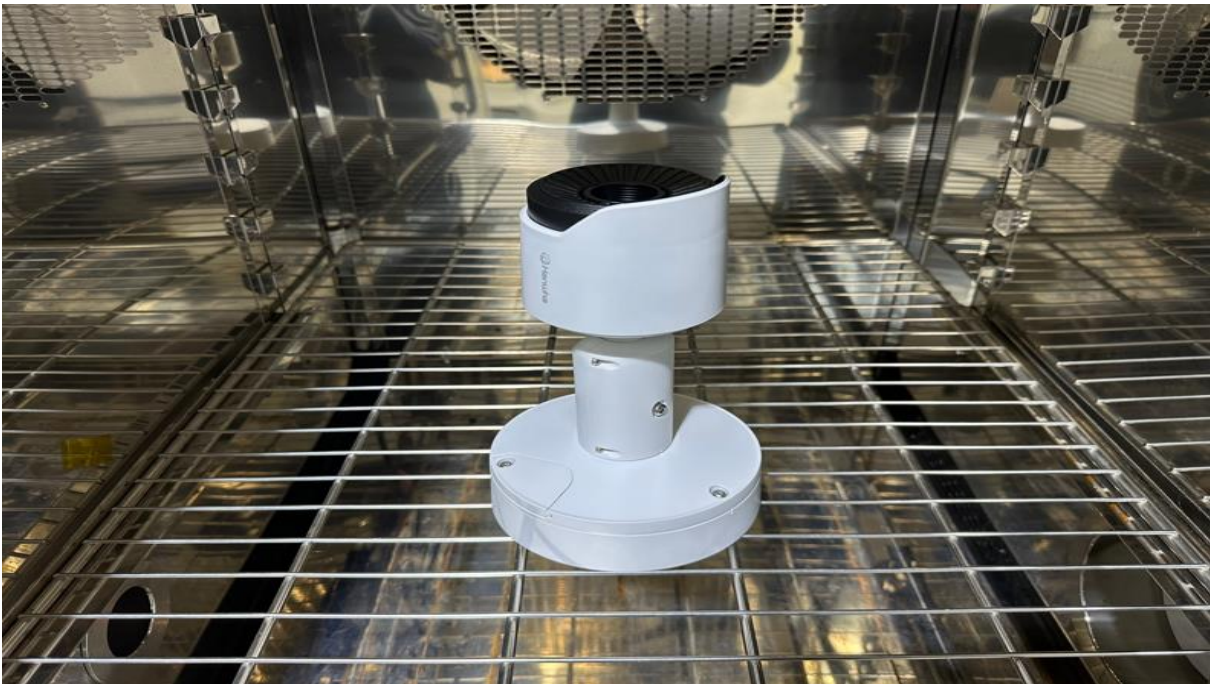
#### 4.3.1 Evidence of test setting

4.2.1 Sample status: Non-operation

4.2.2 Test temperature: 60 °C

4.2.3 Test time: 96 h

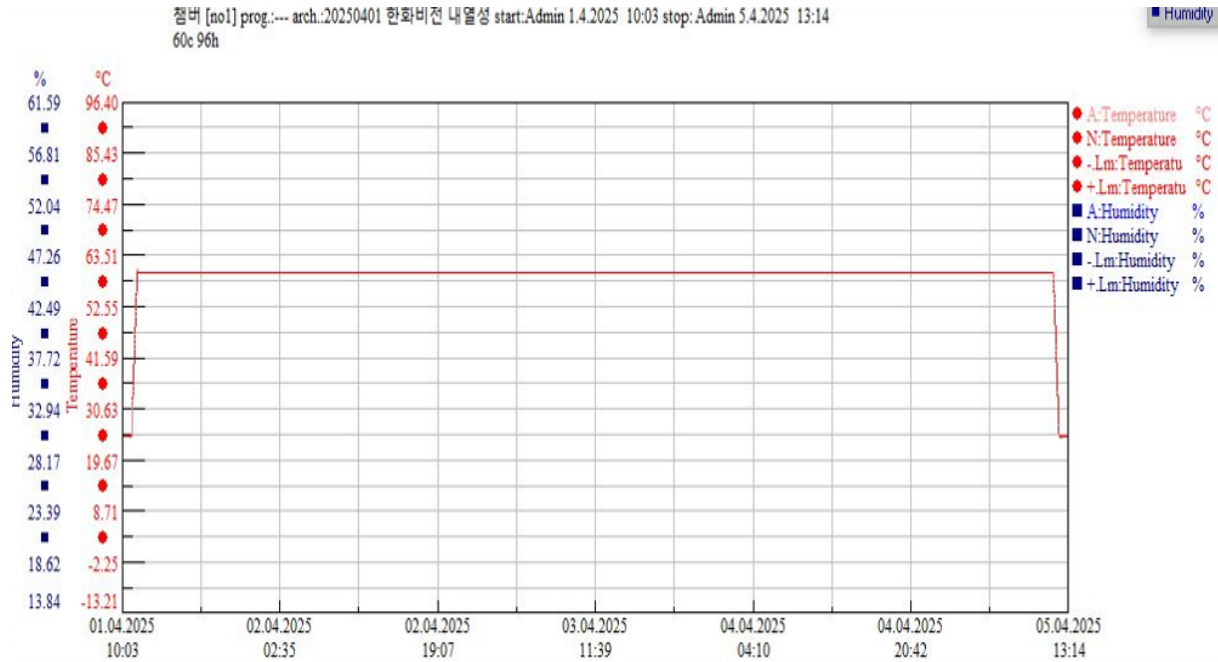
Temperature Data

#### 4.5.1 Test data and graph

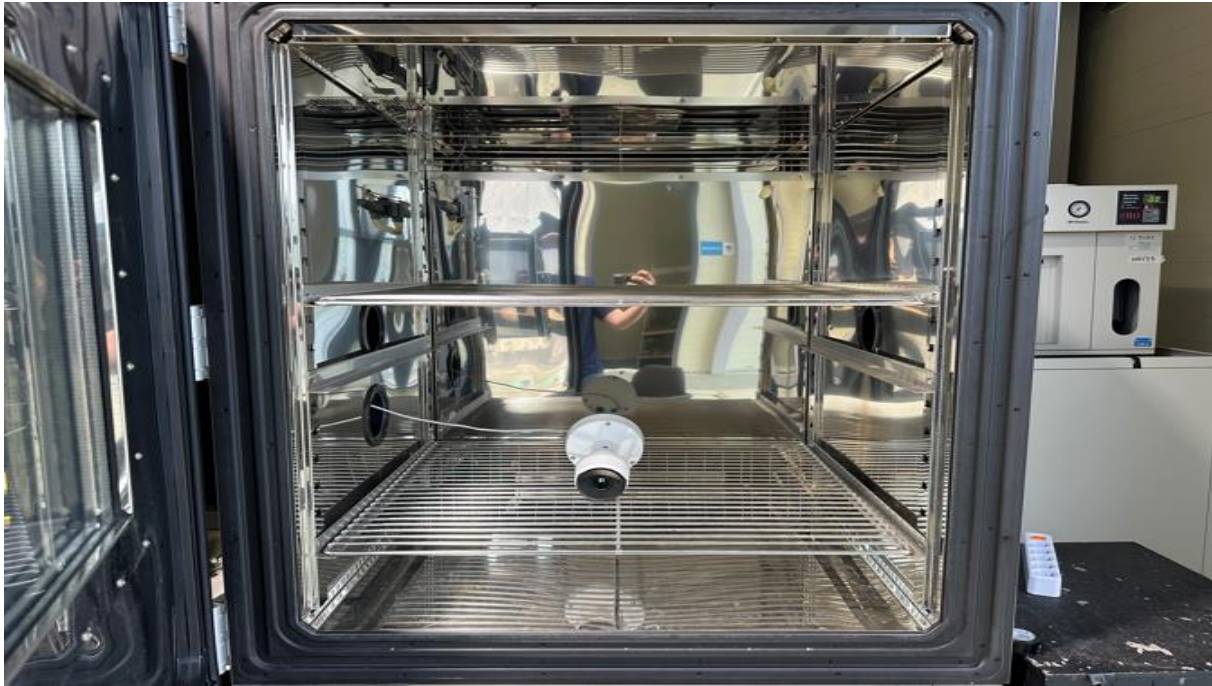
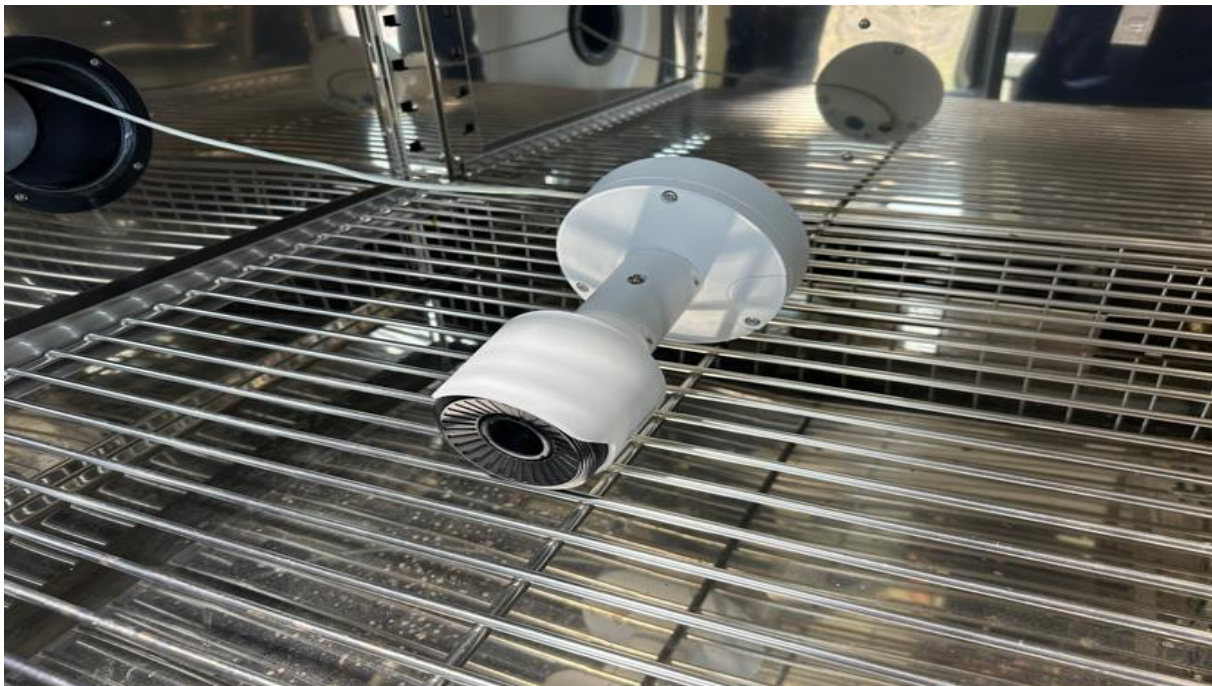
### 5.3.1 Evidence of test setting

5.2.1 Sample status: operation

5.2.2 Test temperature: -40 °C, 60 °C

5.2.3 Test time: 24 h

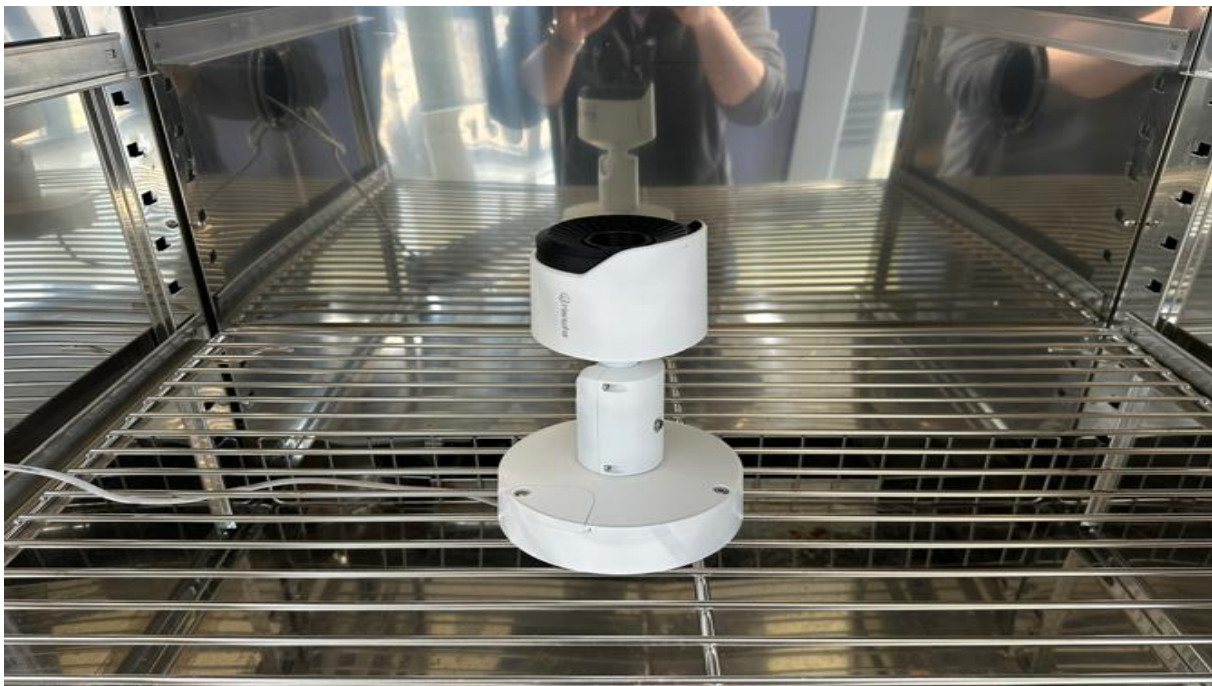
### 8.3.1 Evidence of test setting

8.2.1 Sample status: operation

8.2.2 Test temperature:  $40 \pm 2$  °C

8.2.3 Test Humidity:  $93 \pm 3$  % R.H.

8.2.4 Test time: 240 h
