# TEST REPORT

REPORT No.:  
CTK-2025-01267  
Page (1) / (14) pages

Network Thermal Camera / TNO-C3050T

IEC 62262:2002+AMD1:2021

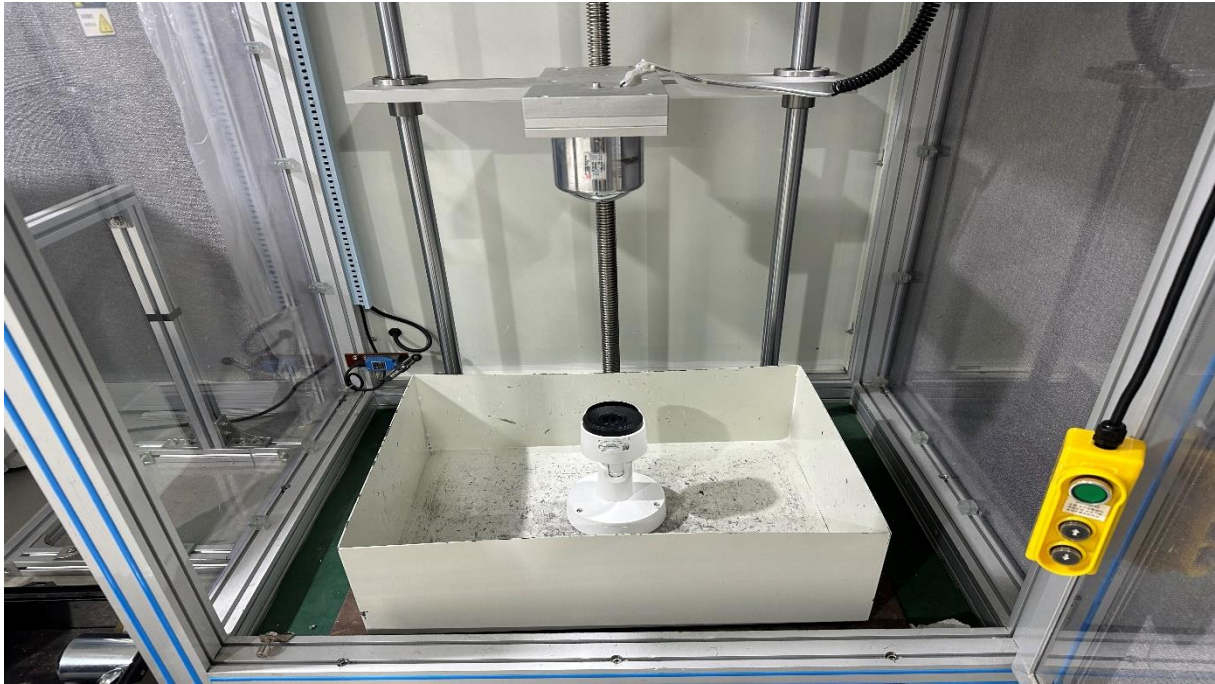
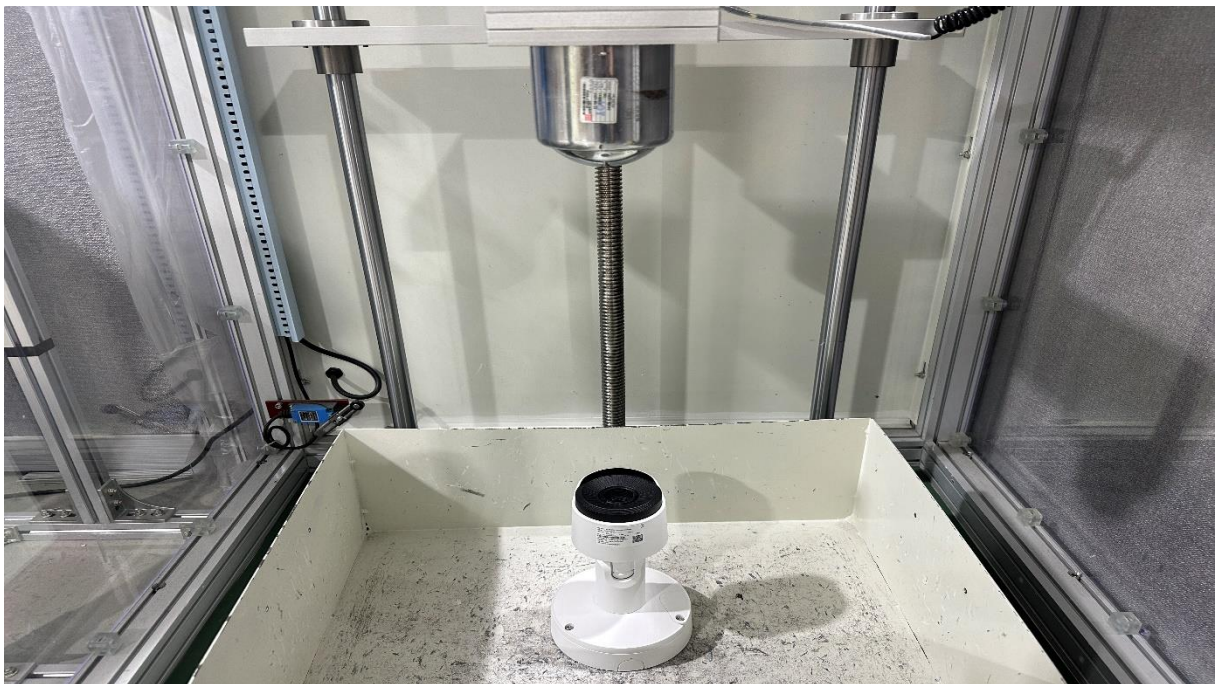
#### 3.3.1 Evidence of test setting

Impact times: five times for each of the exposed surface. (Do not impact more than 3 times in the same spot)

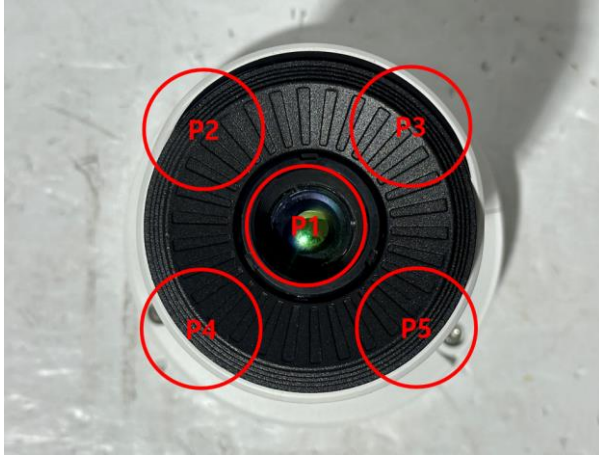
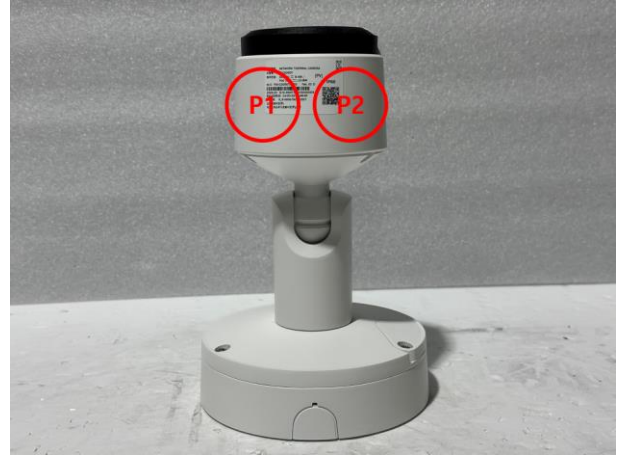
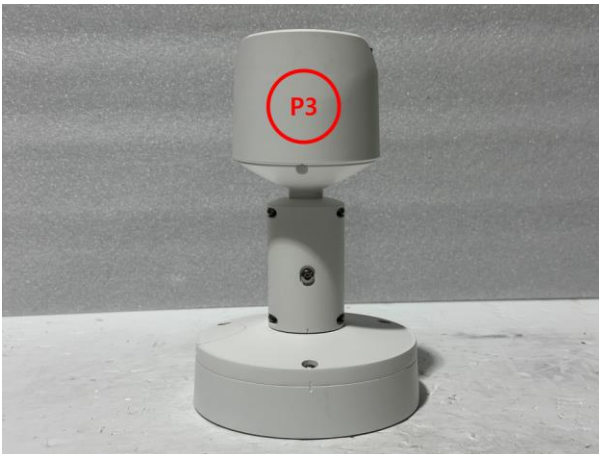
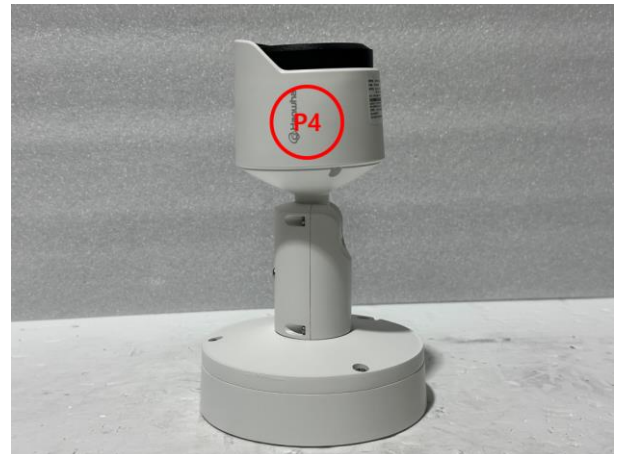
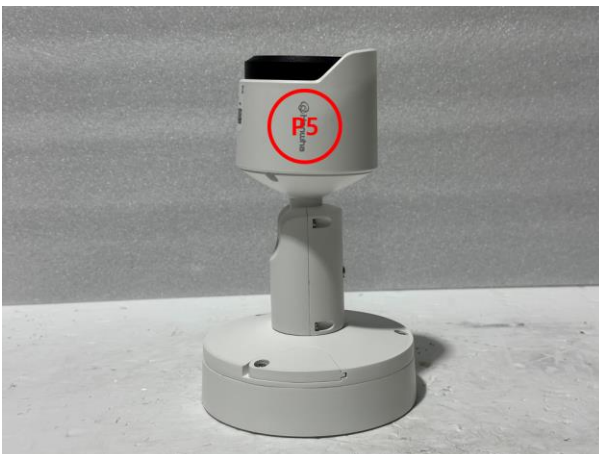
#### 3.5.1 Check the hit area during the test (1)

| Evaluation Criteria | Test Results | Remark |
|---|---|---|
| Visual Inspection | Some scratches were generated on the outside of the product. | - |

Check the hit area the test\_1

Check the hit area the test\_2

Check the hit area the test\_3

Check the hit area the test\_4

Check the hit area the test\_5

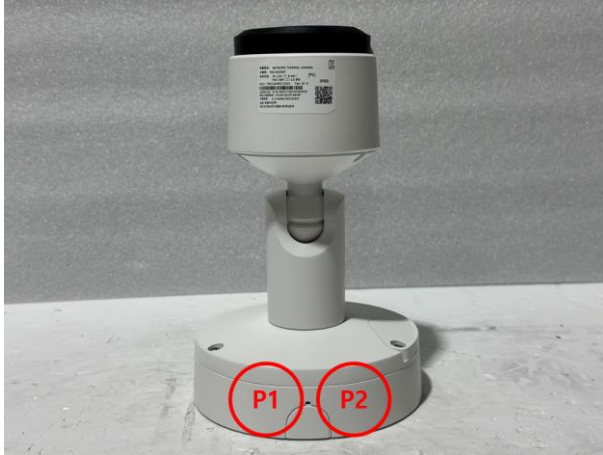
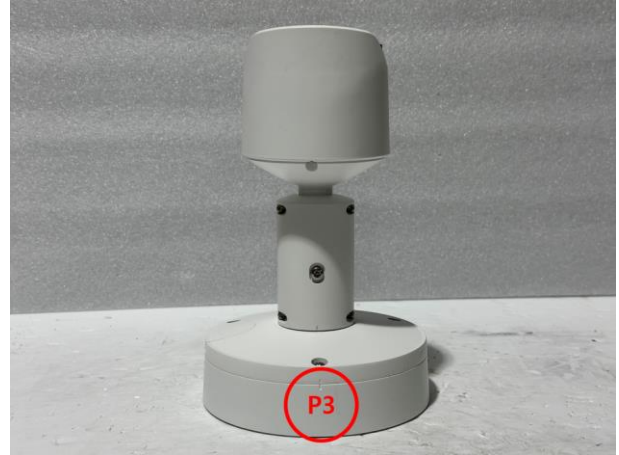
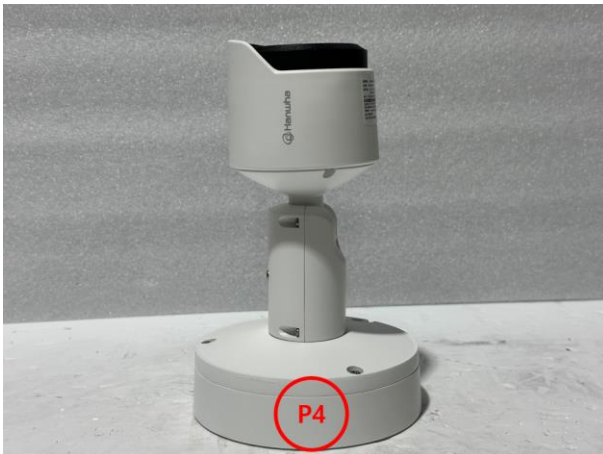
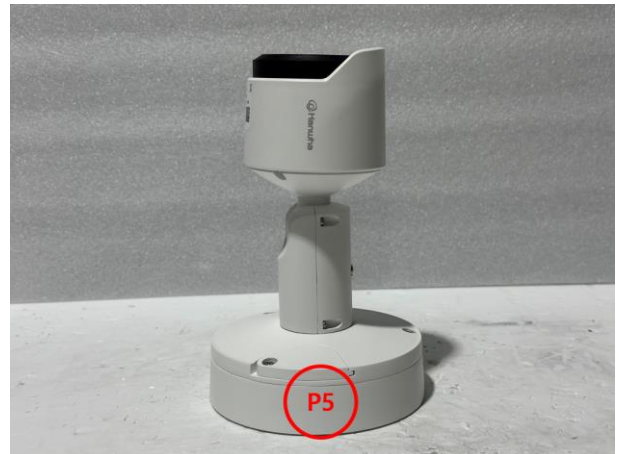
### 3.5.2 Check the hit area during the test (2)

Check the hit area the test\_6

Check the hit area the test\_7

Check the hit area the test\_8

Check the hit area the test\_9

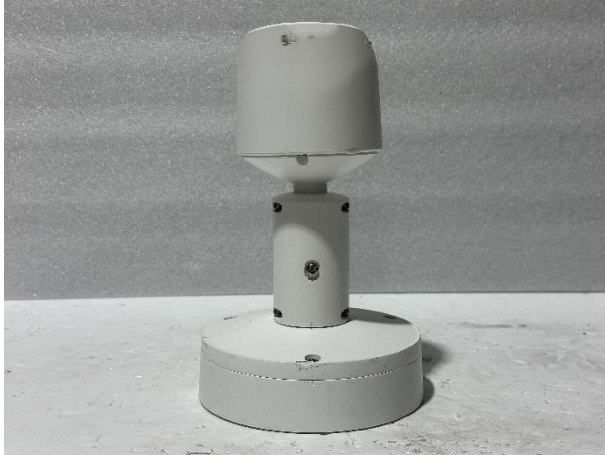
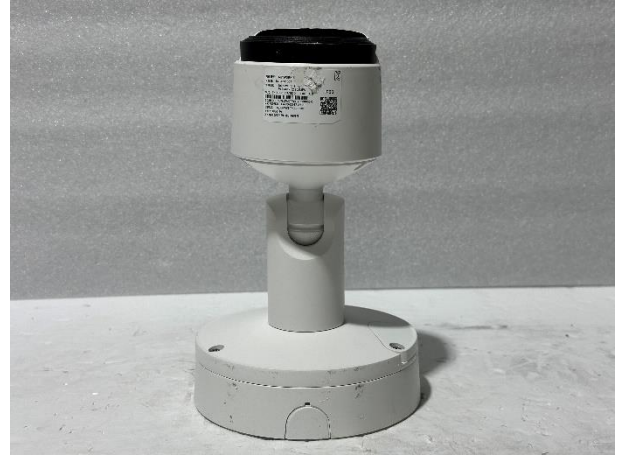
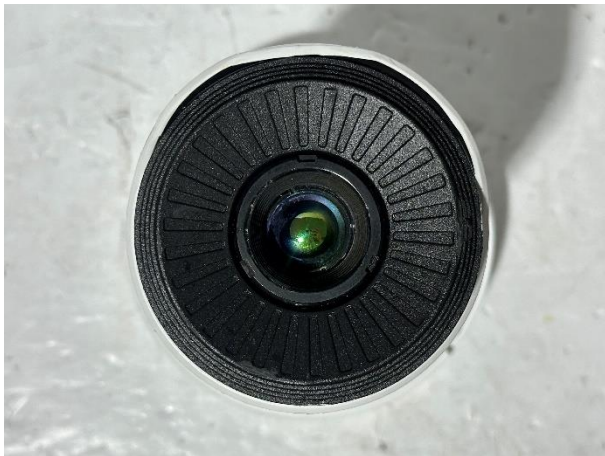
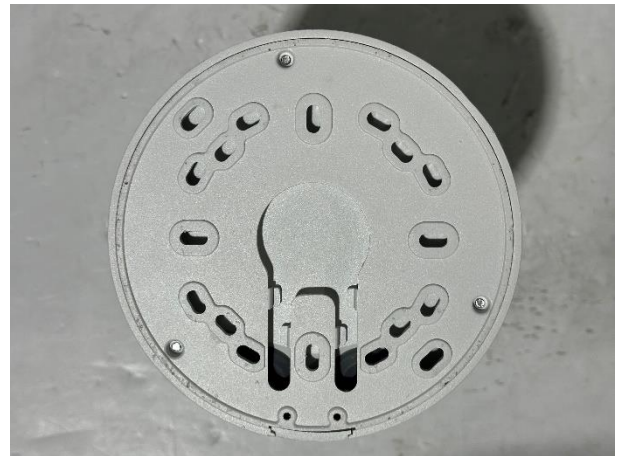
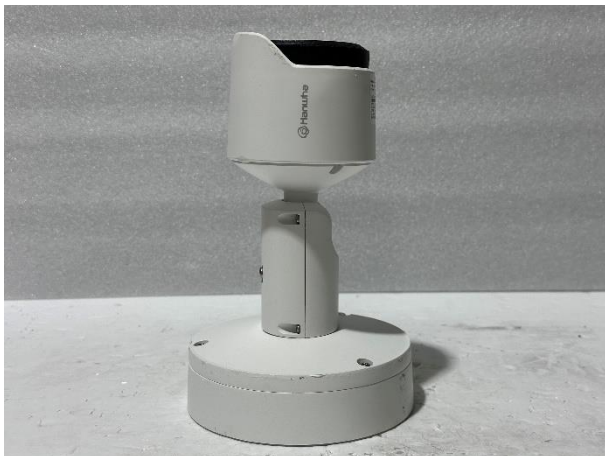
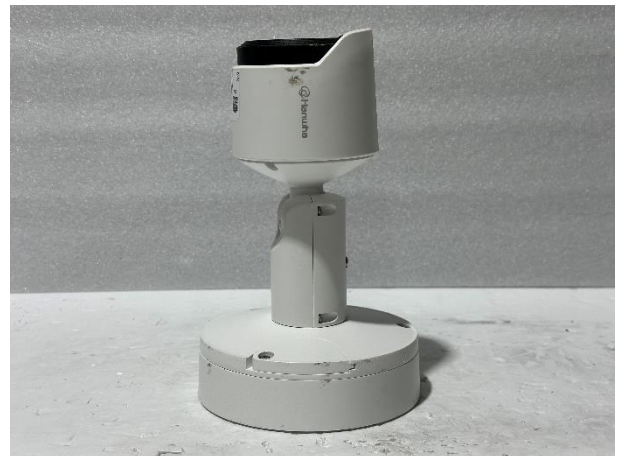
### 3.5.3 Post-test product images

※ Refer to the product photos after the completion of testing in section 3.5.2
