# TEST REPORT

REPORT No.:  
CTK-2025-01264  
Page (1) / (24) pages

NETWORK THERMAL CAMERA / TNO-C3050T

NEMA TS 2-2013 2.2.7.2 Test B ~ 2.2.7.8, NEMA TS 2.2.8,  
NEMA TS 2.2.9

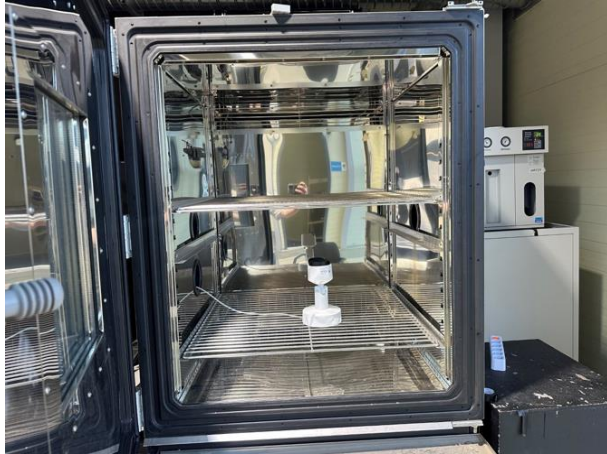
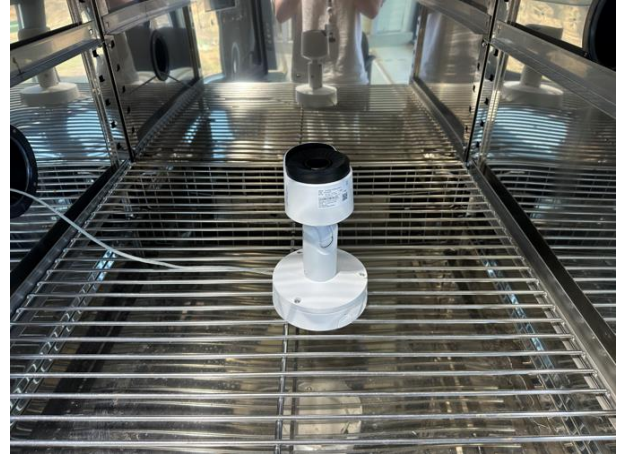
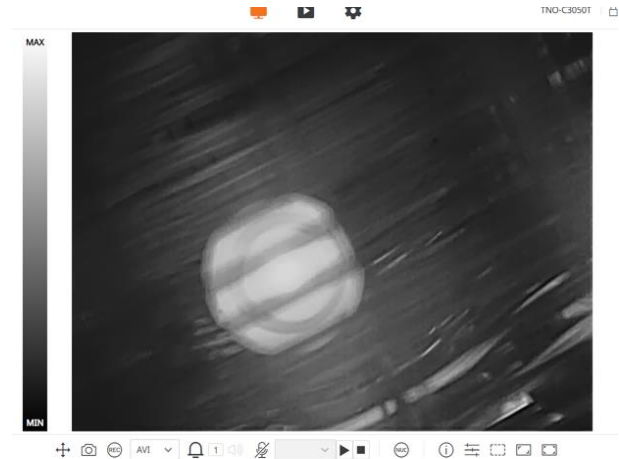
#### 3.3.1 Evidence of test setting (2.2.7.2 Test B ~ 2.2.7.8 Transient Test)

Transient Tests

220V

135V

89V
