# TEST REPORT

REPORT No.:  
CTK-2024-00231-1  
Page (1) / (13) pages

Barcode Reader / TNS-9050IBC

IEC/EN 60068-2-6:2007, Specifications presented by  
the sponsor(reference NEMA TS 2.2.9)

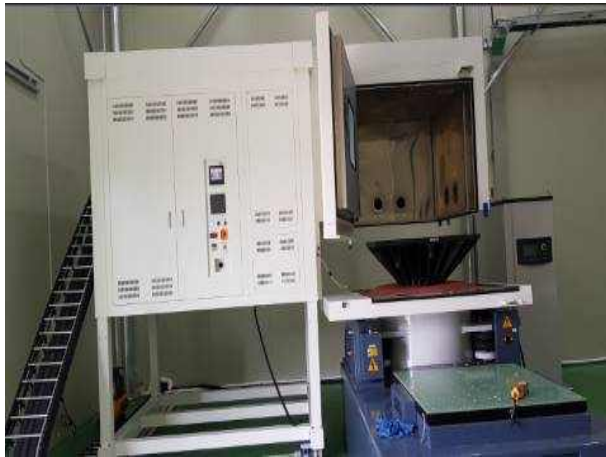
| Testing equipment | Model Name | Manufacturer | Manufacturing Number | Calibration Date |
|---|---|---|---|---|
| VIBRATION TESTING SYSTEM | GT1000M | FAMTECH | D1803072 | N/A |

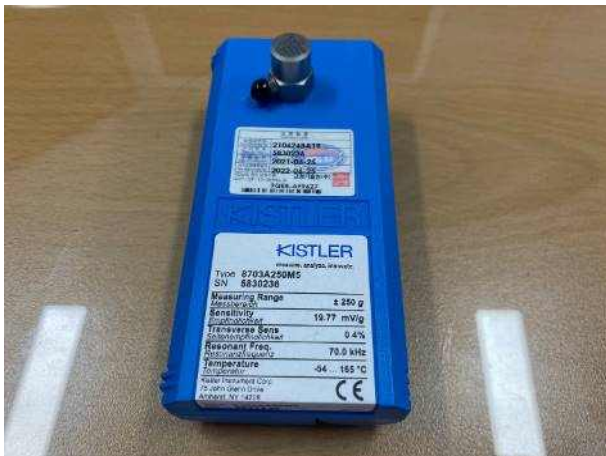
| Testing equipment | Model Name | Manufacturer | Manufacturing Number | Calibration Date |
|---|---|---|---|---|
| Acceleration sensor | 8703A250M5 | KISTLER | 5830236 | 2024-03-27 |

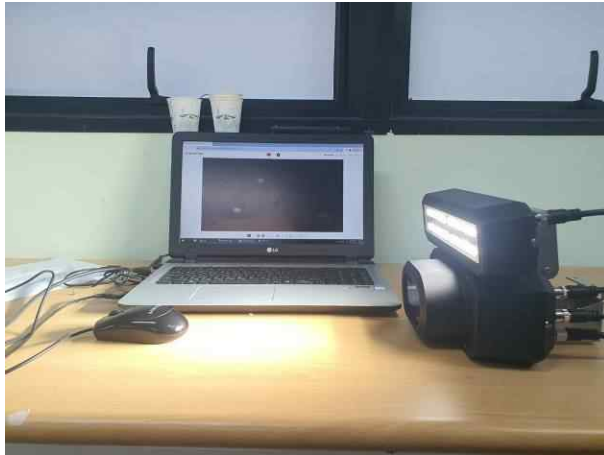
Verification of operation before testing #1

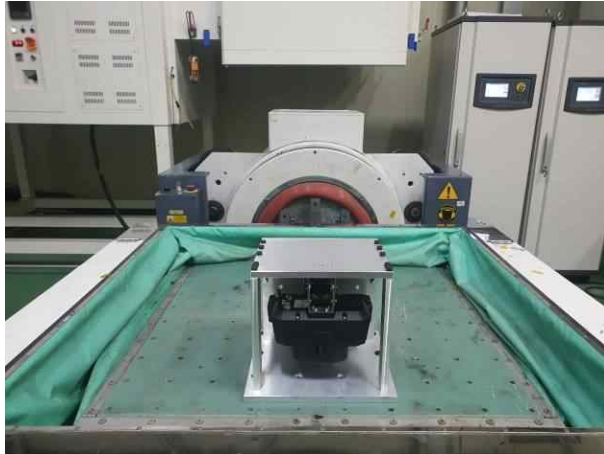
Vibration(Sine) Test[IEC/EN 60068-2-6:2007] – X axis, Test Shock(impact) Test Same configuration

- Sample status : unpackaged / not in operation
- Number of samples : 1 EA
- Applied waveform : Sine
- Frequency(Hz) : 10 ~ 50 / 50 ~ 500
- Acceleration : 0.4 mm / 2.0 g
- Sweep rate(Oct/min) : 1
- Applied axis : X, Y, Z axis
- Test time (h) : All 9(Each axis 3)
- Evaluations Criteria
  - Confirmation of visual changes before/after the test.

- Sample status : unpackaged / not in operation
- Applied waveform : Half sine
- Acceleration(G) : 10
- Nominal duration (ms) : 11
- Applicable axis : X, Y, Z
- Number of impacts : 1 per direction (total 6)
- Evaluation items
  - Check for mechanical damage before and after testing

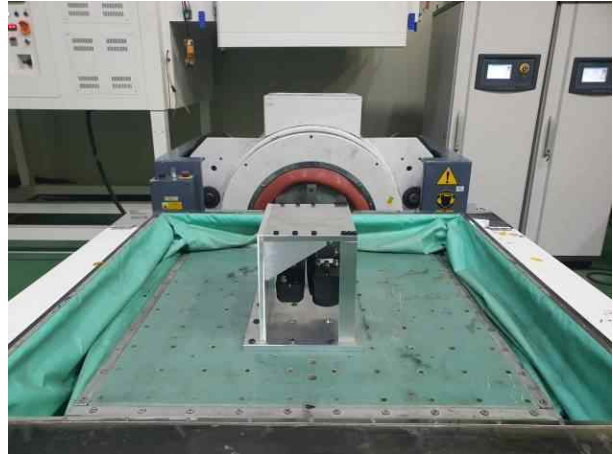
Vibration(Sine) Test[IEC/EN 60068-2-6:2007] – Y axis, Test Shock(impact) Test Same configuration

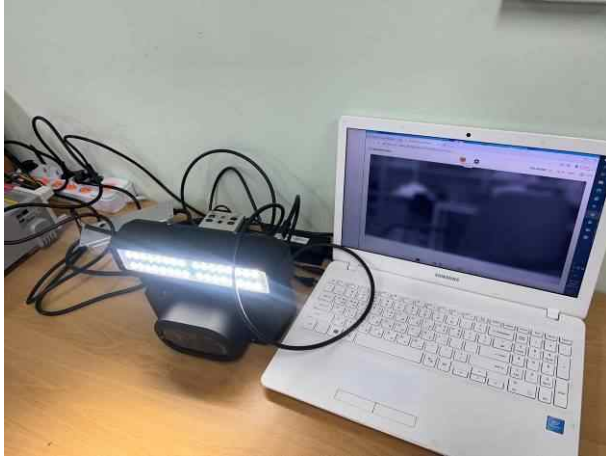
Verification of Normal Operation after testing #1
