# TESTREPORT

KOTITI No. | 82244001100165

- o Name : NETWORK CAMERA
- o Model : TNV-C7013RC

## 6. Test method used : ISO 2060529:2023

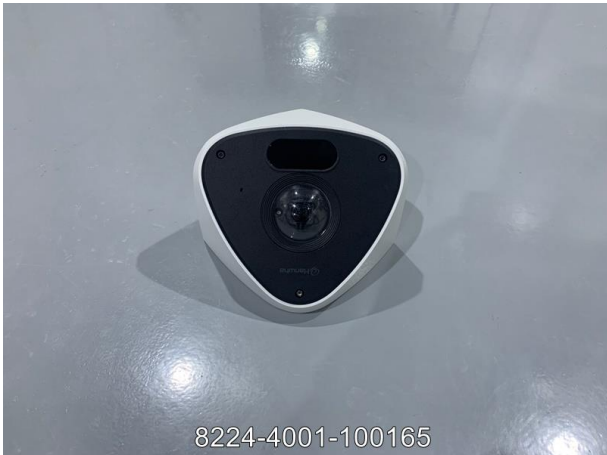
Fig. 1) Test Sample\_front

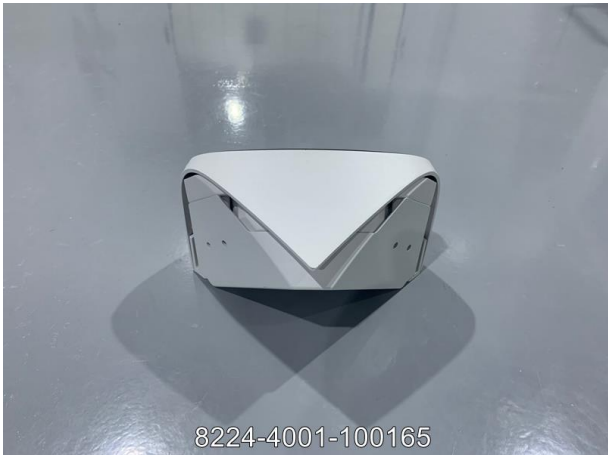
Fig. 2) Test Sample\_back

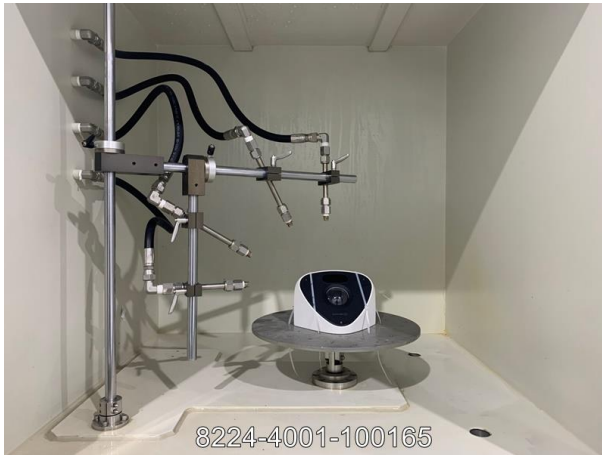
Fig. 4) Test Sample Set-up

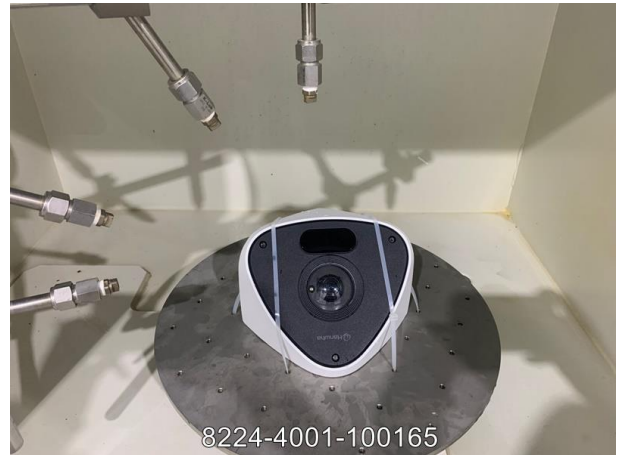
Fig. 5) Test Sample Set-up\_enlarge

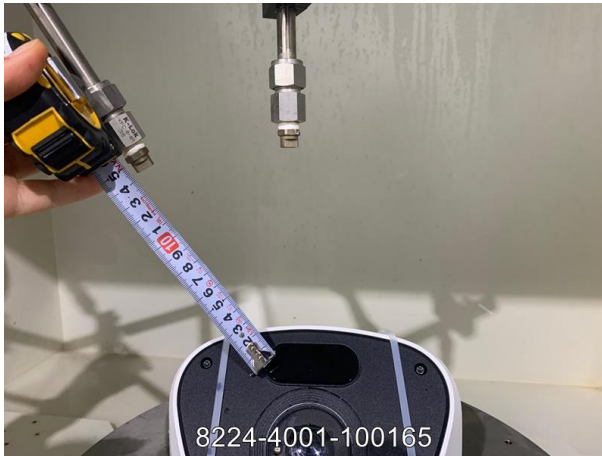
Fig. 6) Nozzle distance

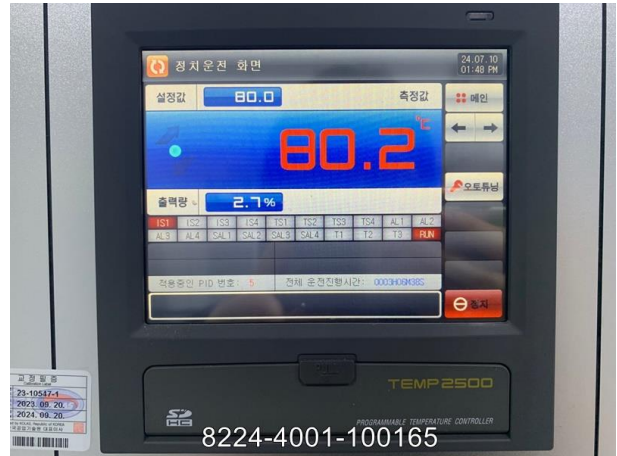
Fig. 7) Test\_water Temp

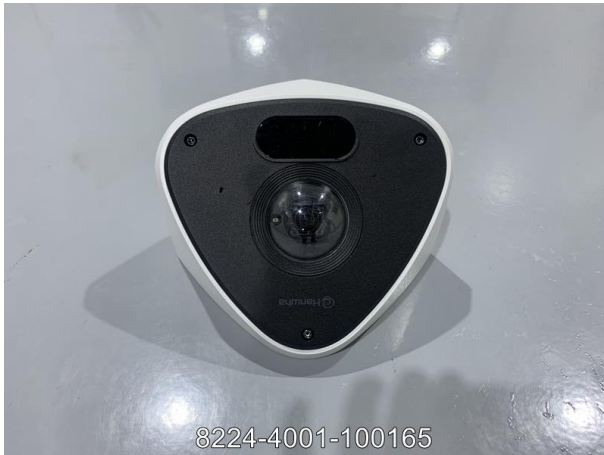
Fig. 8) Test Sample\_After test\_front

| Specimen | Test | Results | Remarks |
|---|---|---|---|
| NETWORK CAMERA | IPX9 | Check empty space between lenz and protector after test, there is no ingress of water | ※Judgement:<br>Visual Inspection |

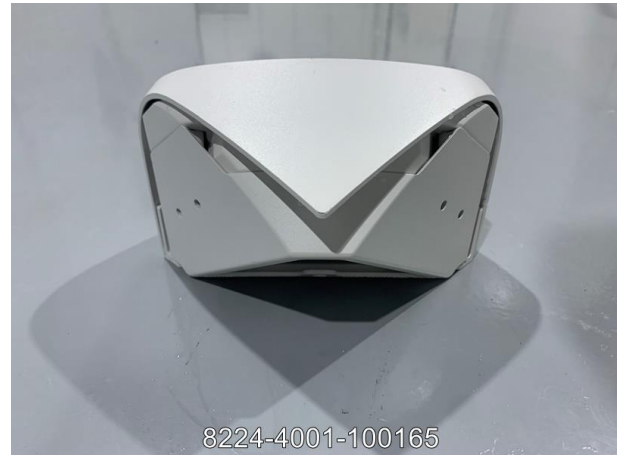
Fig. 9) Test Sample\_After test\_back
