# TEST REPORT

Report No.:  
KR16-YYP0151

**3. Name of Product and Model** : Network Camera /  
PND-9080R\* (N:NTSC/ P:PAL)

**6. Test method used** : IEC 62262: 2002 (IK 08)

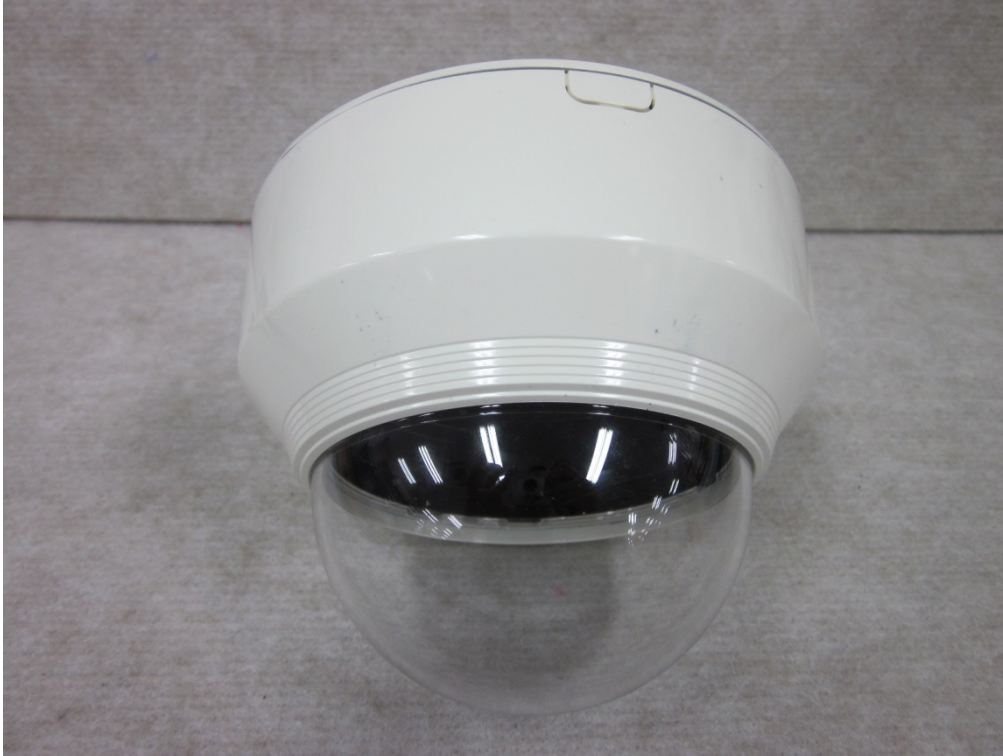
[Front]

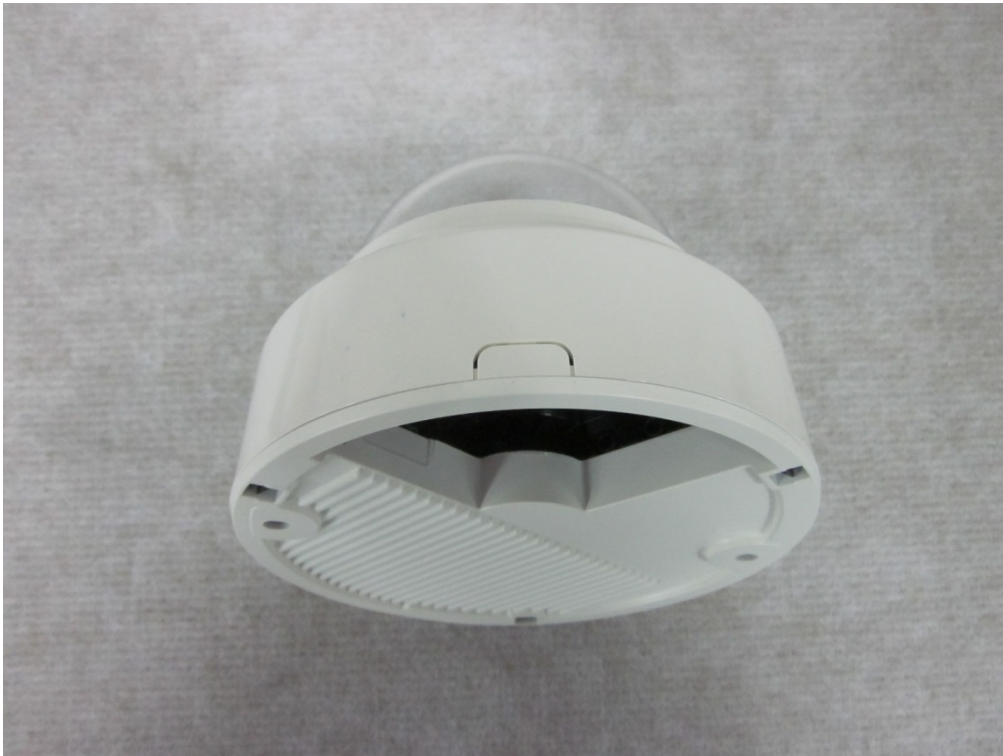
[Rear]

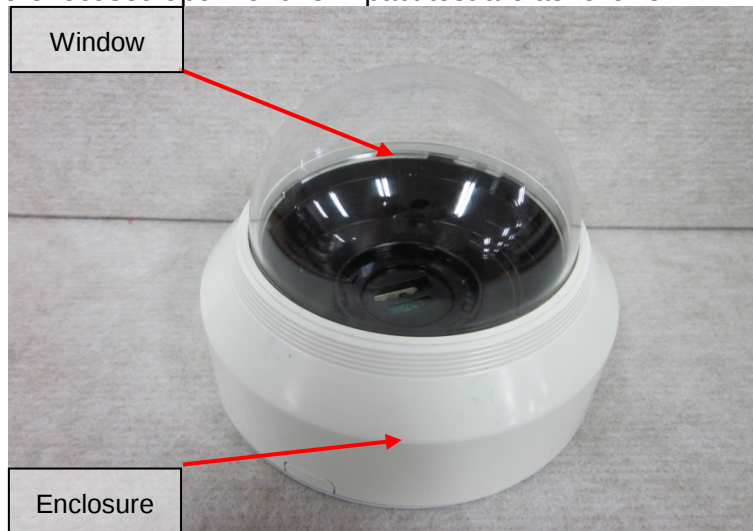
### 3.1.7 Drop Zones:

The areas that were focused upon for this impact test are as follows:

| Drop Zone: Window | | |

| Drop Zone: Enclosure | | |

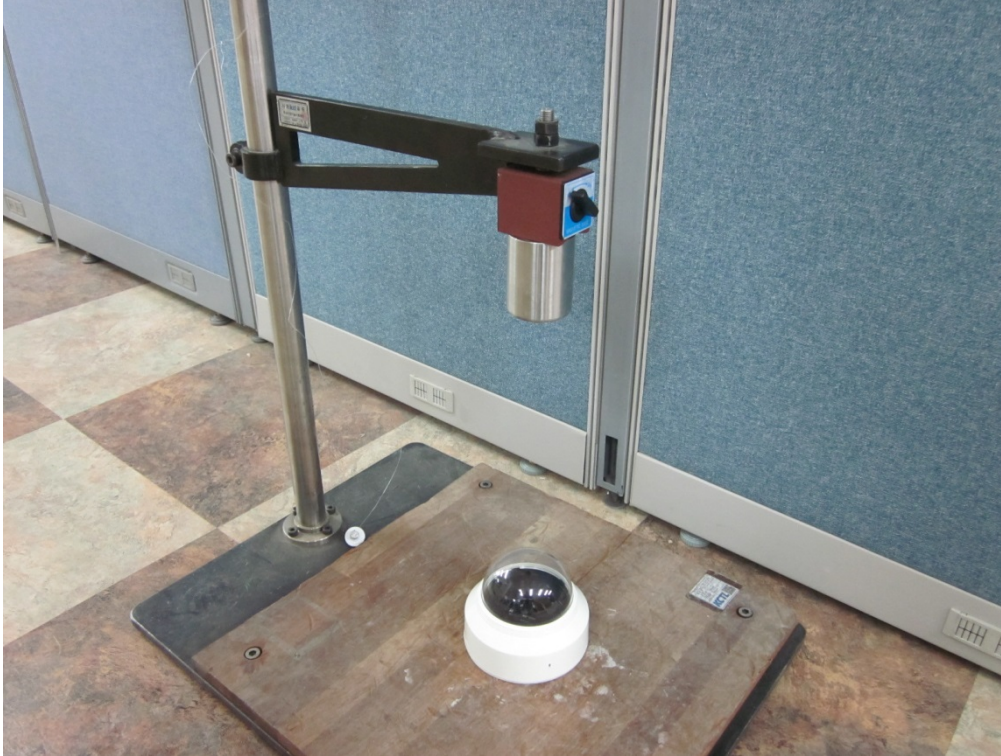
[During the test\_Window]

The verification of IK08 has been done positioning the enclosure on a rigid support.

5 impacts have been applied on each surface in sight with the enclosure.

For the test used Pendulum Hammer

Energy: 5 Joule

Mass: 1.7 kg

High  $\Delta h$ : 295 mm

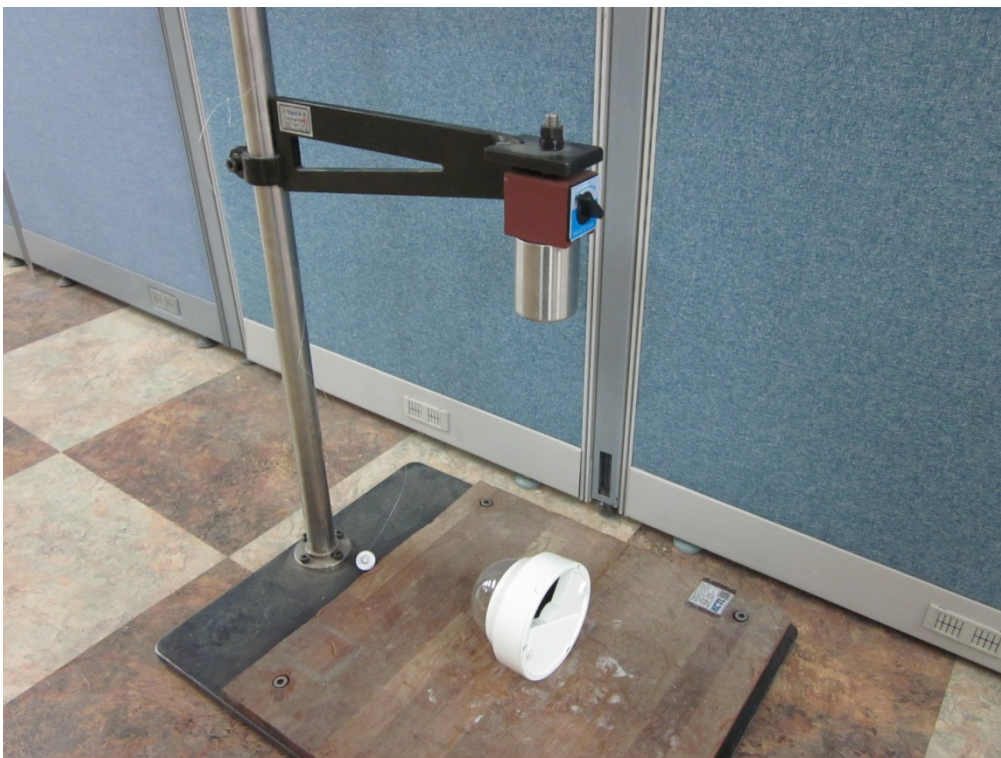
[During the test\_Enclosure]

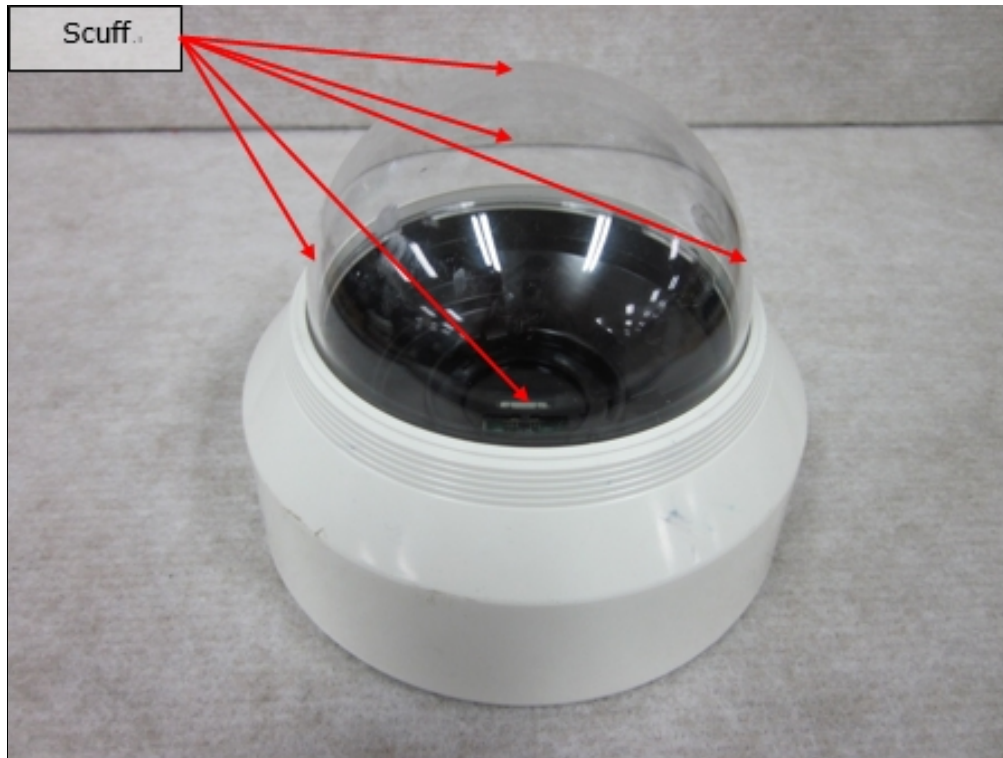
[Test result\_Window]

| Drop Zone: Window | | |
|---|---|---|
| Drop 1 | Vertical drop onto center of Window. | No abnormal was found |

※ Allow extent of damage: Scuff

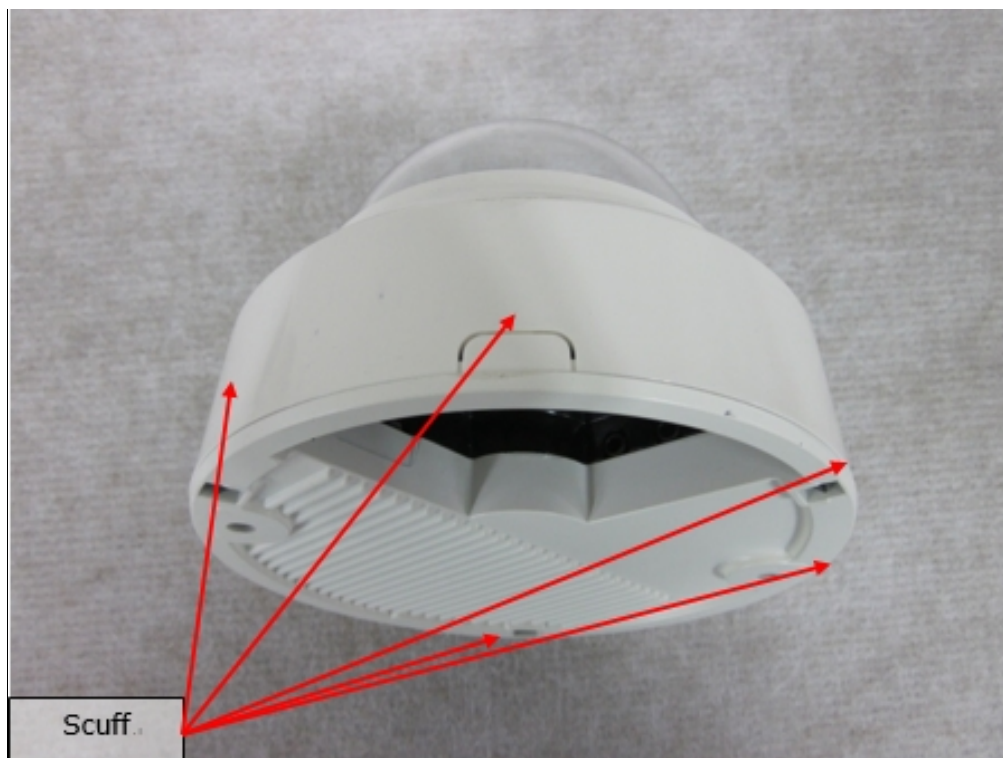
[Test result\_Enclosure]

| Drop Zone: Enclosure | | |
|---|---|---|
| Drop 1 | Normal to surface of enclosure. | No abnormal was found |
