# TEST REPORT

CTK-2025-00637

NETWORK CAMERA / XNO-A9084R

EN 60068-2-1, EN 60068-2-2, EN 60068-2-14, EN 60068-2-6, EN  
60068-2-27, EN 60068-2-78, IEC 60068-2-1, IEC 60068-2-2, IEC  
60068-2-14, IEC 60068-2-6, IEC 60068-2-27, IEC 60068-2-78

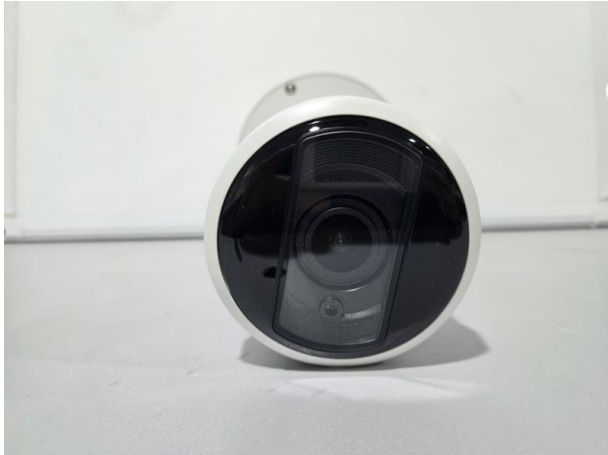
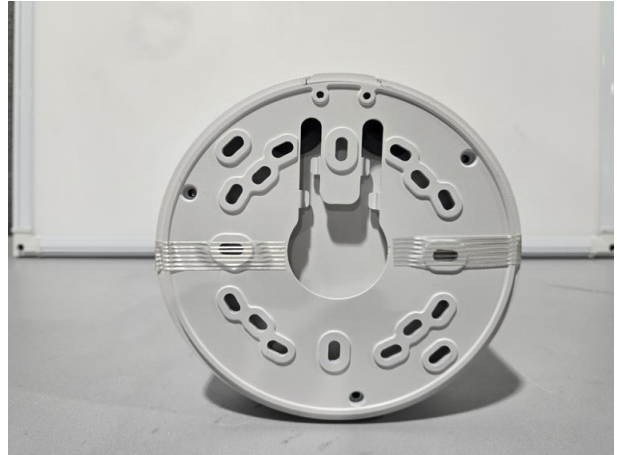
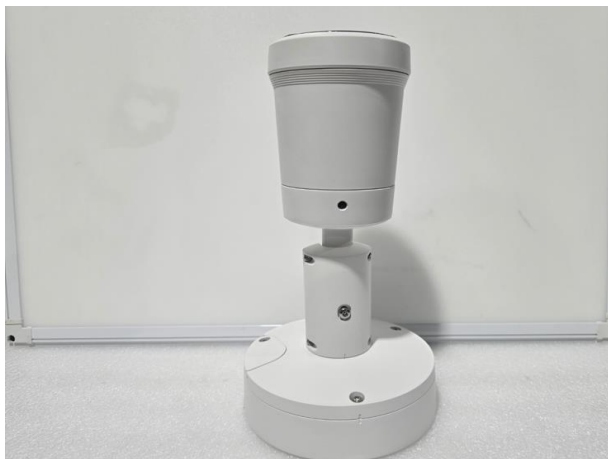
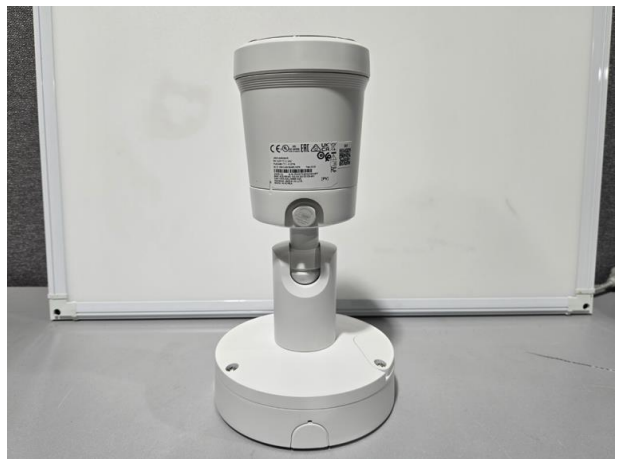
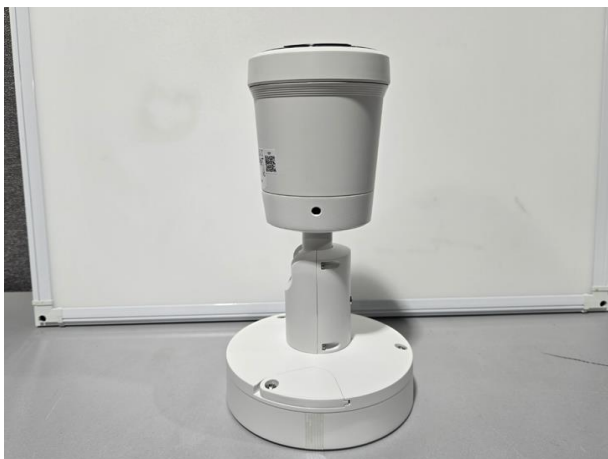
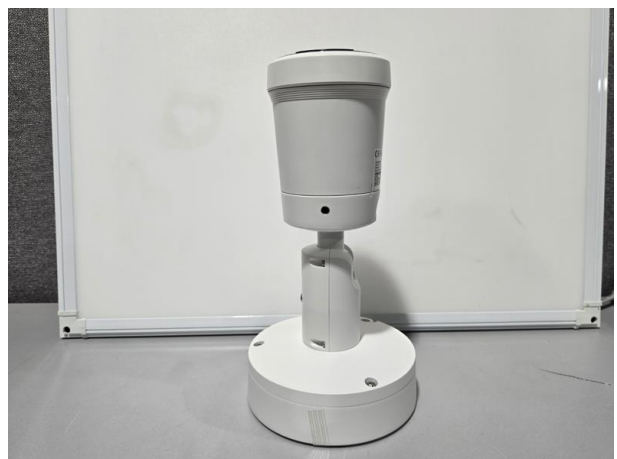
### 2.4.1 Test sample

## 2.4 Pre-test product images

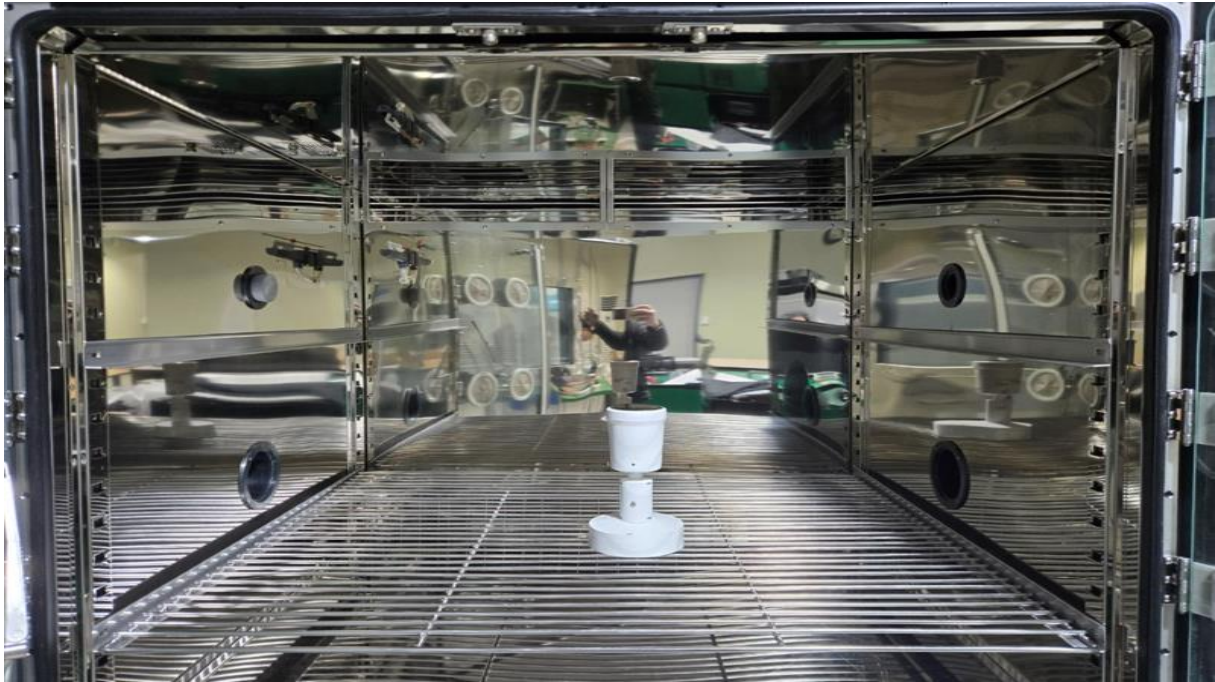
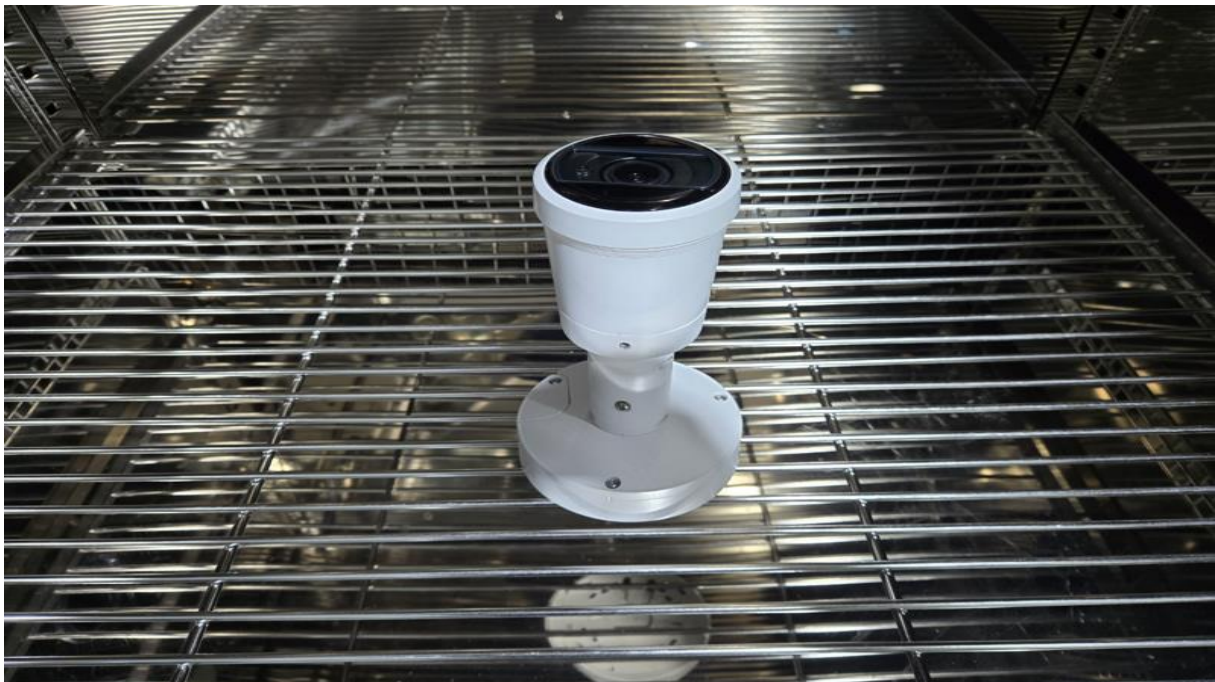
#### 3.3.1 Evidence of test setting

3.2.1 Sample status: Non-operation

3.2.2 Test temperature: -33

3.2.3 Test time: 16 h

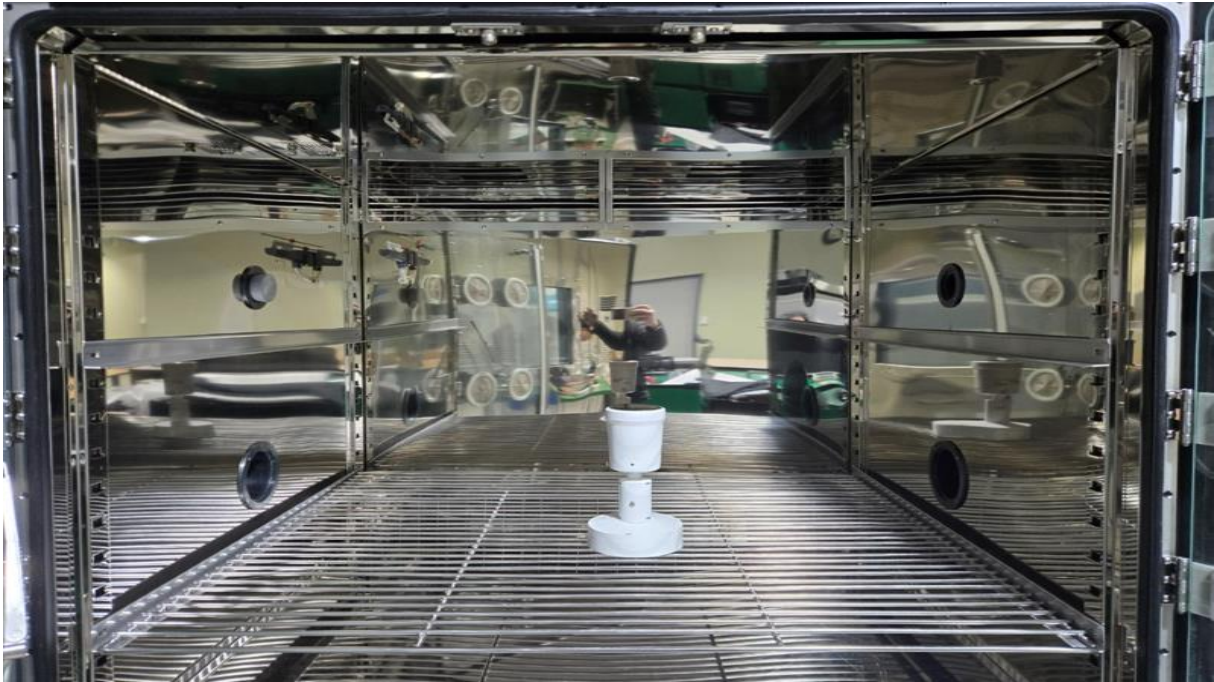
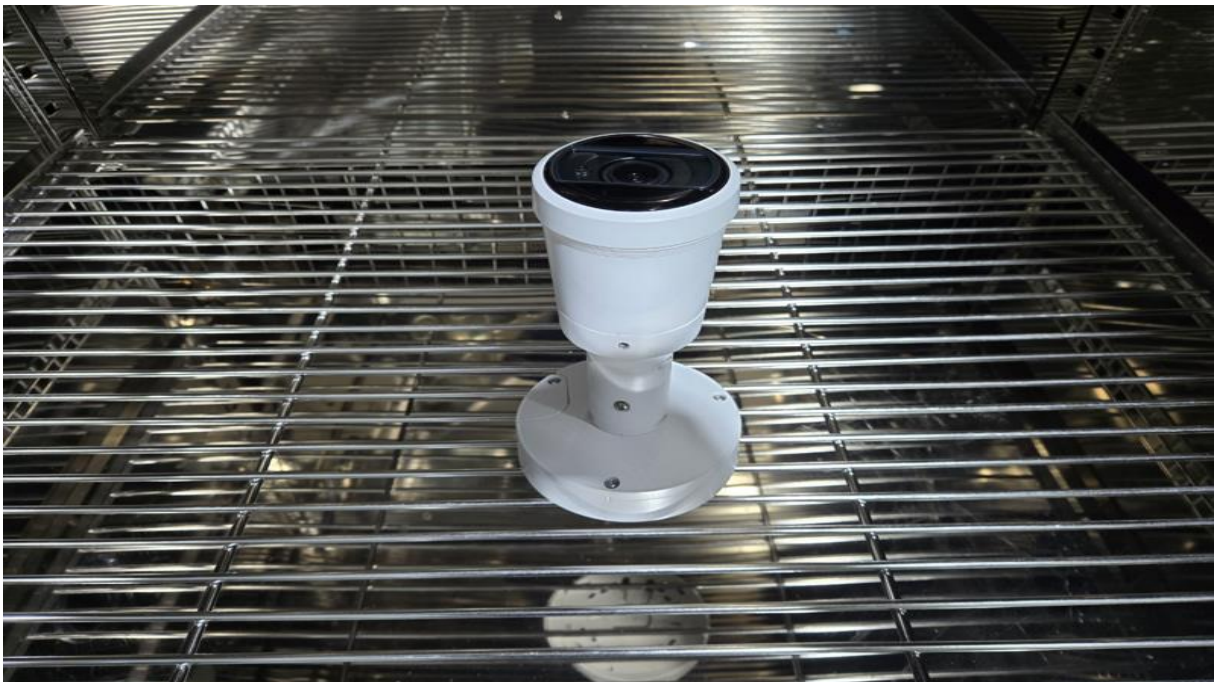
#### 4.3.1 Evidence of test setting

4.2.1 Sample status: Non-operation

4.2.2 Test temperature: 60 °C

4.2.3 Test time: 96 h

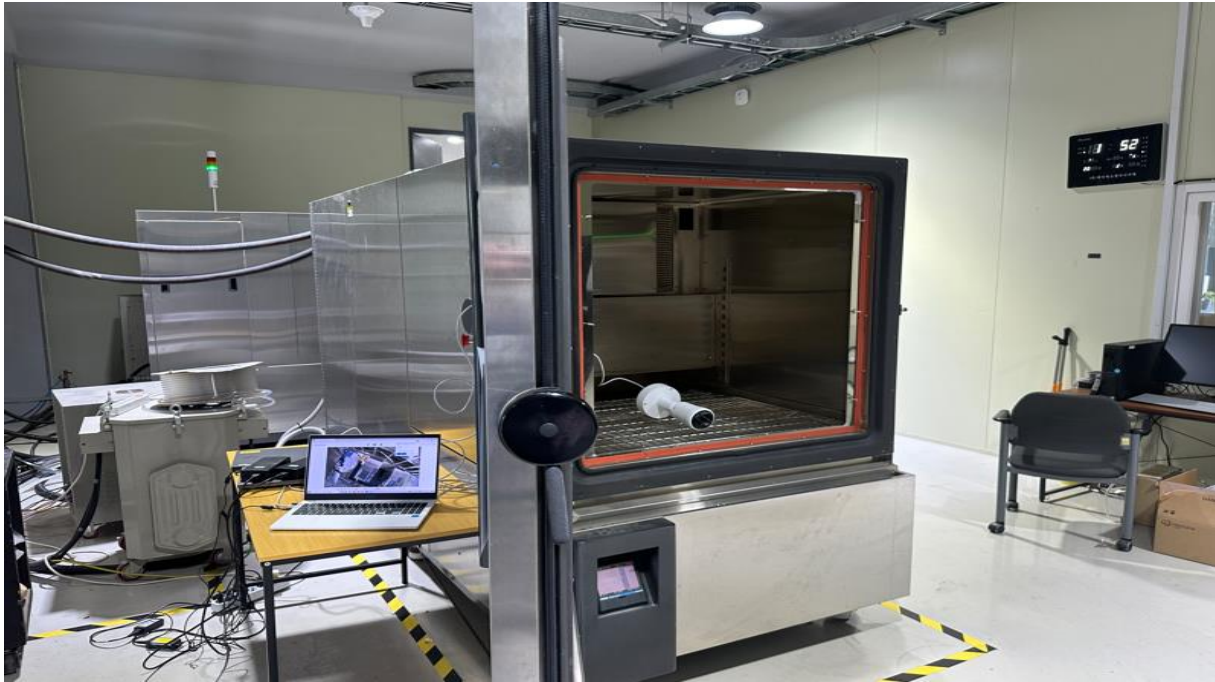
### 5.3.1 Evidence of test setting

5.2.1 Sample status: operation

5.2.2 Test temperature: -40 °C, 50 °C

| T <sub>A</sub> (High)↵ | T <sub>B</sub> (Low)↵ | Temperature change rate(°C/min)↵ | t <sub>1</sub> (idle time)↵ | Cycles↵ |
| 50 °C ↵ | -↵ | 5 °C/min↵ | 3 h↵ | 3↵ |
| -↵ | -40 °C↵ | 1 °C/min↵ | 3 h↵ | 3↵ |

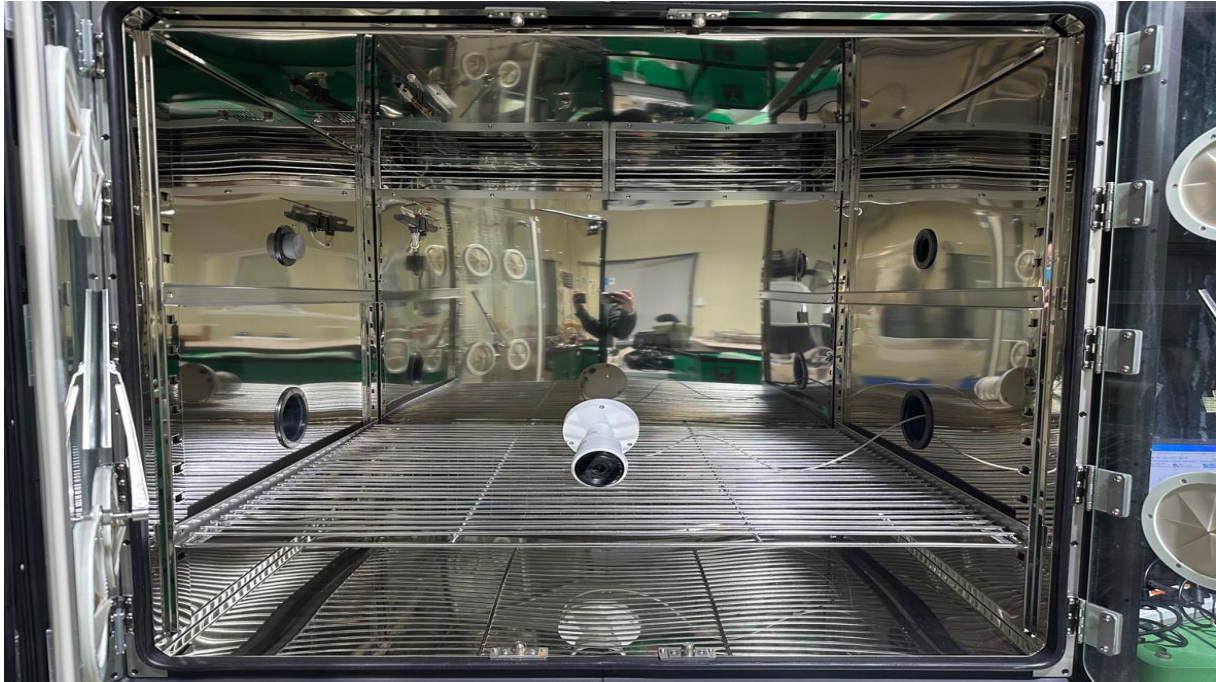
#### 8.3.1 Evidence of test setting

8.2.2 Test temperature:  $40 \pm 2$  °C

8.2.3 Test Humidity:  $93 \pm 3$  % R.H.

8.2.4 Test time: 240 h

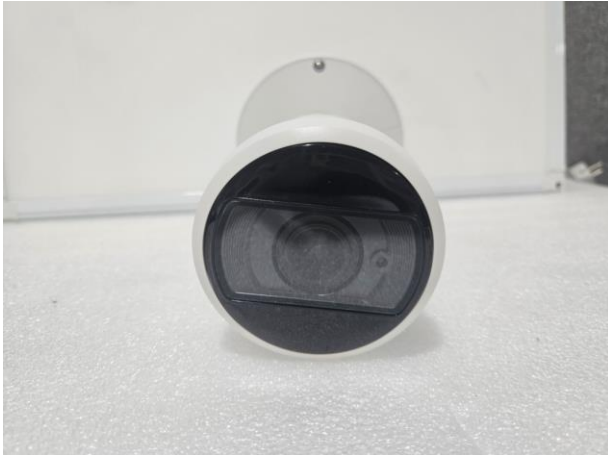
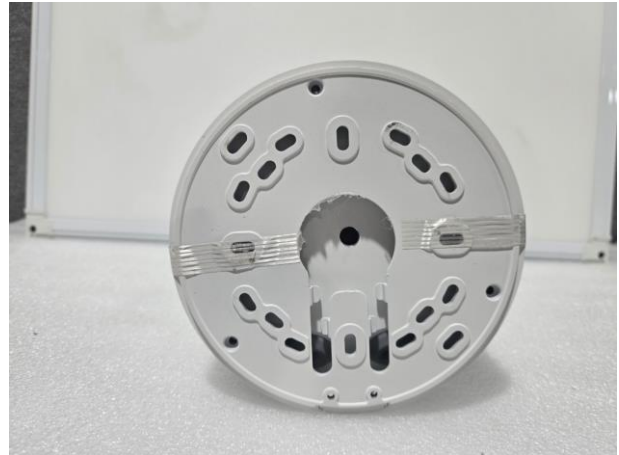
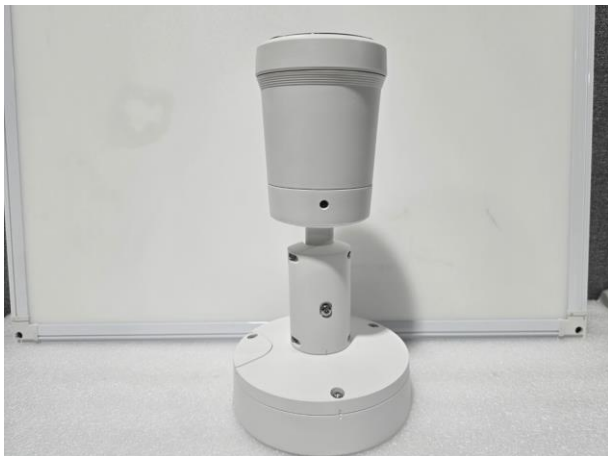
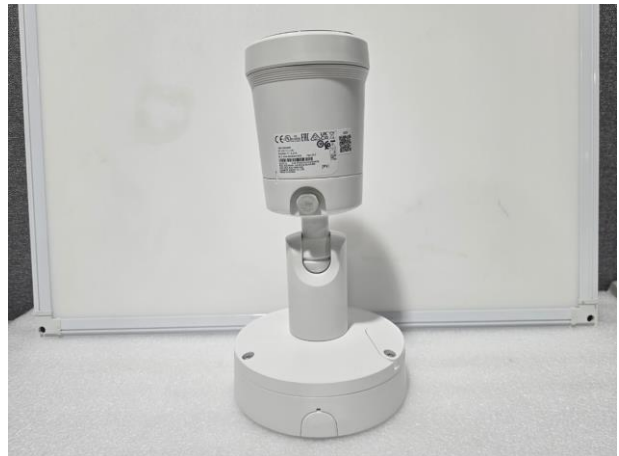
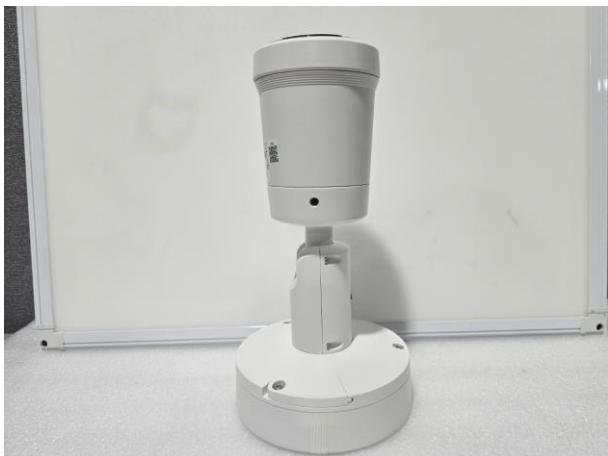
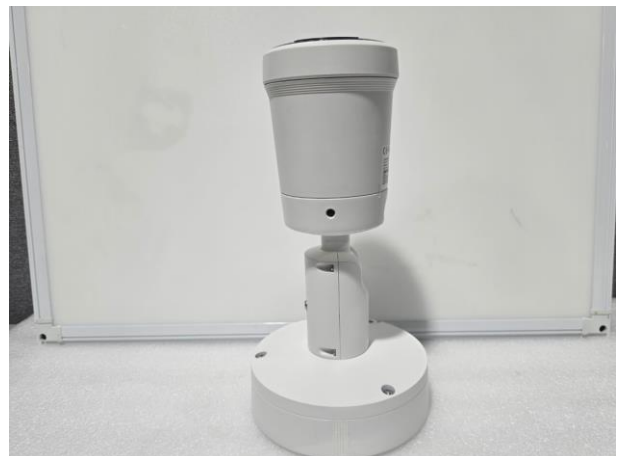
### 8.6.1 Test sample

## 8.6 Post-test product images

| Evaluations Criteria | Test result | | 비고 |
|---|---|---|---|
| | Visual Inspection | Normal | - |
