# TEST REPORT

Report No.:  
KR17-YYP0132-A

3. Name of Product and Model : Network Camera /  
XNP-6120\* (\* N: NTSC / P: PAL)

6. Test method used : IEC 62262: 2002 (IK 10)

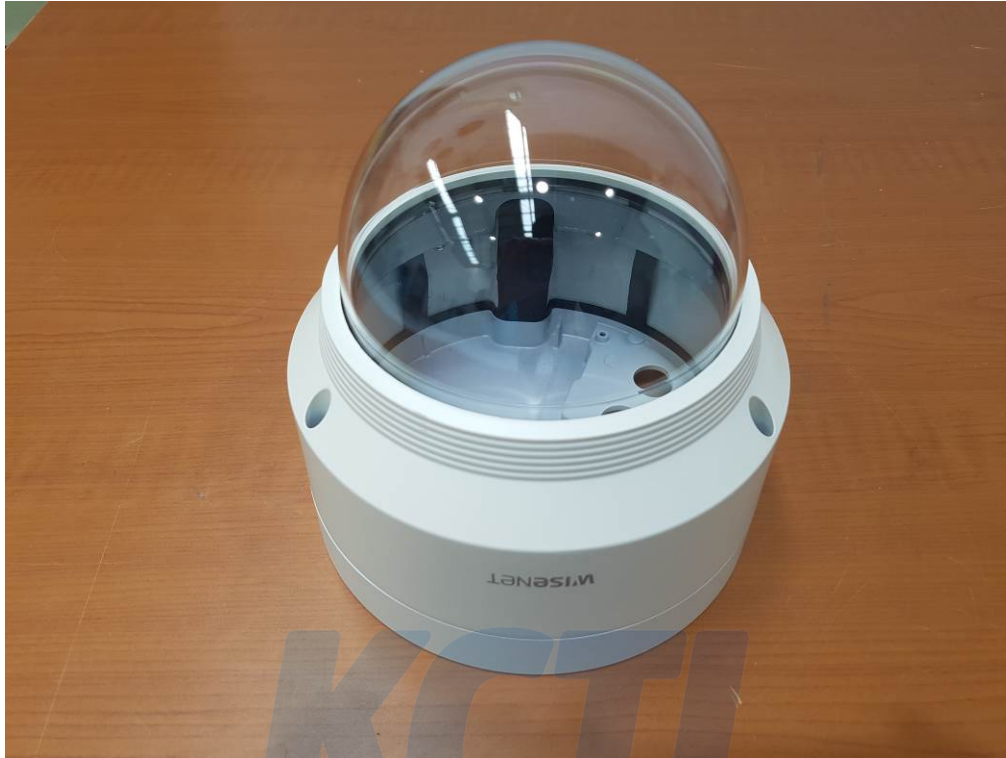
[Front]

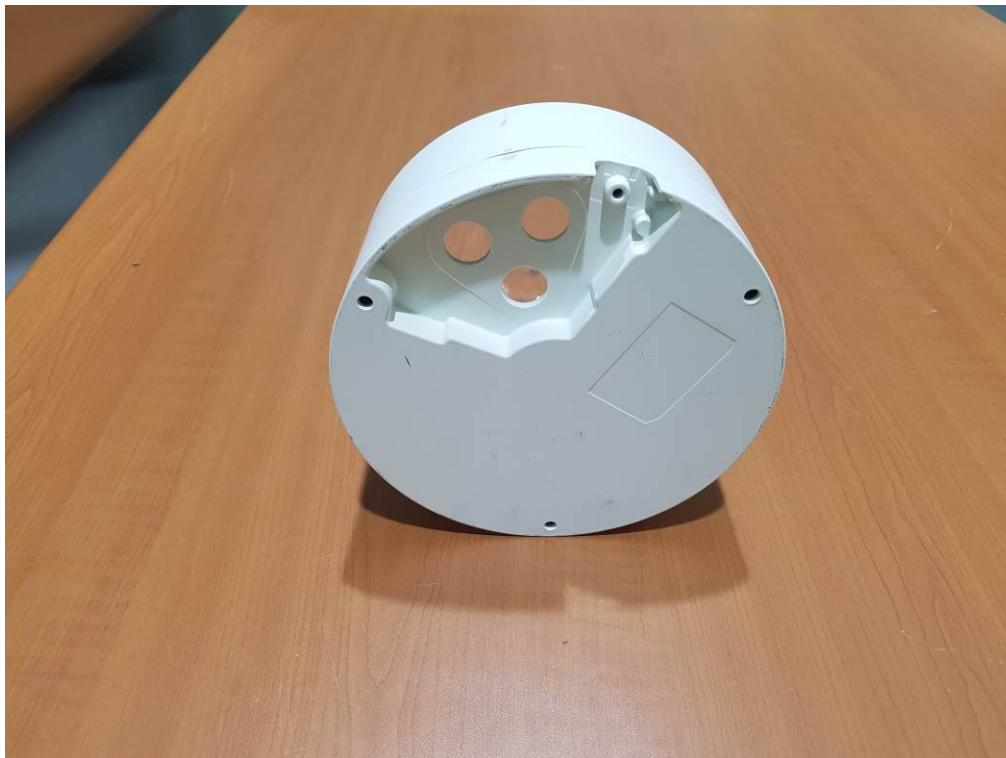
[Rear]

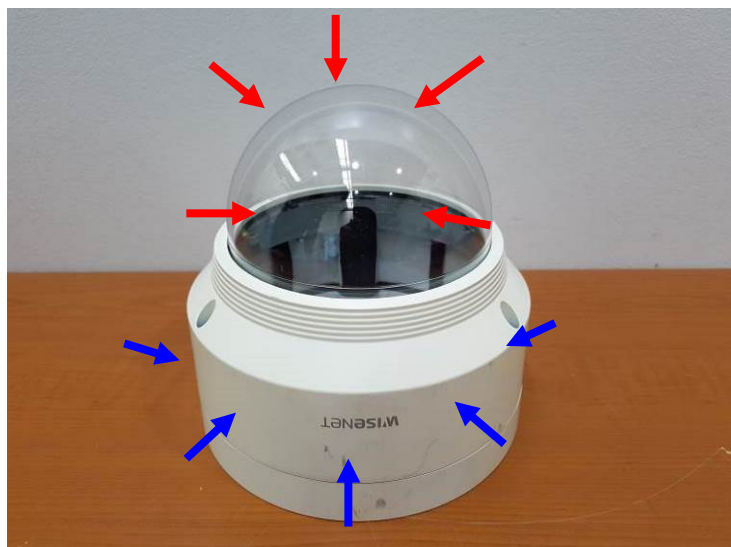
- 1) Test method used: IEC 62262: 2002 (IK 10)
- 2) Energy: 20 J
- 3) Mass: 5.0 kg
- 4) Height: 400 mm
- 5) Pretreatment: None
- 6) Location and number of impact: Window 5 impact, Enclosure 5 impacts

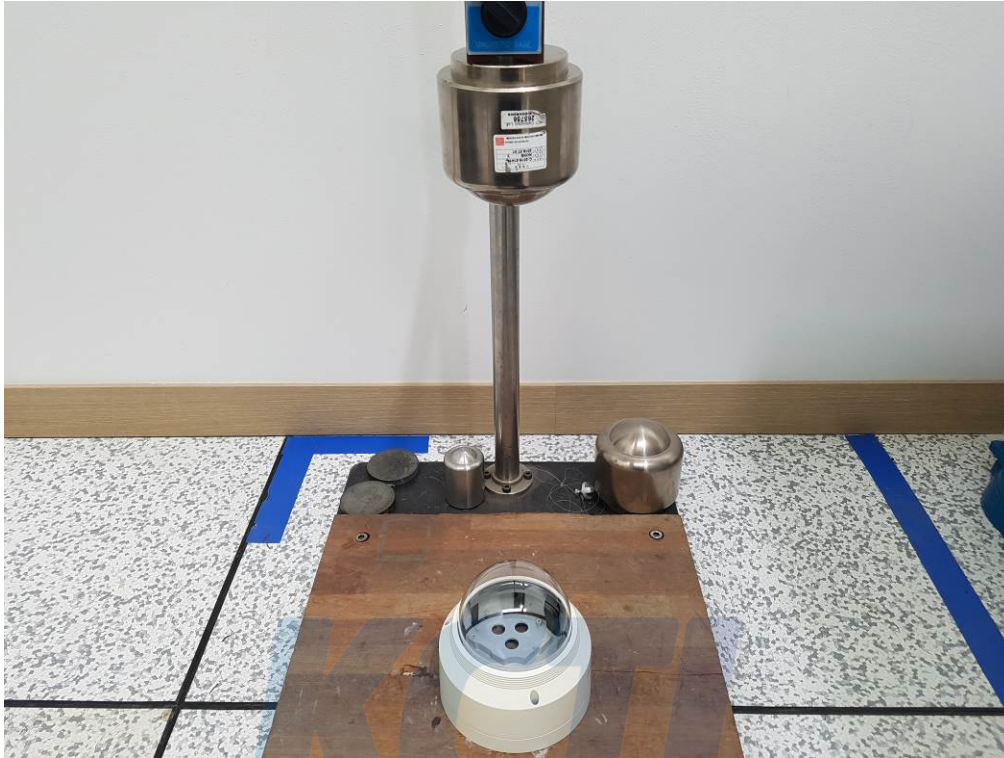
[During the test\_Window]

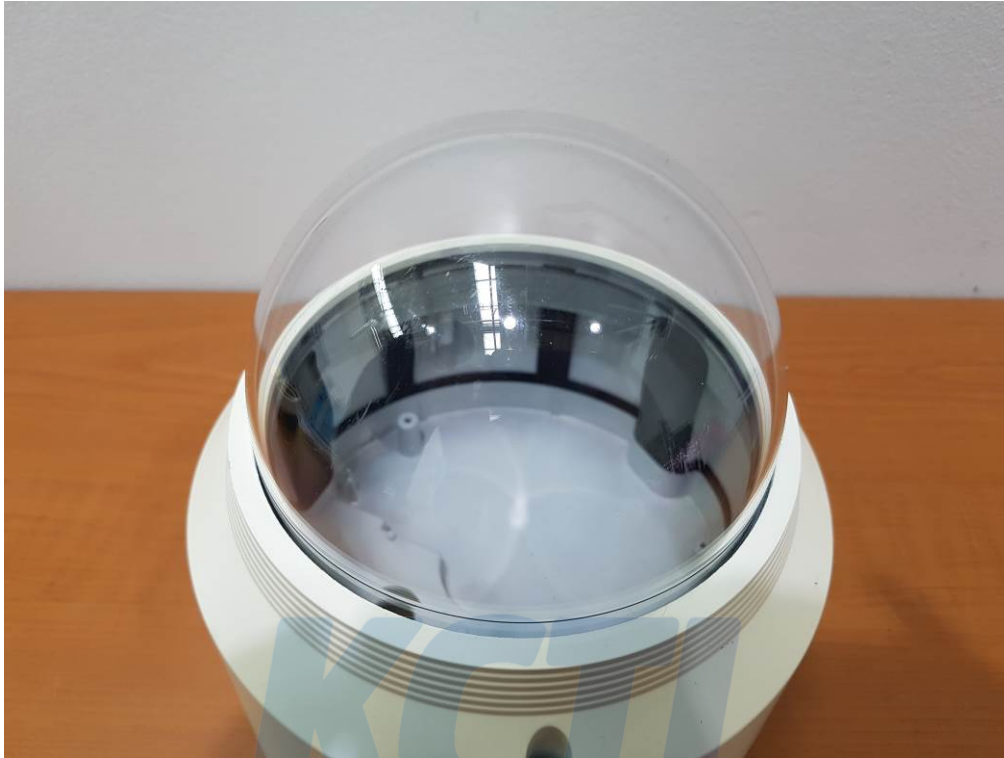
[Test result confirme\_Window]

| Check List | Test Result |
|---|---|
| <ol style="list-style-type: none"> <li>1. Window part <ul style="list-style-type: none"> <li>- Visual inspection after impact test<br/>(Damage, crack, separation occur)</li> <li>- Protected against access to hazardous parts</li> </ul> </li> <li>2. Enclosure part <ul style="list-style-type: none"> <li>- Visual inspection after impact test<br/>(Damage, crack, separation occur)</li> <li>- Protected against access to hazardous parts</li> </ul> </li> </ol> | <p align="center">No abnormal<br/>was found<br/>(Refer to 3.1.7)</p> |

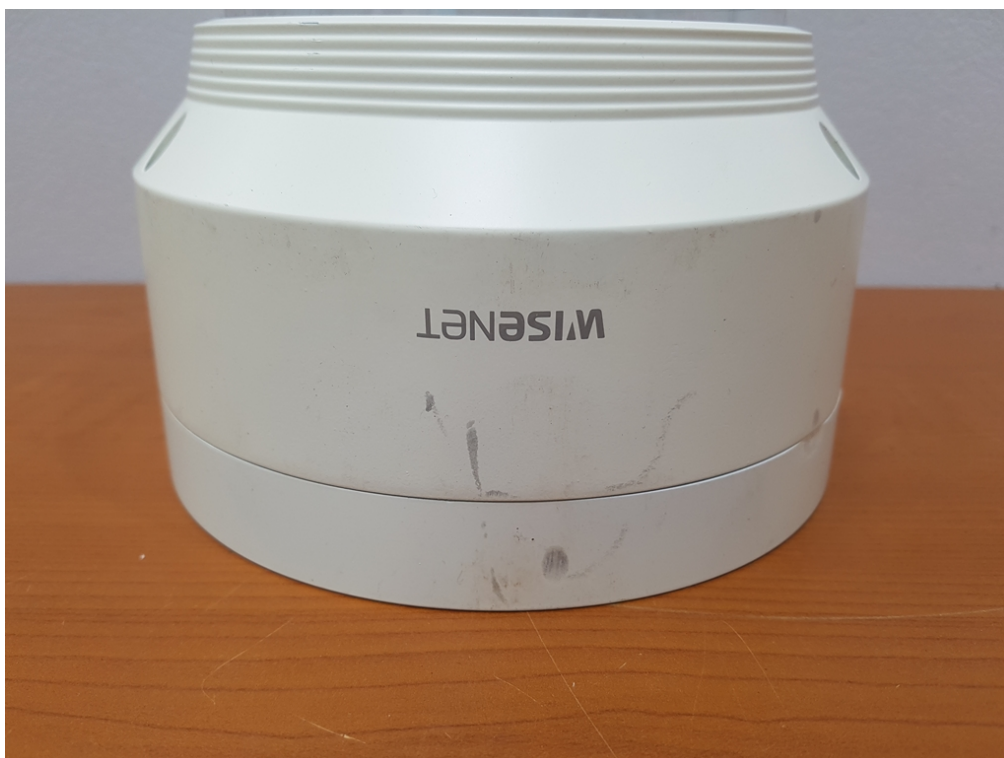
[Test result confirme\_Enclosure 01]

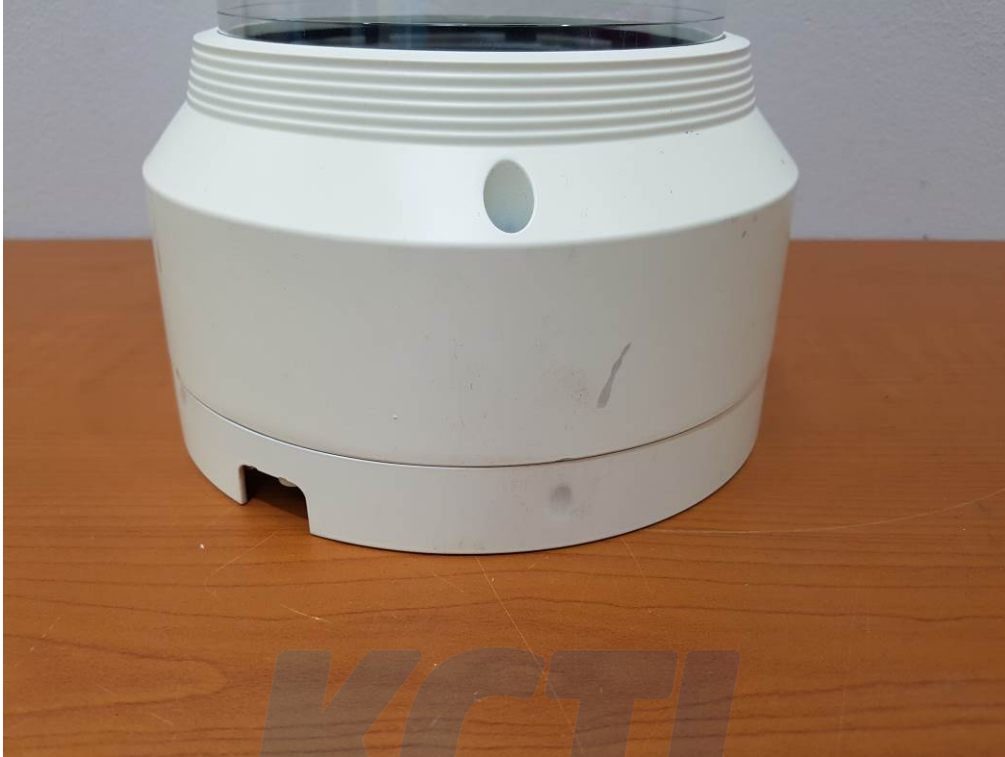
[Test result confirme\_ Enclosure 02]

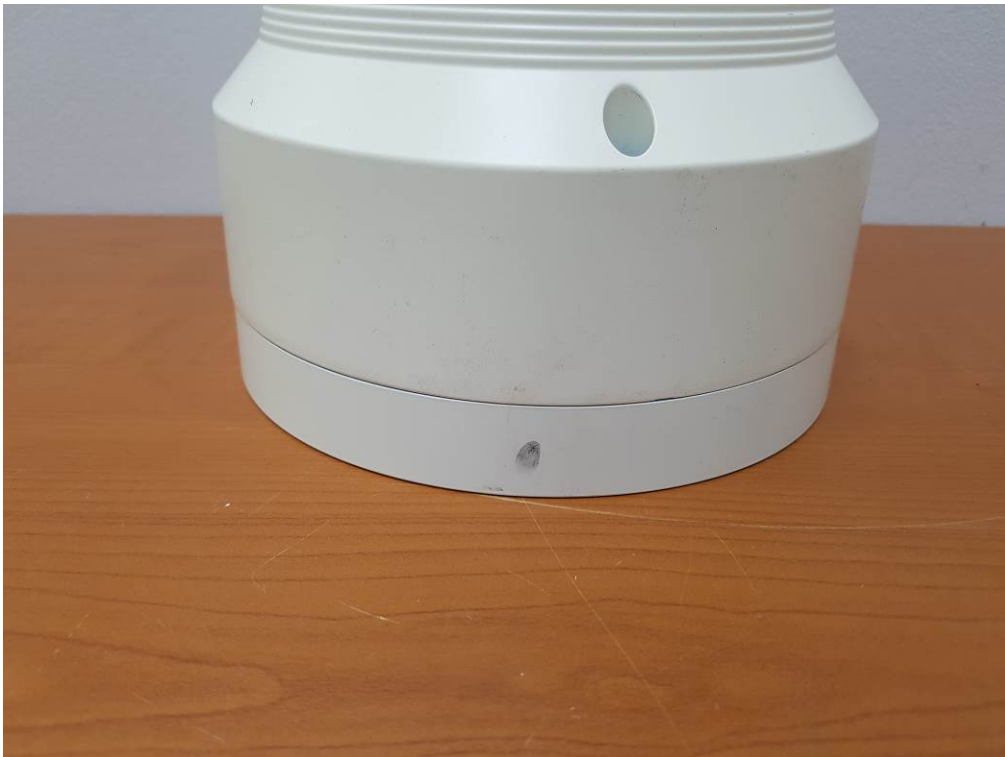
[Test result confirme\_ Enclosure 03]
