| <b>KCTL Inc.</b><br>52-20, Sinjeong-ro 41 beon-gil, Giheung-gu,<br>Yongin-si, Gyeonggi-do 446-599, Korea<br>Tel : 82-31-326-6700 Fax : 82-505-299-8311<br><a href="http://www.kctl.co.kr">www.kctl.co.kr</a> | Report No.:<br><b>KR17-YYP0146</b><br><br>Page (4) of (9) | |

## 2. Product (EUT)

#### 3.1 IK10 Impacts Test

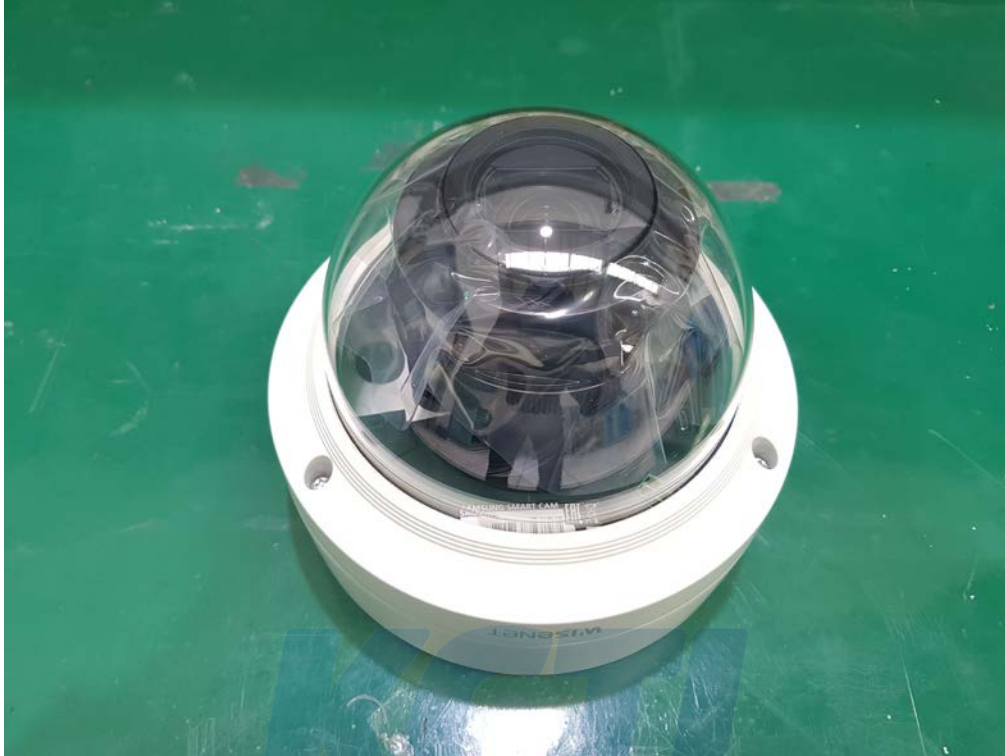
## 2.2 Product Photograph

[Front]

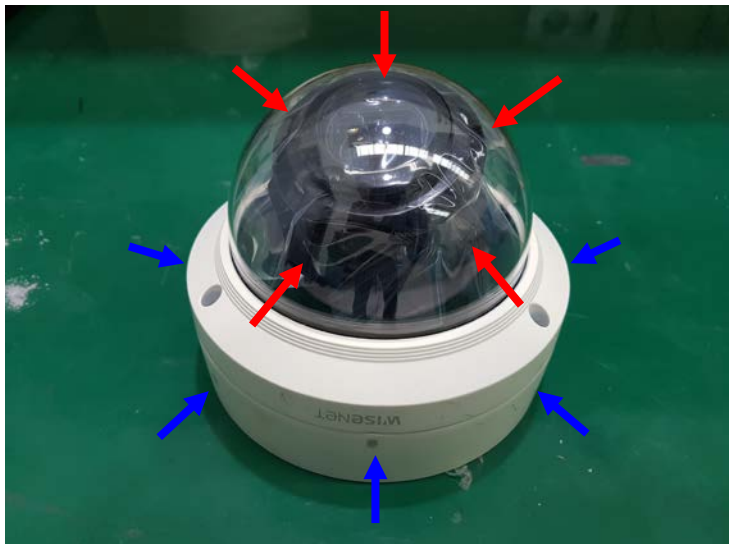
- 1) Test method used: IEC 62262: 2002 (IK 10)
- 2) Energy: 20 J
- 3) Mass: 5.0 kg
- 4) Heigh: 400 mm
- 5) Pretreatment: None
- 6) Location and number of impact: Window 5 impact, Enclosure 5 impacts

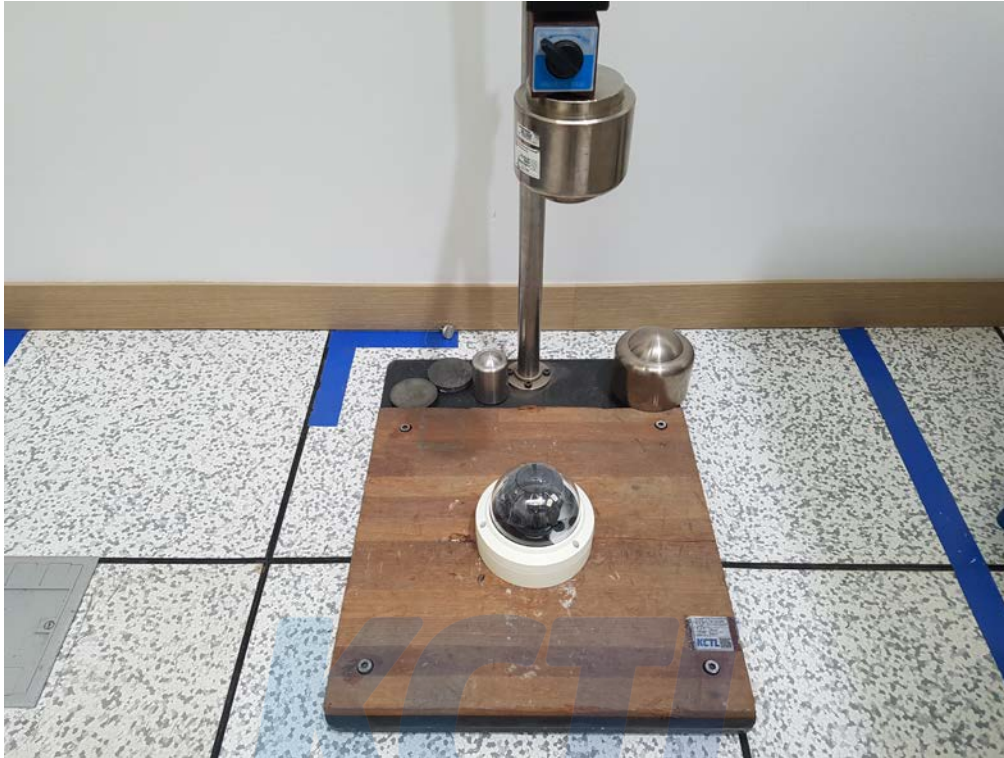
**KCTL****3.1.6 TEST Photograph**

[During the test\_Window]

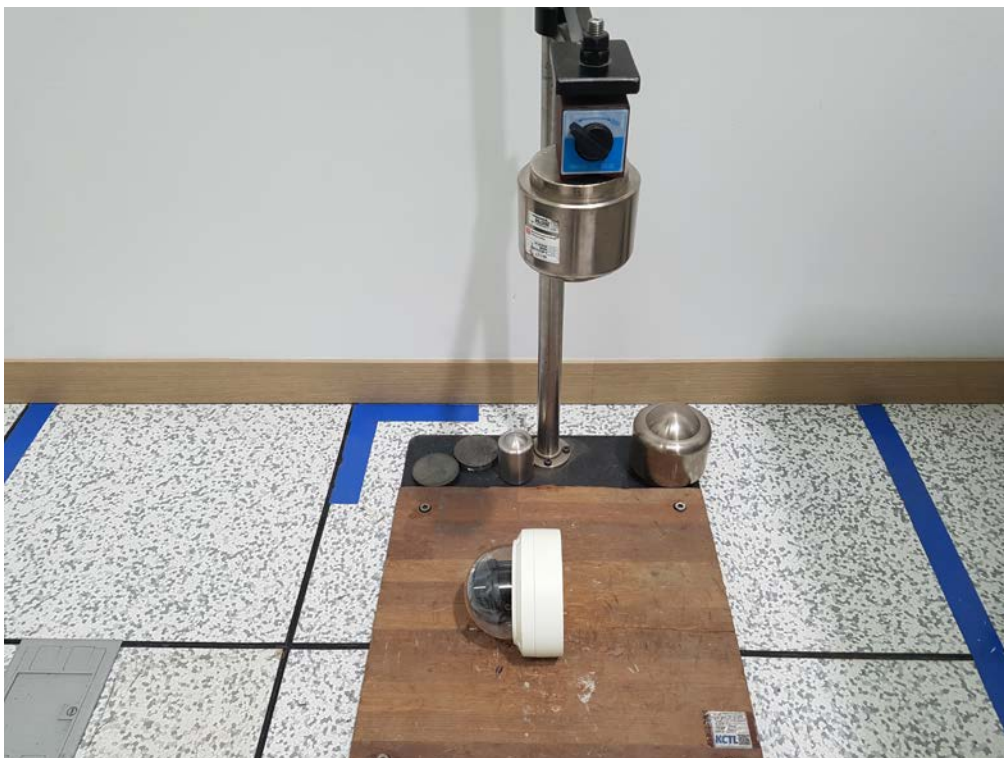
[During the test\_Enclosure]

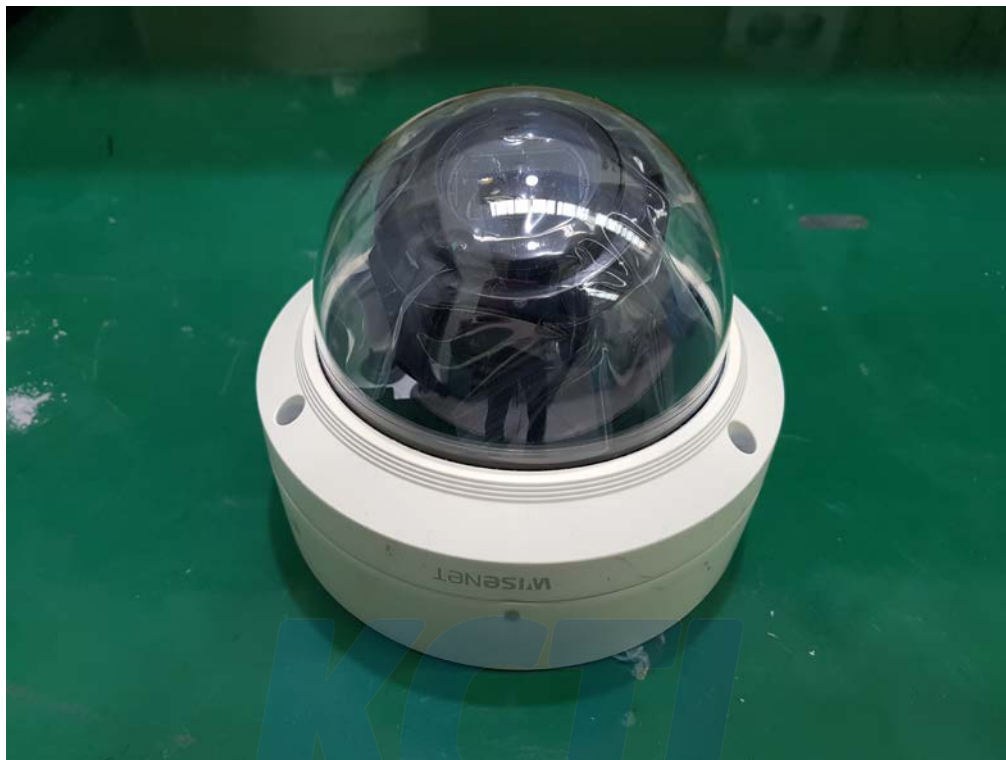
### 3.1.7 Test Result Photograph

[Test result confirme\_Enclosure 01]

| Check List | Test Result |
|---|---|
| <p>1. Window part</p> <ul style="list-style-type: none"> <li>- Visual inspection after impact test<br/>(Damage, crack, separation occur)</li> <li>- Protected against access to hazardous parts</li> </ul> <p>2. Enclosure part</p> <ul style="list-style-type: none"> <li>- Visual inspection after impact test<br/>(Damage, crack, separation occur)</li> <li>- Protected against access to hazardous parts</li> </ul> | <p align="center">No abnormal<br/>was found<br/>(Refer to 3.1.7)</p> |

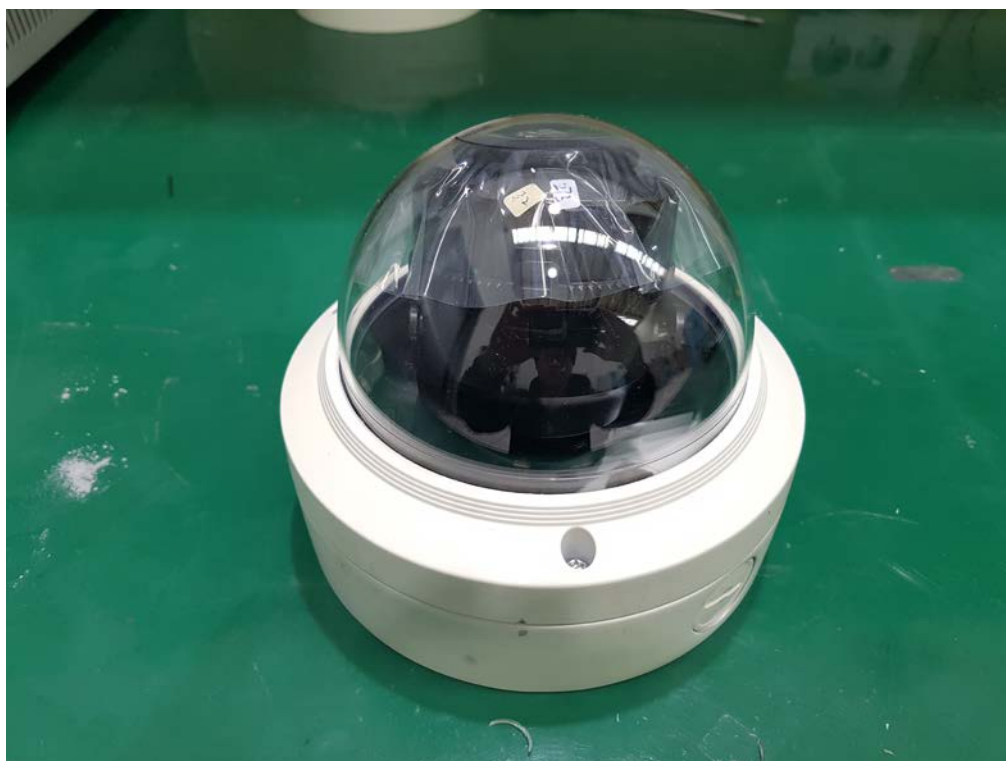
[Test result confirme\_ Enclosure 02]
