# TEST REPORT

Report No.  
CTK-2022-02138  
Page (1) / (9) pages

Network Camera / XNV-9083RZ

KS C IEC 62262: 2005

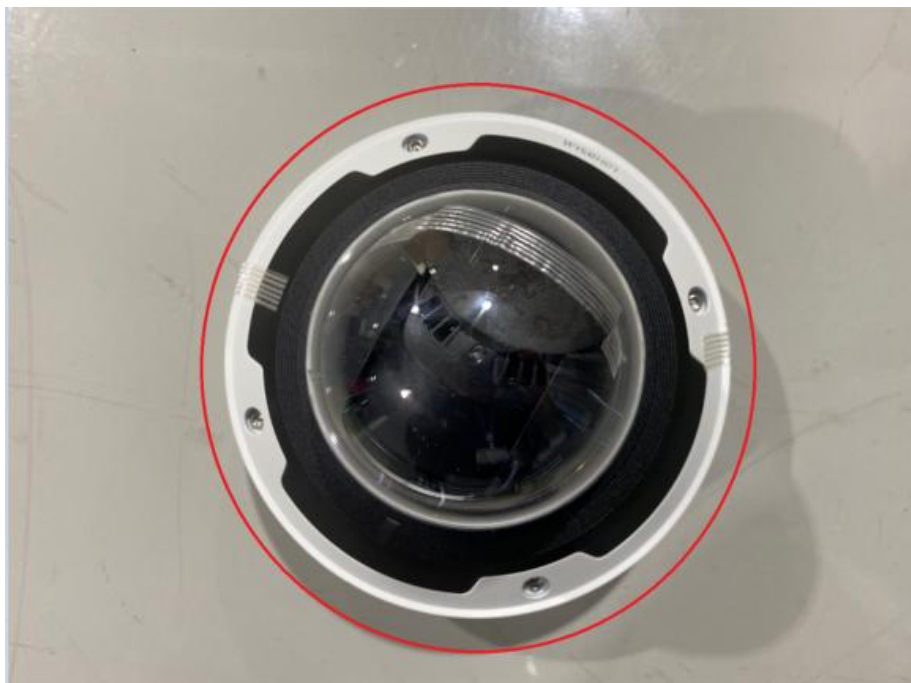
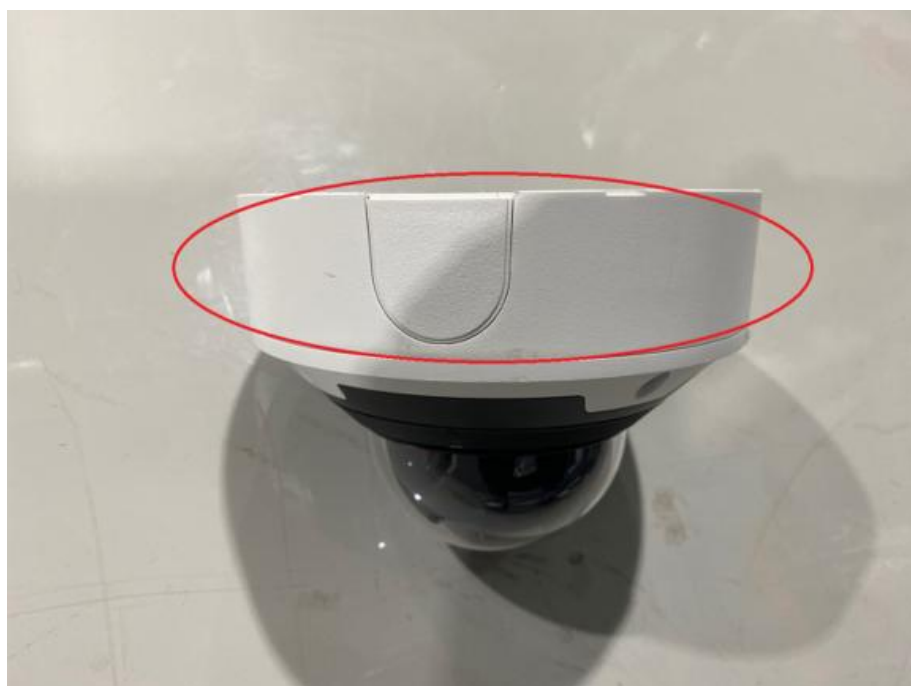
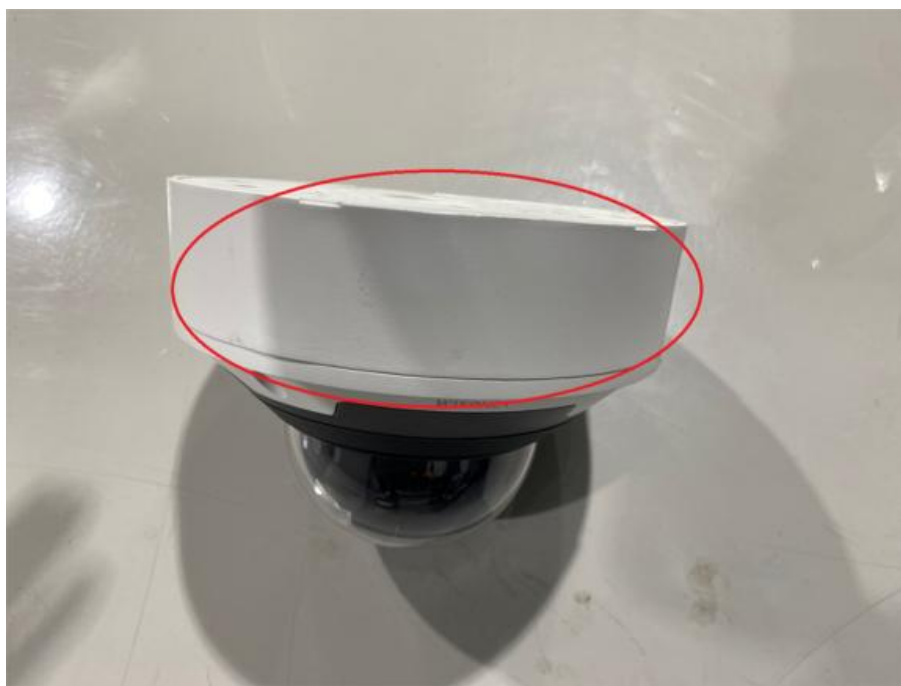
### 2.3. Photos after test

| Item | Contents | Result |
|---|---|---|
| External protection Enclosure | No damage | Pass |
| Comment<br>- Some scratches were generated on the outside of the product. | | |
