# TEST REPORT

REPORT No.:  
CTK-2025-01954  
Page (1) / (13) pages

IP Controller / NHP-P200

IEC 62262:2002+AMD1:2021

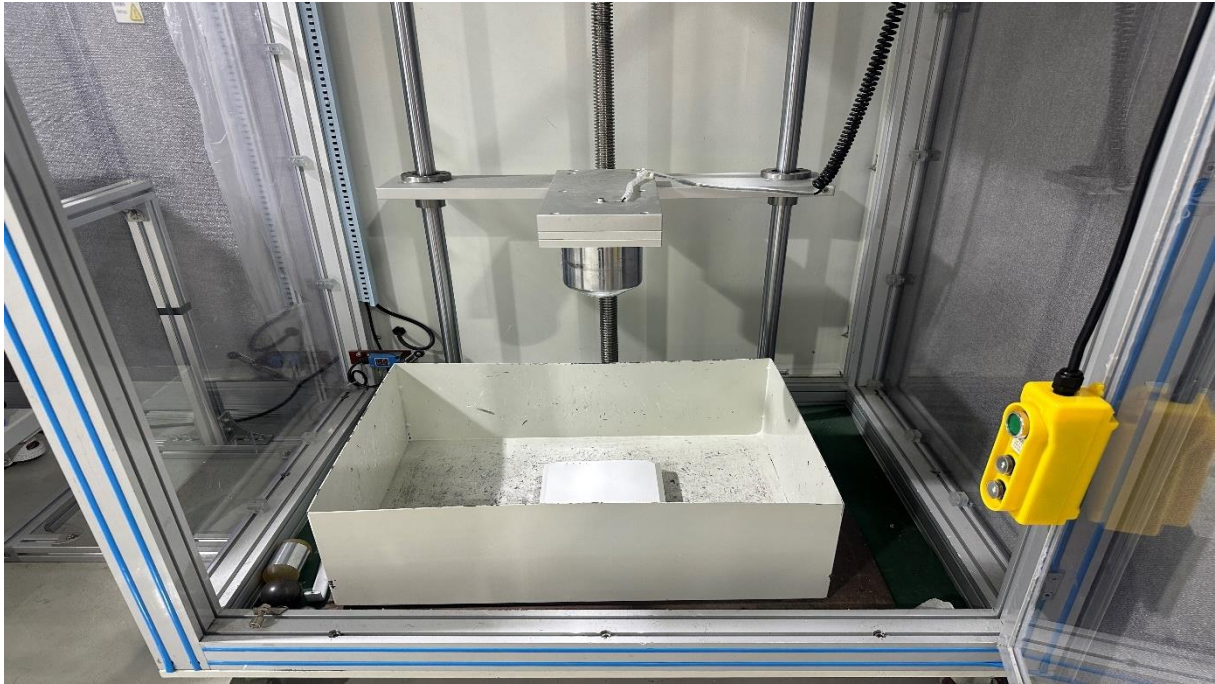
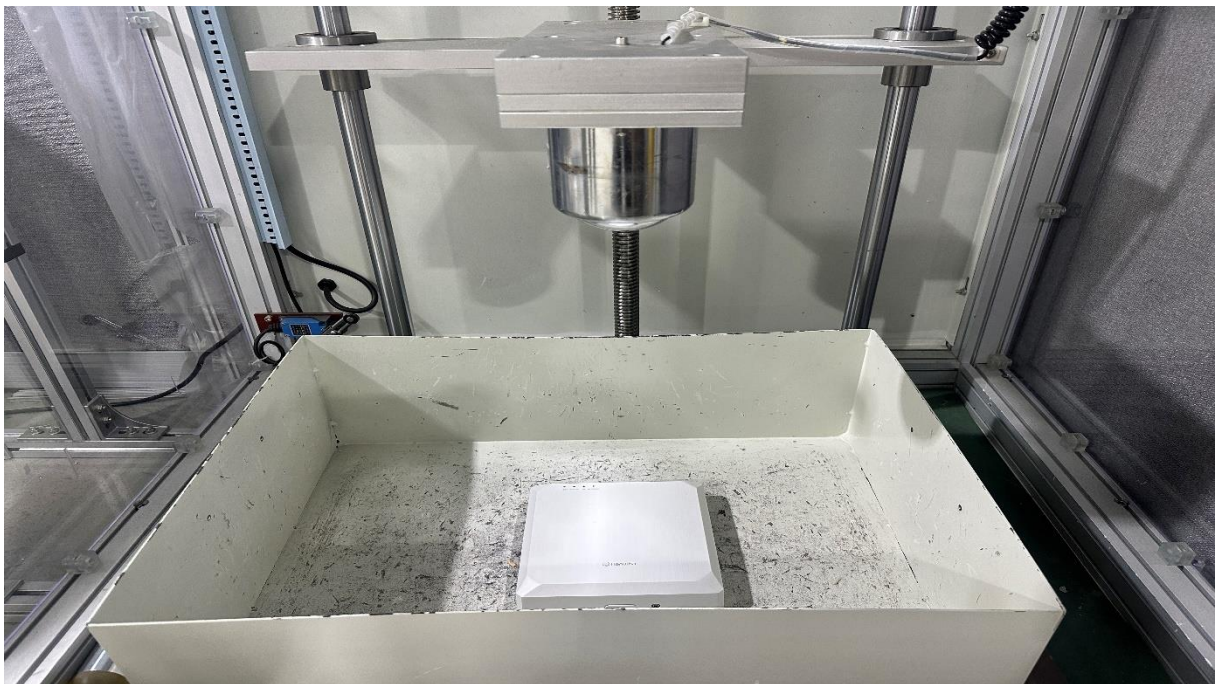
#### 3.3.1 Evidence of test setting

| IK code | Impact Energy (J) | Equivalent mass (kg) | Drop height (mm ± 1%) | Application |
|---|---|---|---|---|
| 10 | 20.00 | 5.00 | 400 | <input checked="" type="checkbox"/> |

Impact times: five times for each of the exposed surface. (Do not impact more than 3 times in the same spot)

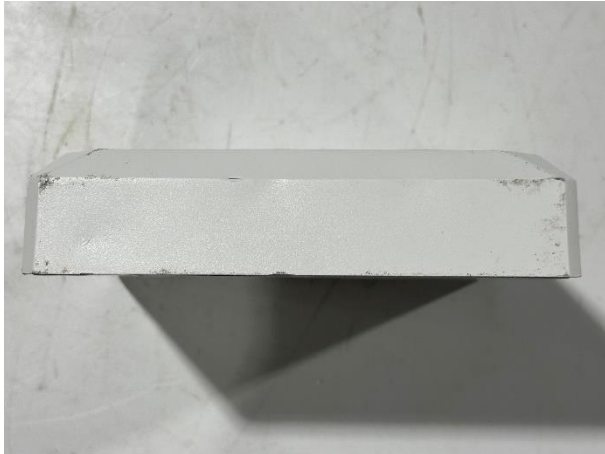
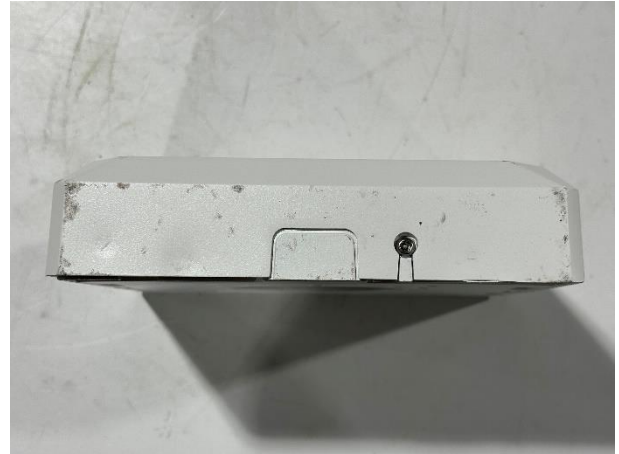
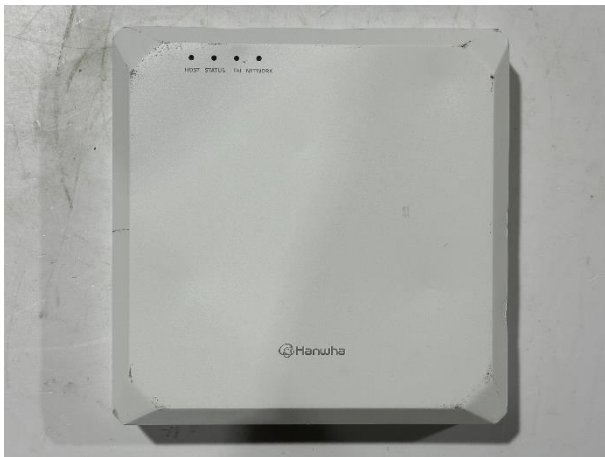
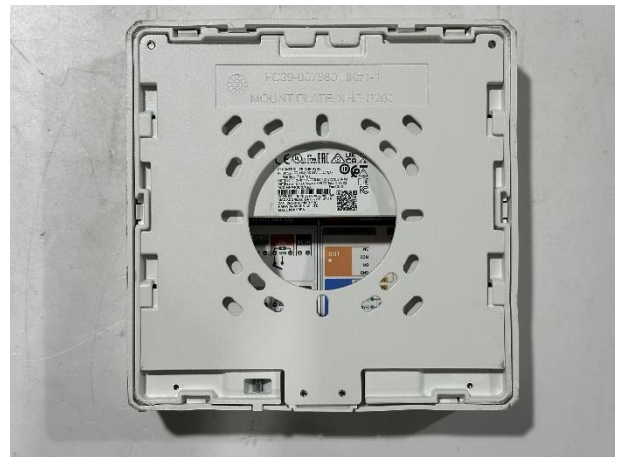
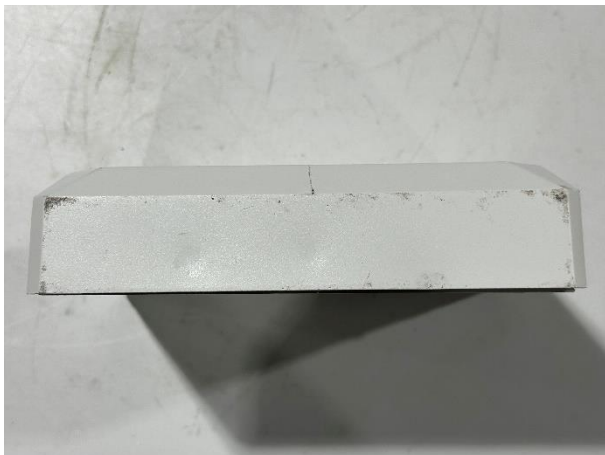
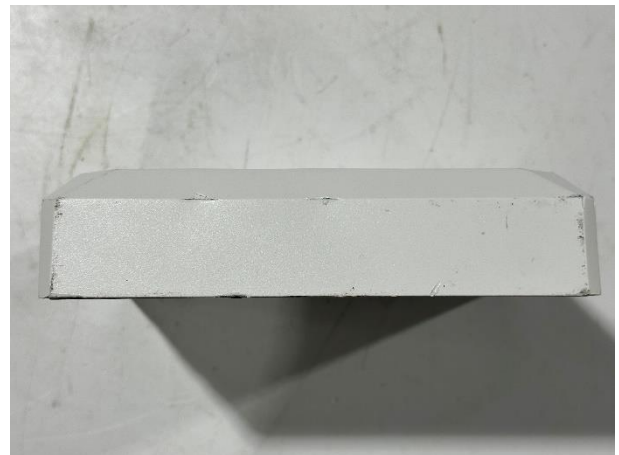
### 3.5.2 Post-test product images

| Evaluation Criteria | Test Results | Remark |
|---|---|---|
| Visual Inspection | Some scratches were generated on the outside of the product.<br>Separation of the internal terminal block component occurred, with no functional issues or abnormalities. | - |

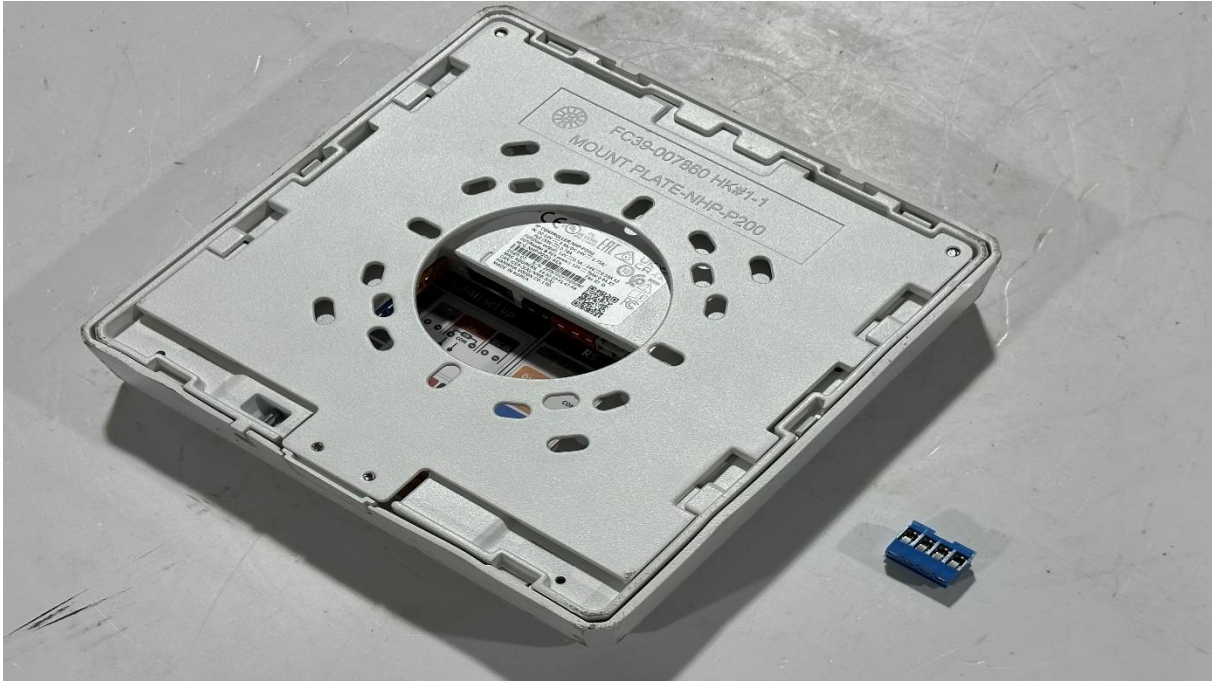
Component separation image
