# TEST REPORT

REPORT No.:  
CTK-2025-01915  
Page (1) / (39) pages

NETWORK CAMERA / PNB-A9092

EN 60068-2-1, EN 60068-2-2, EN 60068-2-14, EN 60068-2-6, EN  
60068-2-27, EN 60068-2-78, IEC 60068-2-1, IEC 60068-2-2, IEC  
60068-2-14, IEC 60068-2-6, IEC 60068-2-27, IEC 60068-2-78

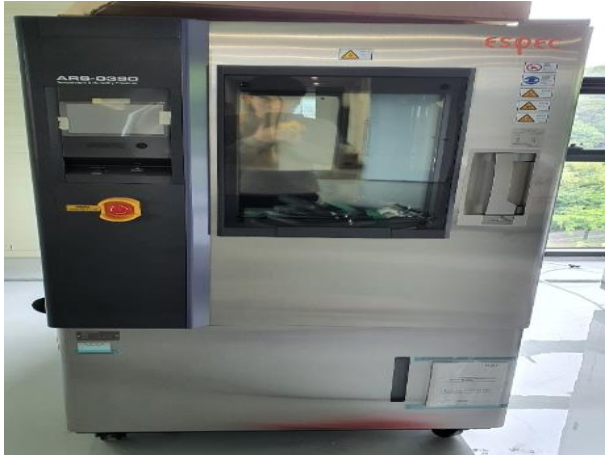
Temperature & Humidity Chamber

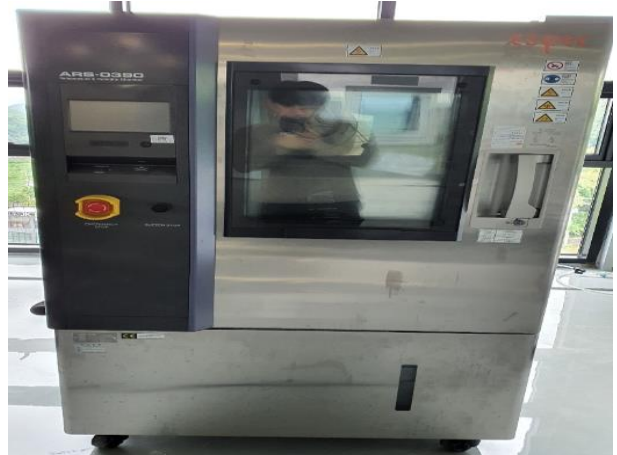
Temperature & Humidity Chamber

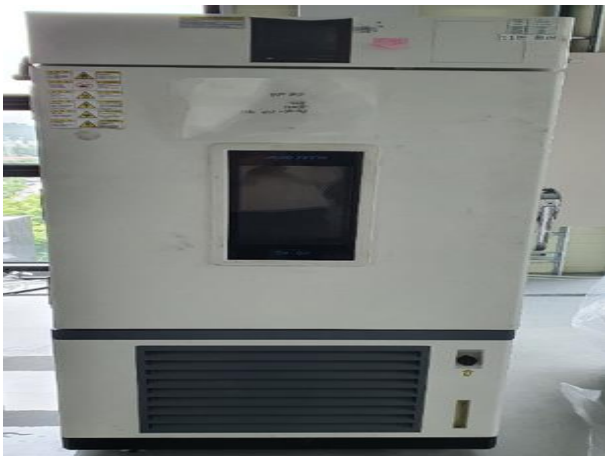
Temperature & Humidity Chamber

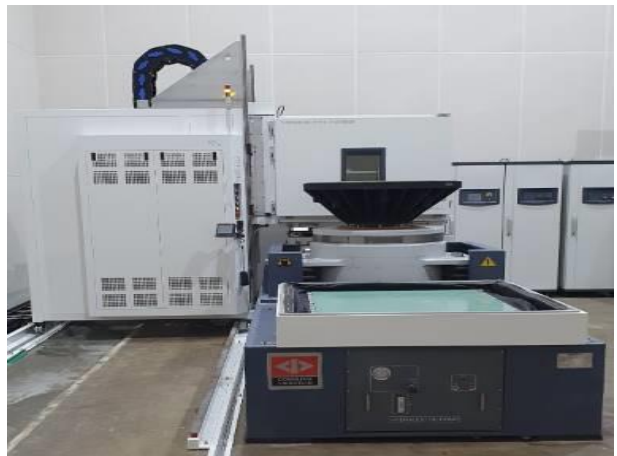
VIBRATION TESTING SYSTEM

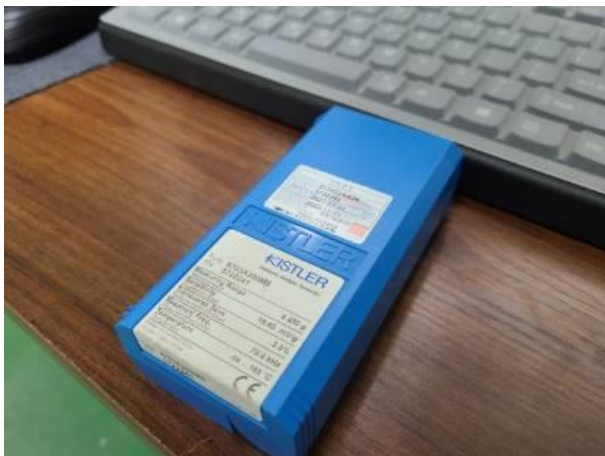
8703A250M5

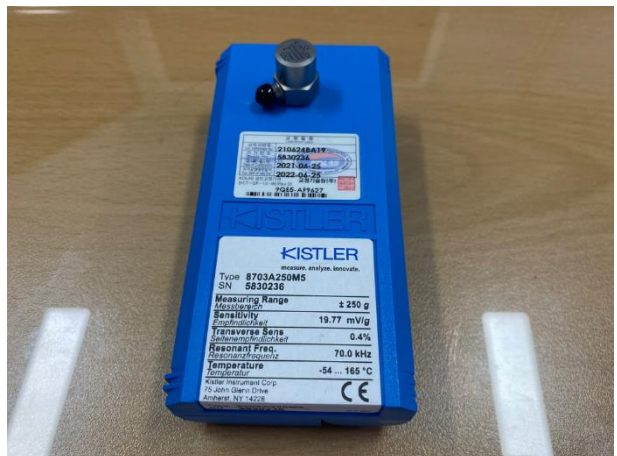
8703A250M5

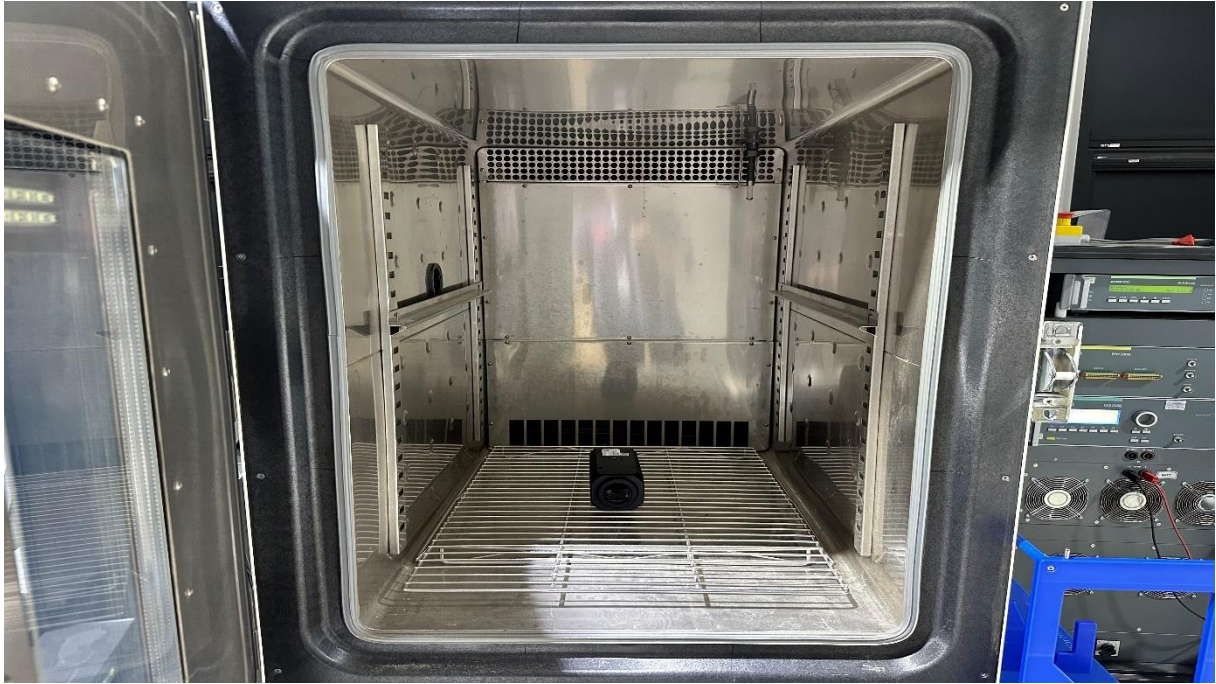
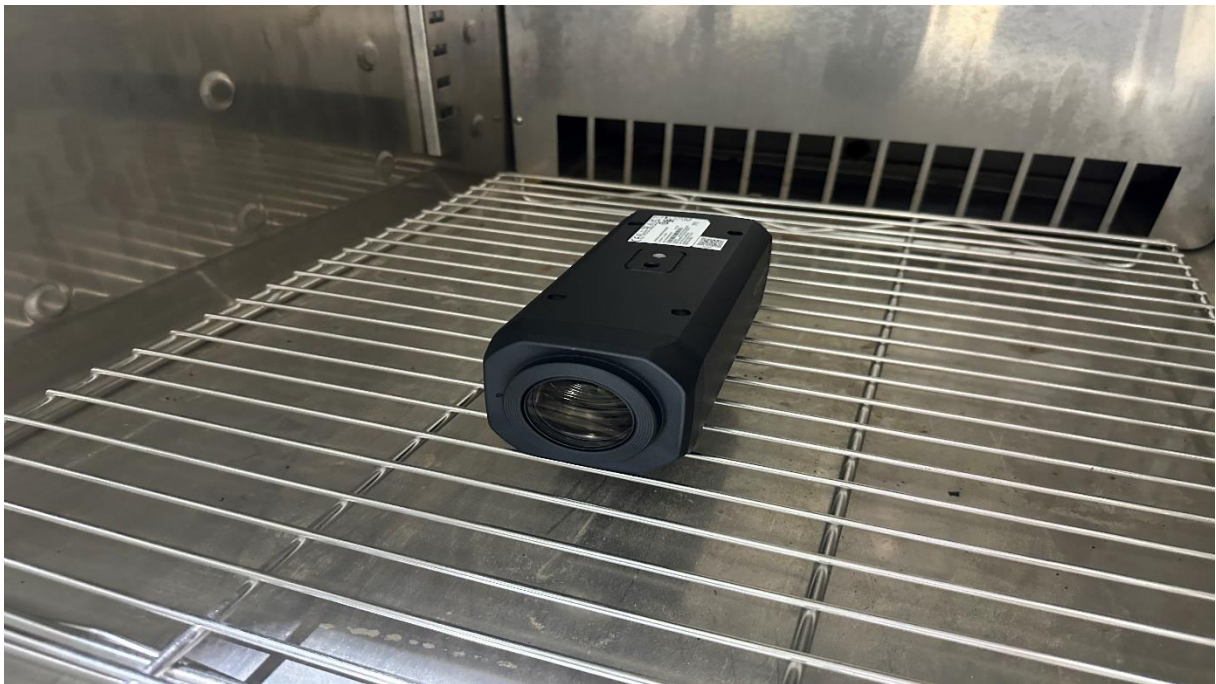
#### 3.3.1 Evidence of test setting

3.2.1 Sample status: Non-operation

3.2.2 Test temperature: -10 °C

3.2.3 Test time: 16 h

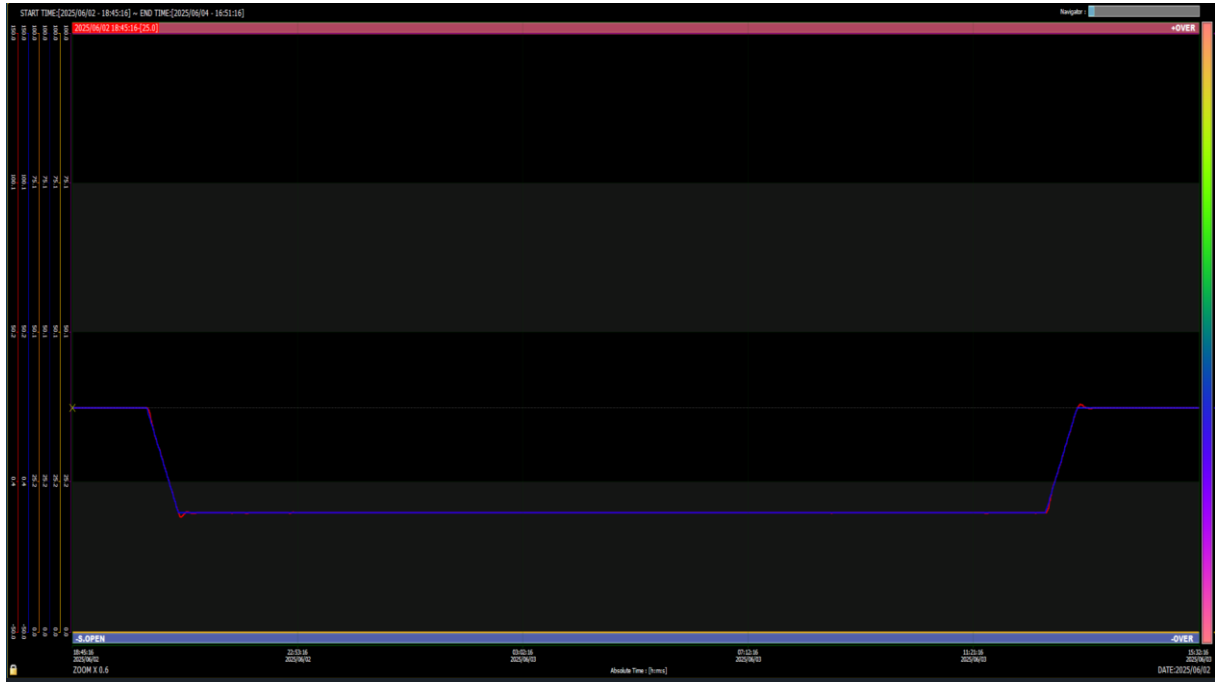
Temperature Data

#### 3.5.1 Test data and graph

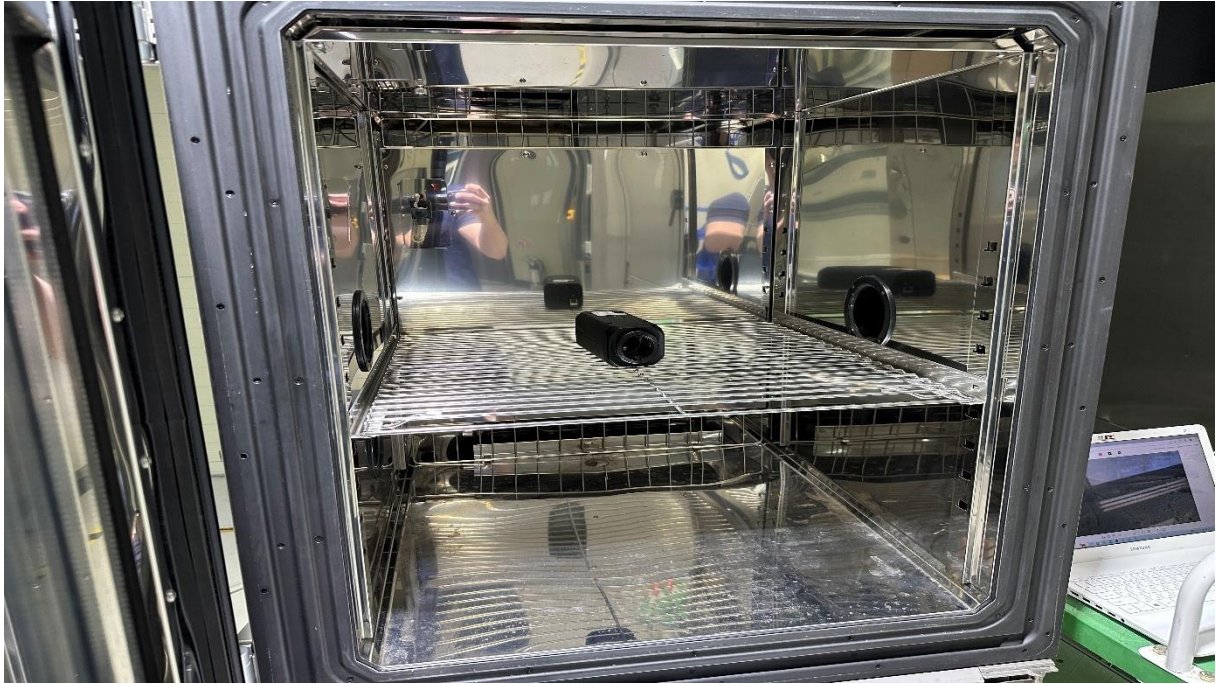
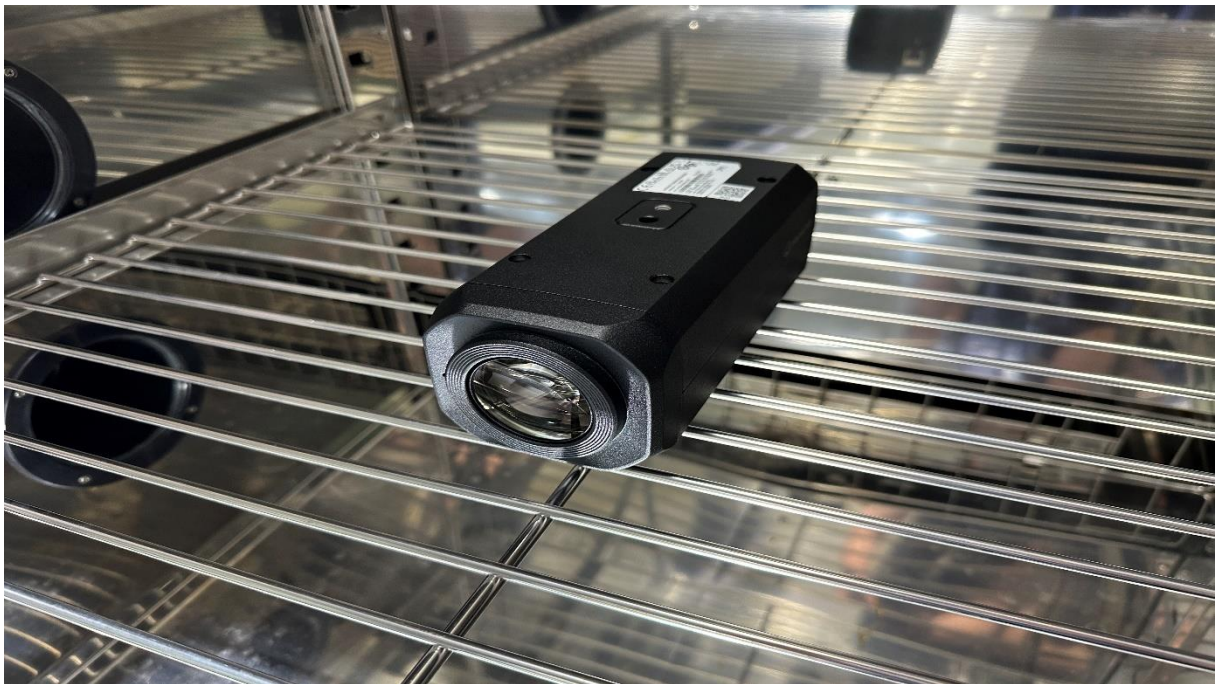
#### 4.3.1 Evidence of test setting

4.2.1 Sample status: Non-operation

4.2.2 Test temperature: 60 °C

4.2.3 Test time: 96 h

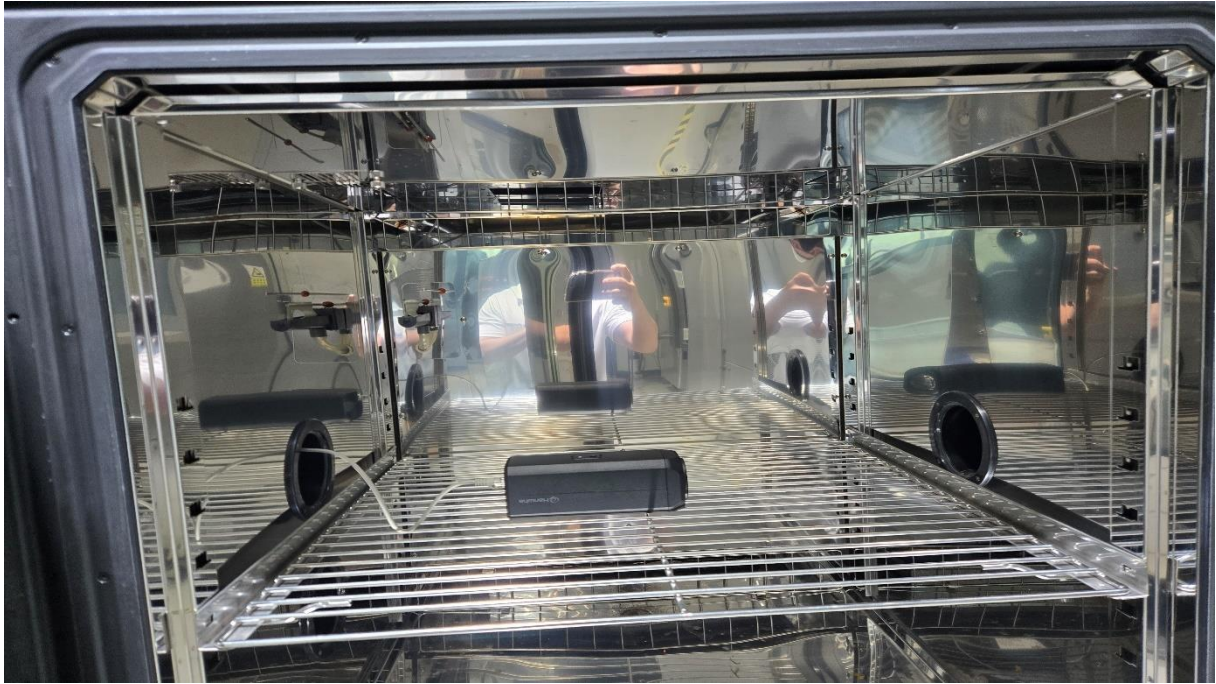
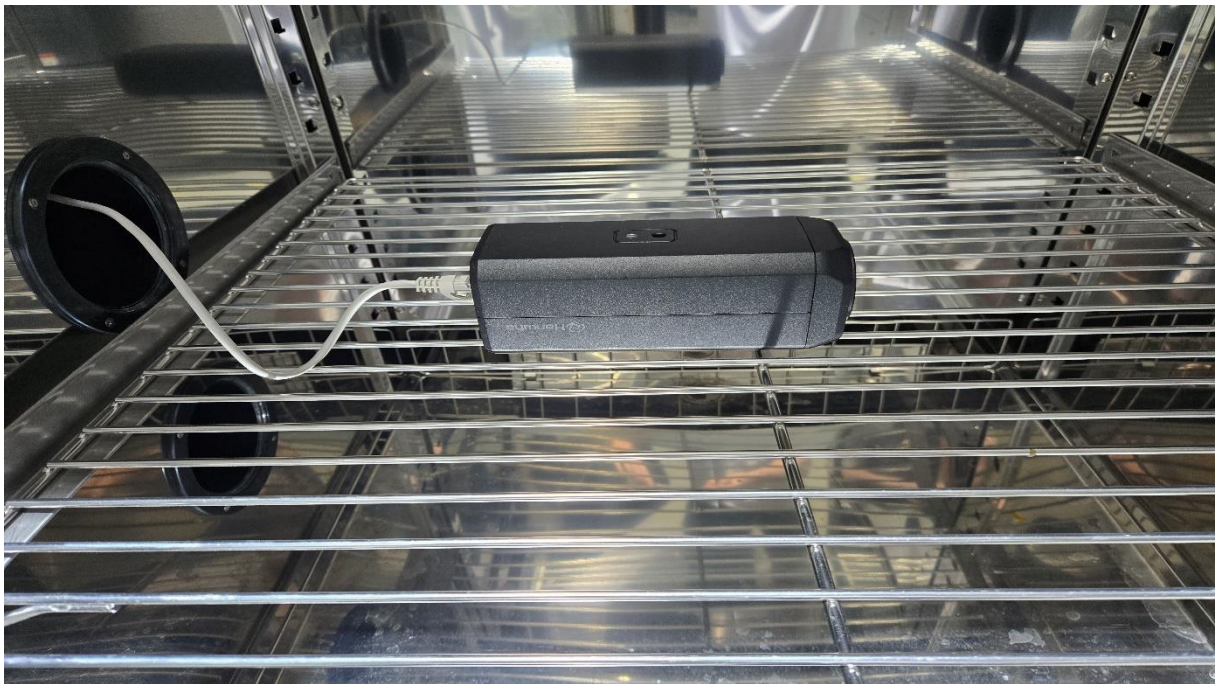
#### 5.3.1 Evidence of test setting

5.2.1 Sample status: operation

5.2.2 Test temperature: -10 °C, 55 °C

| Temp↵ | Temperature change rate(°C/min)↵ | t <sub>1</sub> (idle time)↵ | Cycles↵ |
| High↵ | 5 °C/min↵ | 3 h↵ | 3↵ |
| Low↵ | 1 °C/min↵ | 3 h↵ | 3↵ |

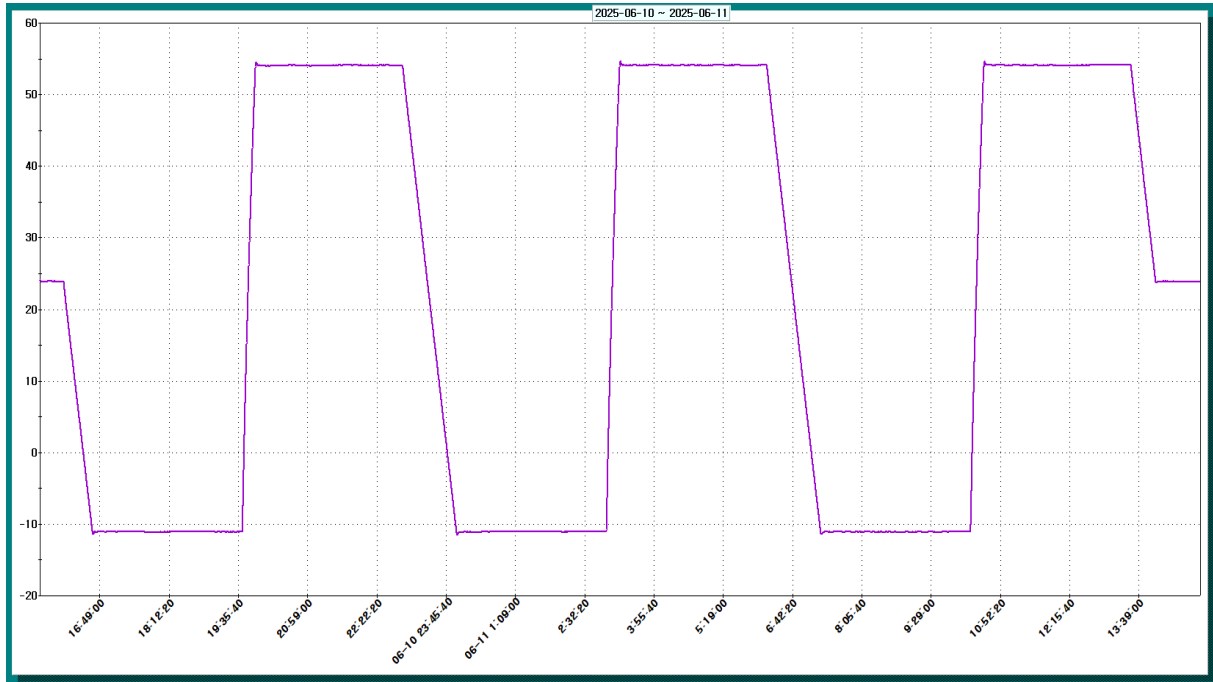
Temperature Data

#### 5.5.1 Test data and graph

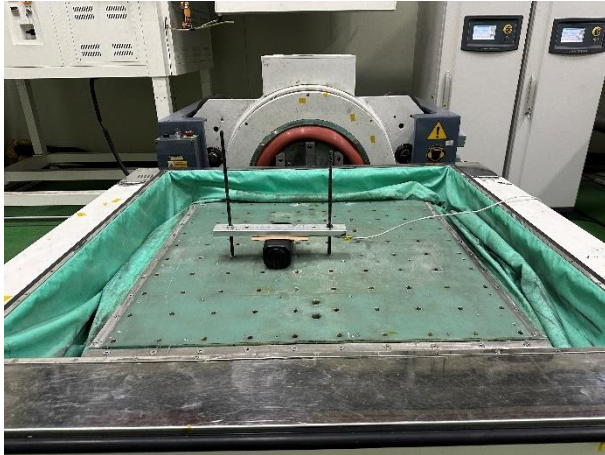
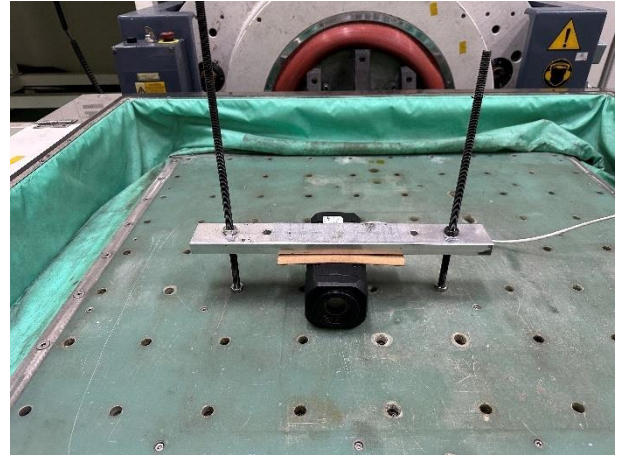
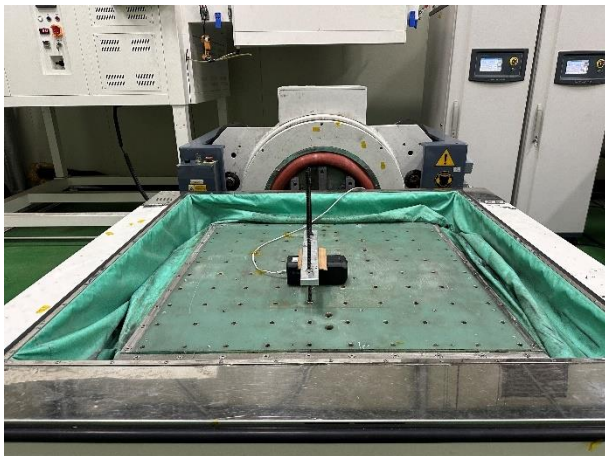
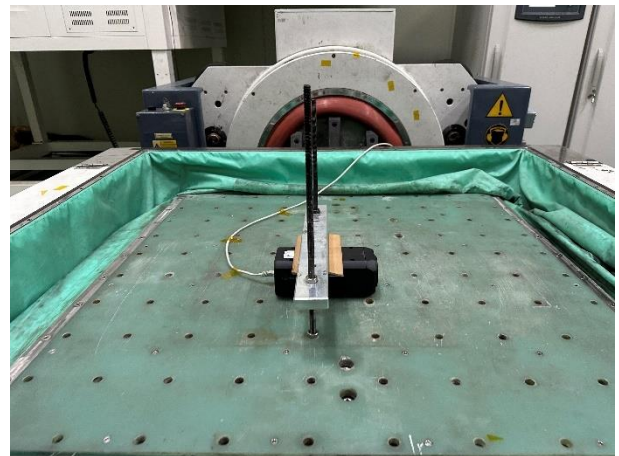
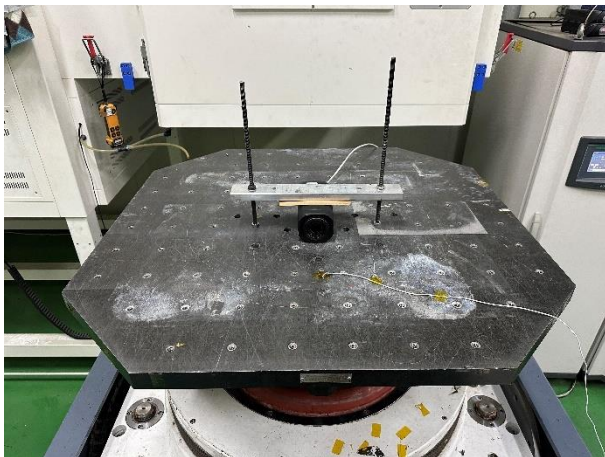
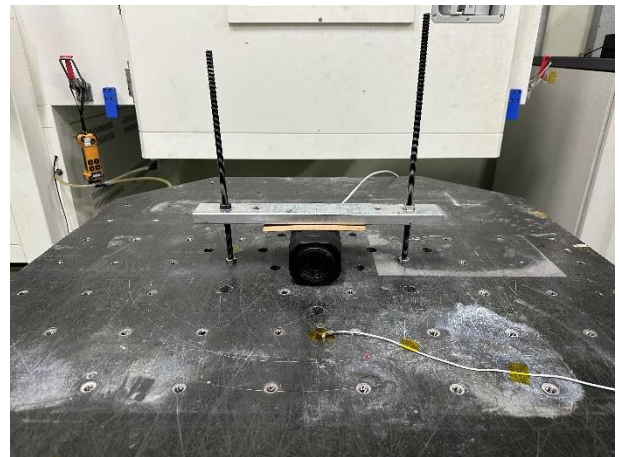
### 6.3.1 Evidence of test setting

- Sample status: operation
- Frequency(Hz): 5 Hz ~ 200 Hz
- Acceleration(G): 1 G
- Sweep rate: 1 oct/min
- Test Axis: X, Y, Z
- Test time(h): Total 30 min (10 min. per each axis)

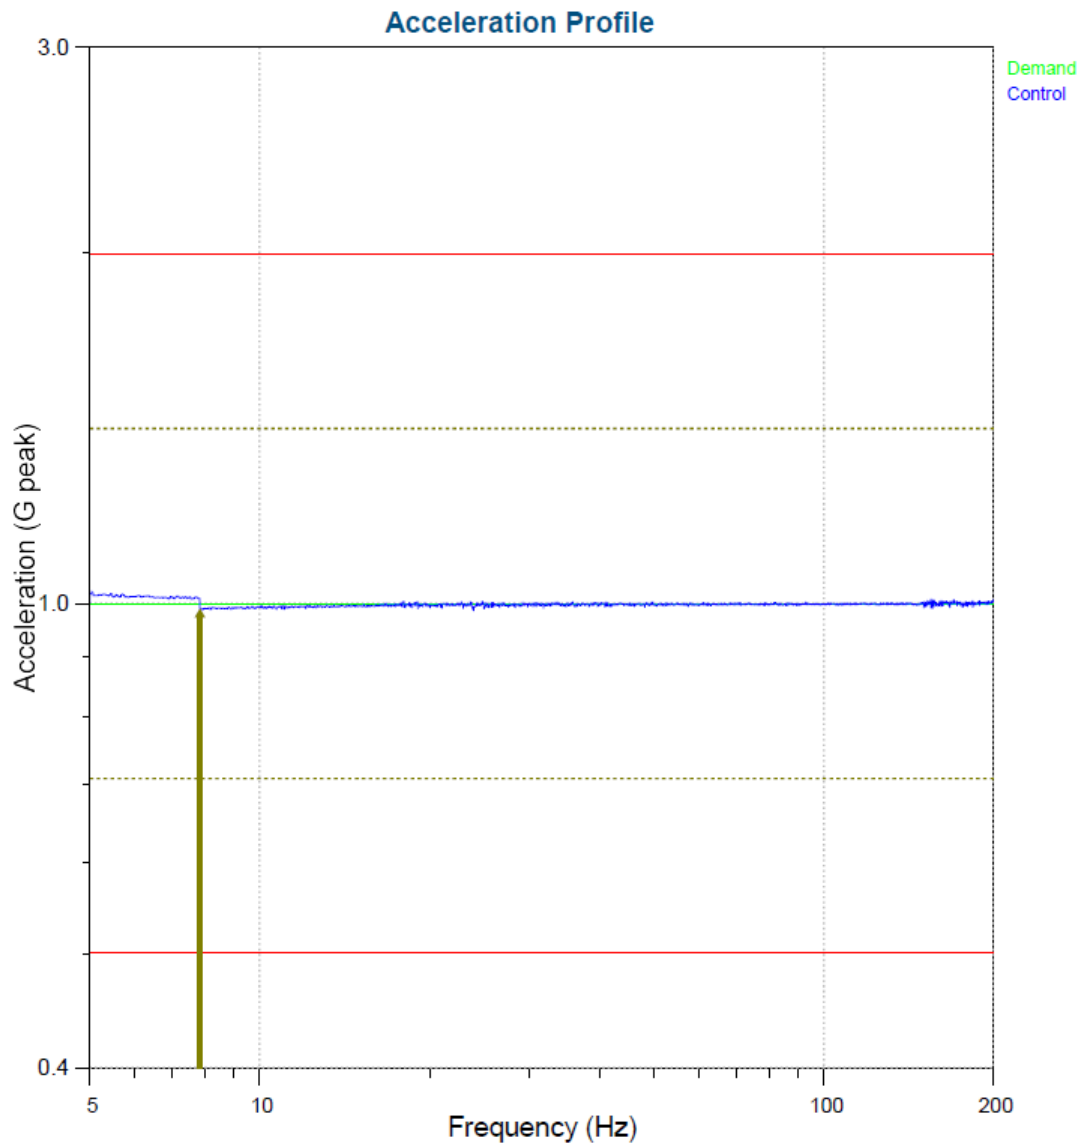
X Axis

#### 6.5.1 Test data and graph (Vibration Test X Axis)

6/26, 2025 14:25:51 Level 1) 100 % Output: 0 Volts peak 60068-2-1

Demand: 1 G Level Time: 0:10:00 Frequency: 7.841 Hz

Control: 0.000749 G Total Time: 0:10:12 End of Timed Test

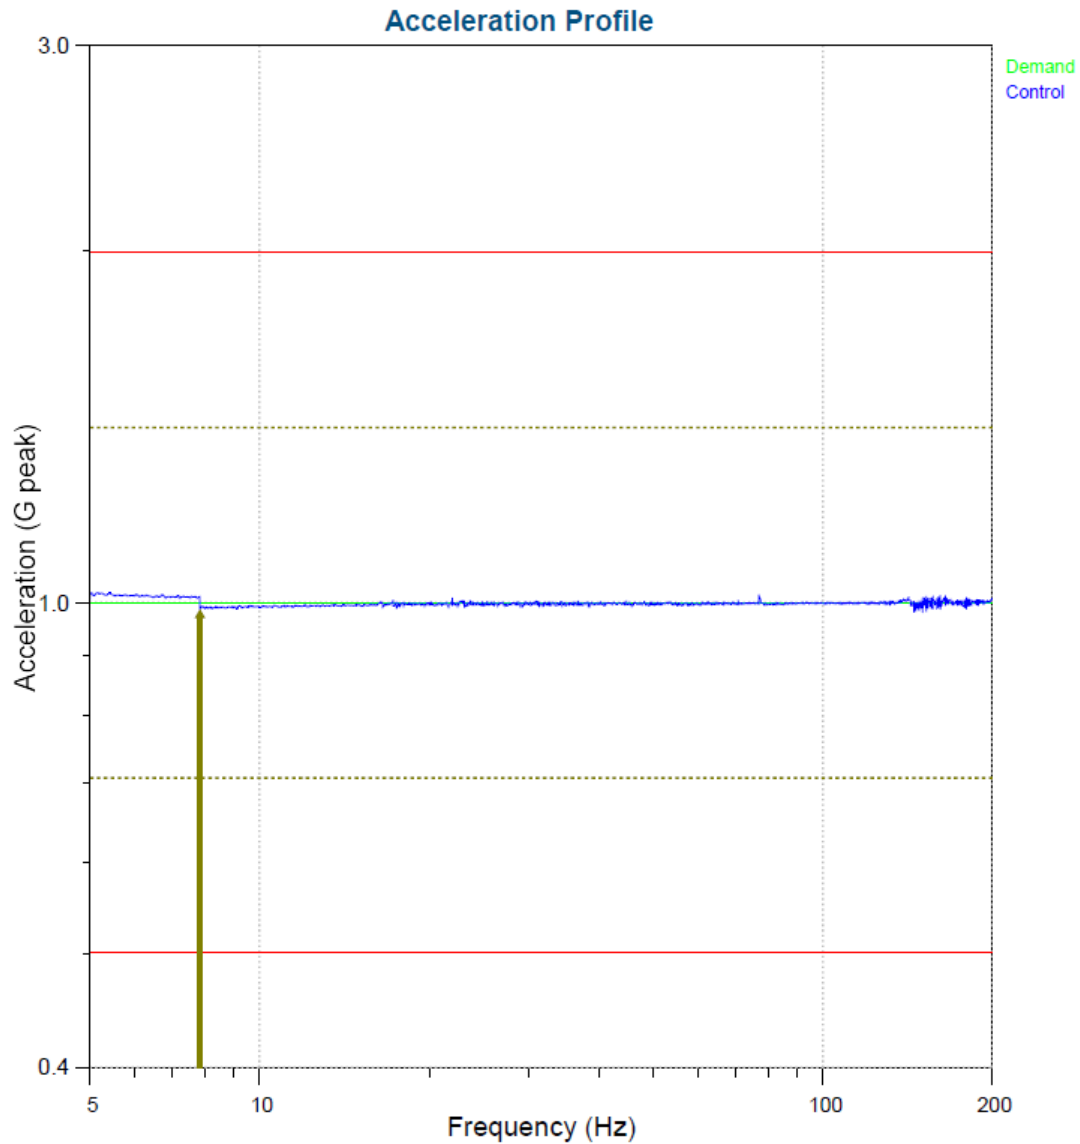
Y Axis

### 6.5.2 Test data and graph (Vibration Test Y Axis)

6/26, 2025 14:42:40 Level 1) 100 % Output: 0 Volts peak 60068-2-t

Demand: 1 G Level Time: 0:10:0 Frequency: 7.846 Hz

Control: 0.001933 G Total Time: 0:10:10 End of Timed Test

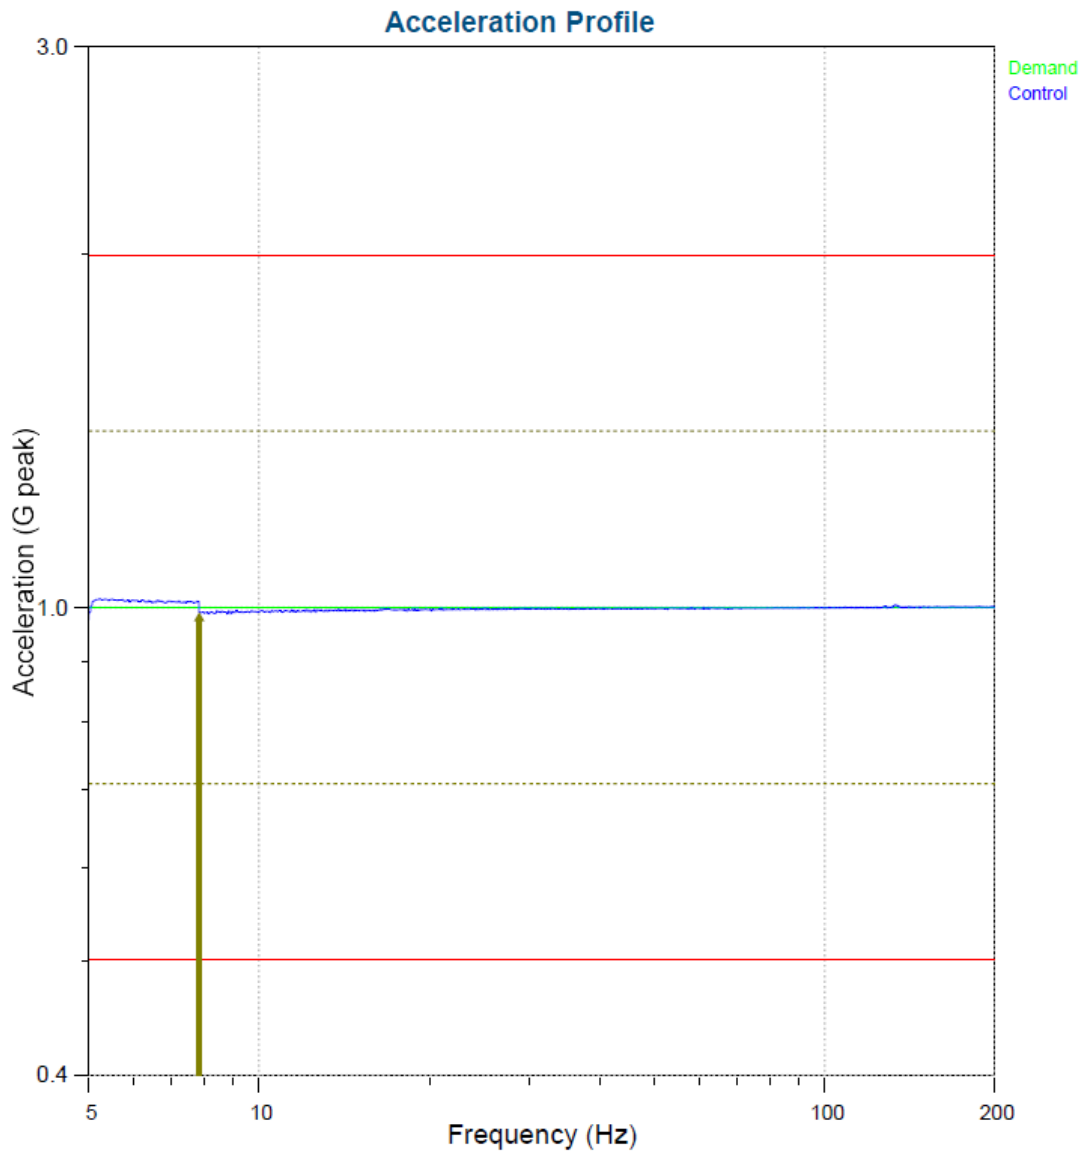
Z Axis

### 6.5.3 Test data and graph (Vibration Test Z Axis)

6/26, 2025 15:37:01 Level 1) 100 % Output: 0 Volts peak 60068-2-f  
Demand: 1 G Level Time: 0:10:0 Frequency: 7.841 Hz  
Control: 0.0008592 G Total Time: 0:10:1 End of Timed Test

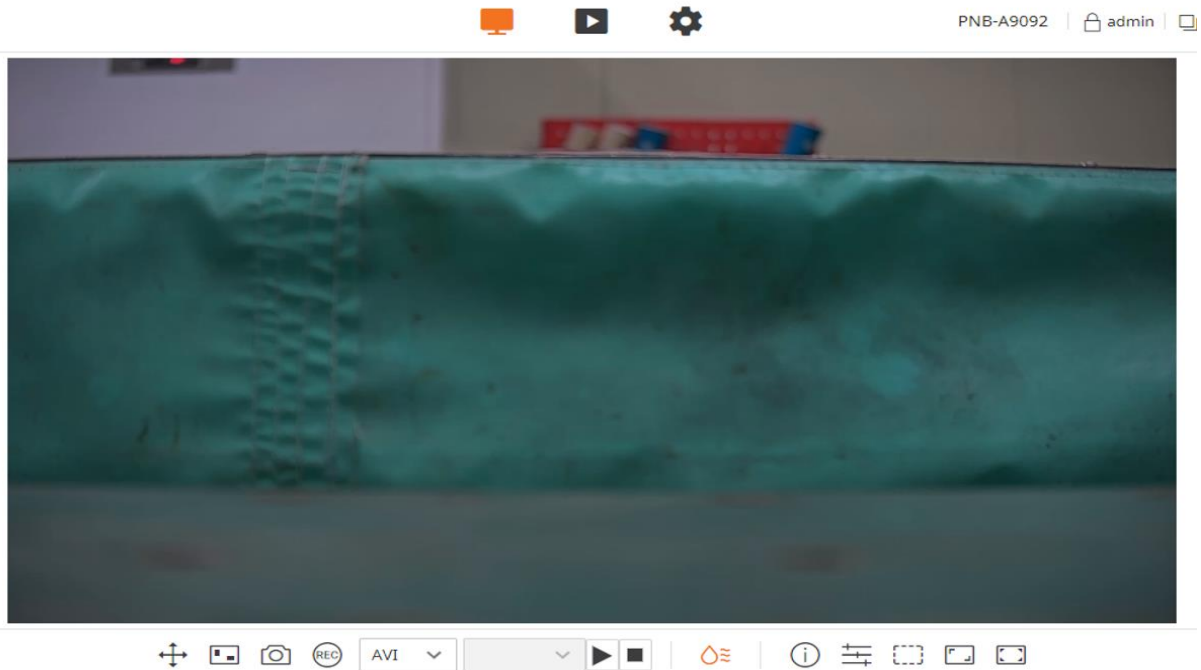
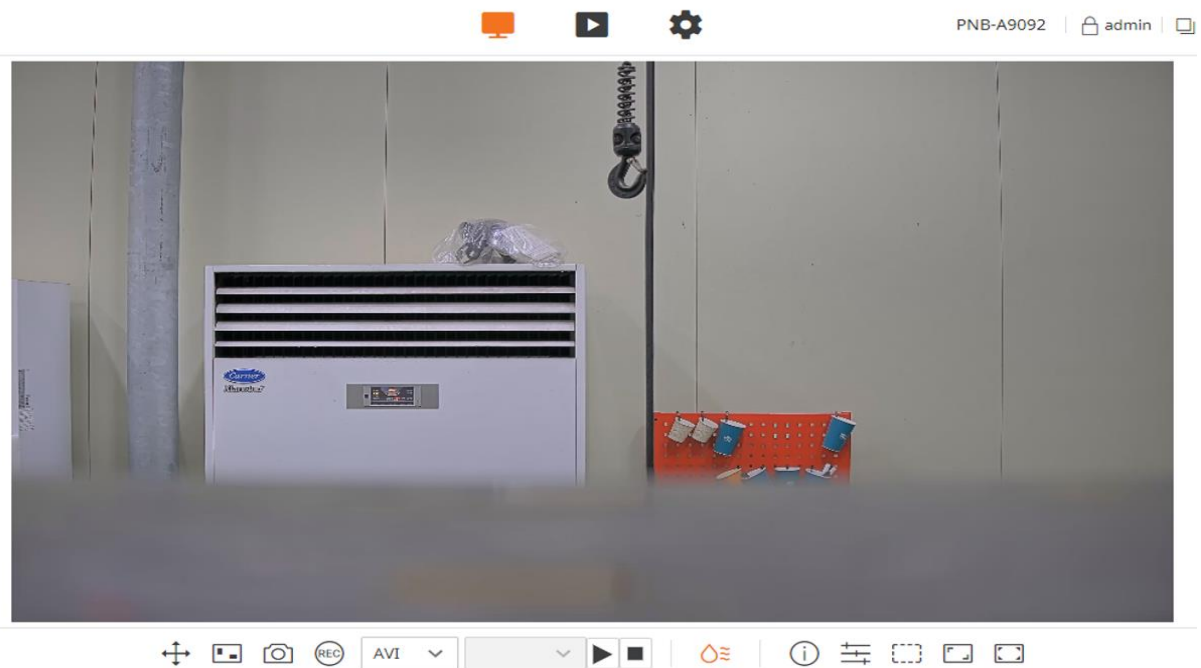
### 6.6.1 Test sample operation and function

| Evaluations Criteria | Test result | | Comment |
|---|---|---|---|
| Vibration Test | Before | Normal | - |
| | After | Normal | - |

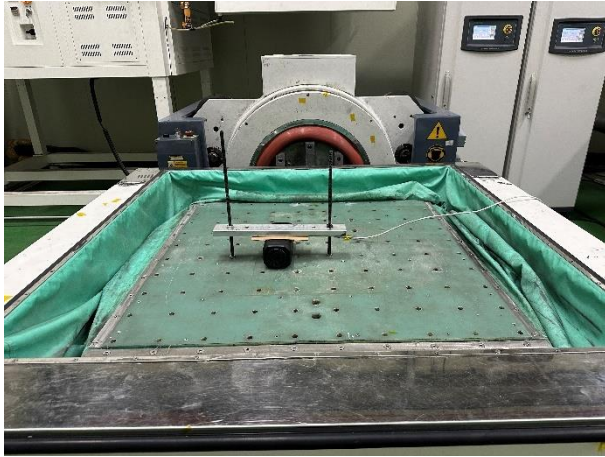
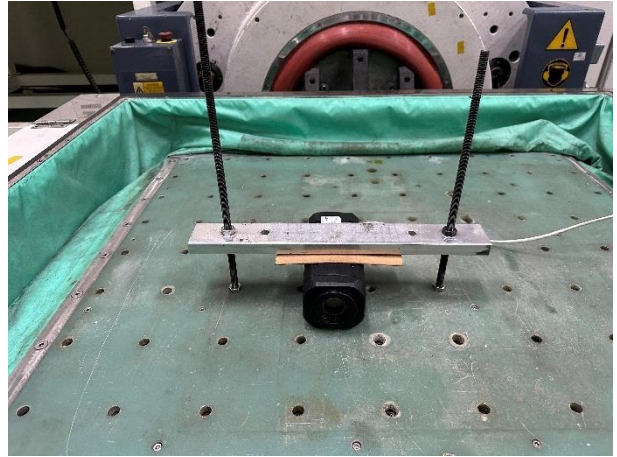
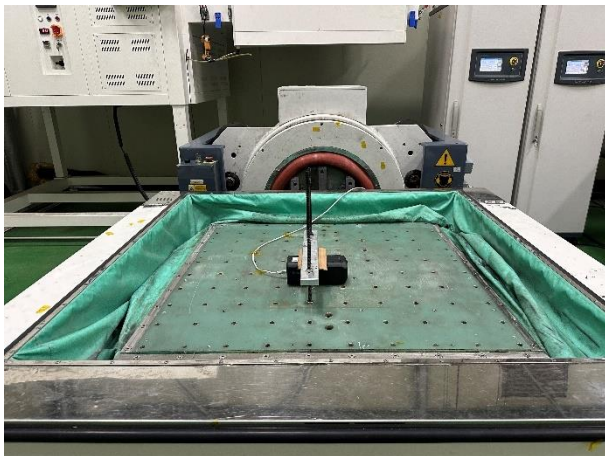
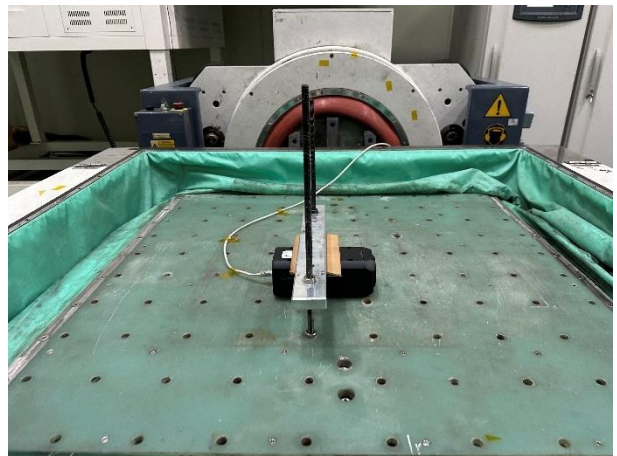
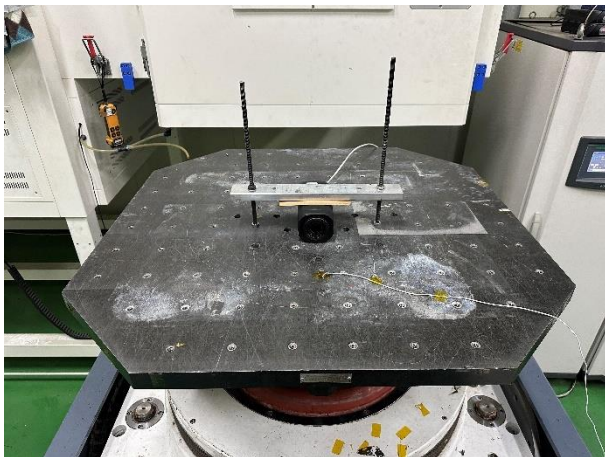
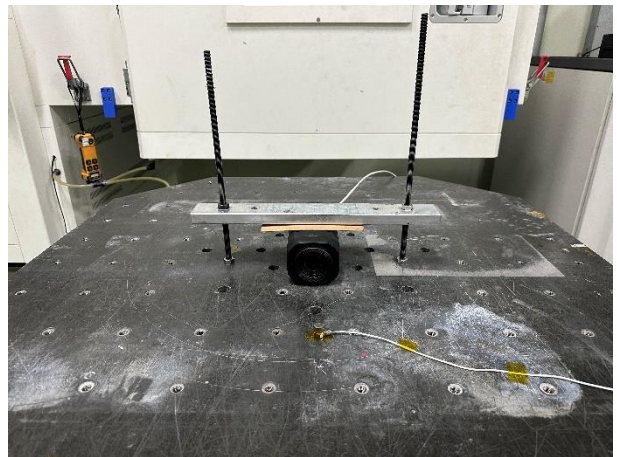
### 7.3.1 Evidence of test setting

7.2.1 Sample status: Non-operation

7.2.2 Acceleration(G): 10 G

7.2.3 Number of impacts: 10 per direction (total 60)

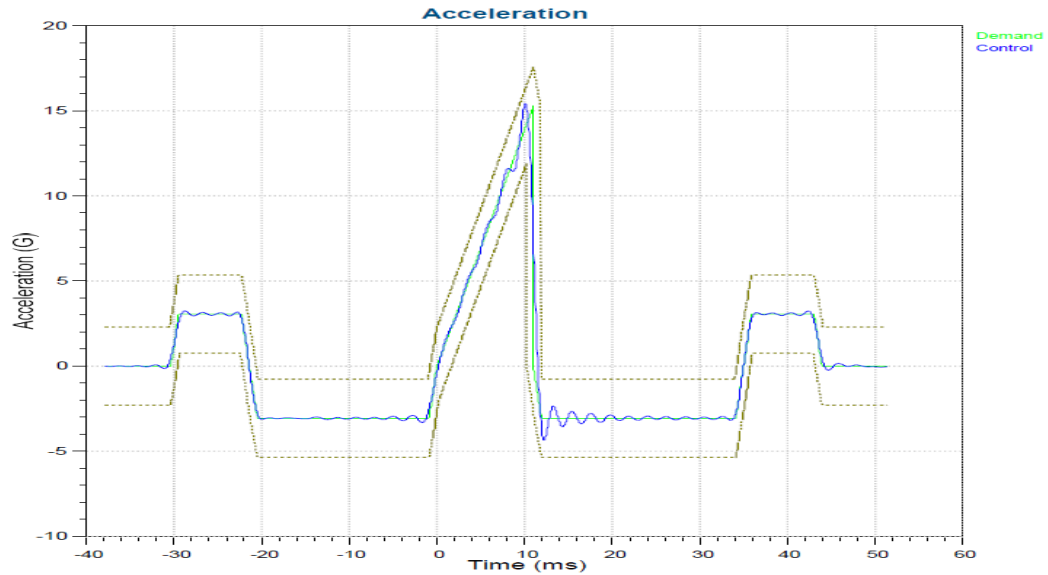
X+

### 7.5.1 Test data and graph (Shock Test X Axis)

6/26, 2025 14:27:11 Level 1) 100 % Output: 1.149 Volts peak 한화비전 60068-2  
Demand: 15.3 C  
Control: 15.42 C Pulse: 10 of 10 Running

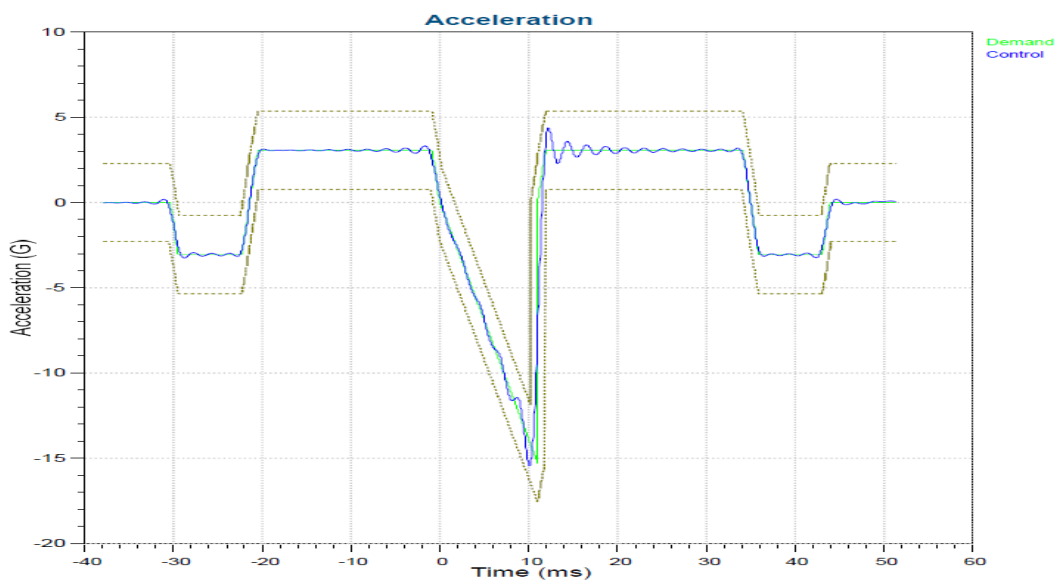
X-

6/26, 2025 14:28:24 Level 2) 100 % Output: 1.141 Volts peak 한화비전 60068-2  
Demand: 15.3 C  
Control: 15.44 C Pulse: 10 of 10 End of Test

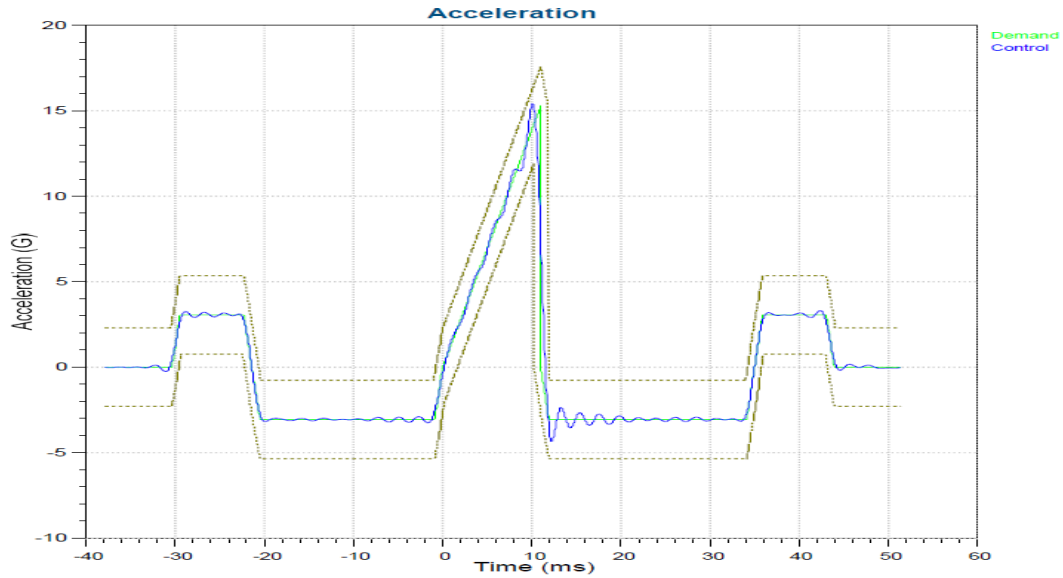
Y+

### 7.5.2 Test data and graph (Shock Test Y Axis)

6/26, 2025 14:43:4\* Level 1) 100 % Output: 1.136 Volts peak 한화비전 60068-2  
Demand: 15.3 C  
Control: 15.41 C Pulse: 10 of 10 Running

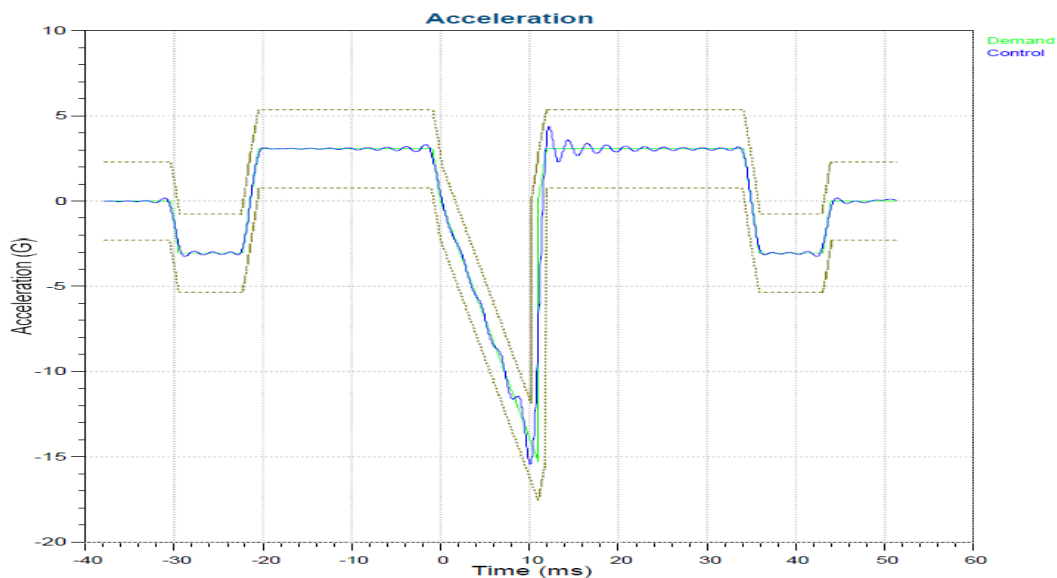
Y-

6/26, 2025 14:44:2! Level 2) 100 % Output: 1.143 Volts peak 한화비전 60068-2  
Demand: 15.3 C  
Control: 15.43 C Pulse: 10 of 10 End of Test

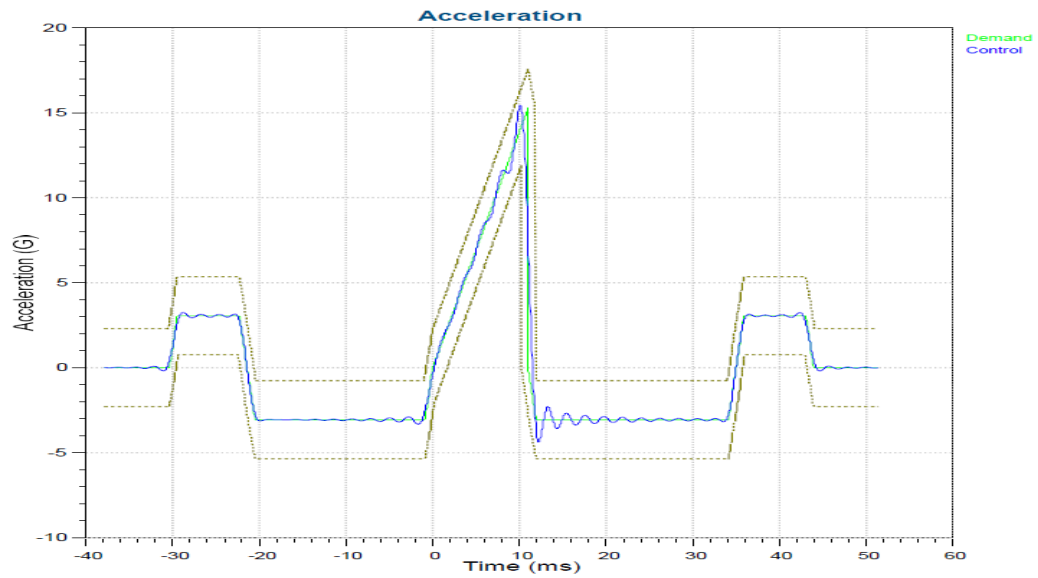
Z+

### 7.5.3 Test data and graph (Shock Test Z Axis)

6/26, 2025 15:37:41 Level 1) 100 %

Output: 1.112 Volts peak

Demand: 15.3 G

Control: 15.43 G

Pulse: 10 of 10

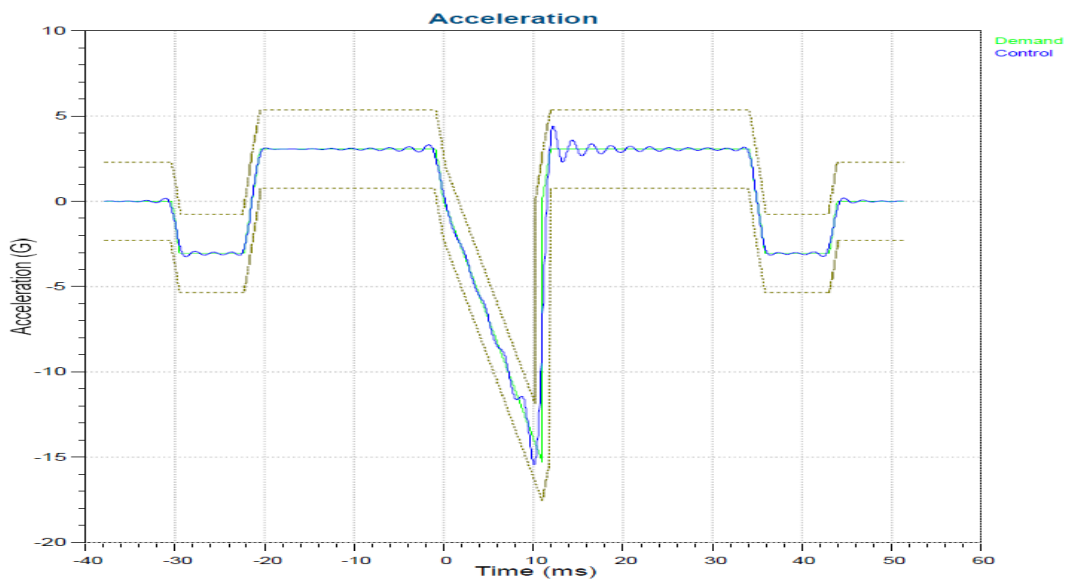
Z-

6/26, 2025 15:38:41 Level 2) 100 %

Output: 1.12 Volts peak

Demand: 15.3 G

Control: 15.44 G

Pulse: 10 of 10

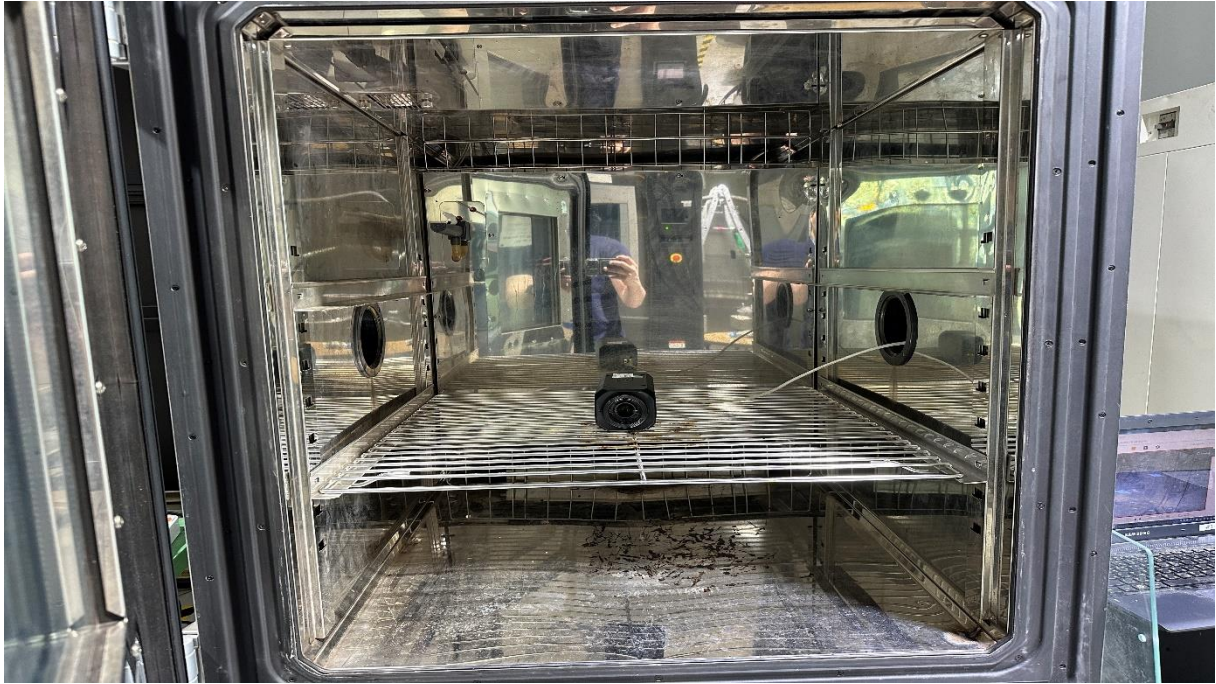
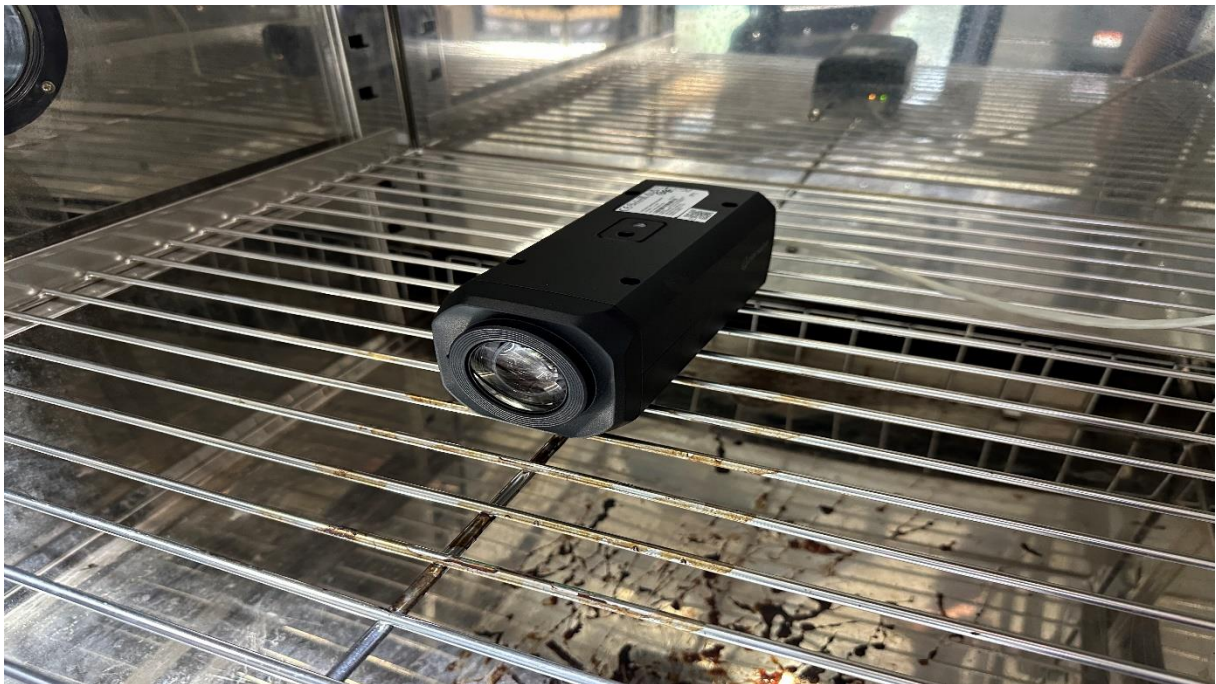
#### 8.3.1 Evidence of test setting

8.2.1 Sample status: operation

8.2.2 Test temperature:  $40 \pm 2$  °C

8.2.3 Test Humidity:  $93 \pm 3$  % R.H.

8.2.4 Test time: 240 h
