# TEST REPORT

REPORT No.:  
CTK-2025-01915  
Page (1) / (39) pages

NETWORK CAMERA / PNB-A9092

EN 60068-2-1, EN 60068-2-2, EN 60068-2-14, EN 60068-2-6, EN  
60068-2-27, EN 60068-2-78, IEC 60068-2-1, IEC 60068-2-2, IEC  
60068-2-14, IEC 60068-2-6, IEC 60068-2-27, IEC 60068-2-78

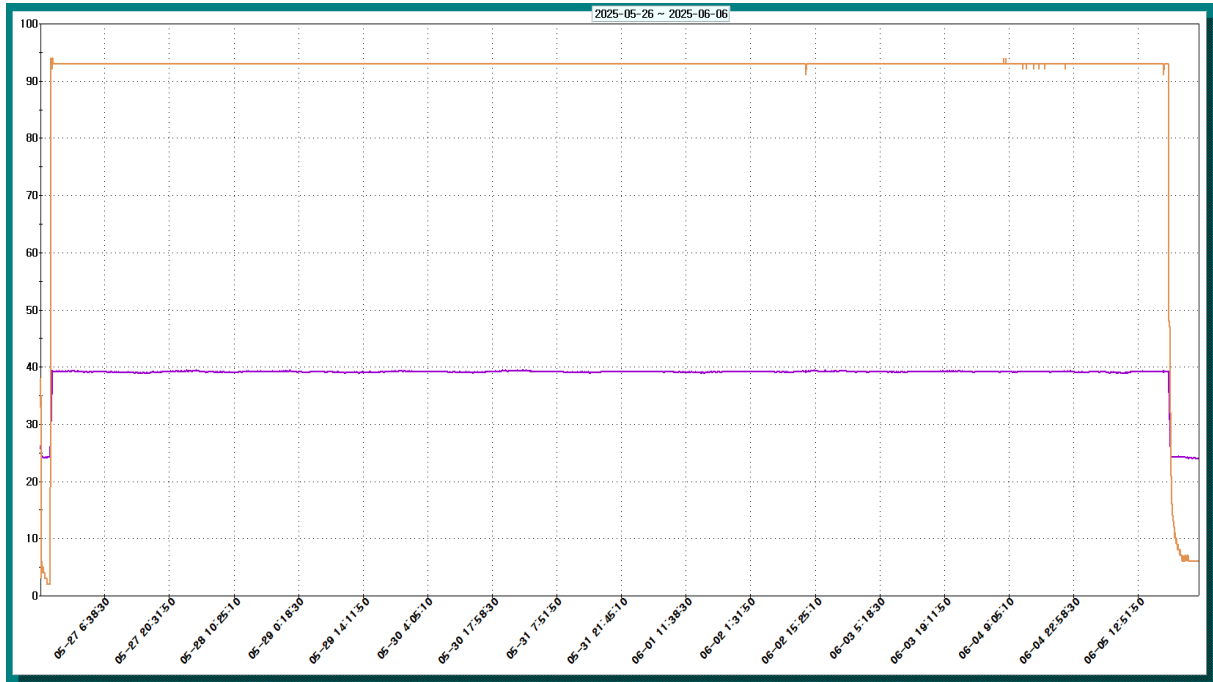
Temperature Data

### 8.5.1 Test data and graph

8.2.2 Test temperature:  $40 \pm 2$  °C

8.2.3 Test Humidity:  $93 \pm 3$  % R.H.

8.2.4 Test time: 240 h

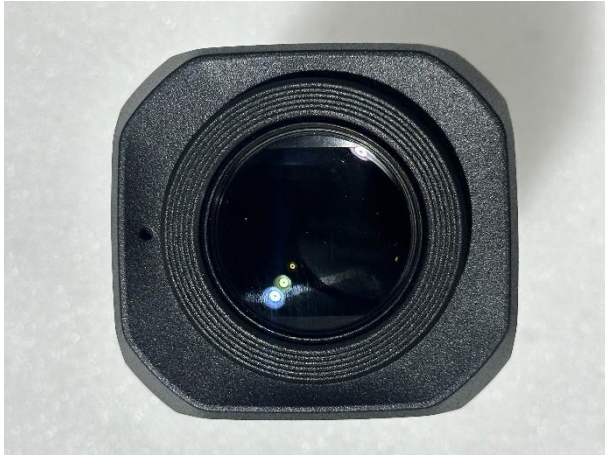
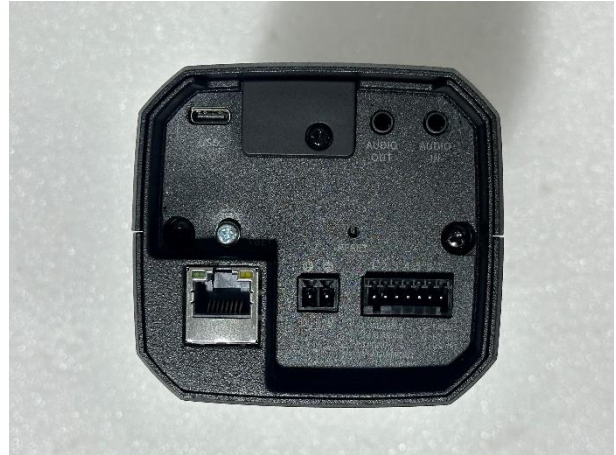
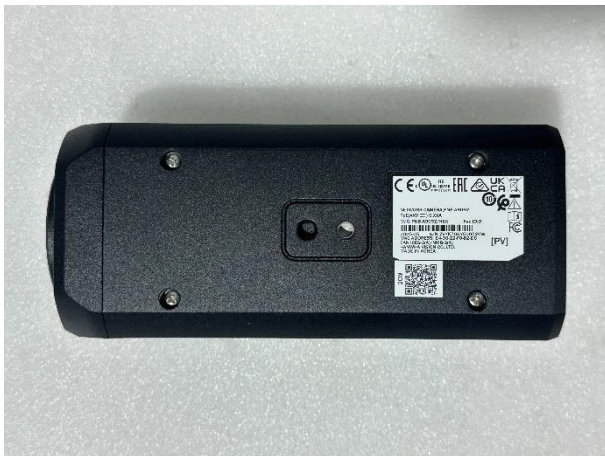
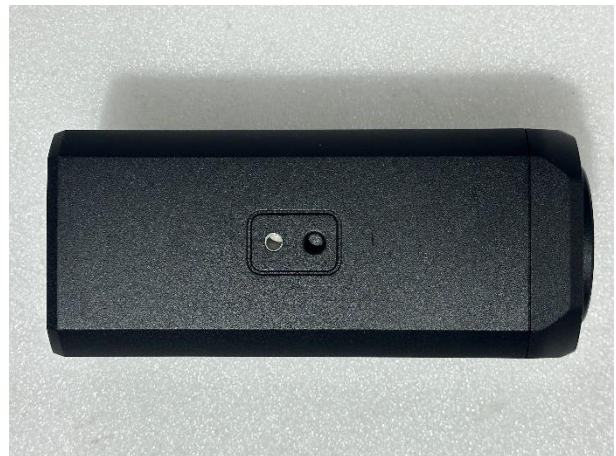
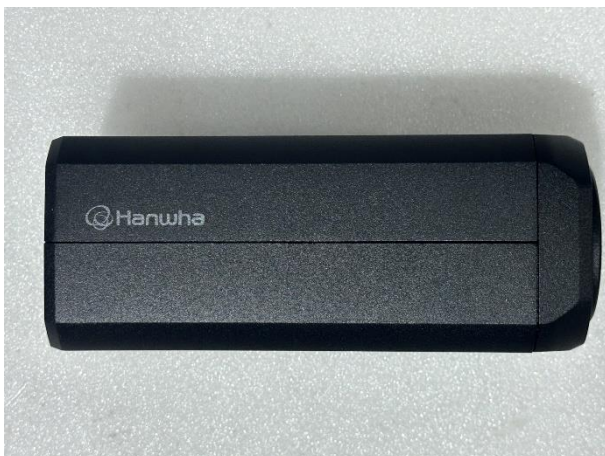
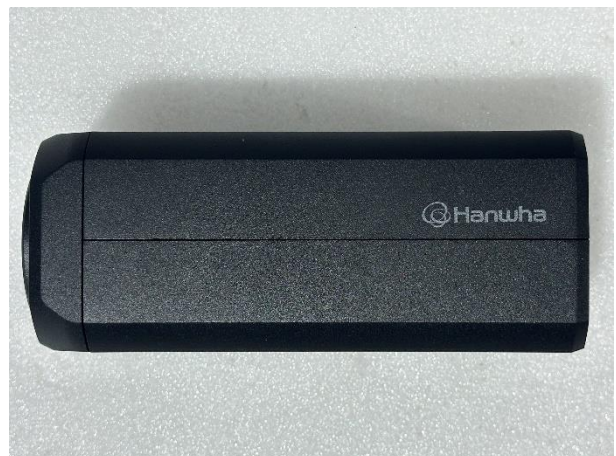
### 8.6.1 Test sample

| Evaluations Criteria | Test result | | 비고 |
|---|---|---|---|
| Sample | Visual Inspection | Normal | - |
