# TEST REPORT

REPORT No.:  
CTK-2025-01911  
Page (1) / (39) pages

NETWORK CAMERA / PND-A9082RV

EN 60068-2-1, EN 60068-2-2, EN 60068-2-14, EN 60068-2-6, EN  
60068-2-27, EN 60068-2-78, IEC 60068-2-1, IEC 60068-2-2, IEC  
60068-2-14, IEC 60068-2-6, IEC 60068-2-27, IEC 60068-2-78

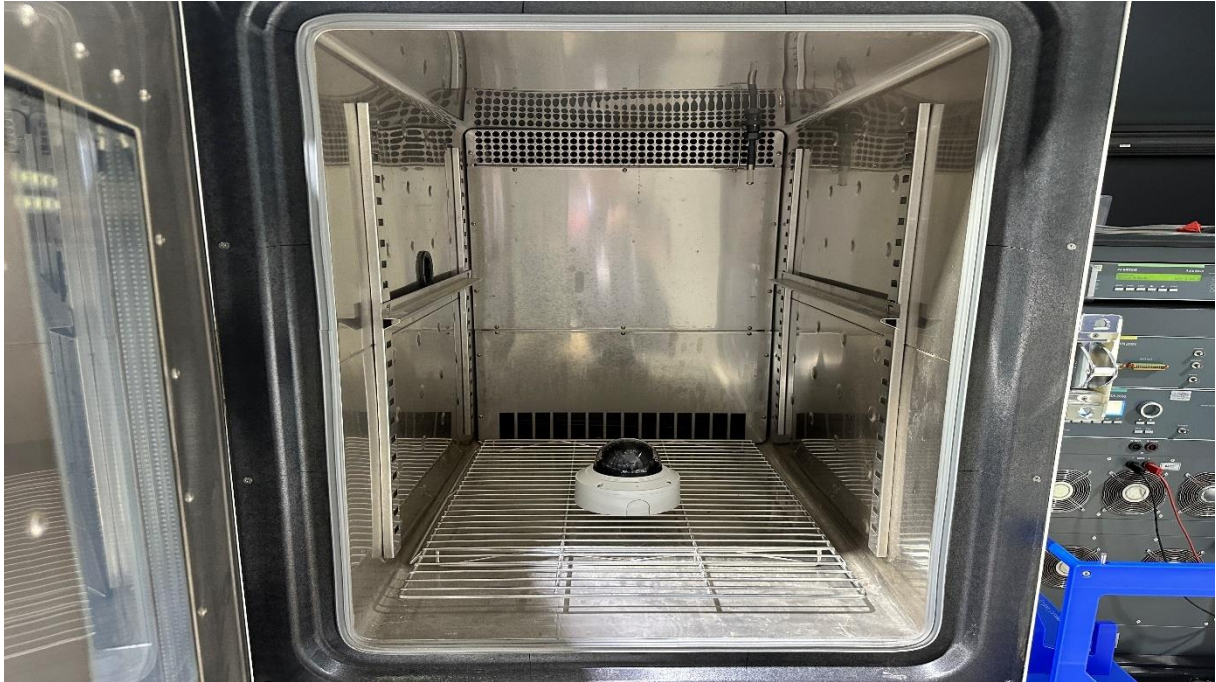
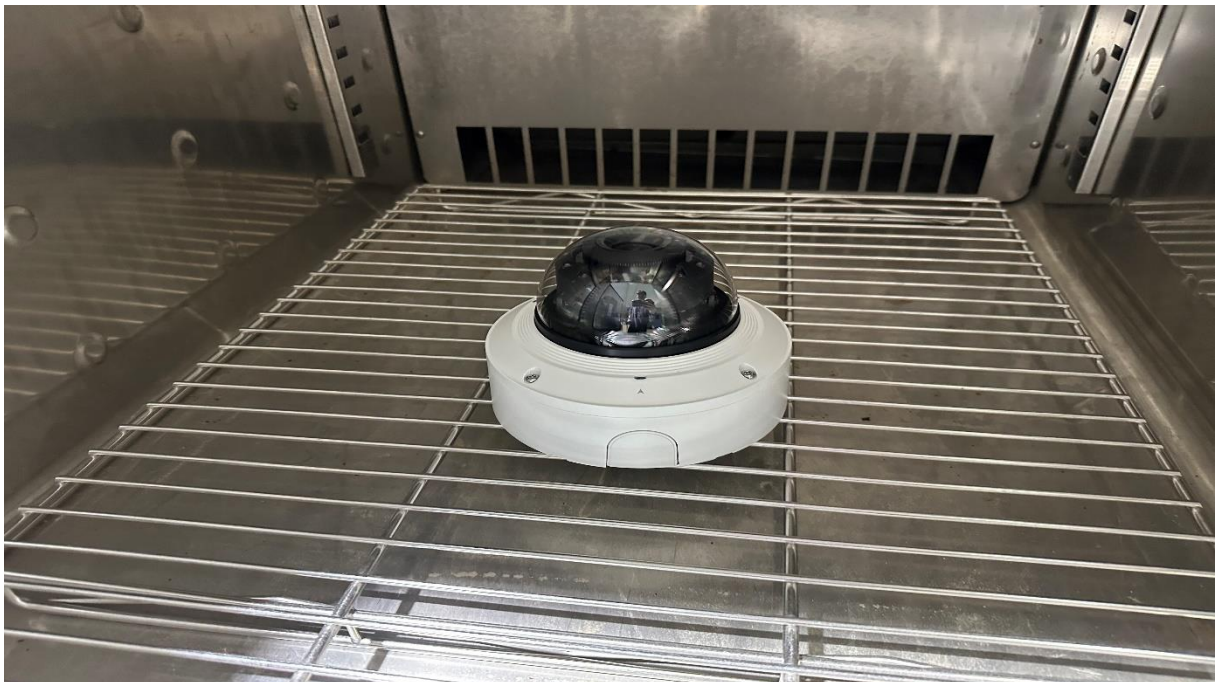
#### 3.3.1 Evidence of test setting

3.2.1 Sample status: Non-operation

3.2.2 Test temperature: -25 °C

3.2.3 Test time: 16 h

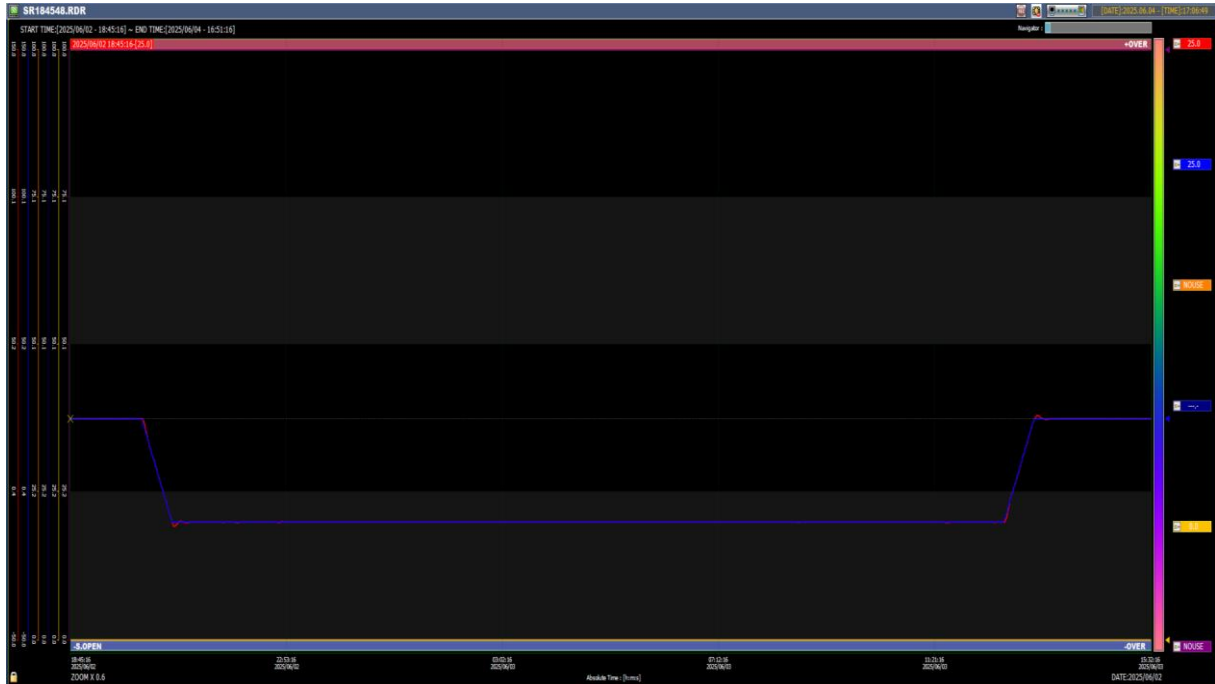
Temperature Data

#### 3.5.1 Test data and graph

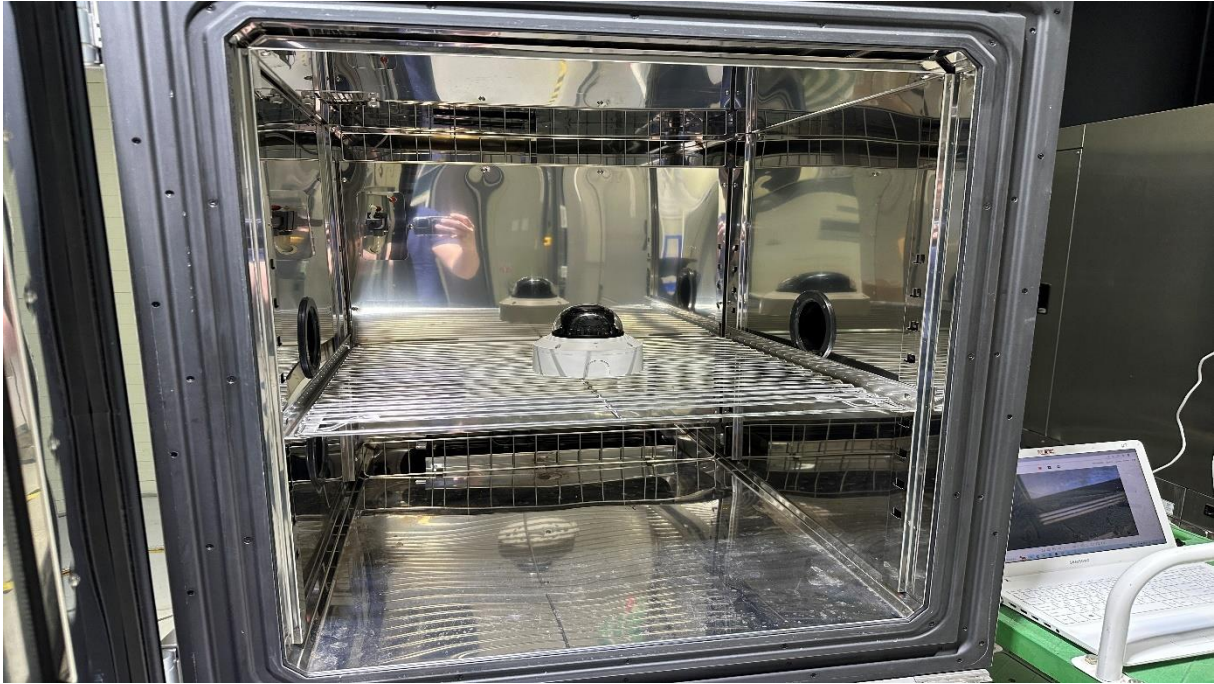
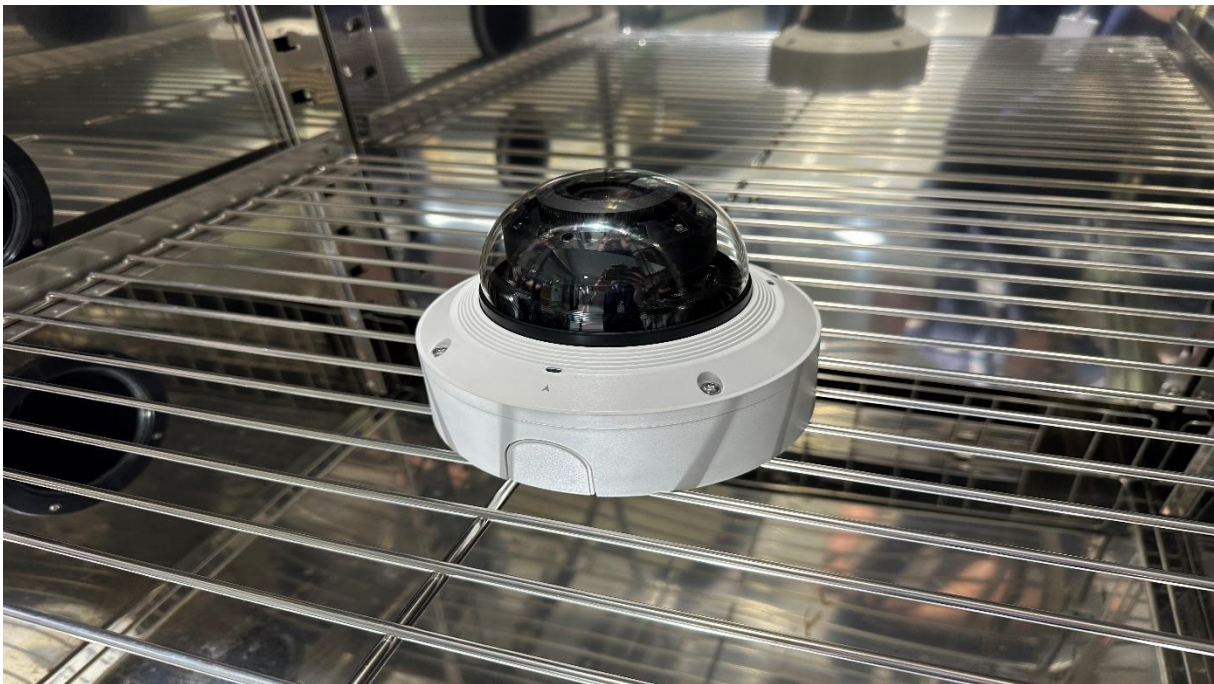
#### 4.3.1 Evidence of test setting

4.2.1 Sample status: Non-operation

4.2.2 Test temperature: 60 °C

4.2.3 Test time: 96 h

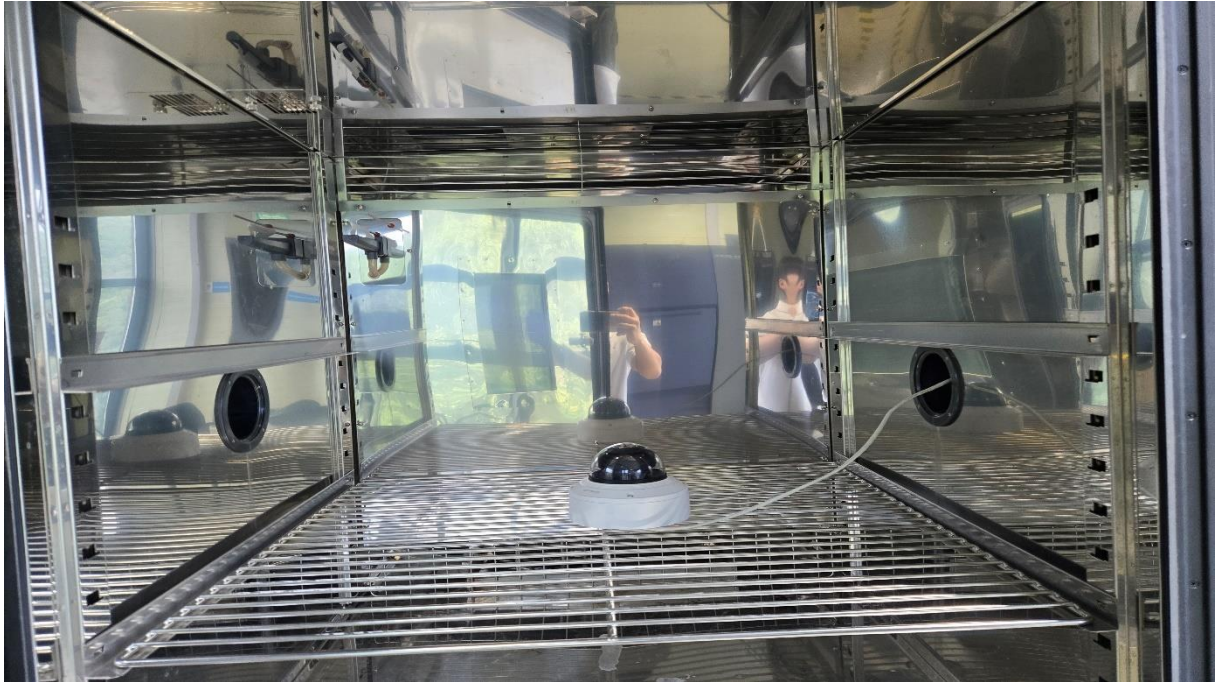
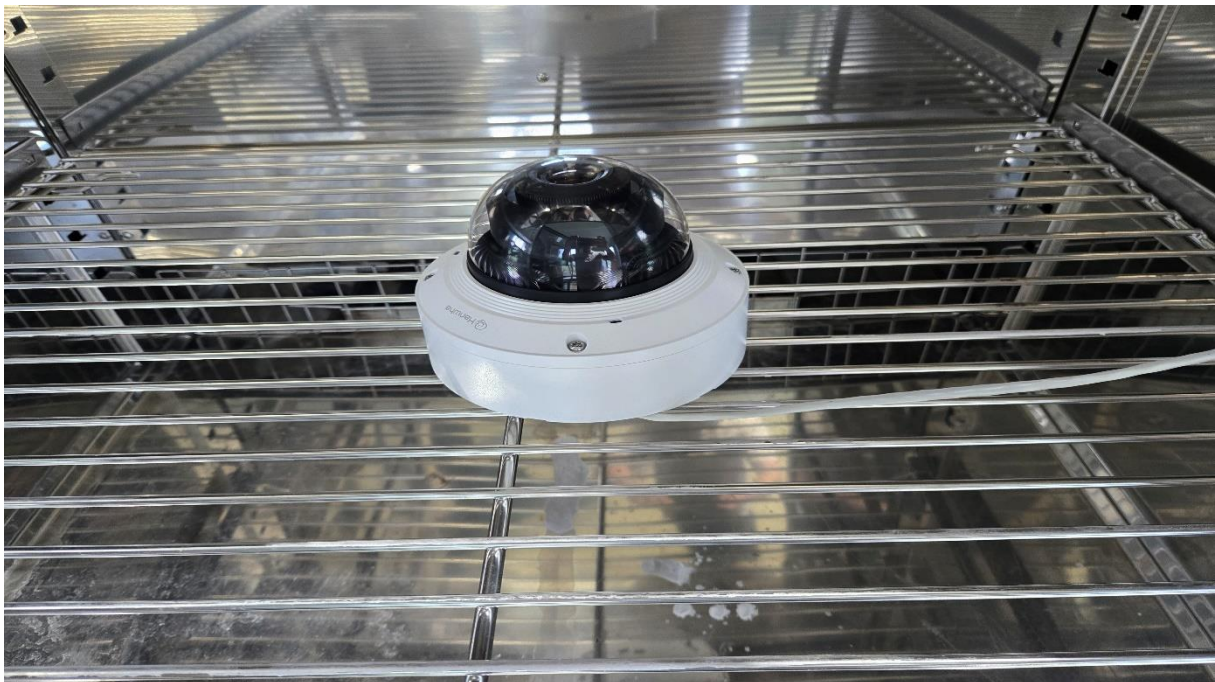
#### 5.3.1 Evidence of test setting

5.2.1 Sample status: operation

5.2.2 Test temperature: -25 °C, 50 °C

| Temp↵ | Temperature change rate(°C/min)↵ | t <sub>1</sub> (idle time)↵ | Cycles↵ |
|---|---|---|---|
| High↵ | 5 °C/min↵ | 3 h↵ | 3↵ |
| Low↵ | 1 °C/min↵ | 3 h↵ | 3↵ |

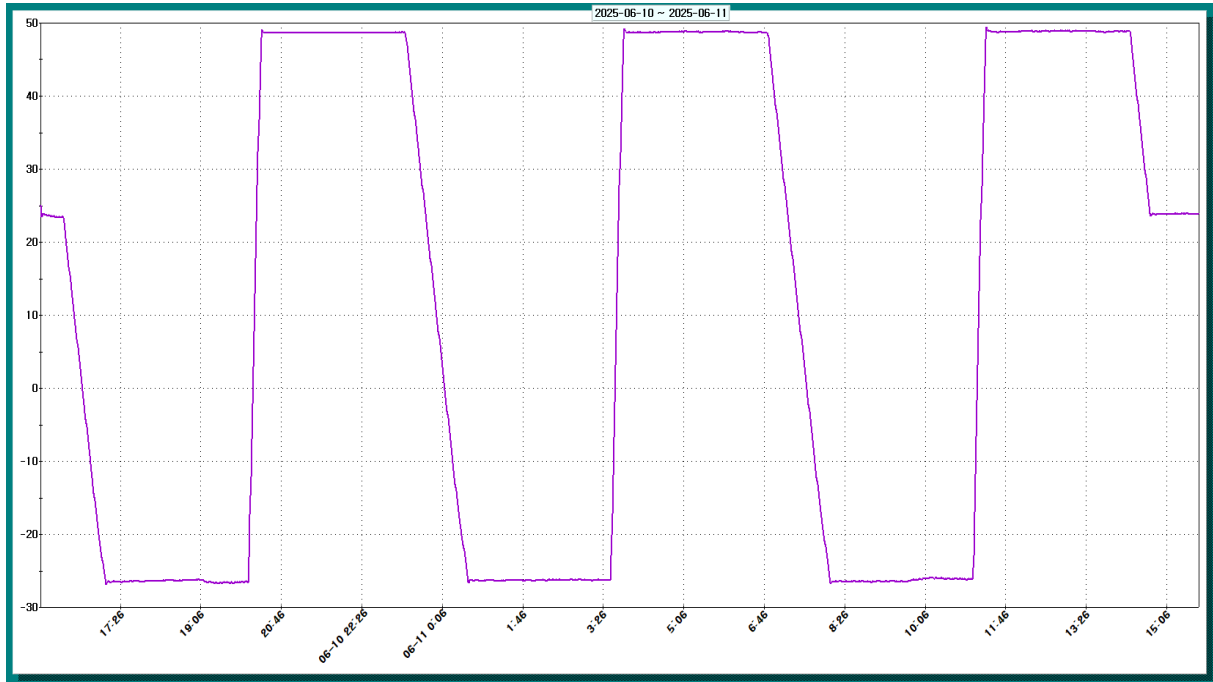
Temperature Data

### 5.5.1 Test data and graph

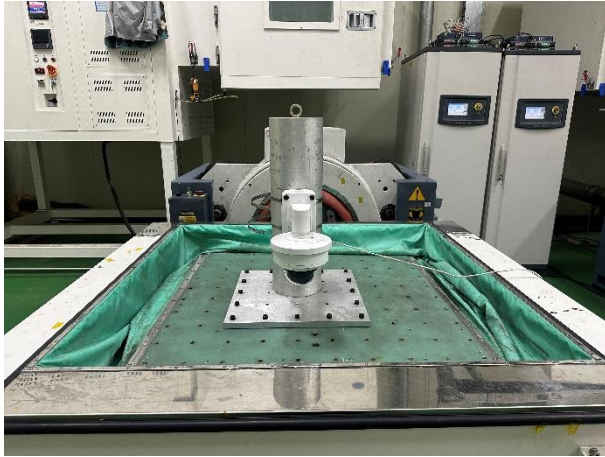
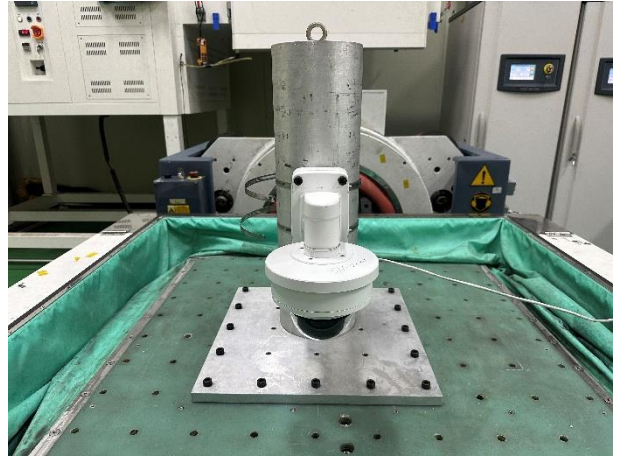
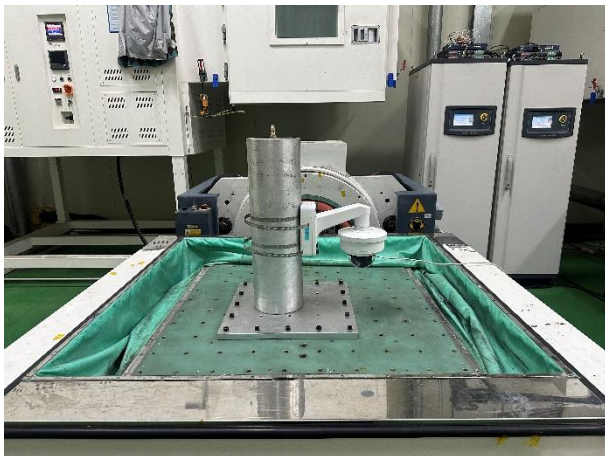
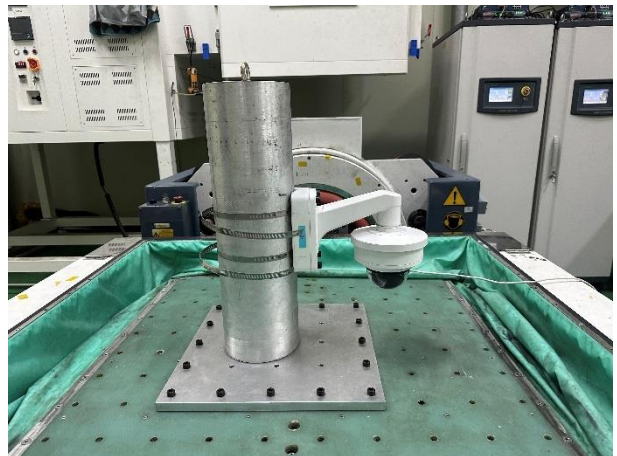
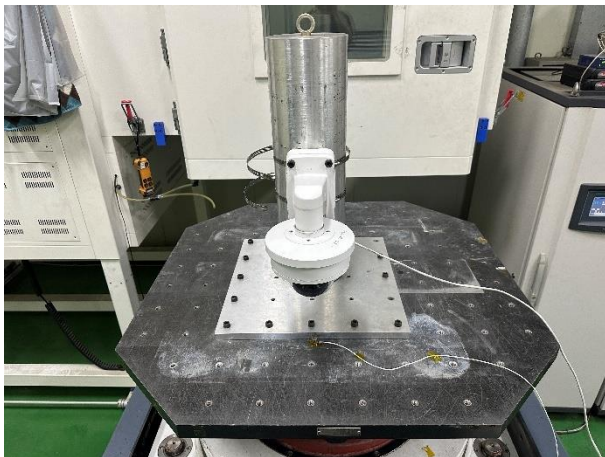
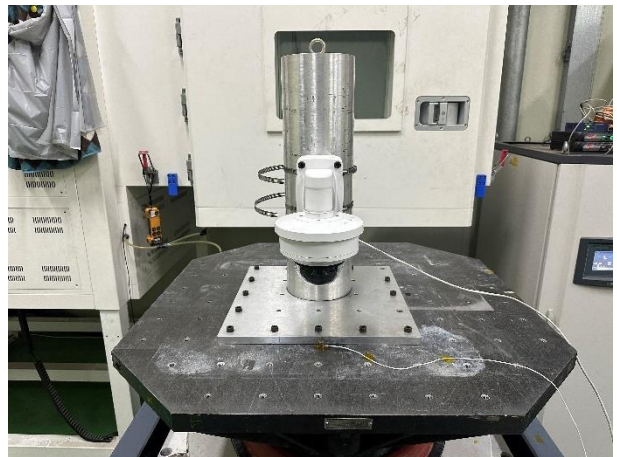
### 6.3.1 Evidence of test setting

- Sample status: operation
- Frequency(Hz): 5 Hz ~ 200 Hz
- Acceleration(G): 1 G
- Sweep rate: 1 oct/min
- Test Axis: X, Y, Z
- Test time(h): Total 30 min (10 min. per each axis)

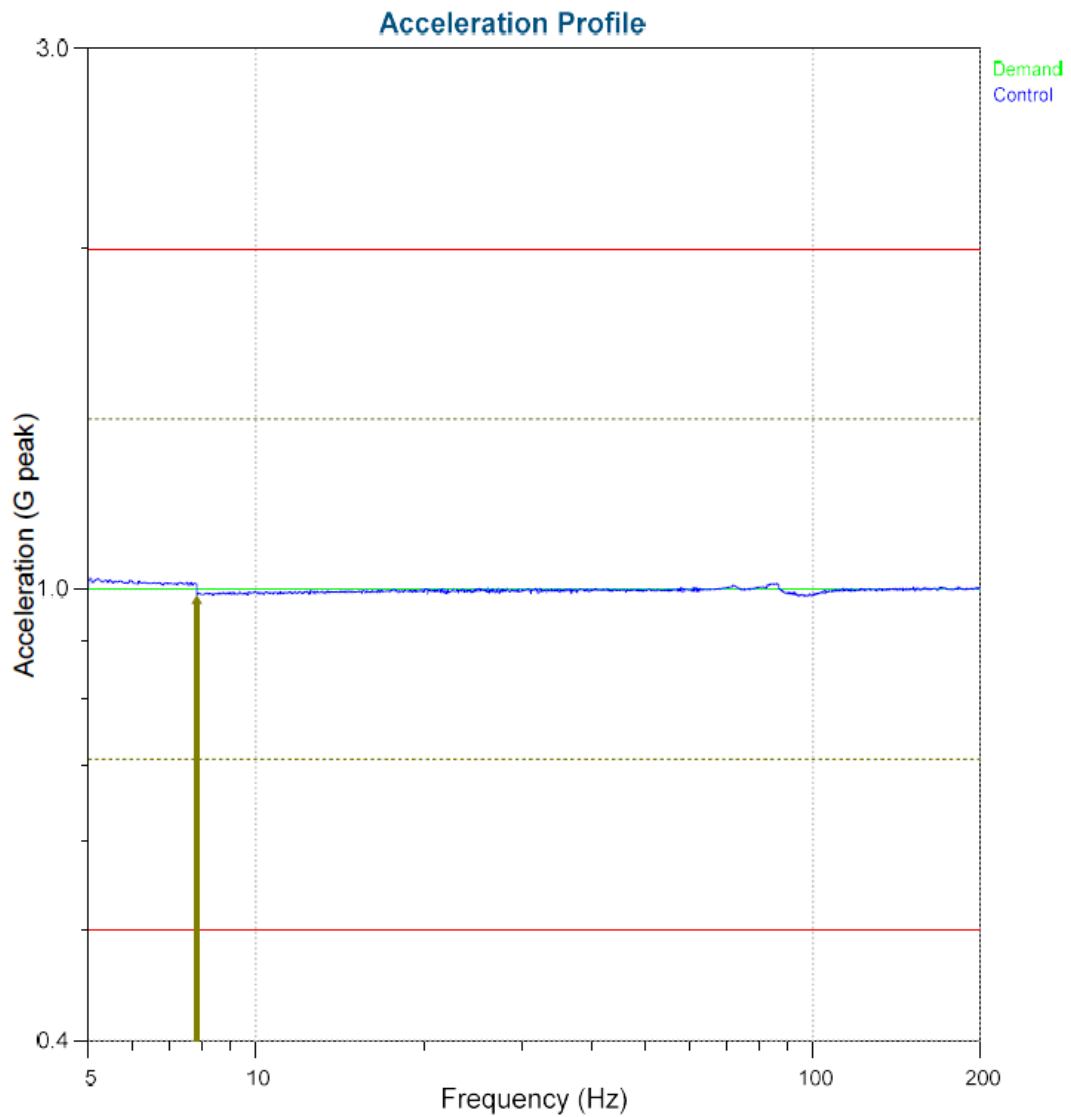
X Axis

#### 6.5.1 Test data and graph (Vibration Test X Axis)

6/26, 2025 11:04:33 Level 1) 100 % Output: 0.0003981 Volts peak

Demand: 1 G Level Time: 0:10:00 Frequency: 7.835 Hz

Control: 0.001587 G Total Time: 0:10:11 End of Timed Test

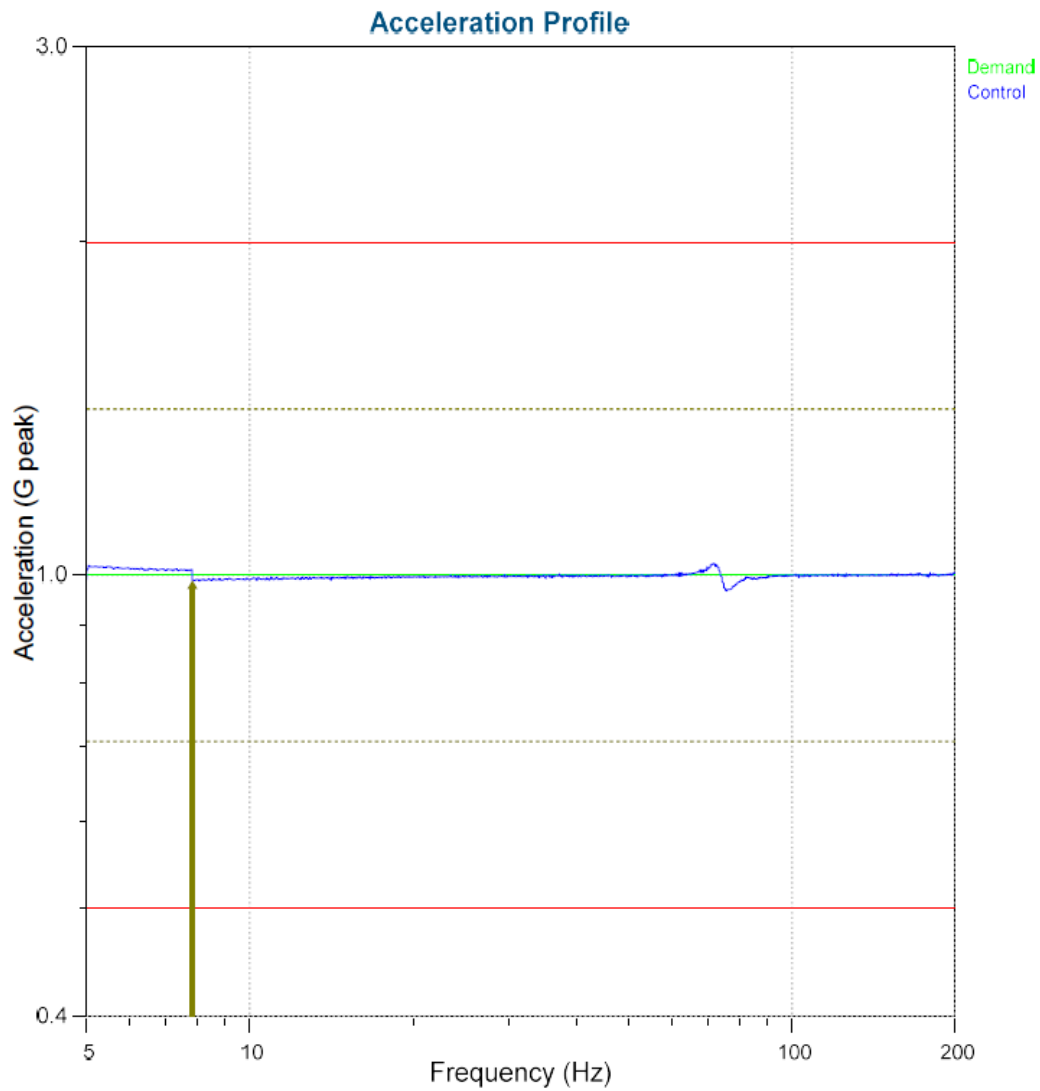
Y Axis

### 6.5.2 Test data and graph (Vibration Test Y Axis)

| 6/26, 2025 11:22:11 | Level 1) 100 % | Output: 0 Volts peak | 60068-2-f |
| Demand: 1 G | Level Time: 0:10:00 | Frequency: 7.841 Hz | |
| Control: 0.001654 G | Total Time: 0:10:11 | End of Timed Test | |

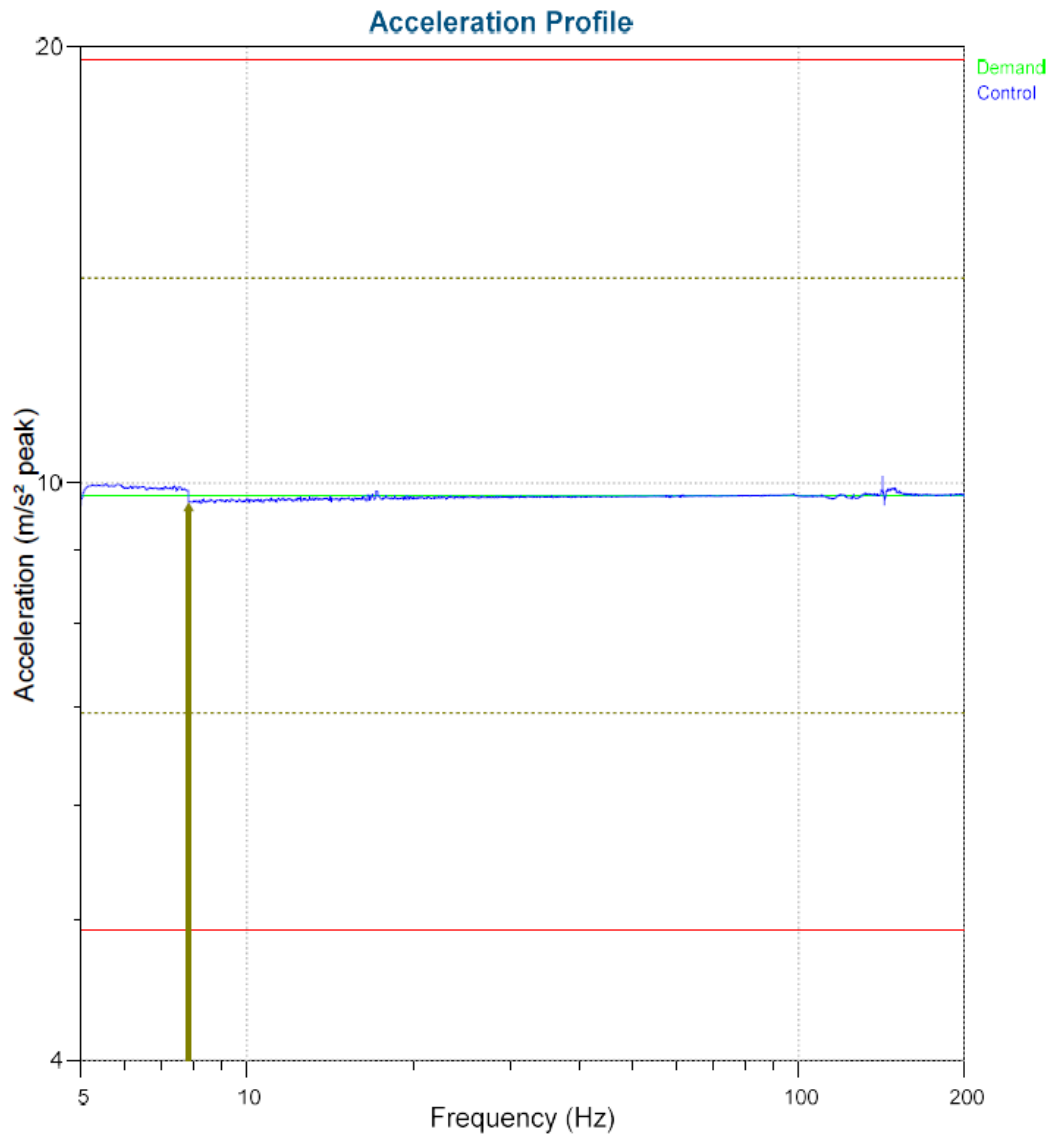
Z Axis

### 6.5.3 Test data and graph (Vibration Test Z Axis)

Demand: 9.807 m/s Level Time: 0:10:0

Frequency: 7.841 Hz

Control: 0.003382 m/s Total Time: 0:10:1

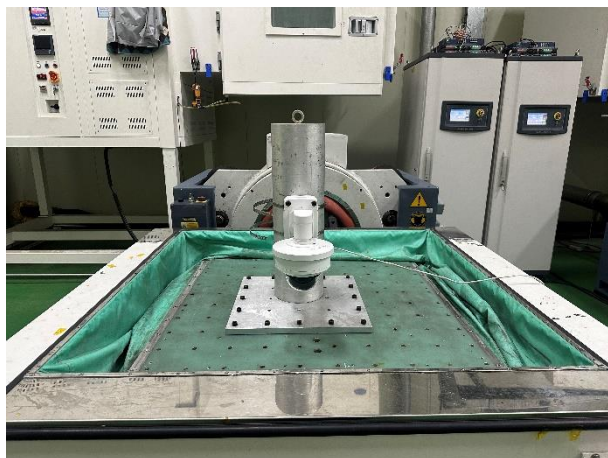
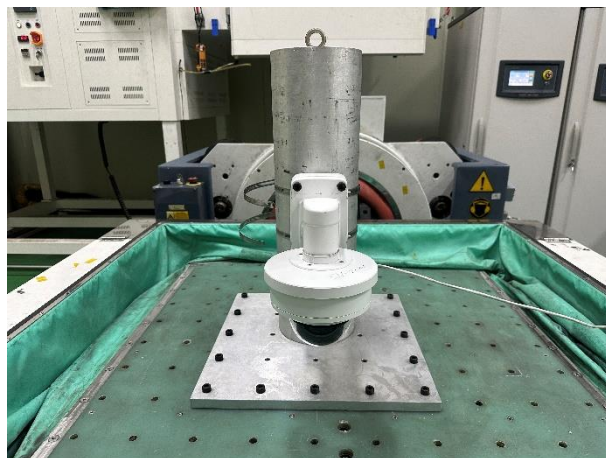
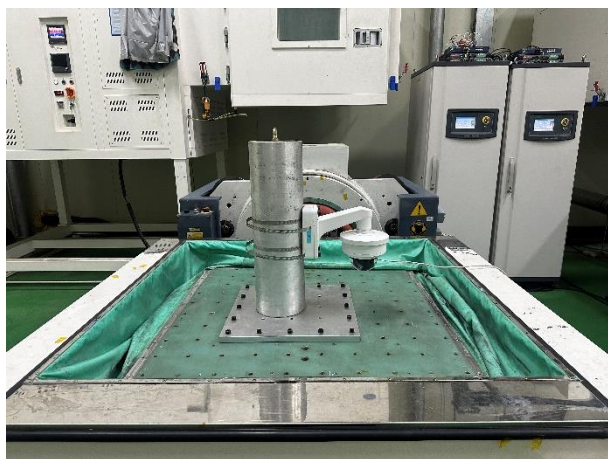
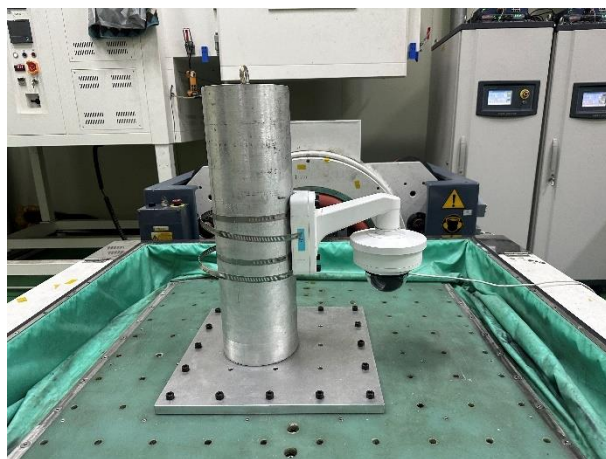
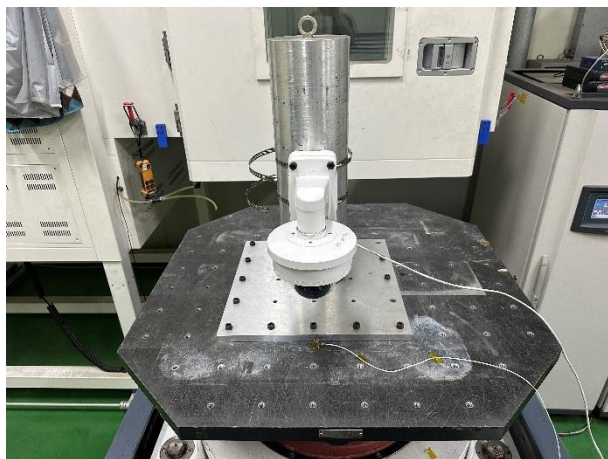
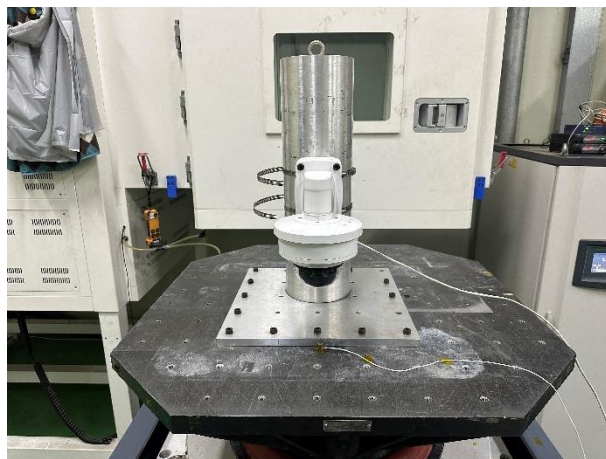
#### 7.3.1 Evidence of test setting

7.2.1 Sample status: Non-operation

7.2.2 Acceleration(G): 10 G

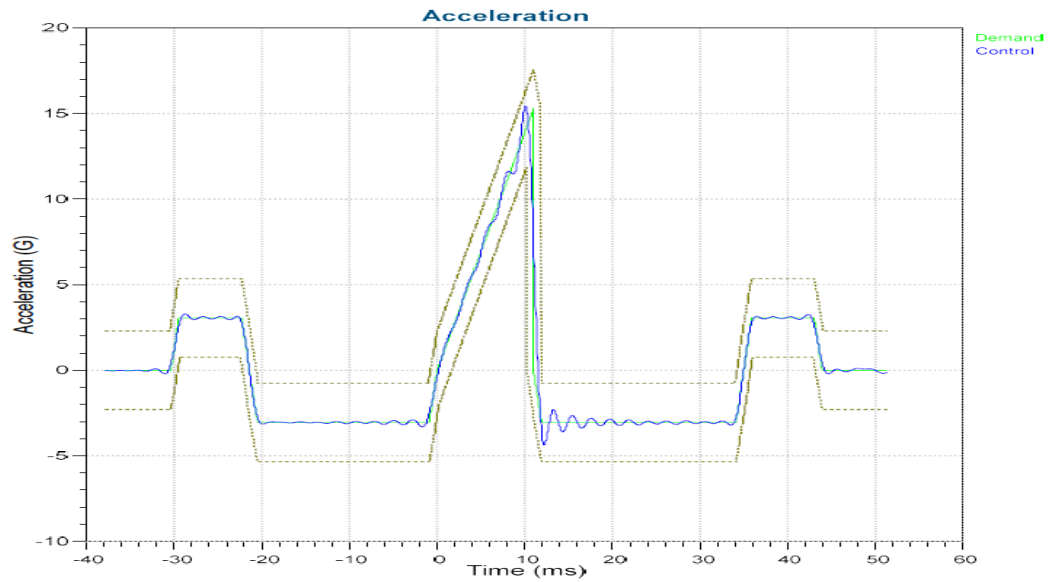
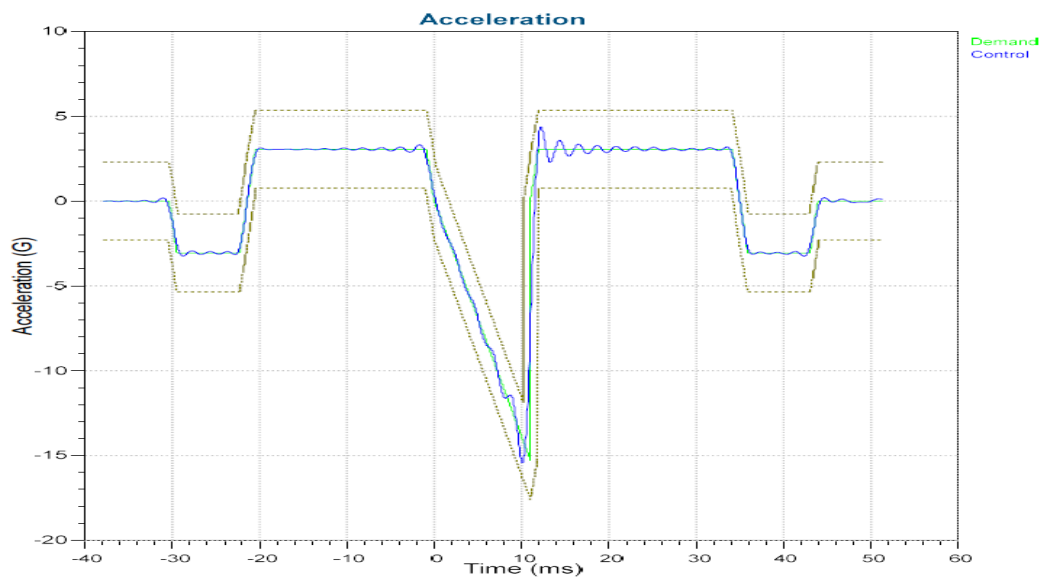
### 7.5.1 Test data and graph (Shock Test X Axis)

Demand: 15.3 C

Control: 15.43 C Pulse: 10 of 10

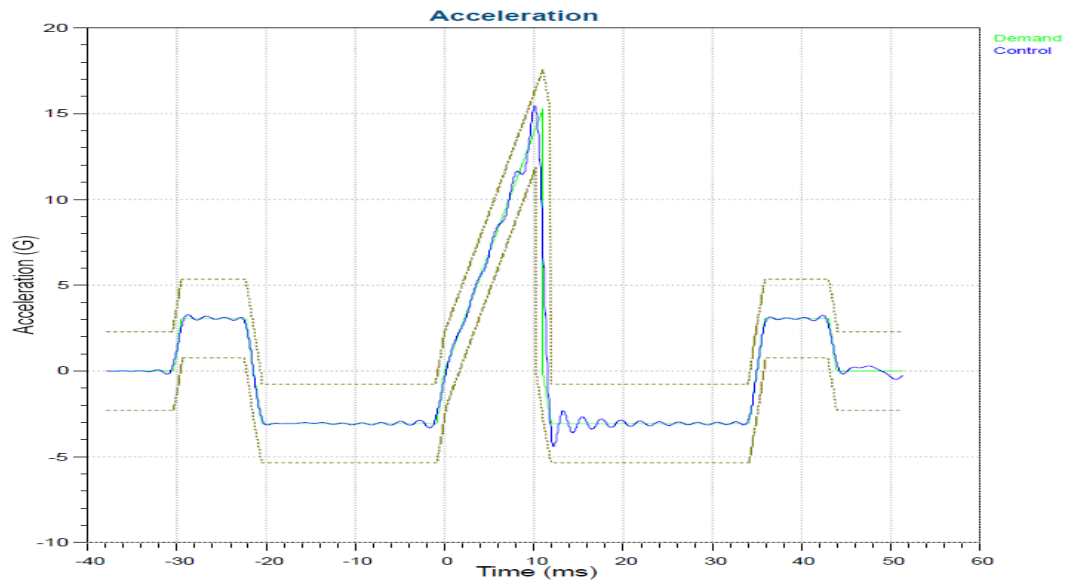
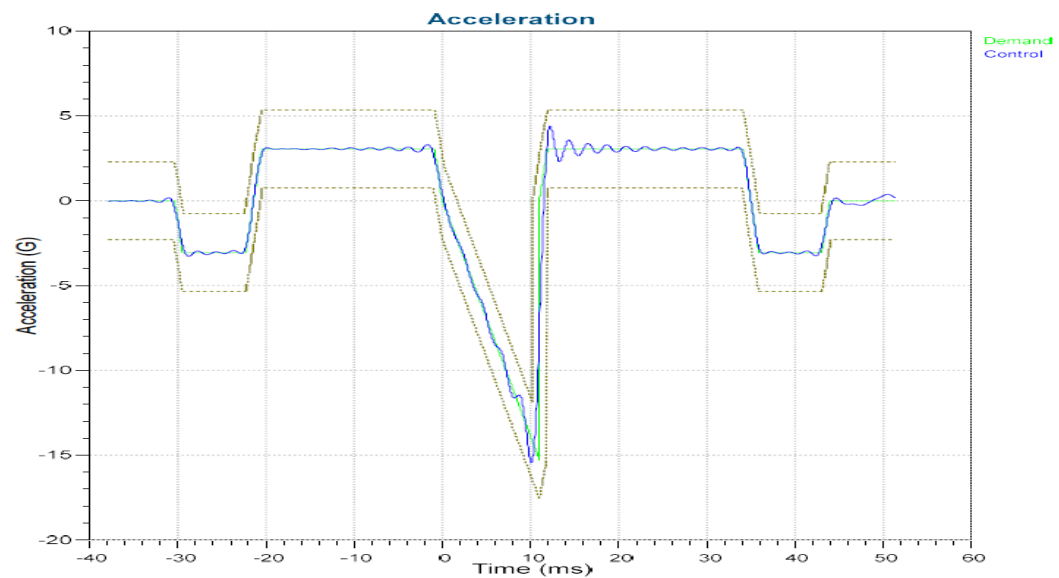
### 7.5.2 Test data and graph (Shock Test Y Axis)

Demand: 15.3 G

Control: 15.46 G Pulse: 10 of 10

Control: 15.44 G Pulse: 10 of 10

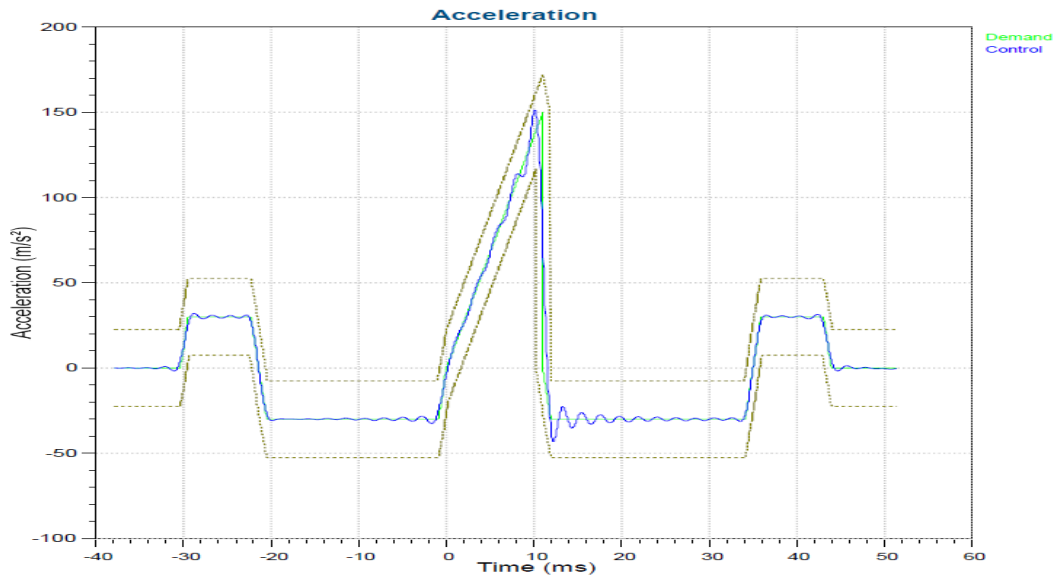
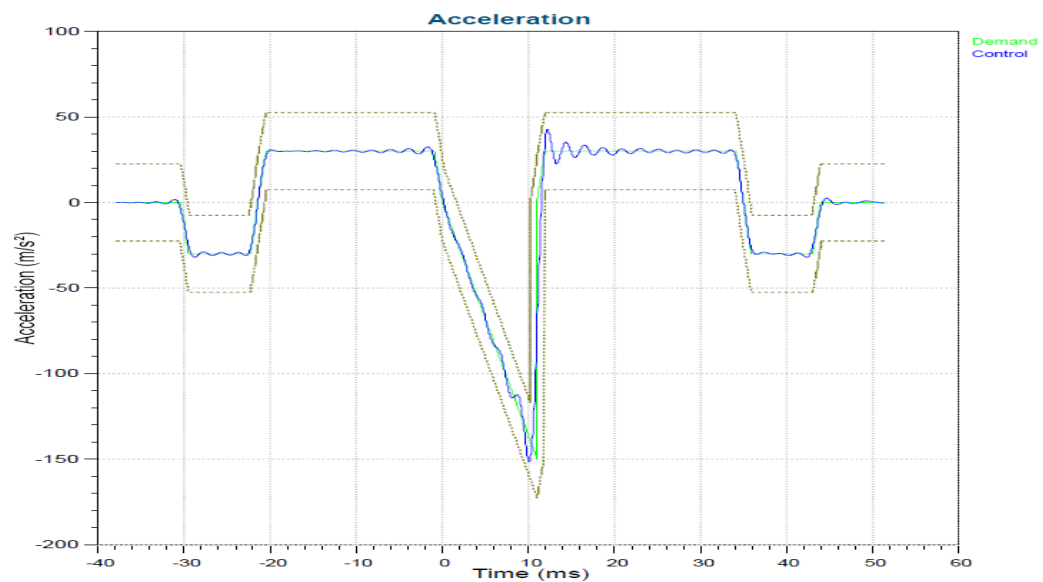
### 7.5.3 Test data and graph (Shock Test Z Axis)

6 27, 2025 15:18:46 Level 1) 100 % Output: 1.315 Volts peal 한화비전 60068-2  
Demand: 150 m/s  
Control: 151.3 m/s Pulse: 10 of 10 Running

6 27, 2025 15:19:27 Level 2) 100 % Output: 1.355 Volts peal 한화비전 60068-2  
Demand: 150 m/s  
Control: 151.6 m/s Pulse: 10 of 10 End of Test

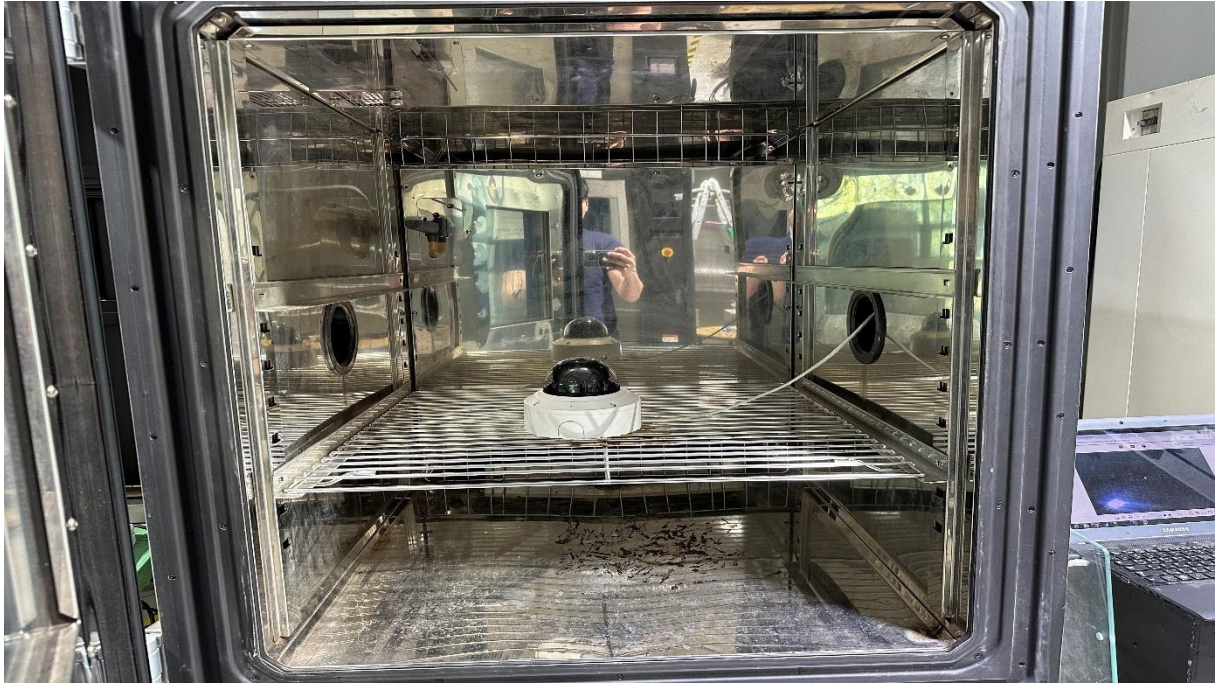
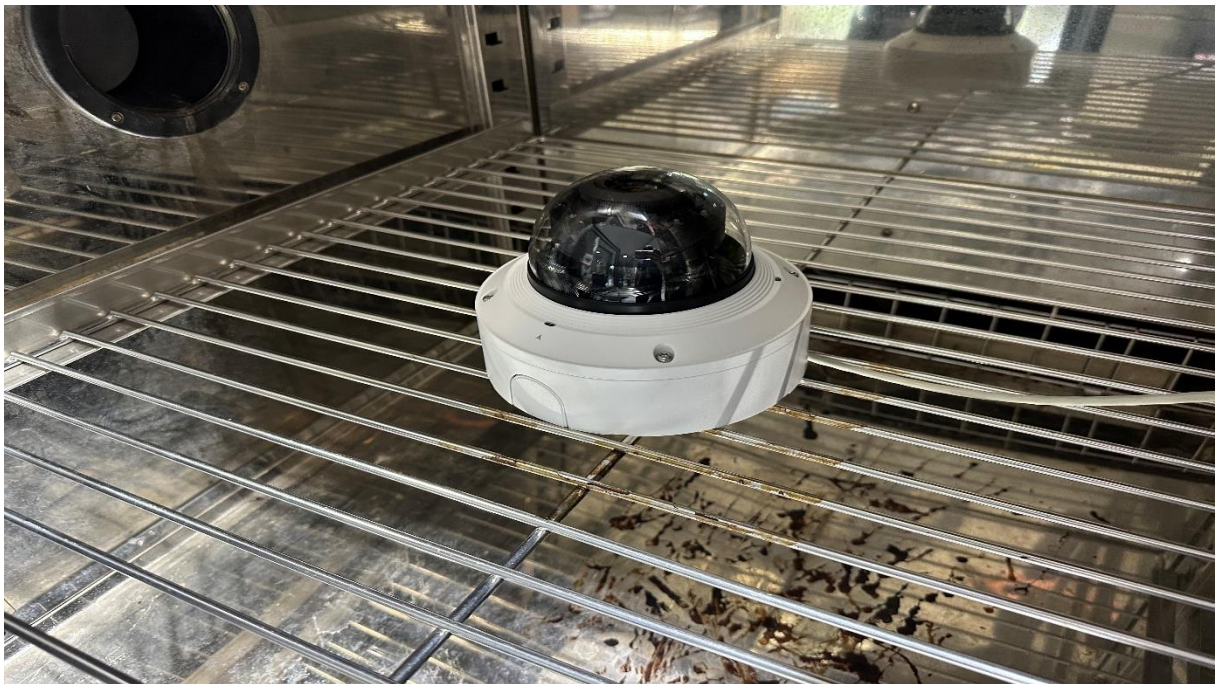
#### 8.3.1 Evidence of test setting

8.2.1 Sample status: operation

8.2.2 Test temperature:  $40 \pm 2$  °C

8.2.3 Test Humidity:  $93 \pm 3$  % R.H.

8.2.4 Test time: 240 h
