## TEST REPORT

1. **Report Number** KR16-YYP0045
2. **Applicant**
  - Name Hanwha Techwin Co., Ltd
  - Address 1204, Changwon-daero, Seongsan-gu, Changwon-si, Gyeongsangnam-do, Korea
  - Date of Receipt June 15, 2016
3. **Manufacturer**
  - Name Hanwha Techwin Co., Ltd
  - Address 1204, Changwon-daero, Seongsan-gu, Changwon-si, Gyeongsangnam-do, Korea
4. **Use of Report** For Quality management
5. **Test item description**
  - Product Name Network Camera
  - Model Name PNF-9010RV\* (\*N: NTSC / P: PAL)
6. **Test method used**
7. **Date of Test** July 4, 2016 ~ August 24, 2016
8. **Environment**
  - Temperature (15~35) °C
  - Relative Humidity (25~75) % R.H
  - Air pressure (86~106) kPa
9. **Test Results** No abnormal was found

| Product Name | Network Camera |
| Model Name | PNF-9010RV* (*N: NTSC / P: PAL) |

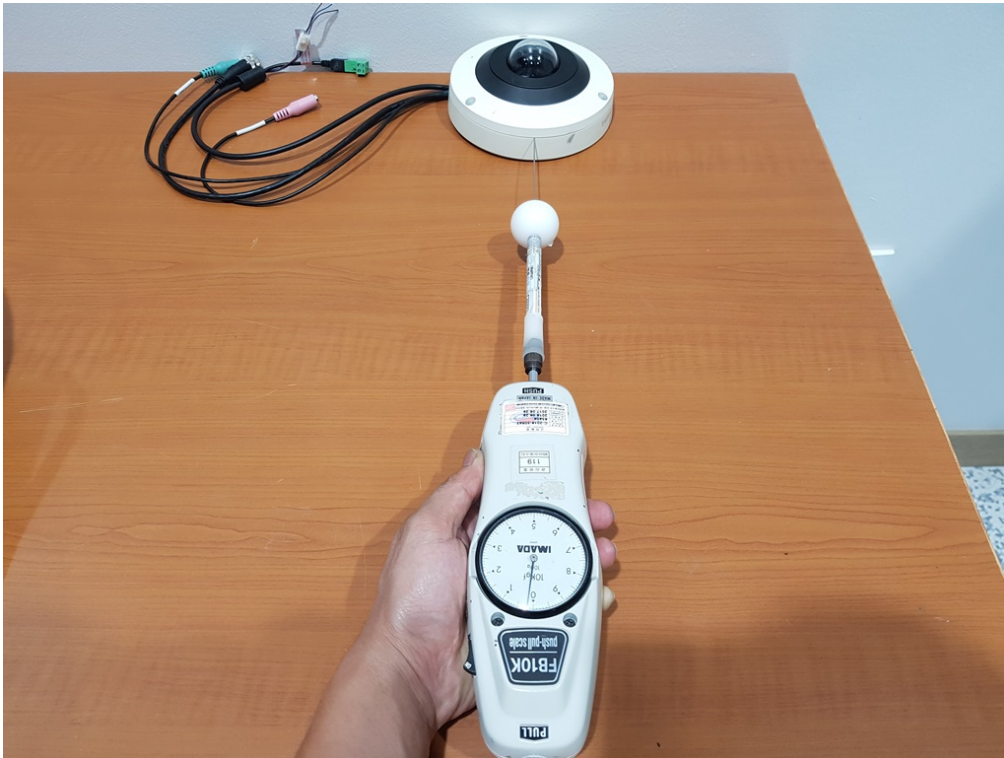
| Item | Description |
|---|---|
| Test condition | 1. Access probe: 1.0 mm $\varnothing$ , 100 mm length,<br>2. Test force: 1 N $\pm$ 10 % |

[During the test]

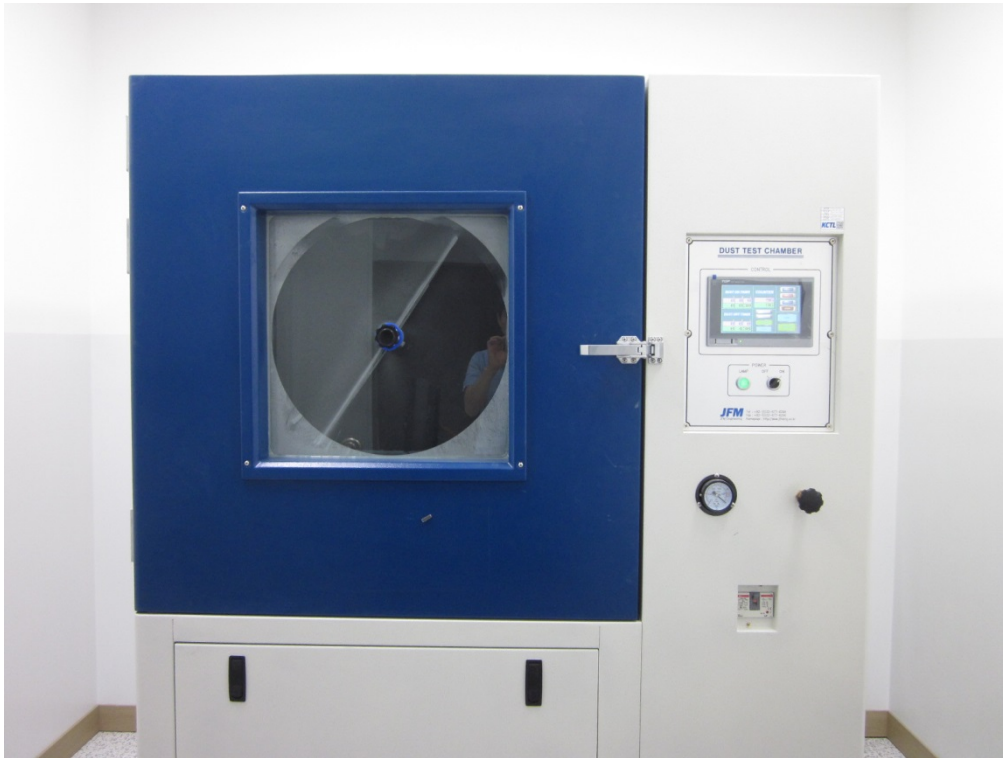
- 1) The enclosure under test is supported inside the test chamber and the pressure inside the enclosure is maintained below the surrounding atmospheric pressure by a vacuum pump
- 2) The suction connection shall be made to a hole specially provided for this test
- 3) The object of the test is to draw into the enclosure, by means of depression, a volume of air 80 times the volume of the sample enclosure tested without exceeding the extraction rate of 60 volumes per hour. In no event shall the depression exceed 2 kPa (20 mbar) on the manometer
- 4) If an extraction rate of 40 to 60 volumes per hour is obtained the duration of the test is 2 h.
- 5) If, with a maximum depression of 2 kPa (20 mbar), the extraction rate is less than 40 volumes per hour, the test is continued until 80 volumes have been drawn through, or a period of 8 h has elapsed.

[During the test]

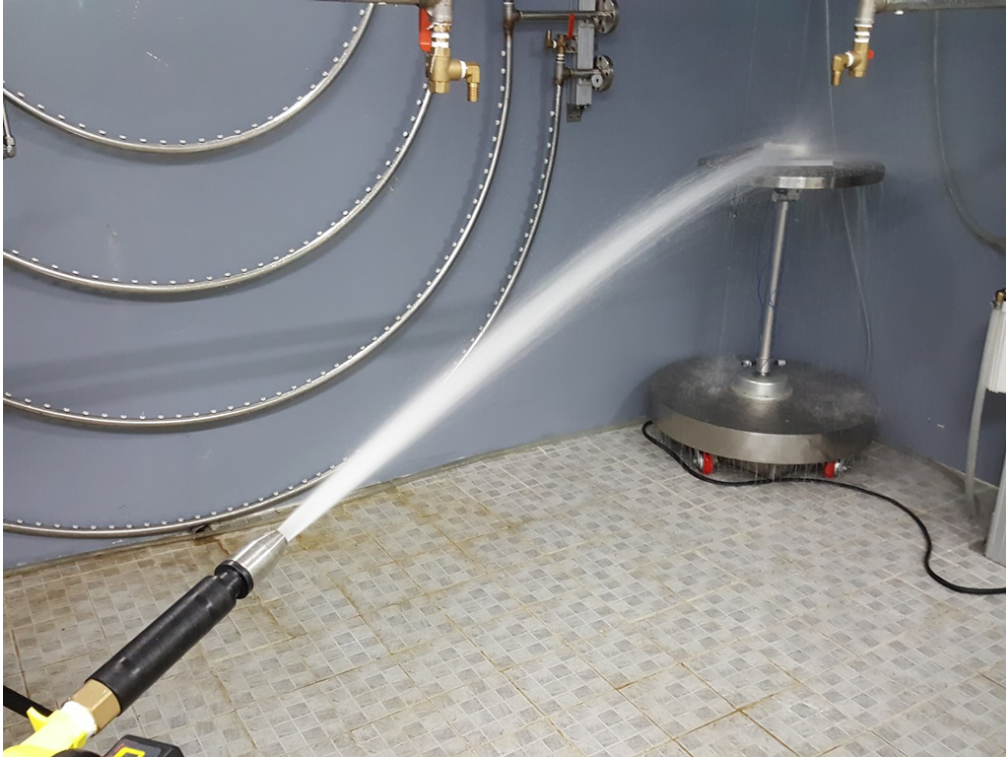
| Item | Description |
|---|---|
| Test condition | 1. Water jet hose nozzle diameter: 12.5 mm<br>2. Water flow rate: 100 L/min $\pm$ 5 %<br>3. Distance: 2.5 ~ 3.0 m |

[During the test]]

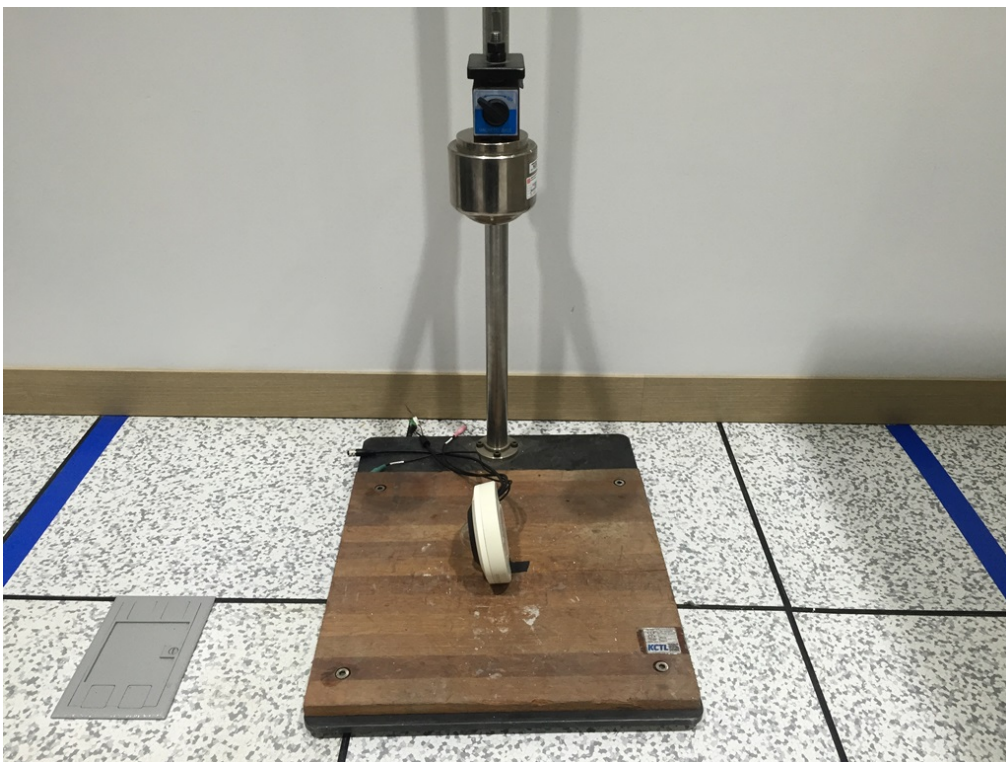
[During the test\_Enclosure]

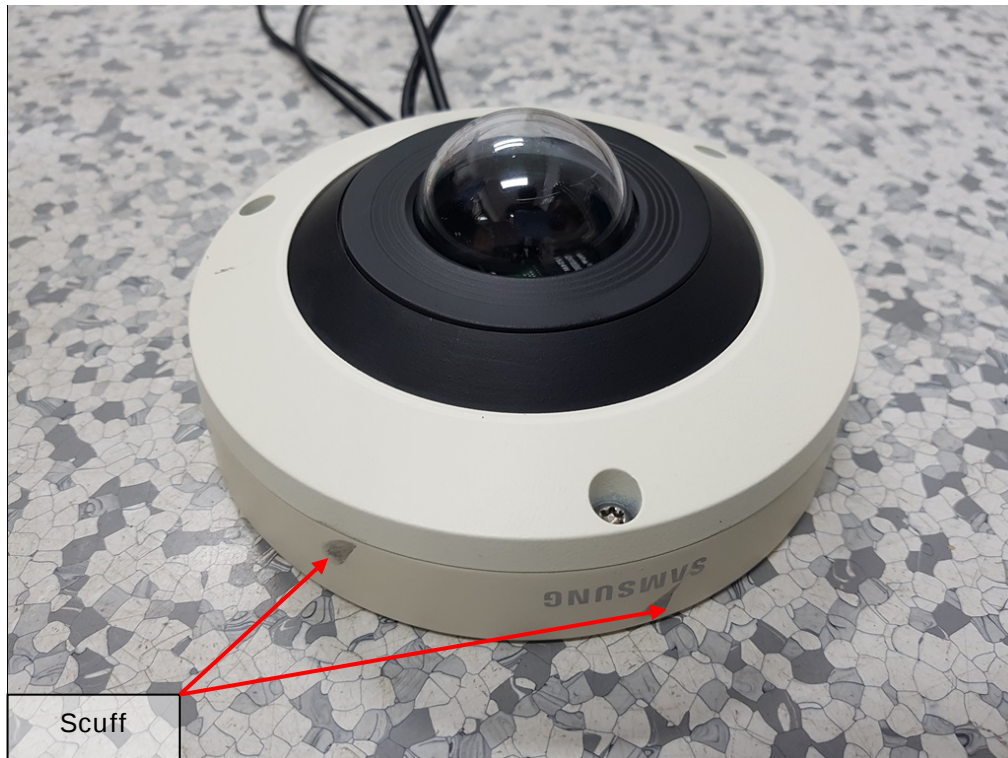
### 3.10.8 Test Result Photograph

[Test result\_Enclosure]
