# TEST REPORT

REPORT No.:  
CTK-2024-00229  
Page (1) / (20) pages

NETWORK CAMERA / PNM-9084RQZ1  
PoE Injector / PT-PSE109GBRO-AH

Specifications presented by the sponsor  
(reference NEMA TS 2.2.7 ~ 9)

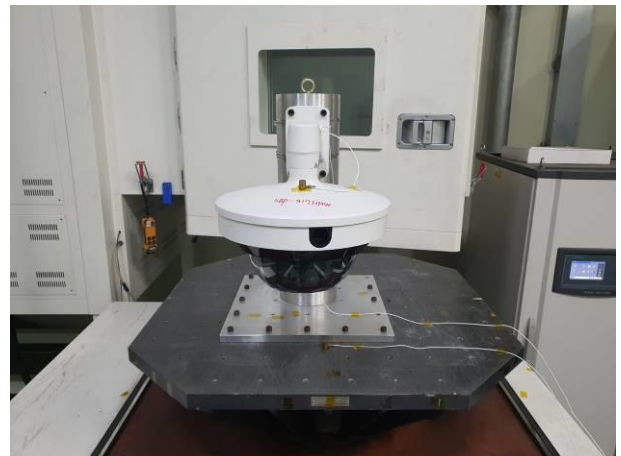
Resonant search - Z axis,  
Endurance, Test Shock(impact) Test Same  
configuration
