# TEST REPORT

| <br>CTK Co., Ltd.<br><small>The Power Leader of Global Regulatory Compliance</small> | <b>CTK Co., Ltd.</b><br>5 Dongbu-ro 221beon-gil, Cheoin-gu, Yongin-si,<br>Gyeonggi-do, Republic of Korea<br>Tel: +82-31-339-9970<br>Fax: +82-31-624-9501 | REPORT No.:<br>CTK-2024-01388<br>Page (1) / (13) pages | |

NETWORK CAMERA / PNM-C16083RQZ

KS C IEC 62262: 2005

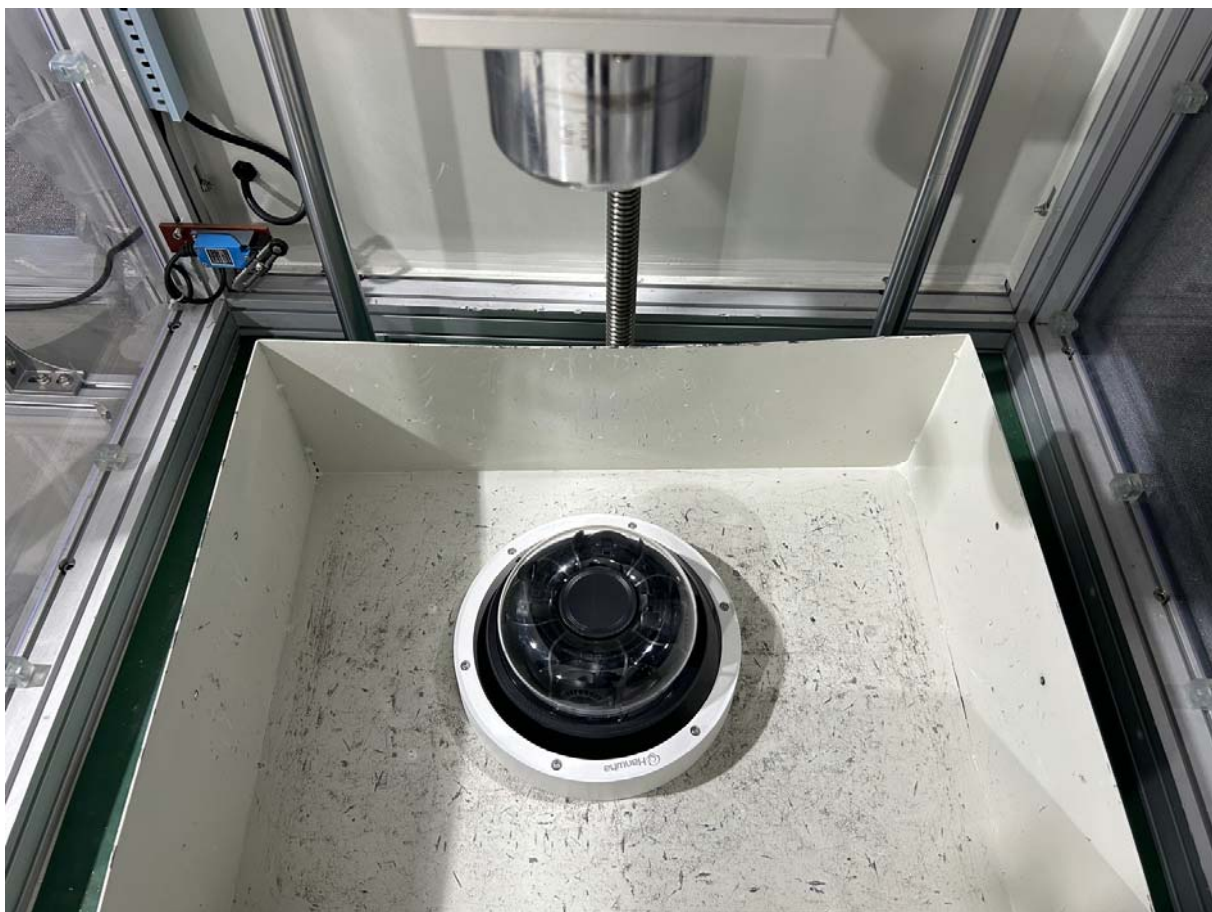
Test environment setup image\_1

| IK code | Impact Energy (J) | Equivalent mass (kg) | Drop height (mm ± 1%) | Application |
|---|---|---|---|---|
| 10 | 20.00 | 5.00 | 400 | <input checked="" type="checkbox"/> |
| - Impact times: five times for each of the exposed surface. (Do not impact more than 3 times in the same spot) | | | | |

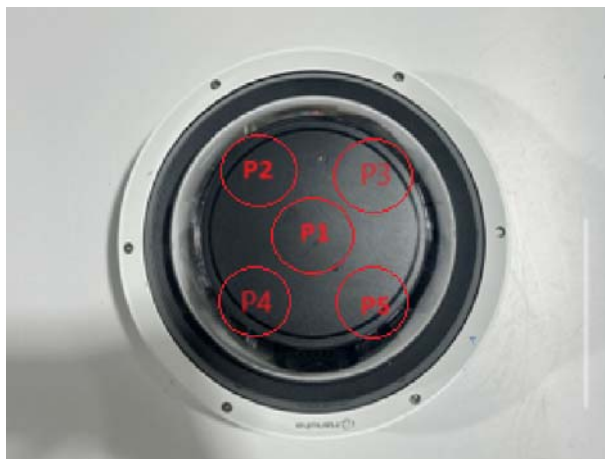
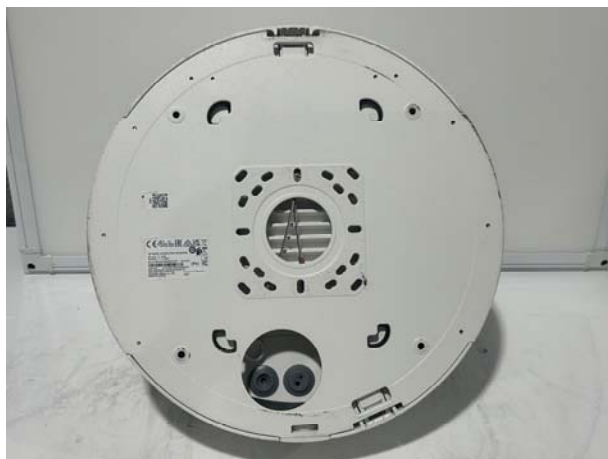
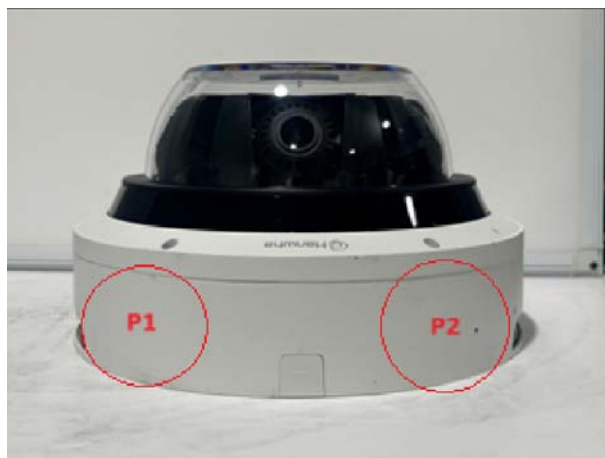
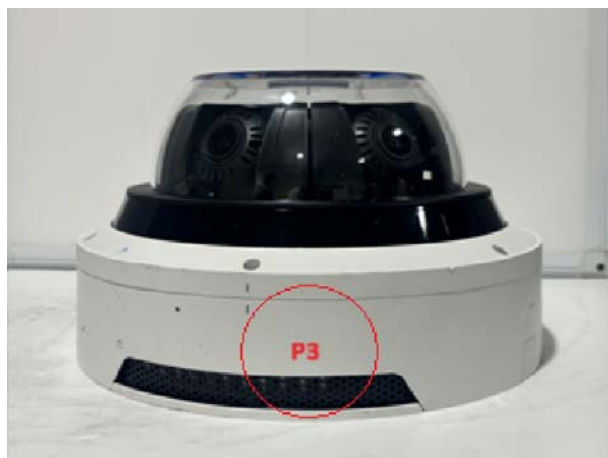
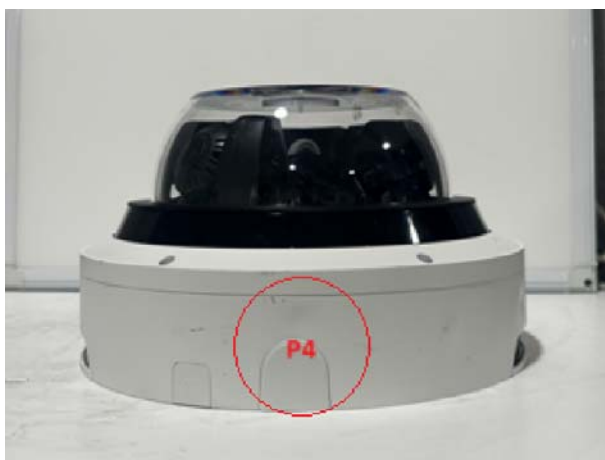
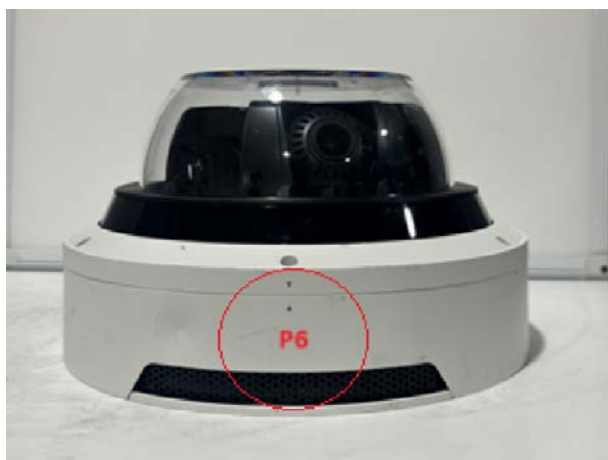
### 4.2.1 Check the hit area during the test

| Evaluation Criteria | | Test Results |
|---|---|---|
| | Post-test | Some scratches were generated on the outside of the product. |
