# TEST REPORT

REPORT No.:  
CTK-2024-01390  
Page (1) / (13) pages

NETWORK CAMERA / PNM-C32084RQZ

IEC 60529:1989 +A1:1999+A2:2013

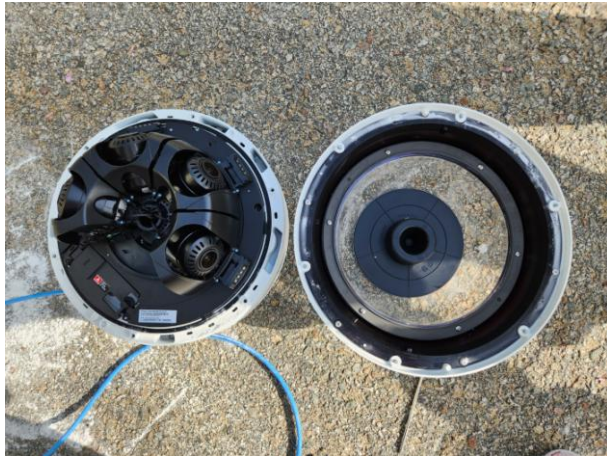
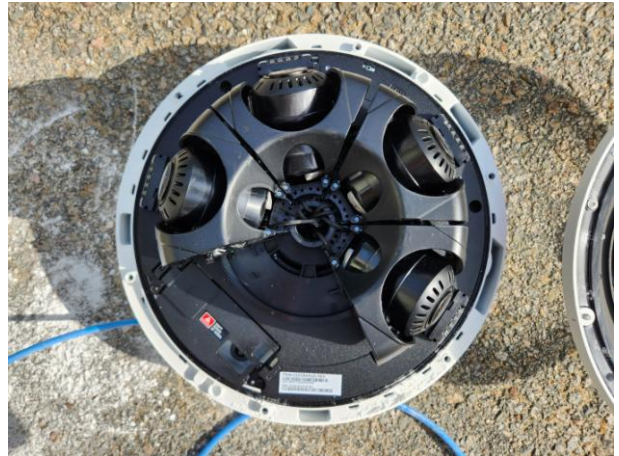
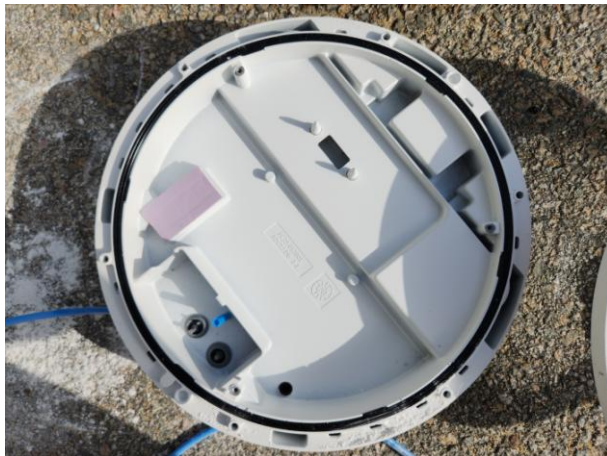
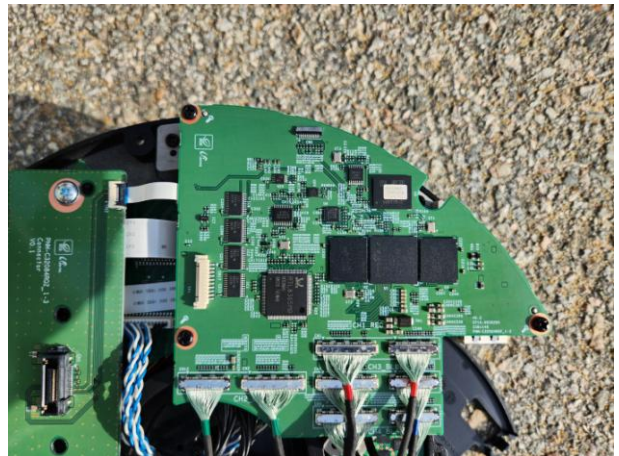
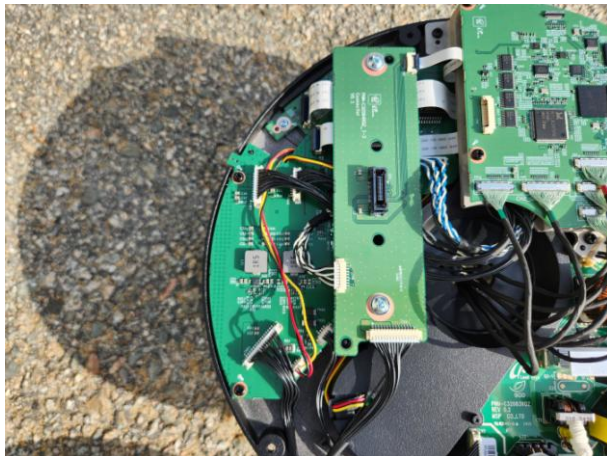
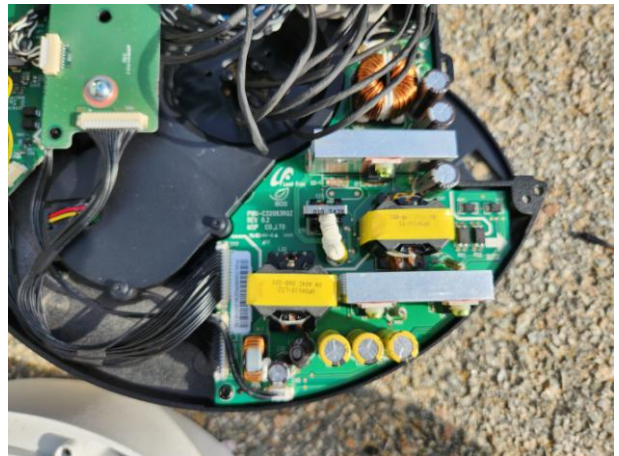
### 4.2.1 Product internal images after test [The First characteristic Numeral Test]

| IP code | Evaluation Criteria | Test Results | Remark |
|---|---|---|---|
| | No ingress of dust. | Normal | - |

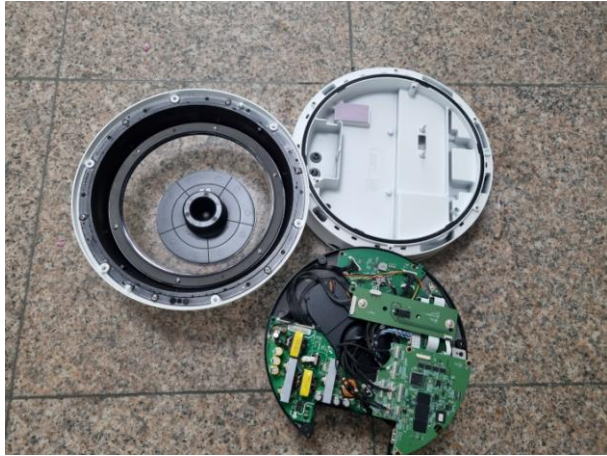
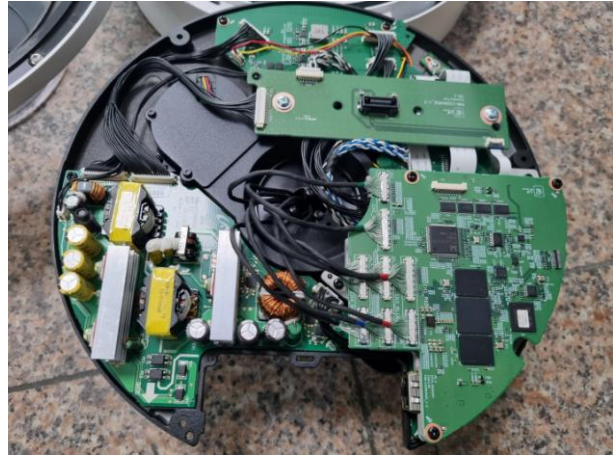
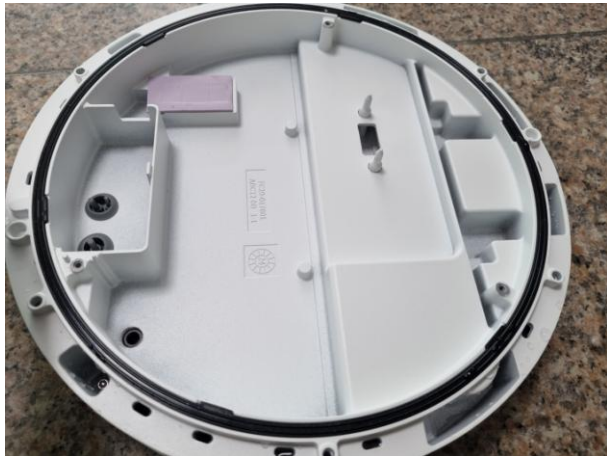
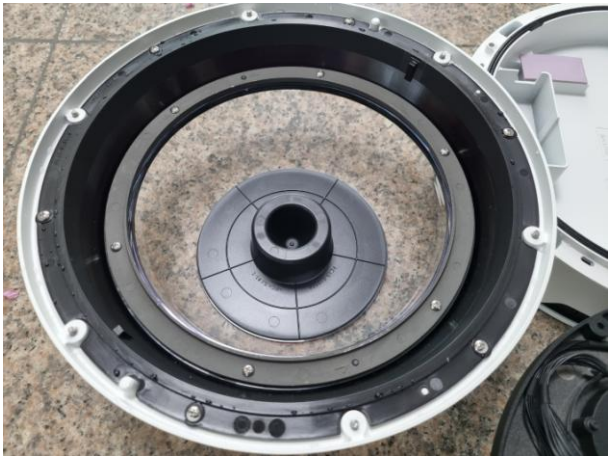
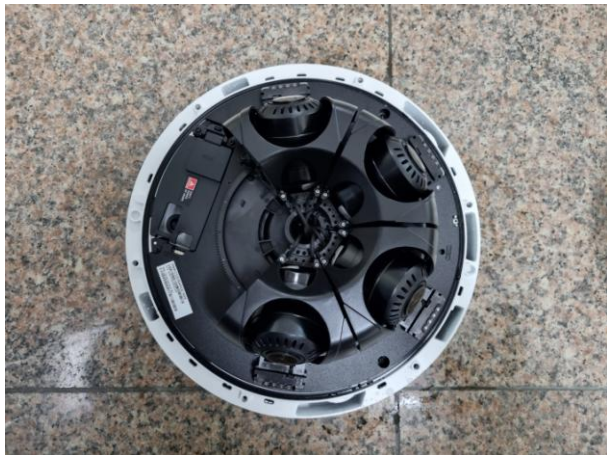
#### 4.2.2 Product internal images after test [The Second characteristic Numeral Test]

| IP code | Evaluation Criteria | Test Results | Remark |
|---|---|---|---|
| IP X6 | No ingress of water. | Normal | - |
