# TEST REPORT

REPORT No.:  
CTK-2024-00230  
Page (1) / (20) pages

NETWORK CAMERA / PNM-C34404RQPZ  
PoE Injector / PT-PSE109GBRO-AH-S

Specifications presented by the sponsor  
(reference NEMA TS 2.2.7 ~ 9)

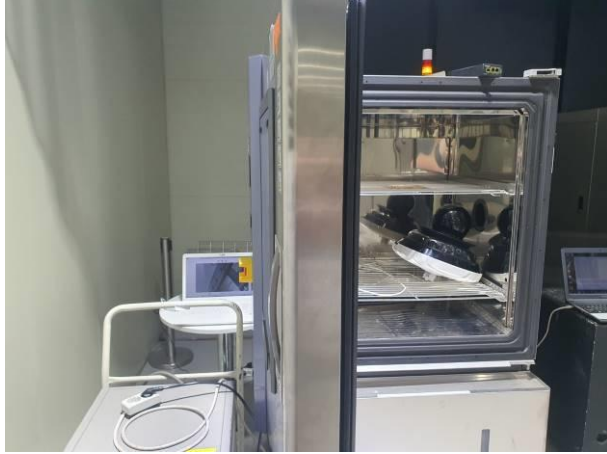
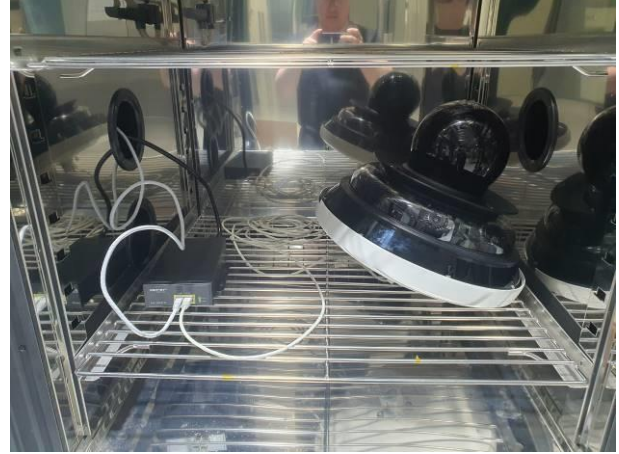
Transient Tests

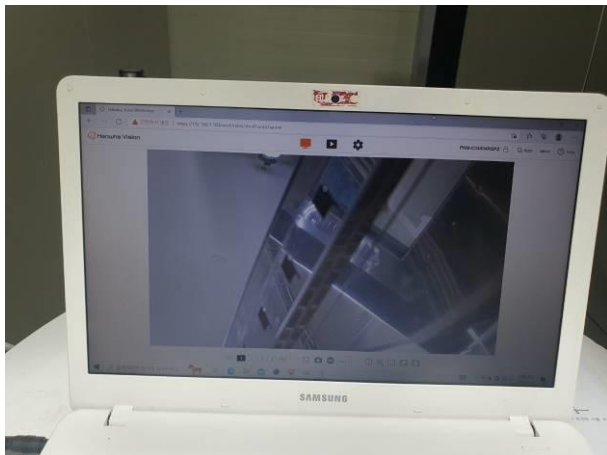
Transient Tests -  
Verification of operation during testing
