# TEST REPORT

REPORT No.:  
CTK-2024-00227  
Page (1) / (20) pages

NETWORK CAMERA / PNO-A9081R  
PoE Injector / PT-PSE106GBR-AH-S

Specifications presented by the sponsor  
(reference NEMA TS 2.2.7 ~ 9)

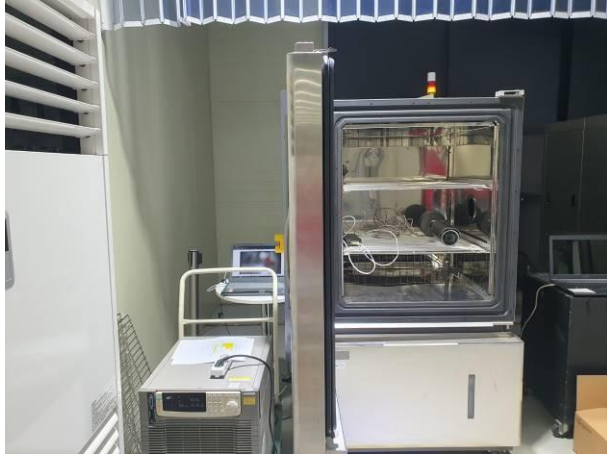
Transient Tests
