# TEST REPORT

REPORT No.:  
CTK-2025-01912  
Page (1) / (39) pages

NETWORK CAMERA / PNO-A9092R

EN 60068-2-1, EN 60068-2-2, EN 60068-2-14, EN 60068-2-6, EN  
60068-2-27, EN 60068-2-78, IEC 60068-2-1, IEC 60068-2-2, IEC  
60068-2-14, IEC 60068-2-6, IEC 60068-2-27, IEC 60068-2-78

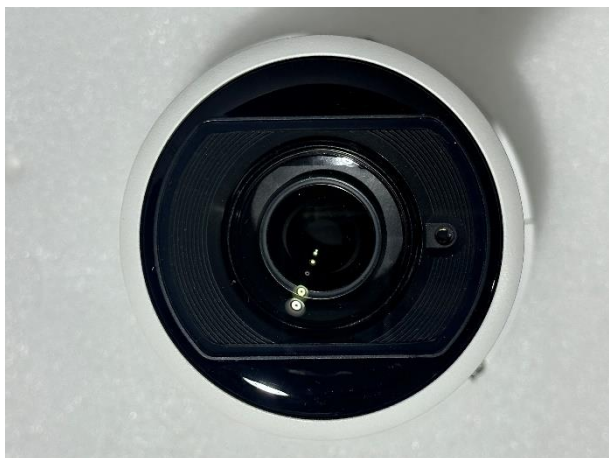
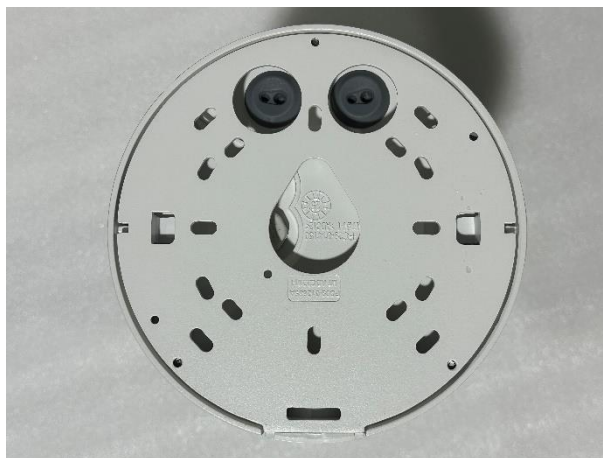
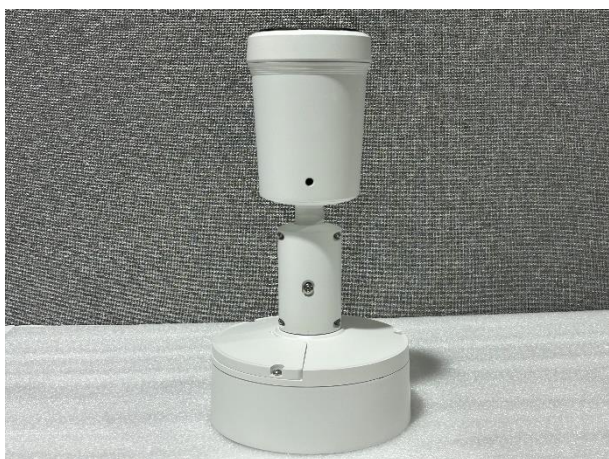
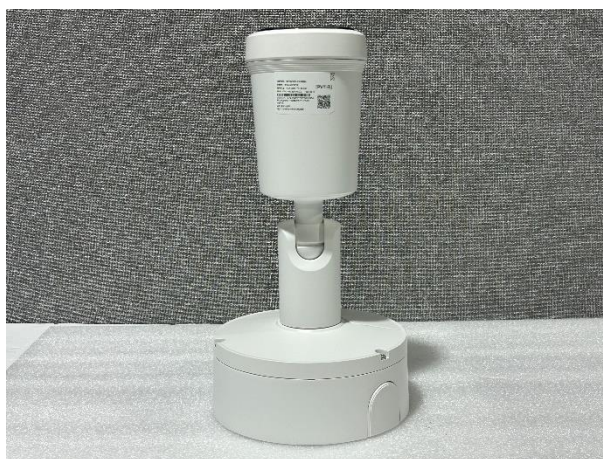
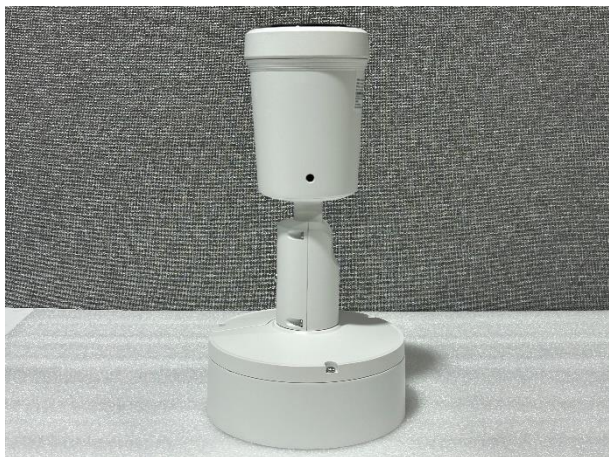
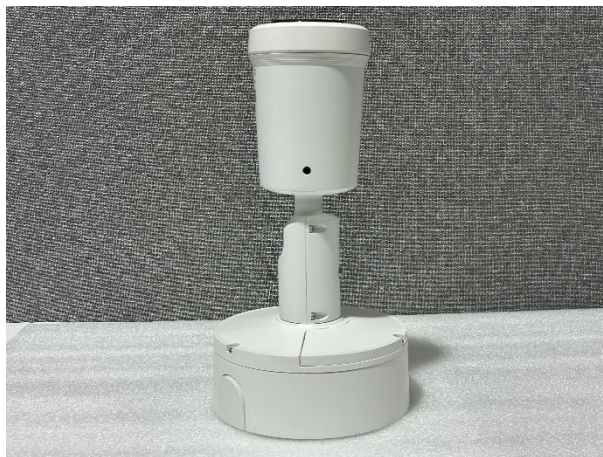
### 2.4.1 Test sample

Top

Bottom

Front

Rear

Left side

Right side

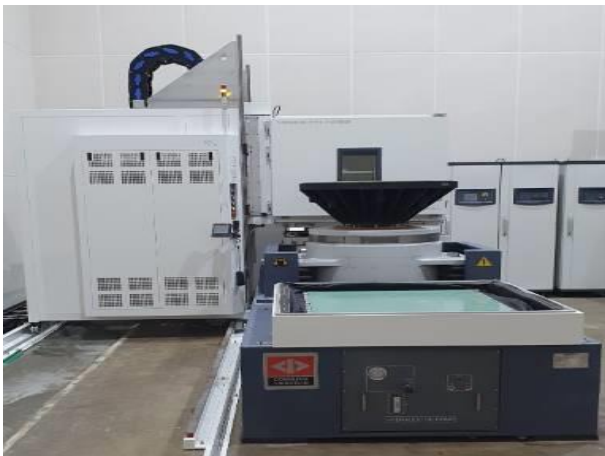
VIBRATION TESTING SYSTEM

| Testing equipment | Model Name | Manufacturer | Manufacturing Number | Calibration Date |
|---|---|---|---|---|
| VIBRATION TESTING SYSTEM | LT1010 | FAMTECH | D2012335 | N/A |

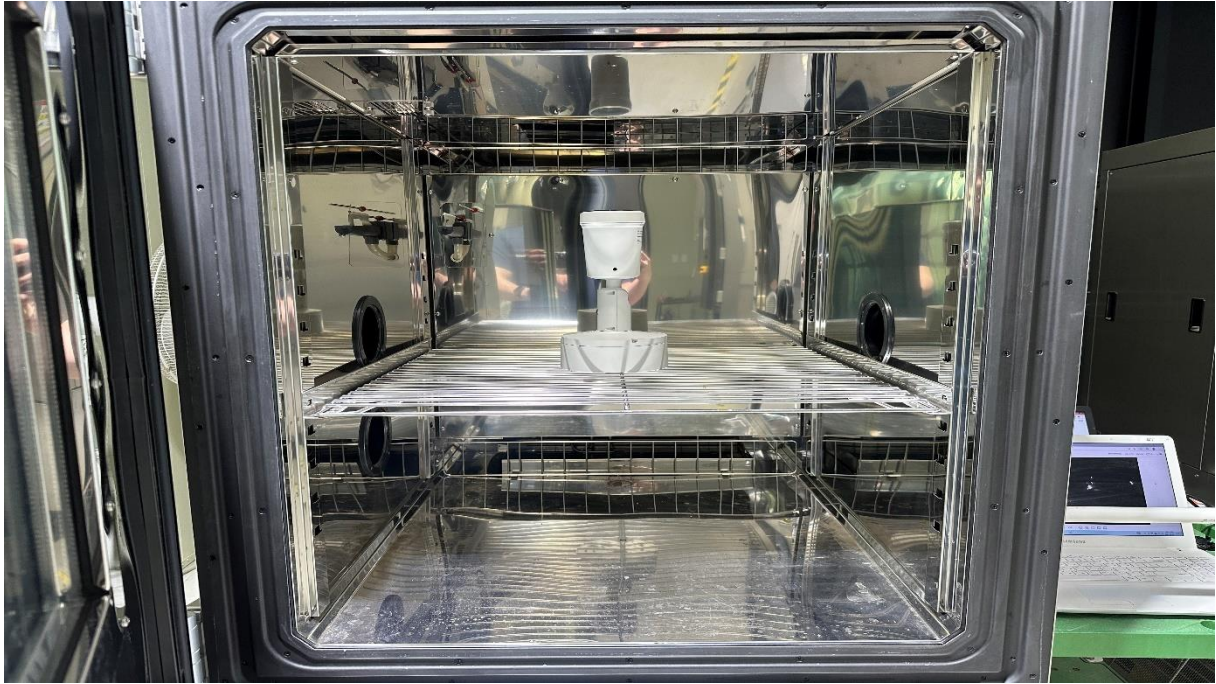
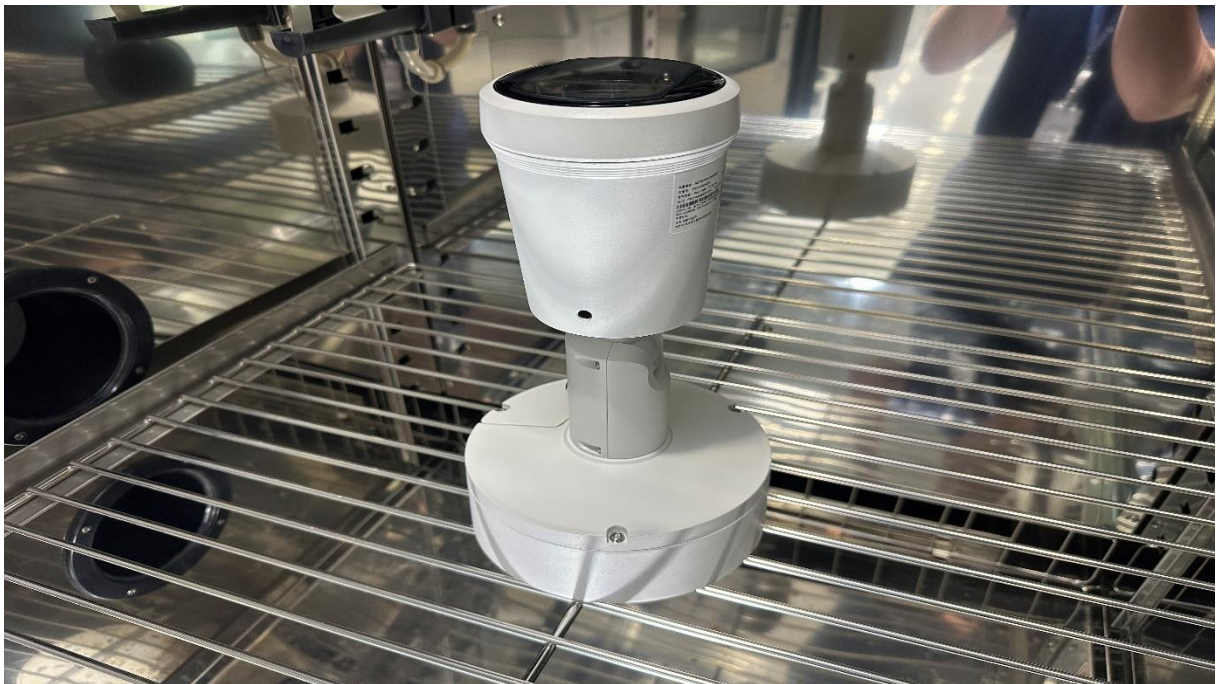
#### 3.3.1 Evidence of test setting

3.2.1 Sample status: Non-operation

3.2.2 Test temperature: -50 °C

3.2.3 Test time: 16 h

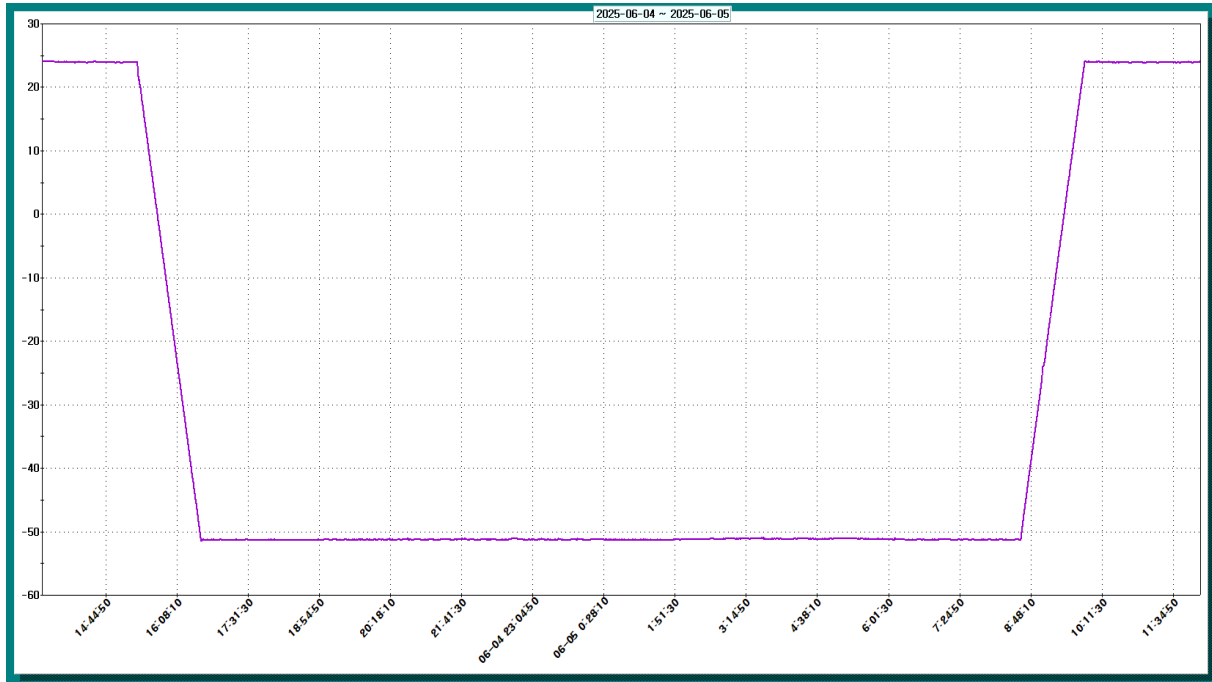
#### 3.5.1 Test data and graph

Temperature Data

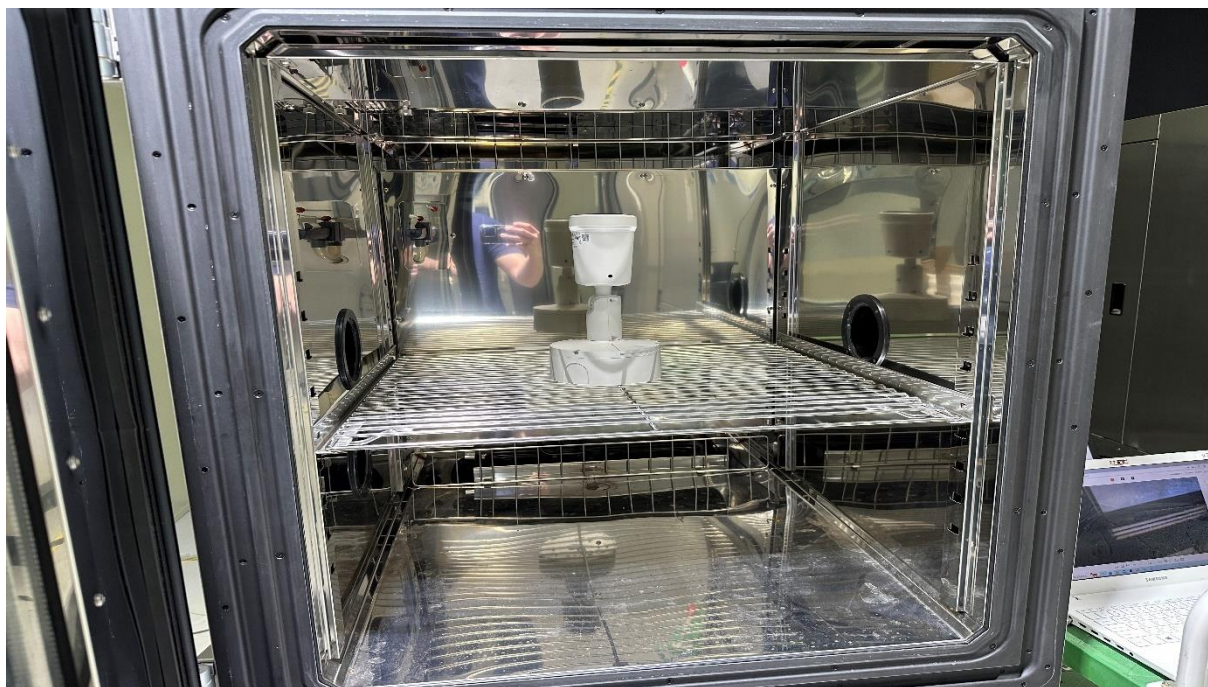
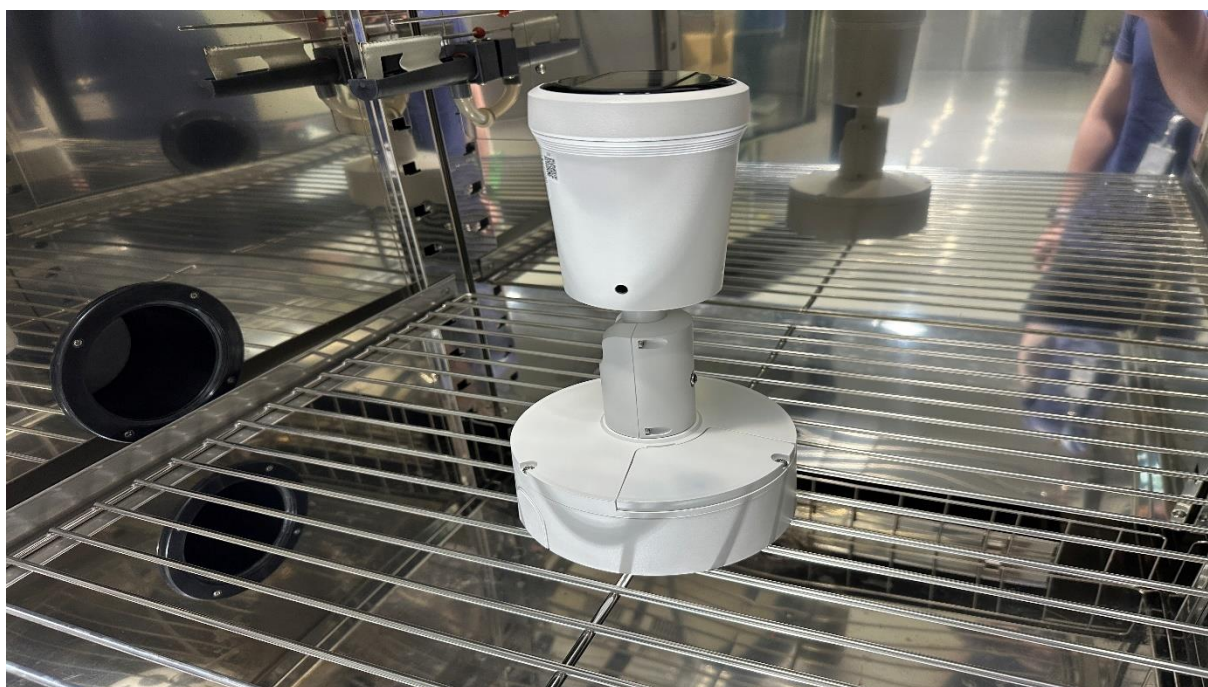
#### 4.3.1 Evidence of test setting

4.2.1 Sample status: Non-operation

4.2.2 Test temperature: 60 °C

4.2.3 Test time: 96 h

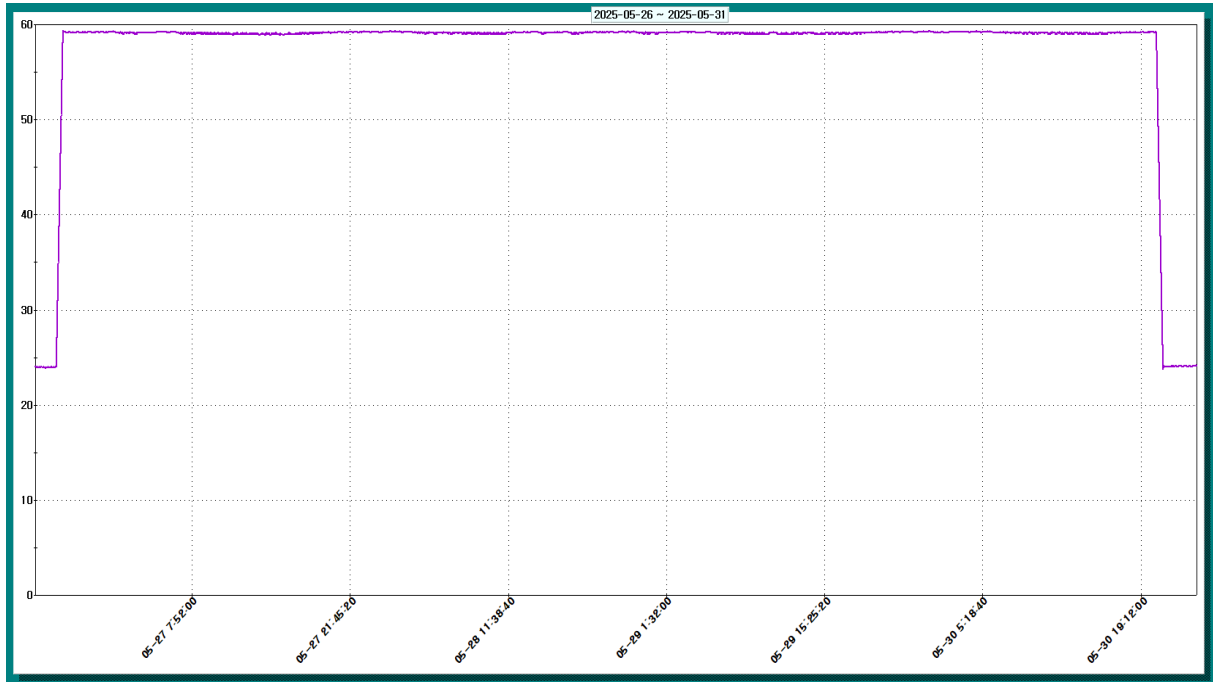
#### 4.5.1 Test data and graph

Temperature Data

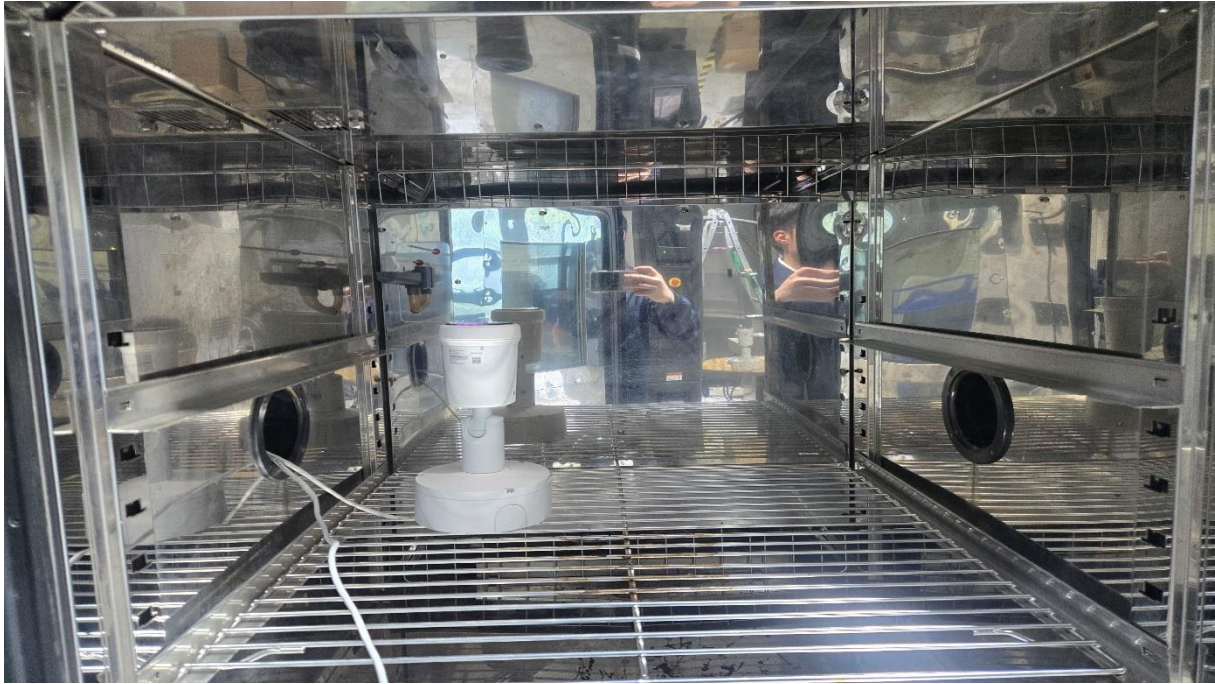
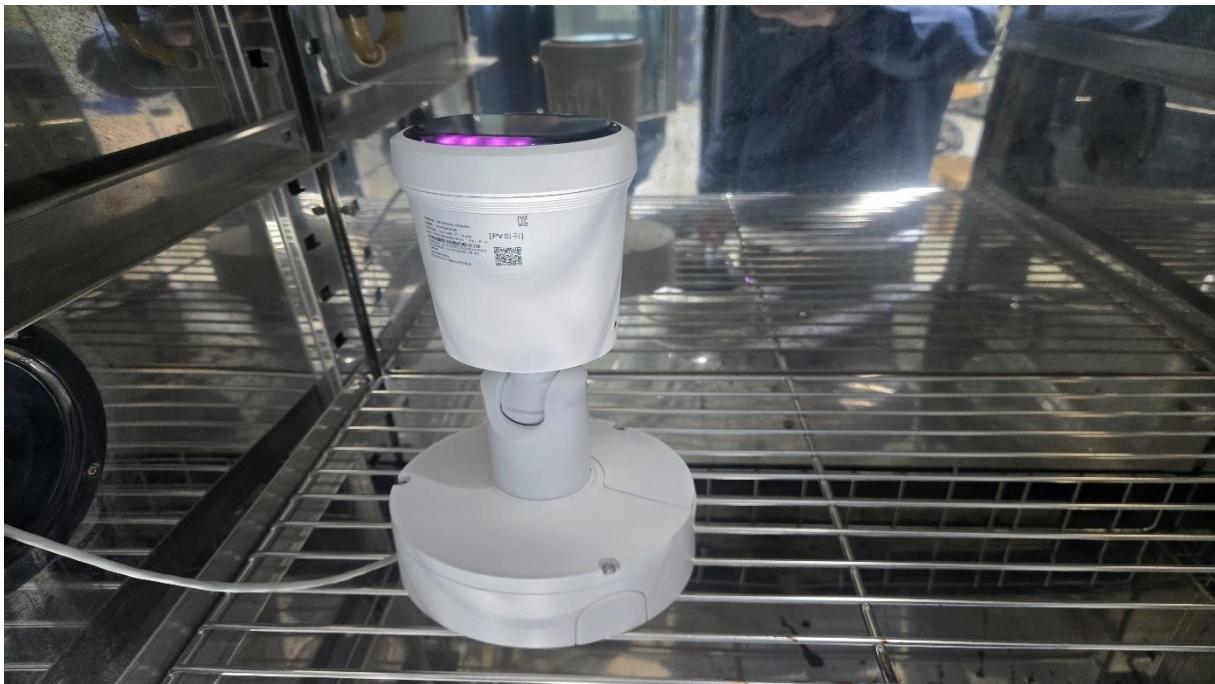
#### 5.3.1 Evidence of test setting

5.2.1 Sample status: operation

5.2.2 Test temperature: -50 °C, 55 °C

| Temp↵ | Temperature change rate(°C/min)↵ | t <sub>1</sub> (idle time)↵ | Cycles↵ |
| High↵ | 5 °C/min↵ | 3 h↵ | 3↵ |
| Low↵ | 1 °C/min↵ | 3 h↵ | 3↵ |

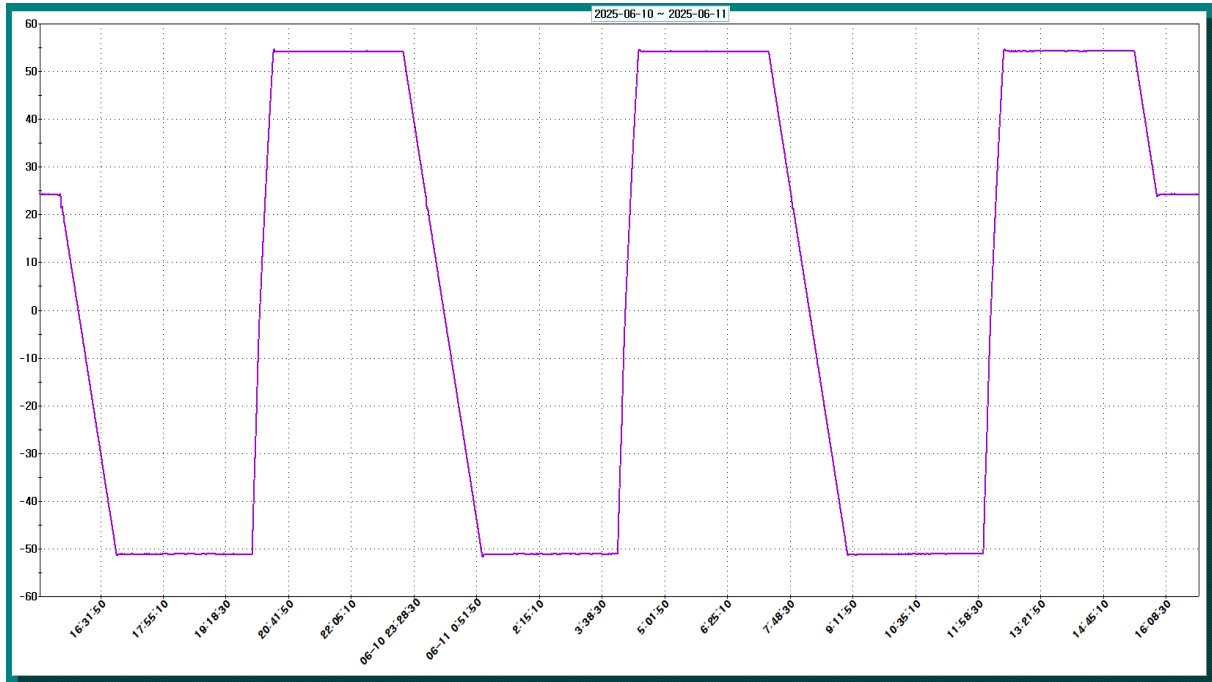
#### 5.5.1 Test data and graph

Temperature Data

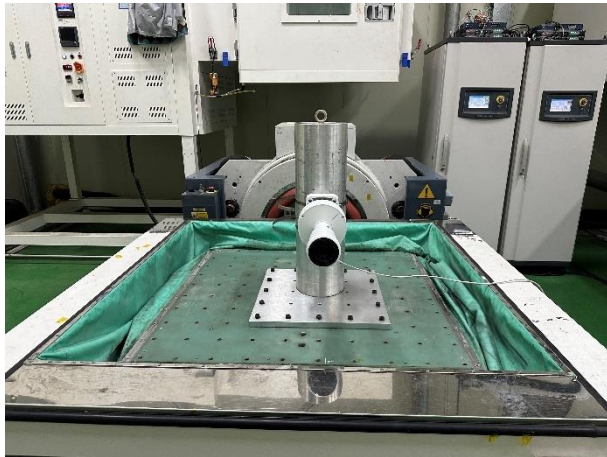
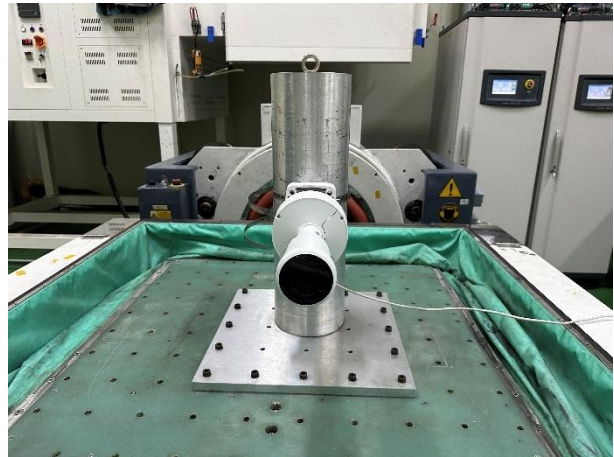
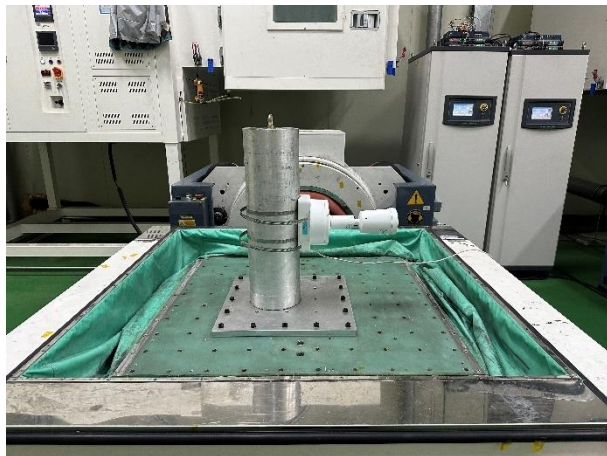
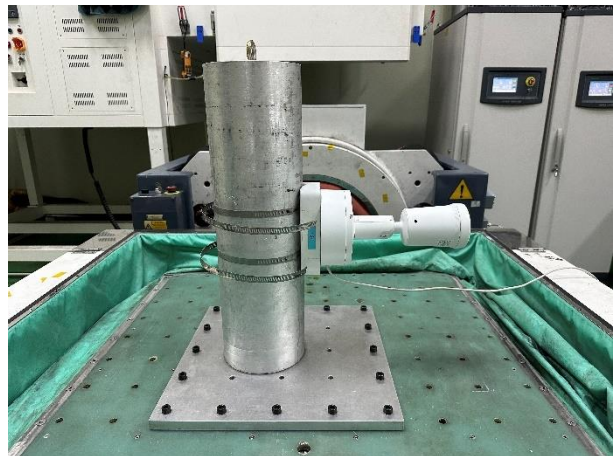
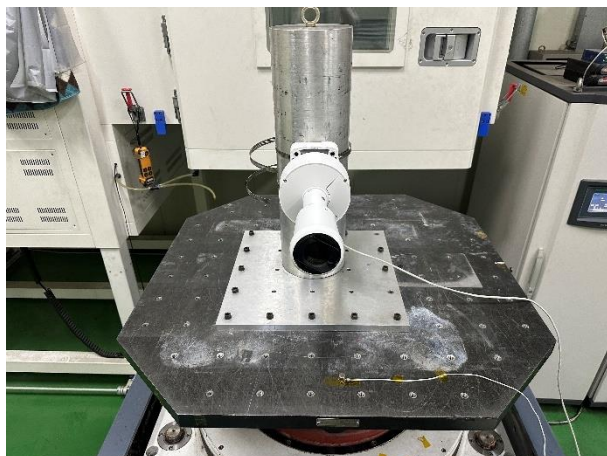
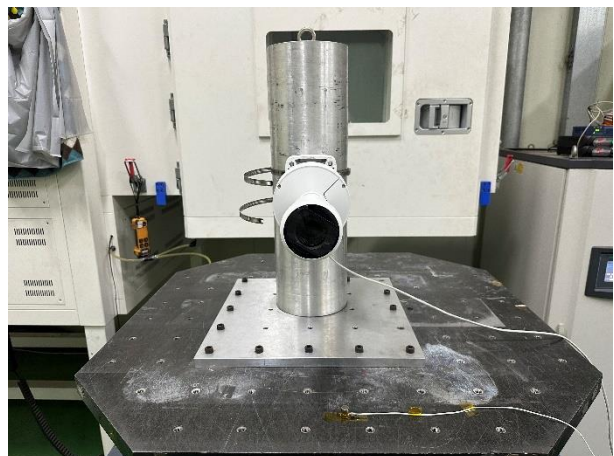
### 6.3.1 Evidence of test setting

- Sample status: operation
- Frequency(Hz): 5 Hz ~ 200 Hz
- Acceleration(G): 1 G
- Sweep rate: 1 oct/min
- Test Axis: X, Y, Z
- Test time(h): Total 30 min (10 min. per each axis)

X axis\_1

X axis\_2

Y axis\_1

Y axis\_2

Z axis\_1

Z axis\_2

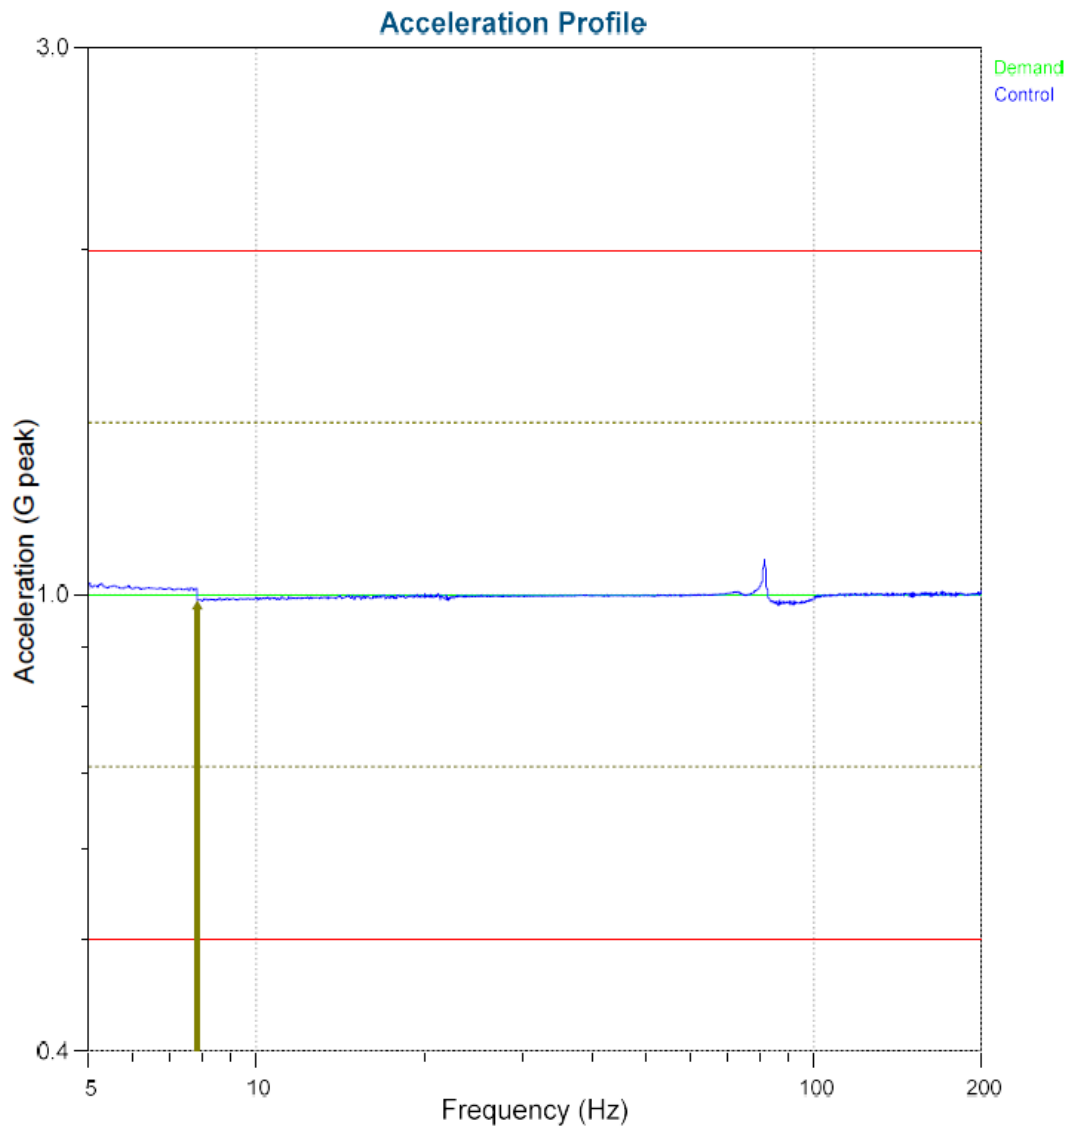
#### 6.5.1 Test data and graph (Vibration Test X Axis)

6/26, 2025 14:00:2: Level 1) 100 % Output: 0 Volts peak 60068-2-f

Demand: 1 G Level Time: 0:10:0 Frequency: 7.846 Hz

Control: 0.001126 G Total Time: 0:10:1 End of Timed Test

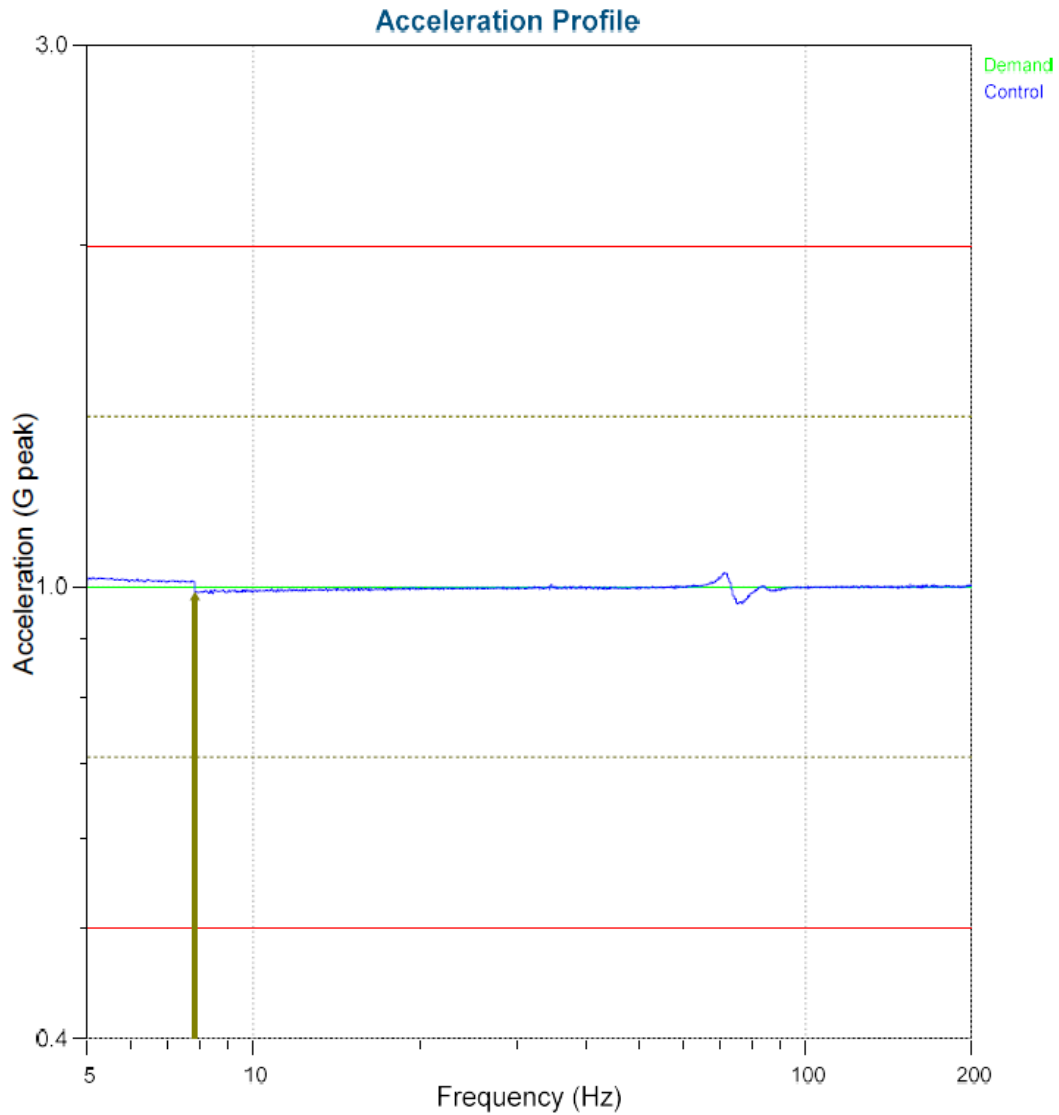
### 6.5.2 Test data and graph (Vibration Test Y Axis)

Demand: 1 G

Level Time: 0:10:0

Frequency: 7.846 Hz

Control: 0.0007871 G Total Time: 0:10:12

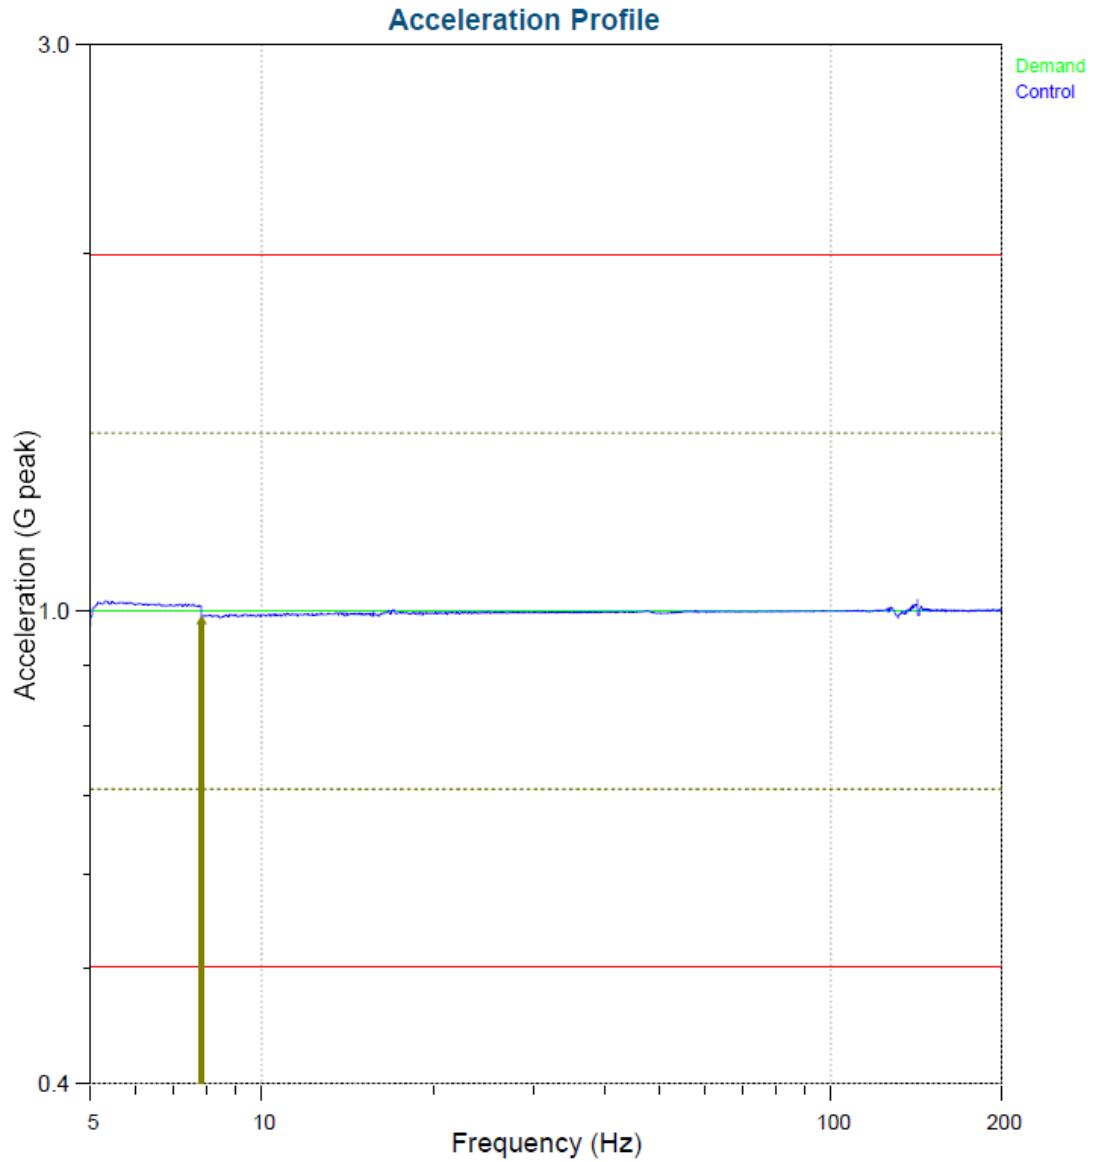
### 6.5.3 Test data and graph (Vibration Test Z Axis)

6/26, 2025 15:58:30 Level 1) 100 % Output: 0 Volts peak 60068-2-1  
Demand: 1 G Level Time: 0:10:00 Frequency: 7.846 Hz  
Control: 0.001835 G Total Time: 0:10:11 End of Timed Test

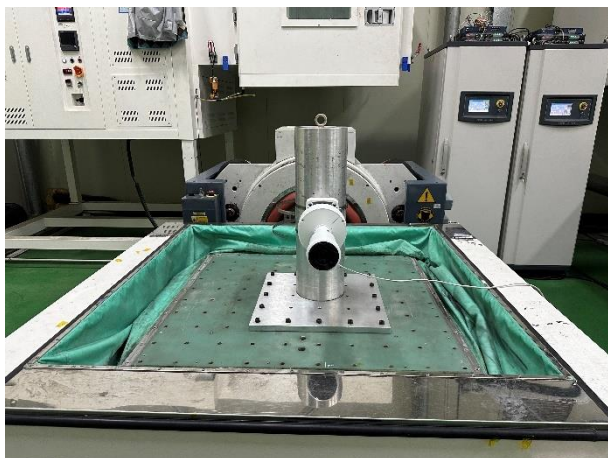
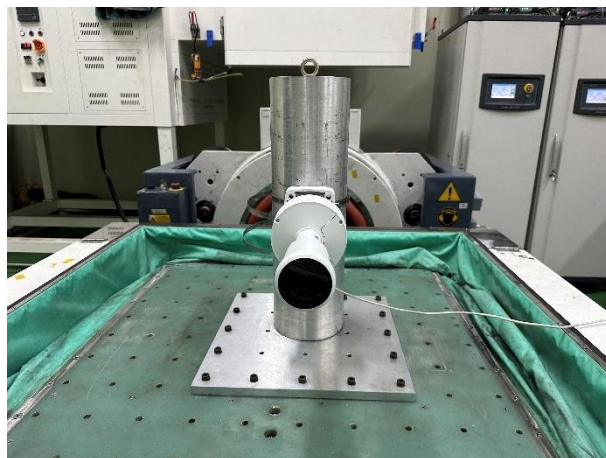
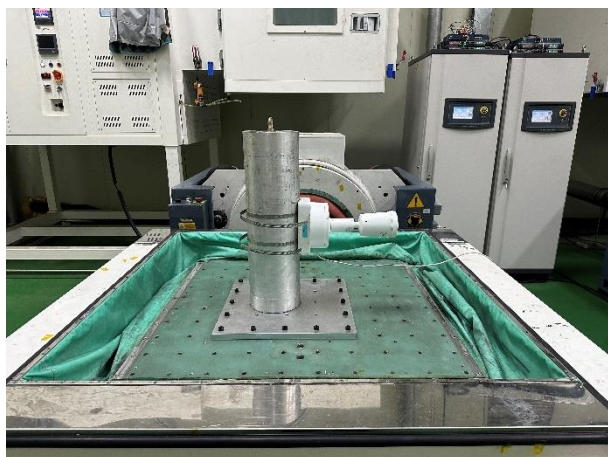
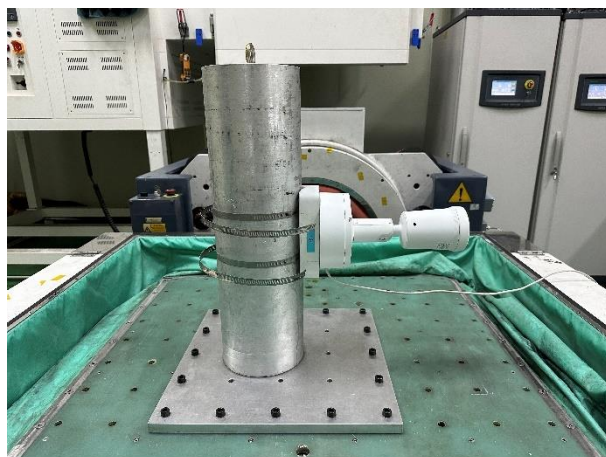
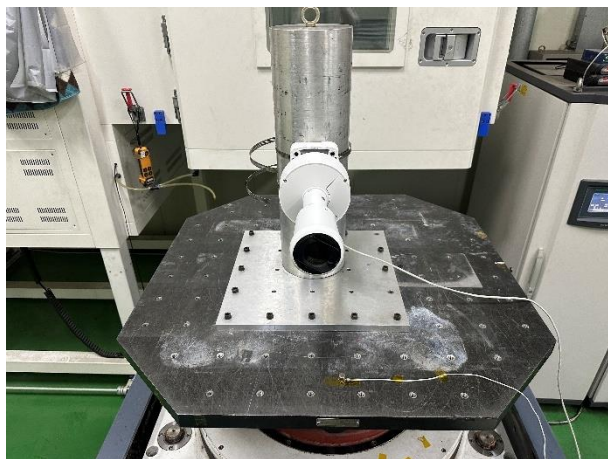
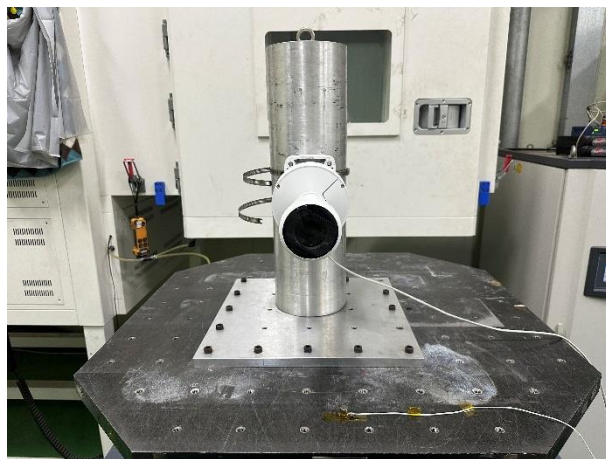
#### 7.3.1 Evidence of test setting

X axis\_1

X axis\_2

Y axis\_1

Y axis\_2

Z axis\_1

Z axis\_2

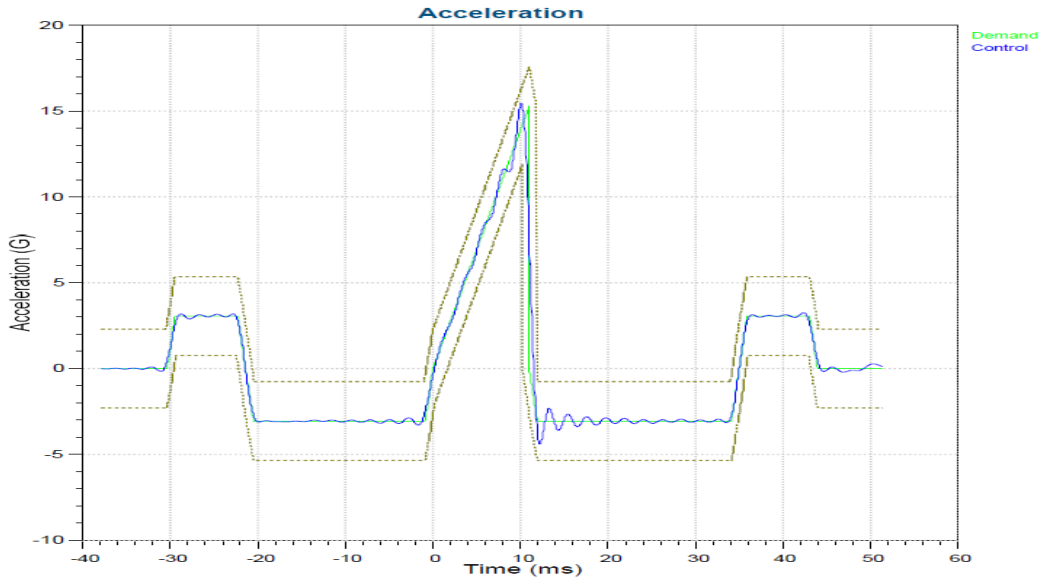
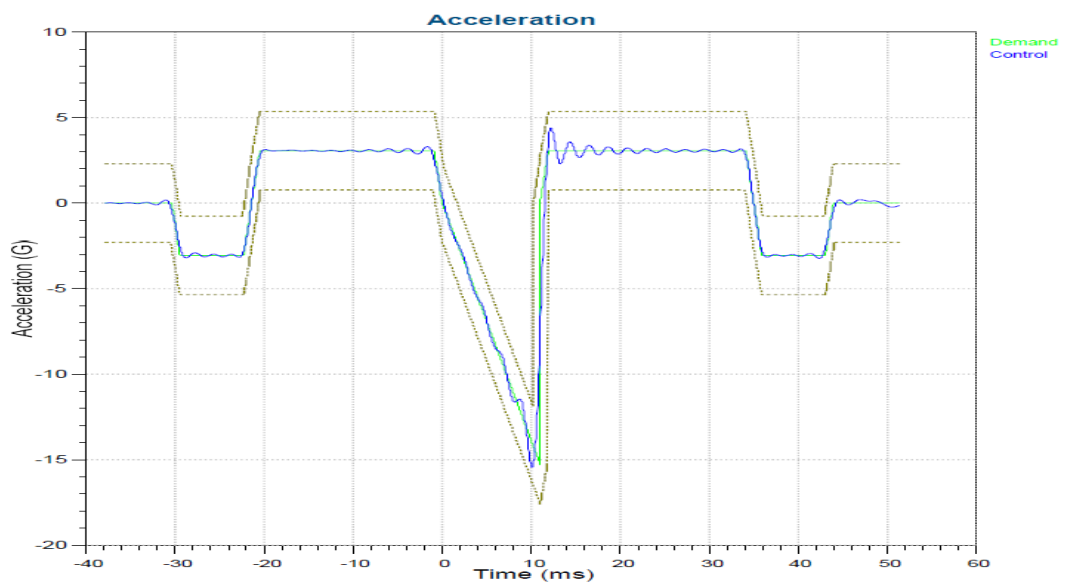
### 7.5.1 Test data and graph (Shock Test X Axis)

X+

X-

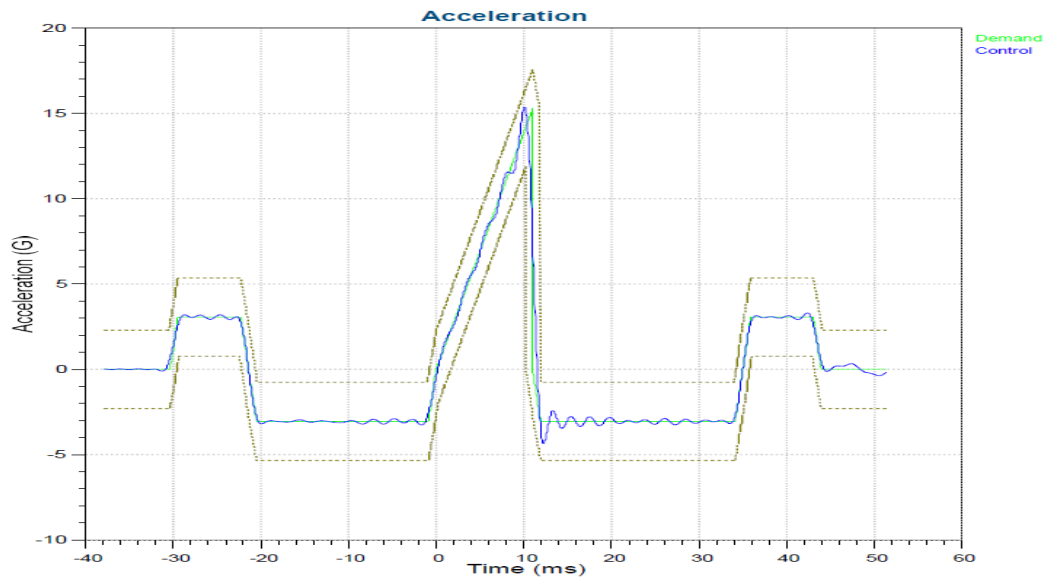
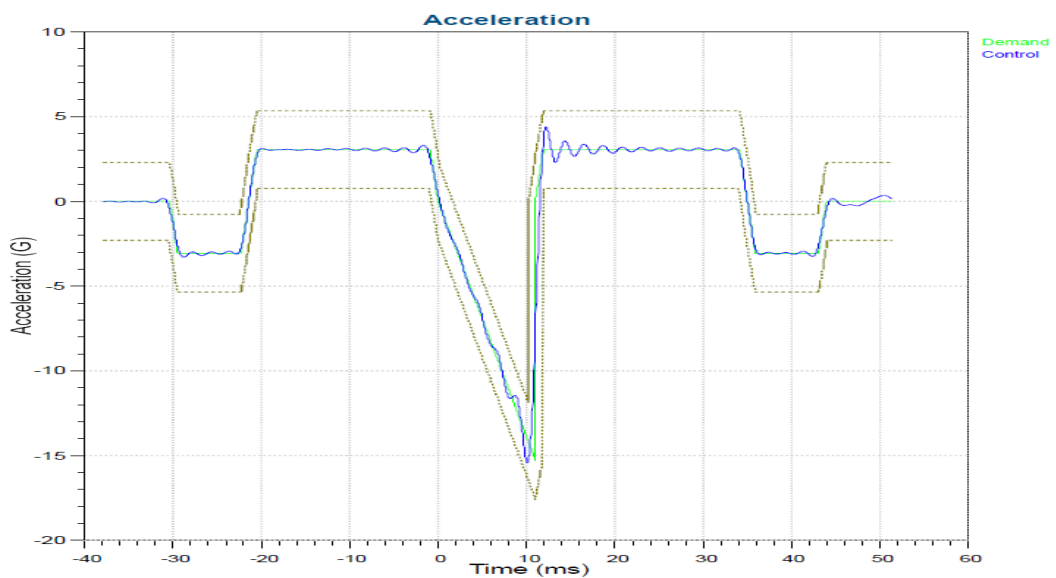
### 7.5.2 Test data and graph (Shock Test Y Axis)

6/26/2025 13:41:41 Level 1) 100 % Output: 1.257 Volts peak 한화비전 60068-2  
Demand: 15.3 G  
Control: 15.37 G Pulse: 10 of 10 Running

6/26/2025 13:42:31 Level 2) 100 % Output: 1.264 Volts peak 한화비전 60068-2  
Demand: 15.3 G  
Control: 15.43 G Pulse: 10 of 10 End of Test

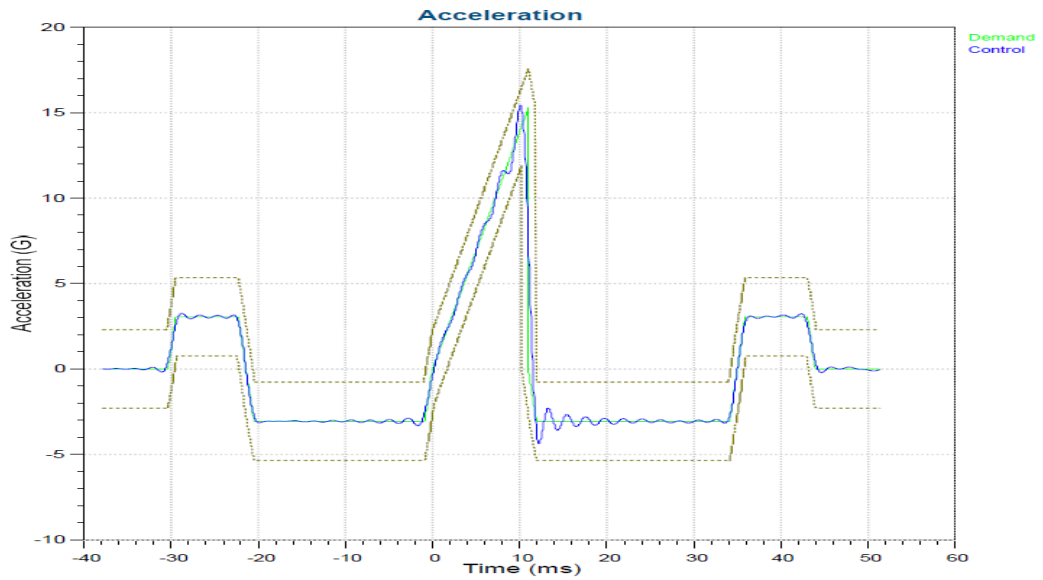
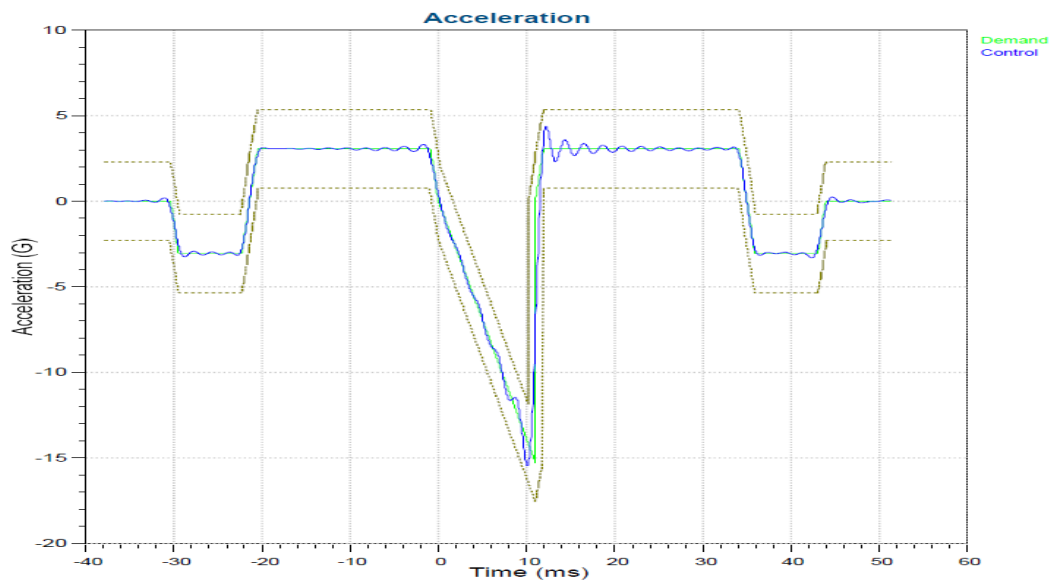
### 7.5.3 Test data and graph (Shock Test Z Axis)

6/26, 2025 15:59:38 Level 1) 100 %

Output: 1.282 Volts peak

Demand: 15.3 C

Control: 15.43 C Pulse: 10 of 10

6/26, 2025 16:00:22 Level 2) 100 %

Output: 1.345 Volts peak

Control: 15.46 C Pulse: 10 of 10

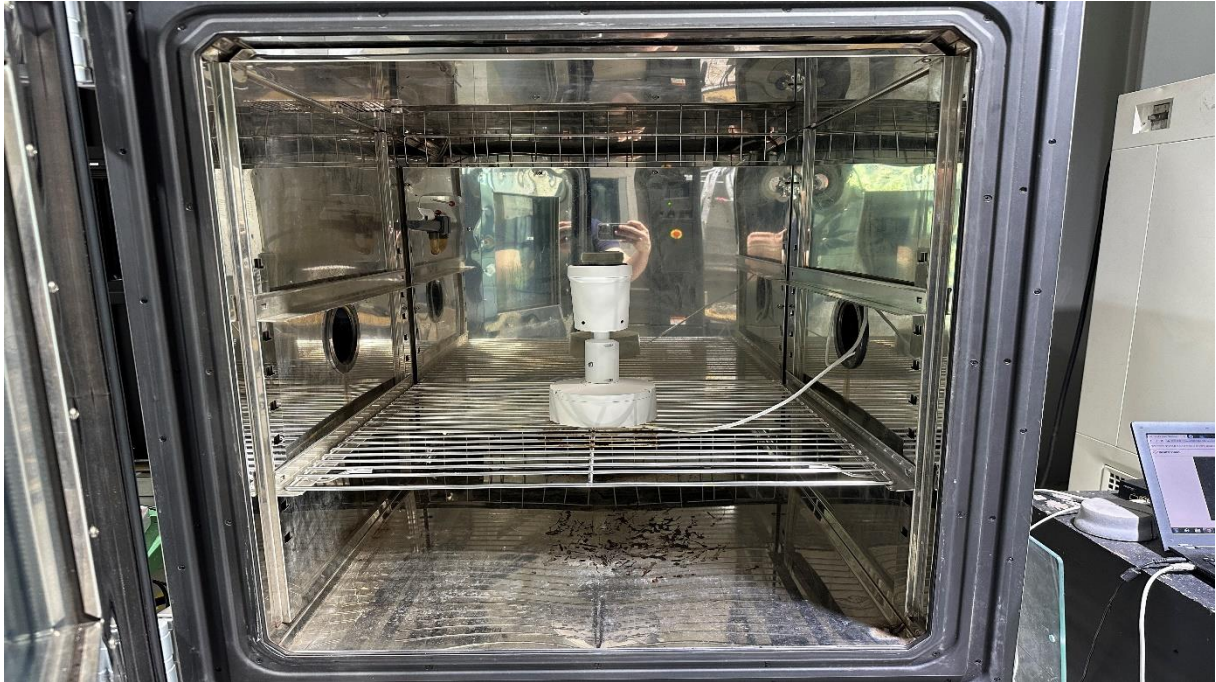
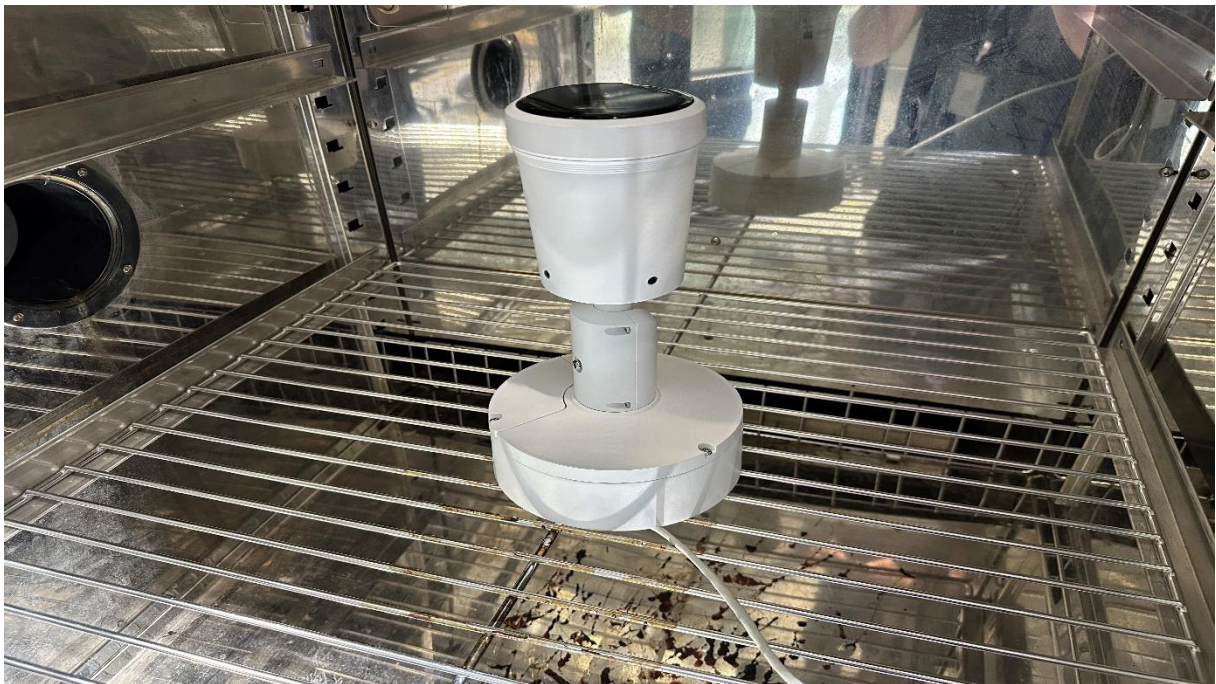
#### 8.3.1 Evidence of test setting

8.2.1 Sample status: operation

8.2.2 Test temperature:  $40 \pm 2$  °C

8.2.3 Test Humidity:  $93 \pm 3$  % R.H.

8.2.4 Test time: 240 h
