# TEST REPORT

REPORT No.:  
CTK-2025-01912  
Page (1) / (39) pages

NETWORK CAMERA / PNO-A9092R

EN 60068-2-1, EN 60068-2-2, EN 60068-2-14, EN 60068-2-6, EN  
60068-2-27, EN 60068-2-78, IEC 60068-2-1, IEC 60068-2-2, IEC  
60068-2-14, IEC 60068-2-6, IEC 60068-2-27, IEC 60068-2-78

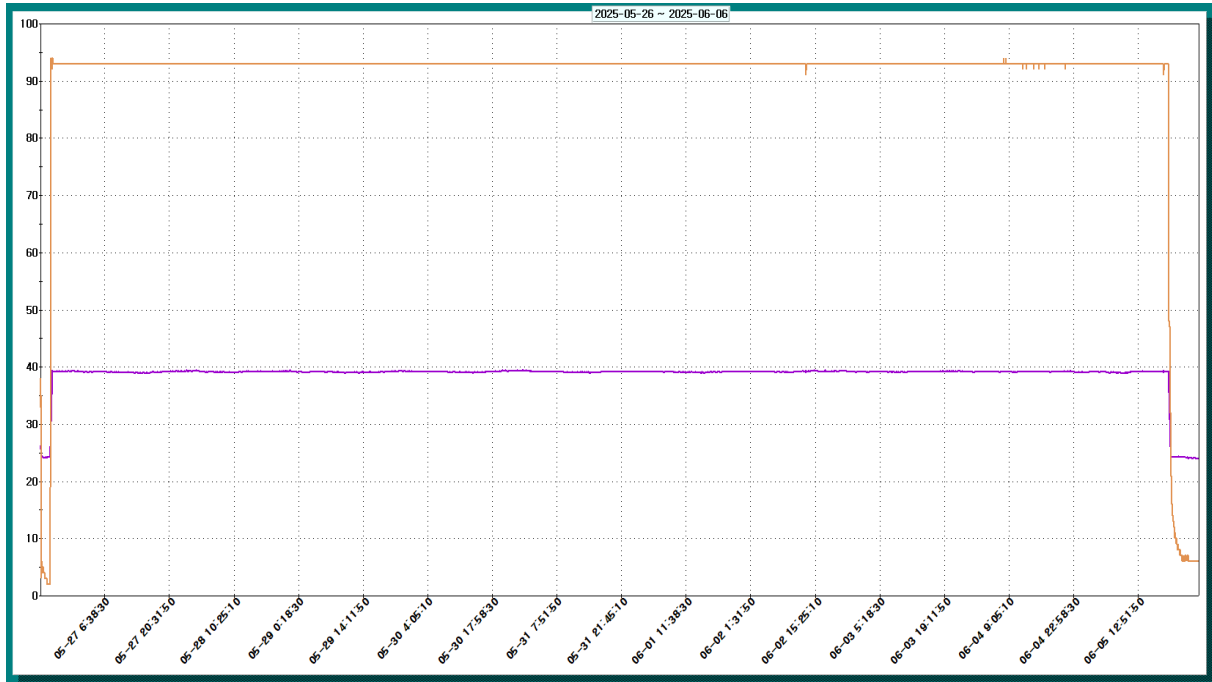
### 8.5.1 Test data and graph

Temperature Data

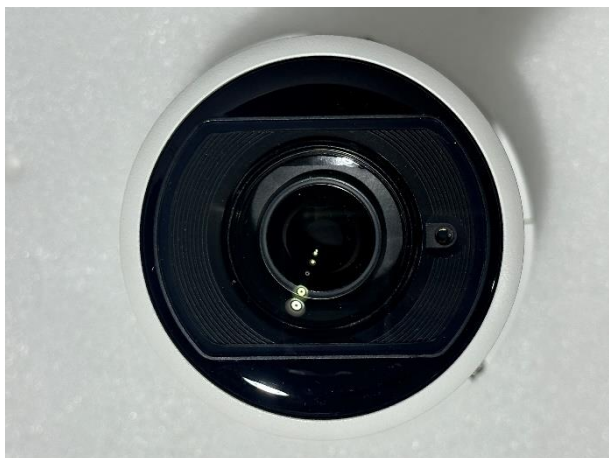
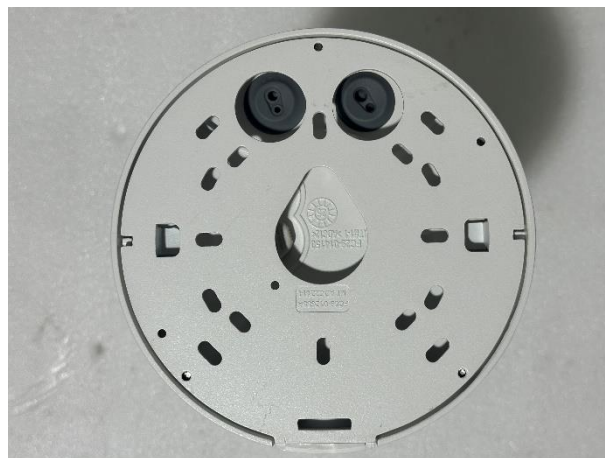
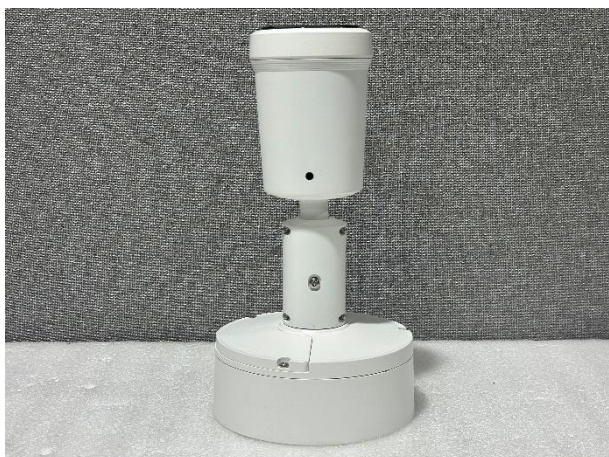
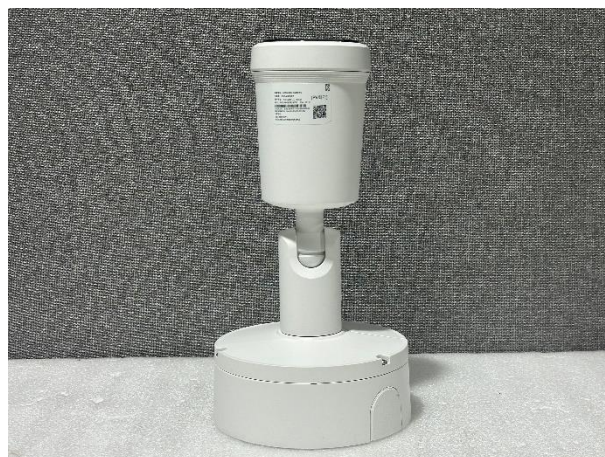
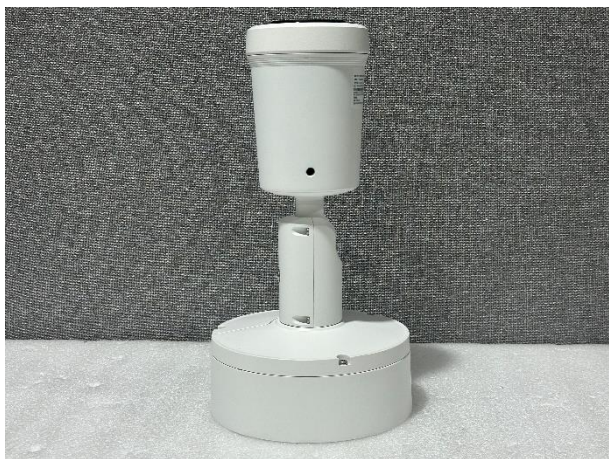
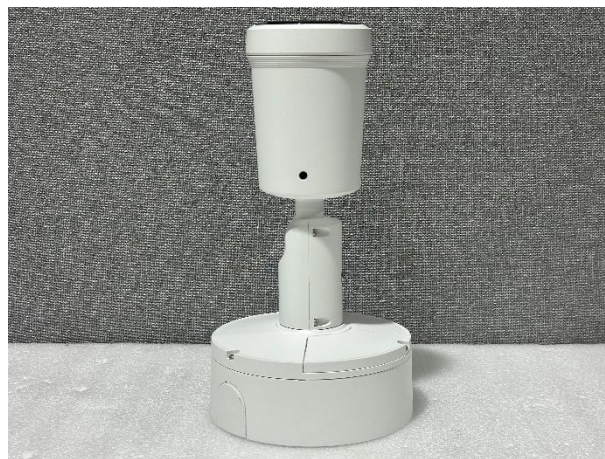
#### 8.6.1 Test sample

Top

Bottom

Front

Rear

Left side

Right side

| Evaluations Criteria | Test result | | 비고 |
|---|---|---|---|
| Sample | Visual Inspection | Normal | - |
