# TEST REPORT

REPORT No.:  
CTK-2025-01913  
Page (1) / (26) pages

NETWORK CAMERA / PNO-A9092R

NEMA TS 2-2013 2.2.7.3 Test C ~ 2.2.7.8 Test H,  
NEMA TS 2.2.8, NEMA TS 2.2.9

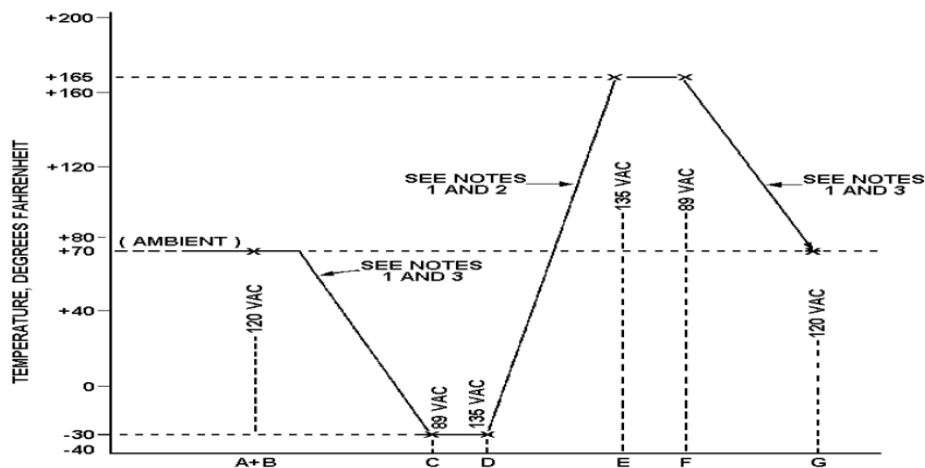
#### 3.2.7 Test Methods

- 3.2.1 2.2.7.3 Test C: - 34 °C, 89 Vac, 10 h (Check interim operation after 5 h and operation check after 10h)
- 3.2.2 2.2.7.4 Test D: - 34 °C, 135 Vac, 1 h (Operating state)
- 3.2.3 2.2.7.5 Test E: 74 °C, 18 %, 135 Vac, 15 h (Operating state)
- 3.2.4 2.2.7.6 Test F: 74 °C, 18 %, 89 Vac (Operation check after 2.2.7.5 Test E)
- 3.2.5 2.2.7.7 Test G: (21 ±6) °C, 120 Vac (Operating state)
- 3.2.6 2.2.7.8 Test H: Check for mechanical damage

- Evaluations Criteria :
  - Check for mechanical damage before and after testing
- Test methods

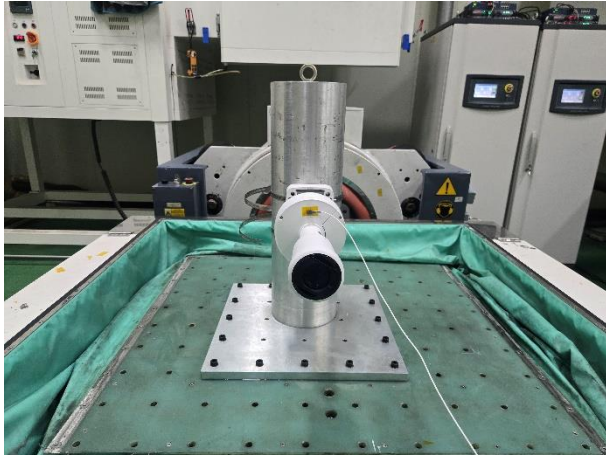
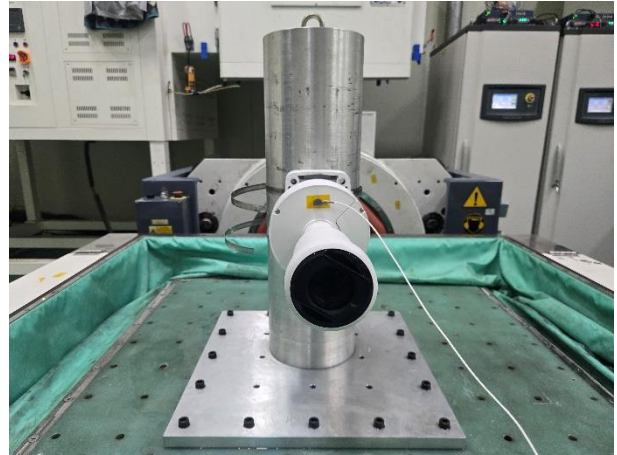
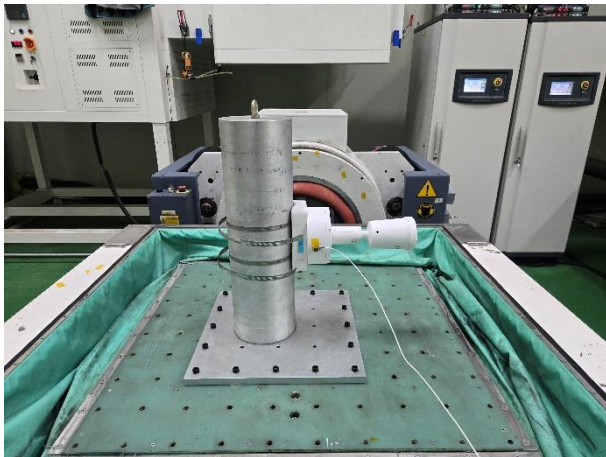
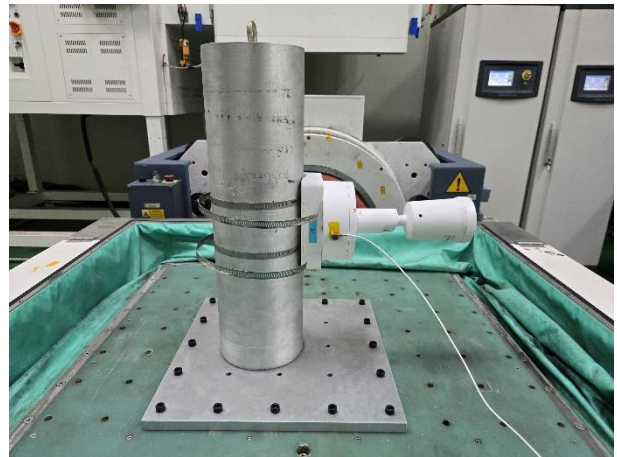
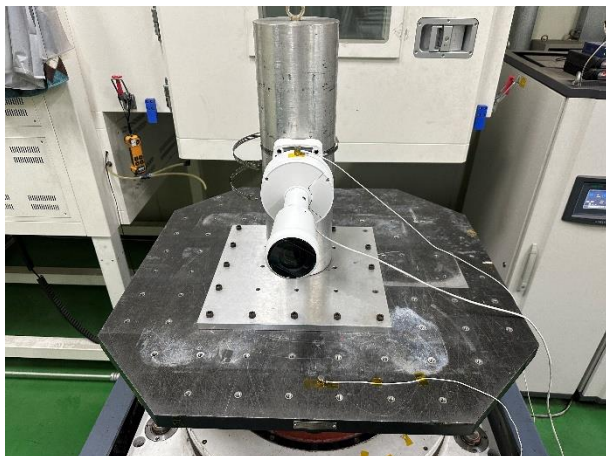
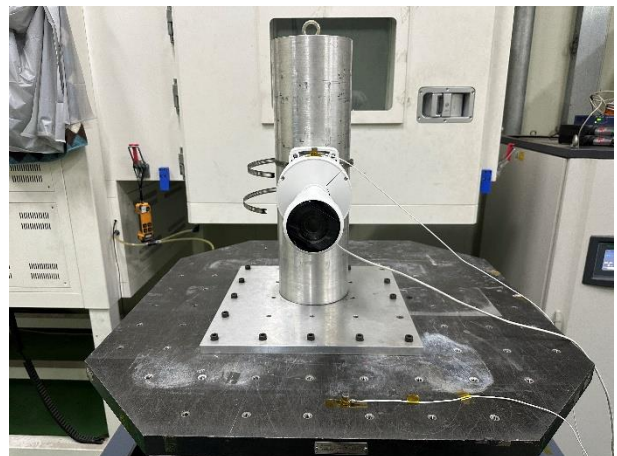
#### 4.3.1 Evidence of test setting (NEMA TS 2-2013 2.2.8)

- Applicable axis : X, Y, Z
- Test time(h) : 12.5
- Evaluation items
  - Check for mechanical damage before and after testing
- Test methods
  - With the test unit securely fastened to the test table, set the test table for a double amplitude displacement of 0.015 inch.

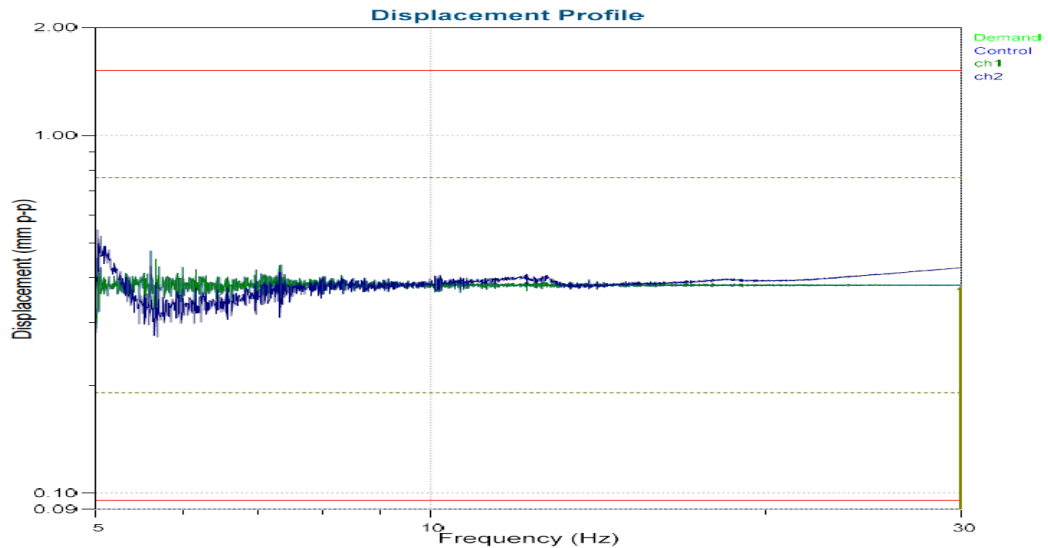
#### Resonant search Test ( X Axis )

6/25, 2025 11:24:00 Level 1) 100 % Output: 0 Volts peak NEMA TS-2 2.2.8 - search.  
Demand: 0.381 mm Level Time: 0:12:30 Frequency: 30 Hz  
Control: 5.965e-05 mm Total Time: 0:12:31 End of Sweep Test

- Sample status : unpackaged / not in operation
- Applied waveform : Sine
- Frequency(Hz) : 5 ~ 30
- Double amplitude displacement (inch) : 0.015
- Sweep rate(Sweep/min) : 12.5

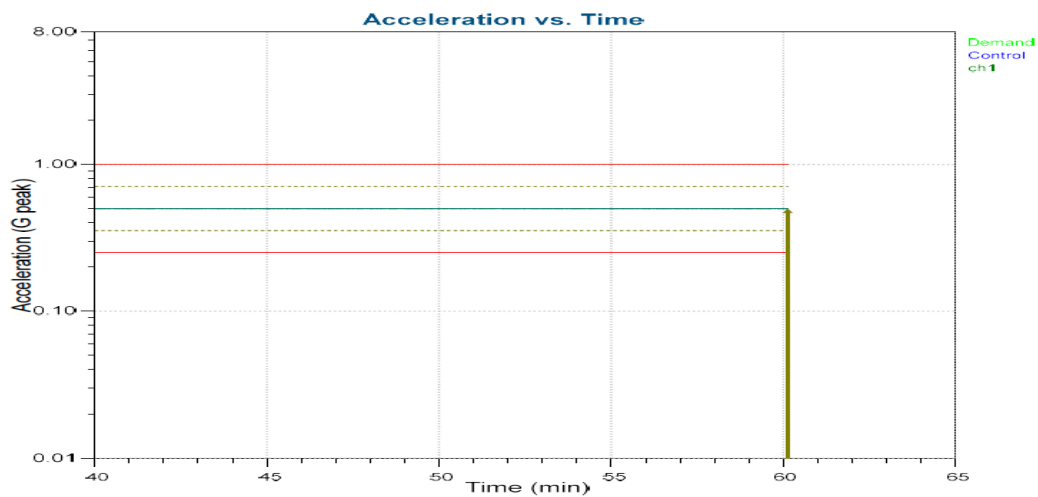
#### Endurance Test ( X Axis )

6/25, 2025 13:47:36 Level 1) 100 % Output: 0 Volts peak 한화비전 공진 L  
Demand: 0.5 G Level Time: 1:00:00 Frequency: 30 Hz  
Control: 0.000344 G Total Time: 1:00:07 End of Timed Test

- Sample status : unpackaged / not in operation
- Applied waveform : Sine
- Frequency(Hz) : 30 or 3.2.2 Test results
- Acceleration(G) : 0.5
- Applicable axis : X, Y, Z
- Test time(h) : All 3(Each axis 1)
- Evaluation items
  - Check for mechanical damage before and after testing
- Test methods
  - Vibrate the test unit in each plane at its resonant frequency for a period of 1 hour at an amplitude resulting in 0.5 g acceleration. (test profile)
  - When more than one resonant frequency has been recorded in accordance with Section 1.2 Item 4, the test period of 1 hour shall be divided equally between the resonant frequencies.
  - The total time of the endurance test shall be limited to 3 hours, 1 hour in each of three mutually perpendicular planes.

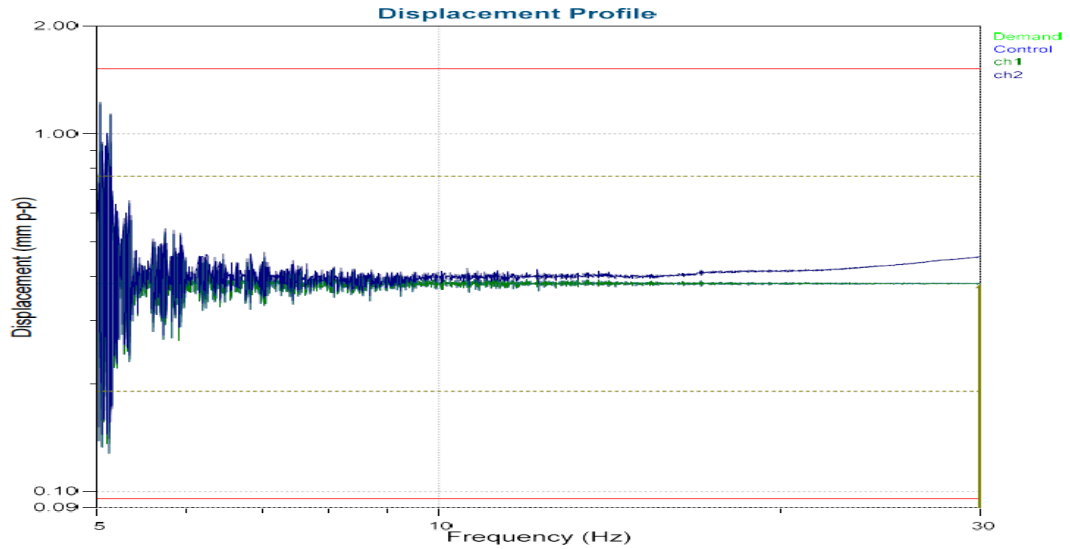
### Resonant search Test ( Y Axis )

6 25, 2025 09:55:1: Level 1) 100 % Output: 0 Volts peak NEMA TS-2 2.2.8 - search.  
Demand: 0.381 mm Level Time: 0:12:3 Frequency: 30 Hz  
Control: 0.0003437 mm Total Time: 0:12:5: End of Sweep Test

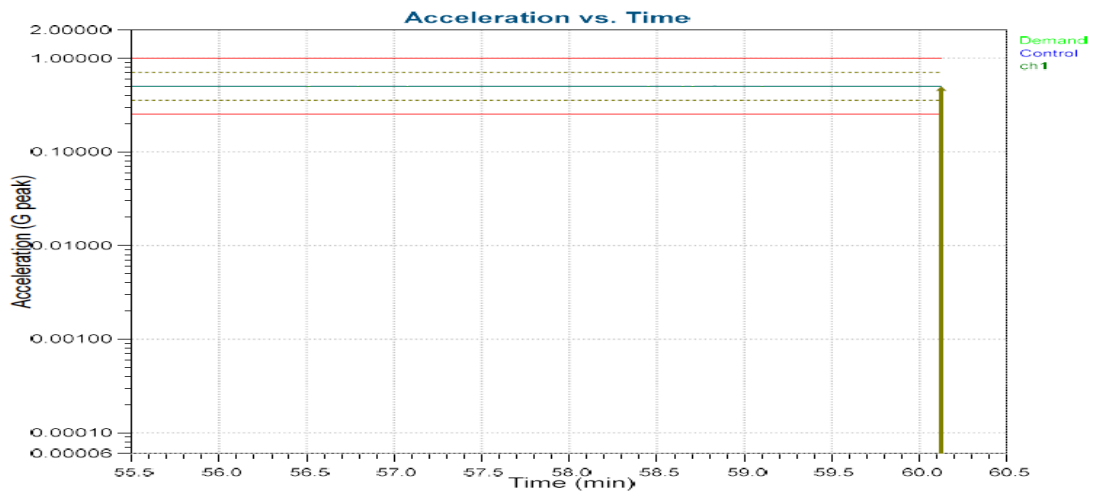
### Endurance Test ( Y Axis )

6 25, 2025 11:00:28 Level 1) 100 % Output: 0 Volts peak 한화비전 공진 L  
Demand: 0.5 G Level Time: 1:00:00 Frequency: 30 Hz  
Control: 0.000979 G Total Time: 1:00:07 End of Timed Test

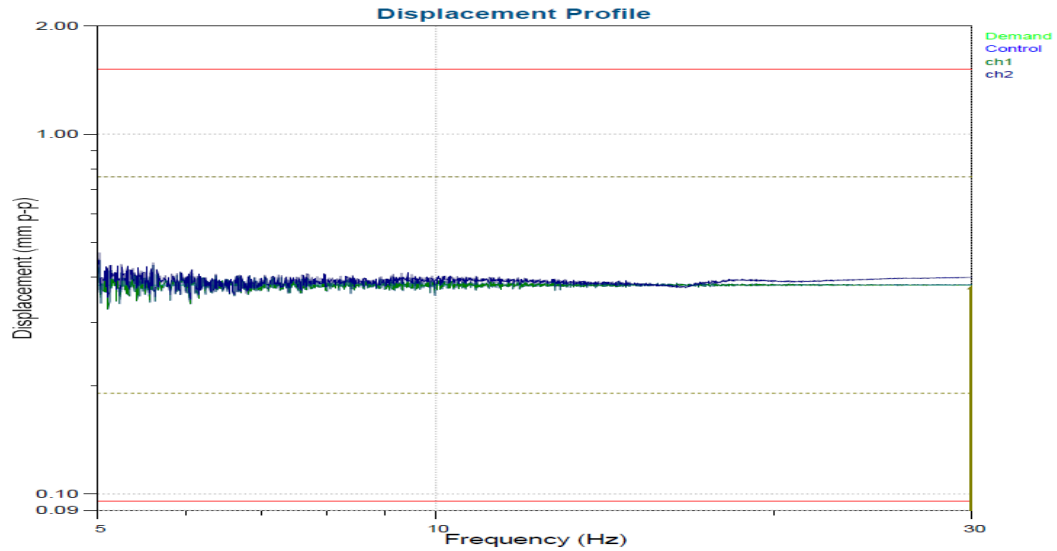
### Resonant search Test ( Z Axis )

6/26, 2025 16:15:21 Level 1) 100 % Output: 1.027e-05 Volts peak NEMA TS-2 2.2.8 - search.  
Demand: 0.381 mm Level Time: 0:12:30 Frequency: 30 Hz  
Control: 0.0003939 mm Total Time: 0:12:30 End of Sweep Test

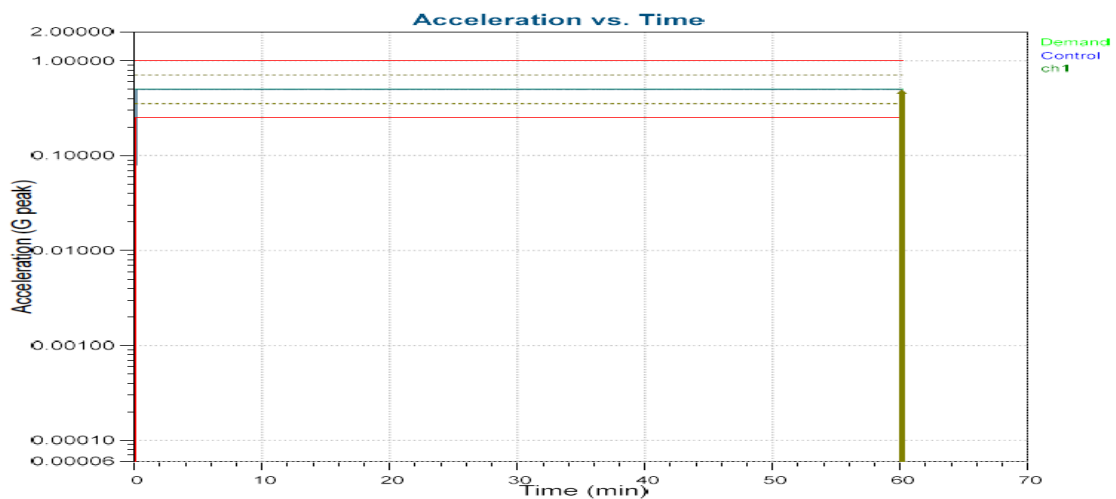
### Endurance Test ( Z Axis )

6/26, 2025 17:15:55 Level 1) 100 % Output: 0 Volts peak 한화비전 공진 L  
Demand: 0.5 G Level Time: 1:00:00 Frequency: 30 Hz  
Control: 0.0003754 G Total Time: 1:00:07 End of Timed Test

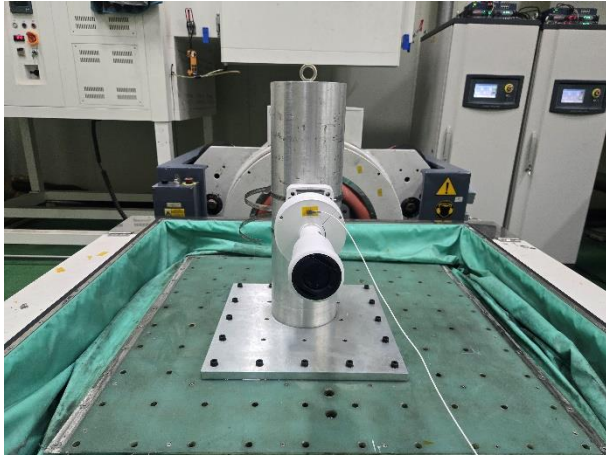
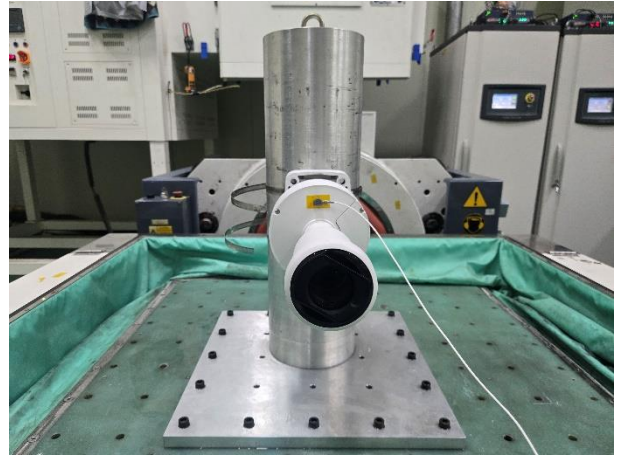
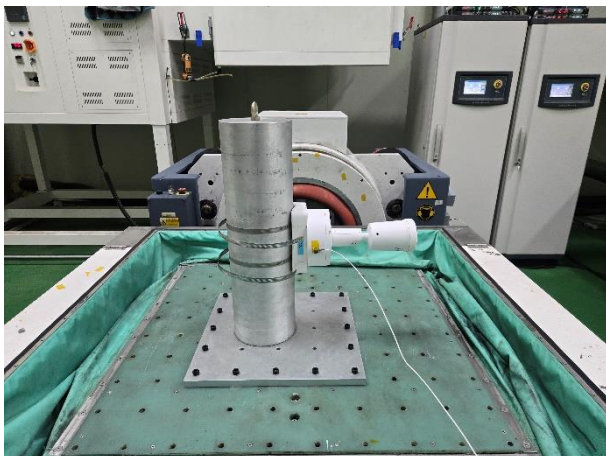
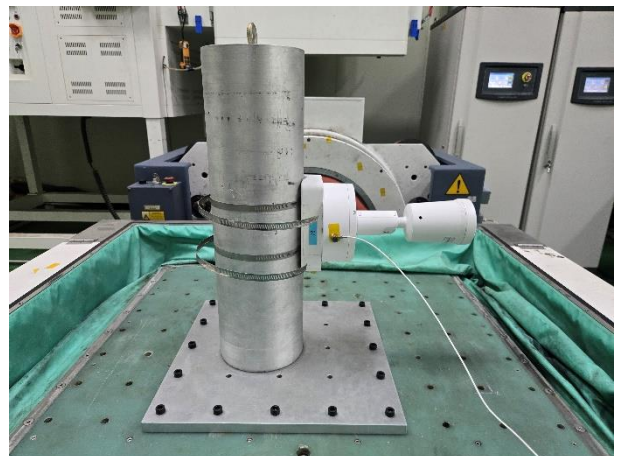
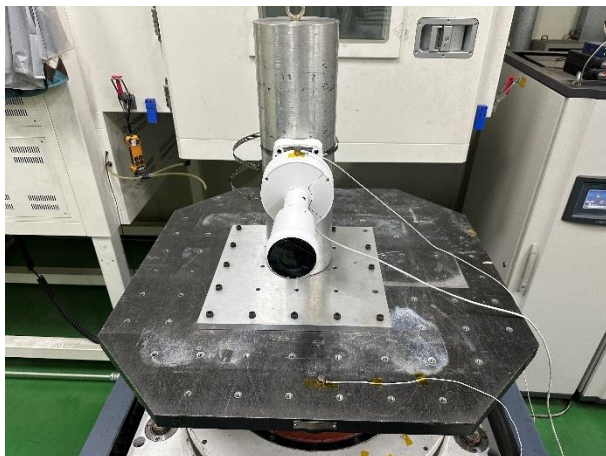
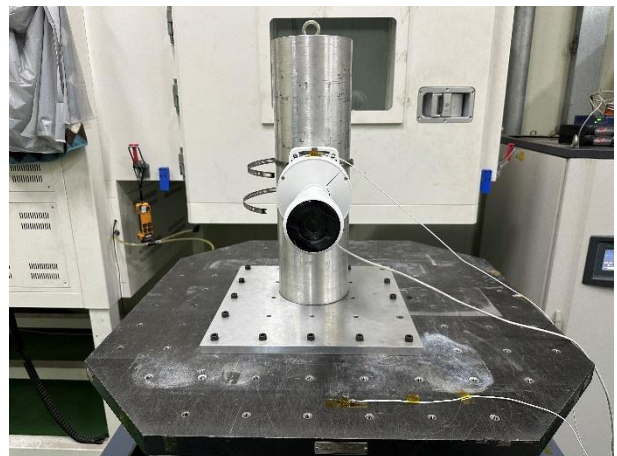
#### 5.3.1 Evidence of test setting (NEMA TS 2-2013 2.2.9)

5.2.2 Applied waveform: Half sine

5.2.3 Acceleration(G): 10 G

5.2.4 Nominal duration (ms): 11

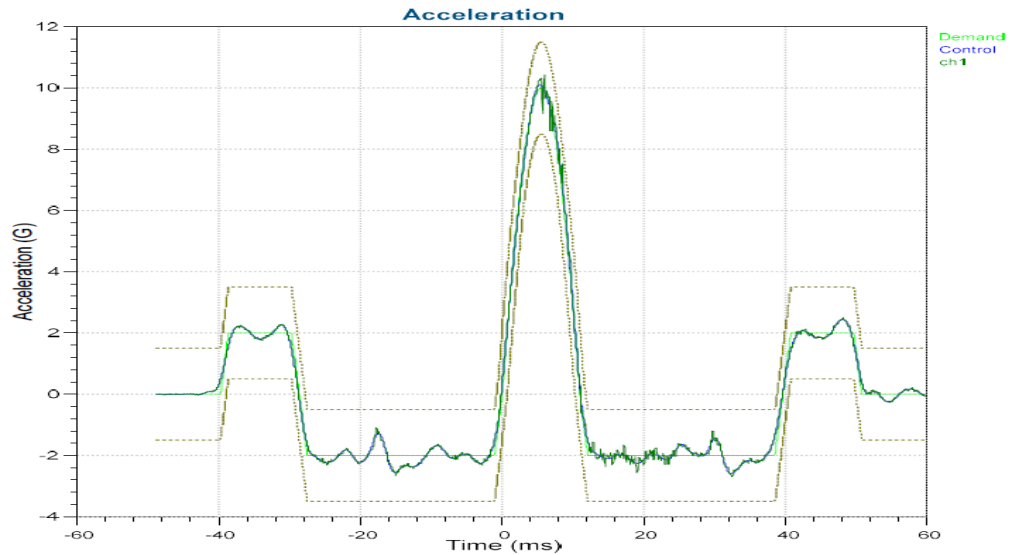
X+

6 25, 2025 13:48:28 Level 1) 100 % Output: 0.748 Volts peak 2025-05-02 NEMA TS-2 2.2.5

Demand: 10 G

Control: 10.11 G Pulse: 1 of 1 Running

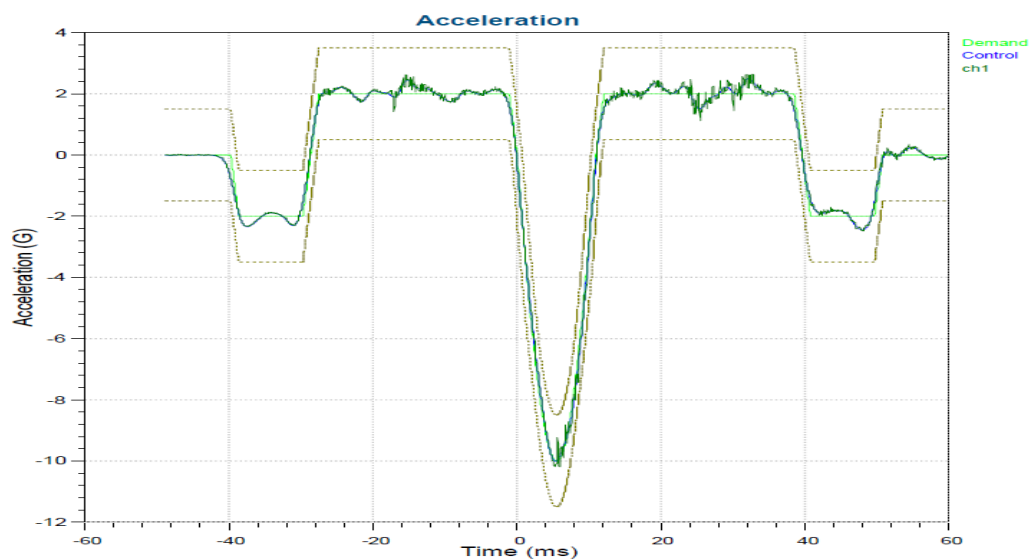
X-

6 25, 2025 13:49:37 Level 2) 100 % Output: 0.7475 Volts peak 2025-05-02 NEMA TS-2 2.2.5

Demand: 10 G

Control: 10.01 G Pulse: 1 of 1 End of Test

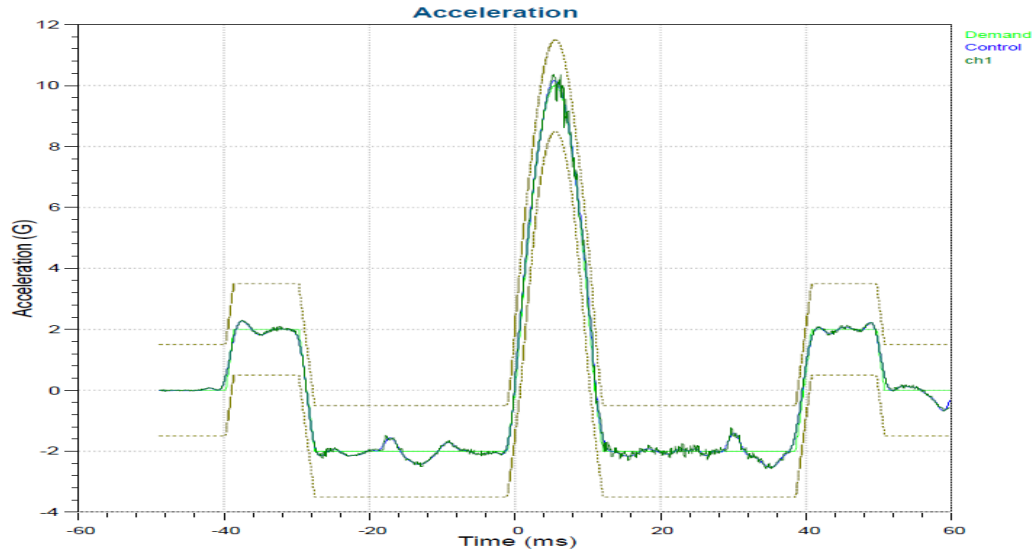
Y+

6 25, 2025 11:01:24 Level 1) 100 % Output: 0.7719 Volts peak 2025-05-02 NEMA TS-2 2.2.5

Demand: 10 G

Control: 10.16 G Pulse: 1 of 1 Running

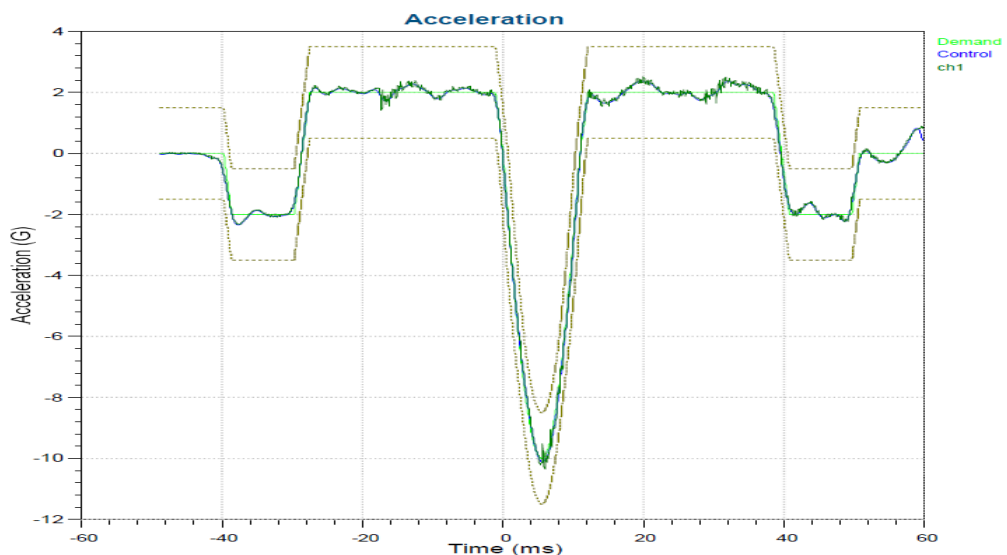
Y-

6 25, 2025 11:01:53 Level 2) 100 % Output: 0.769 Volts peak 2025-05-02 NEMA TS-2 2.2.5

Demand: 10 G

Control: 10.11 G Pulse: 1 of 1 End of Test

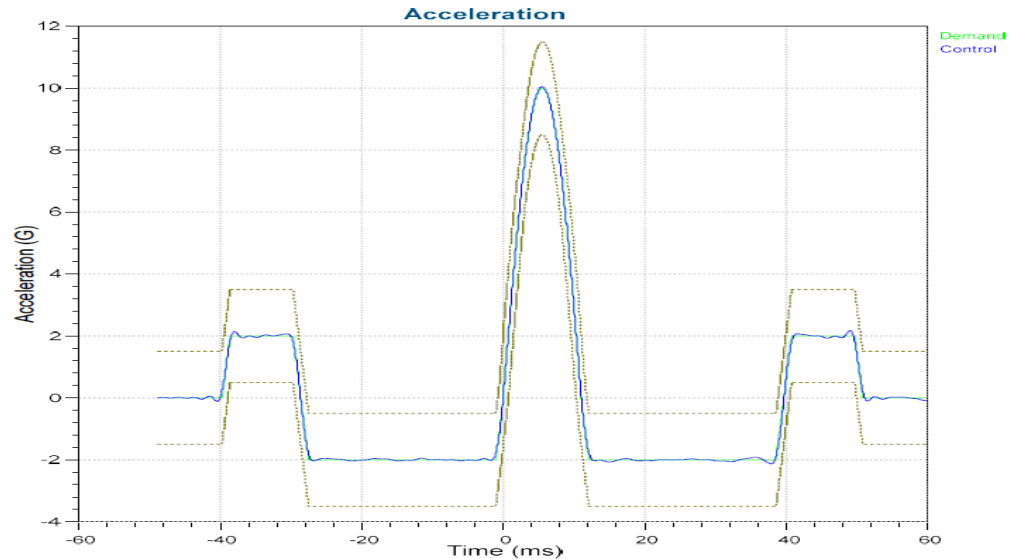
Z+

6 26, 2025 17:16:34 Level 1) 100 % Output: 0.6886 Volts peak 2025-05-02 NEMA TS-2 2.2.5

Demand: 10 G

Control: 10.05 G Pulse: 1 of 1 Running

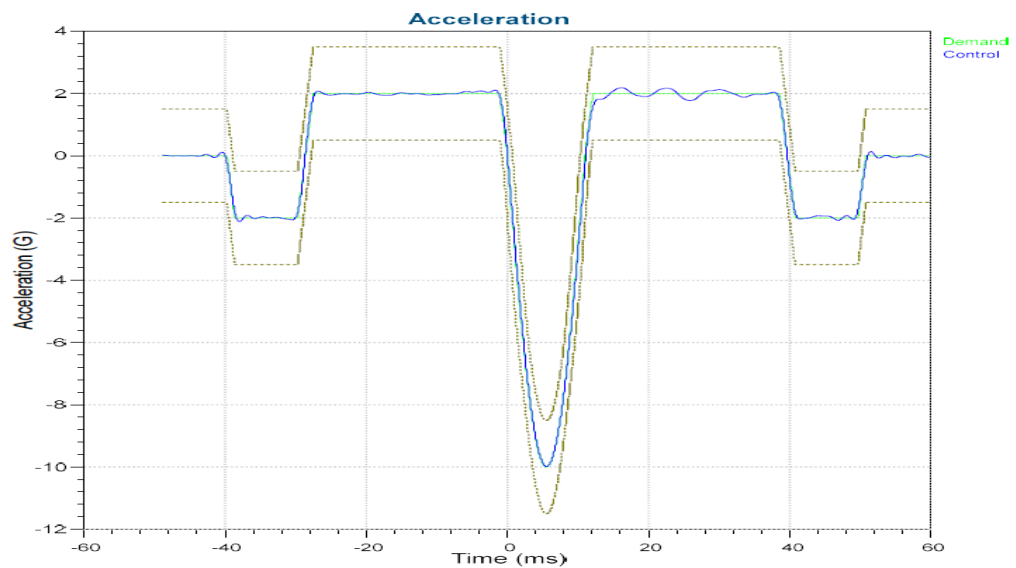
Z-

6 26, 2025 17:17:25 Level 2) 100 % Output: 0.6896 Volts peak 2025-05-02 NEMA TS-2 2.2.5

Demand: 10 G

Control: 9.986 G Pulse: 1 of 1 End of Test
