# TEST REPORT

REPORT No.:  
CTK-2024-00022  
Page (1) / (19) pages

NETWORK CAMERA / PNO-A9311R  
PoE Injector / PT-PSE106GBR-AH-S

Specifications presented by the sponsor  
(reference NEMA TS 2.2.7 ~ 9)

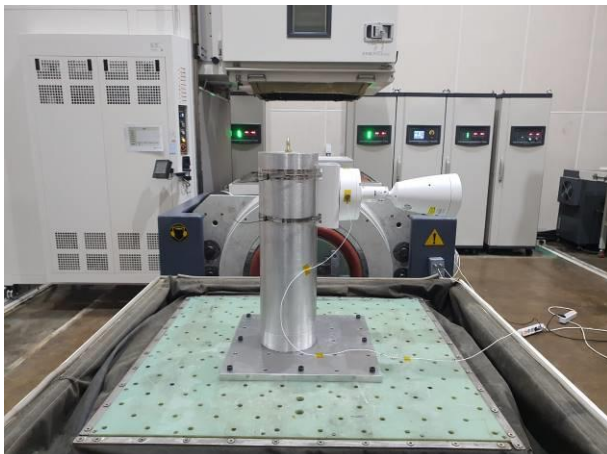
Resonant search - Y axis,  
Endurance, Test Shock(impact) Test Same  
configuration
