# TEST REPORT

REPORT No.:  
CTK-2025-01909  
Page (1) / (39) pages

NETWORK CAMERA / PNV-A9082RZ

EN 60068-2-1, EN 60068-2-2, EN 60068-2-14, EN 60068-2-6, EN  
60068-2-27, EN 60068-2-78, IEC 60068-2-1, IEC 60068-2-2, IEC  
60068-2-14, IEC 60068-2-6, IEC 60068-2-27, IEC 60068-2-78

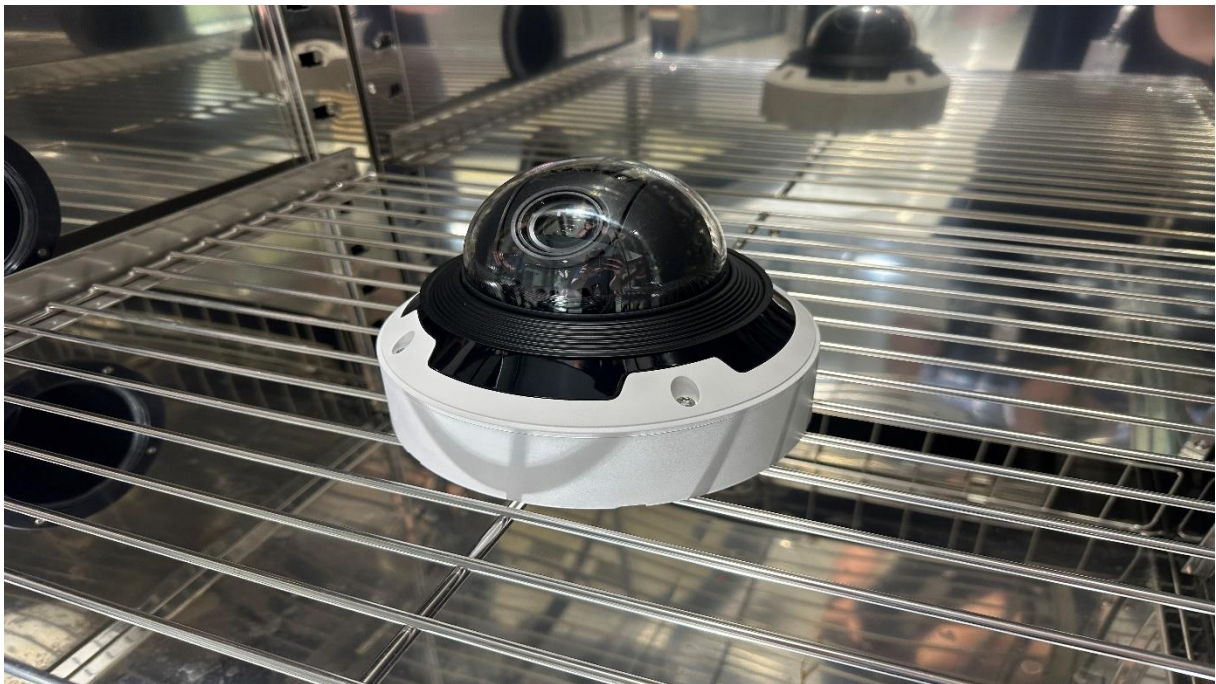
#### 3.3.1 Evidence of test setting

3.2.1 Sample status: Non-operation

3.2.2 Test temperature: -50 °C

3.2.3 Test time: 16 h

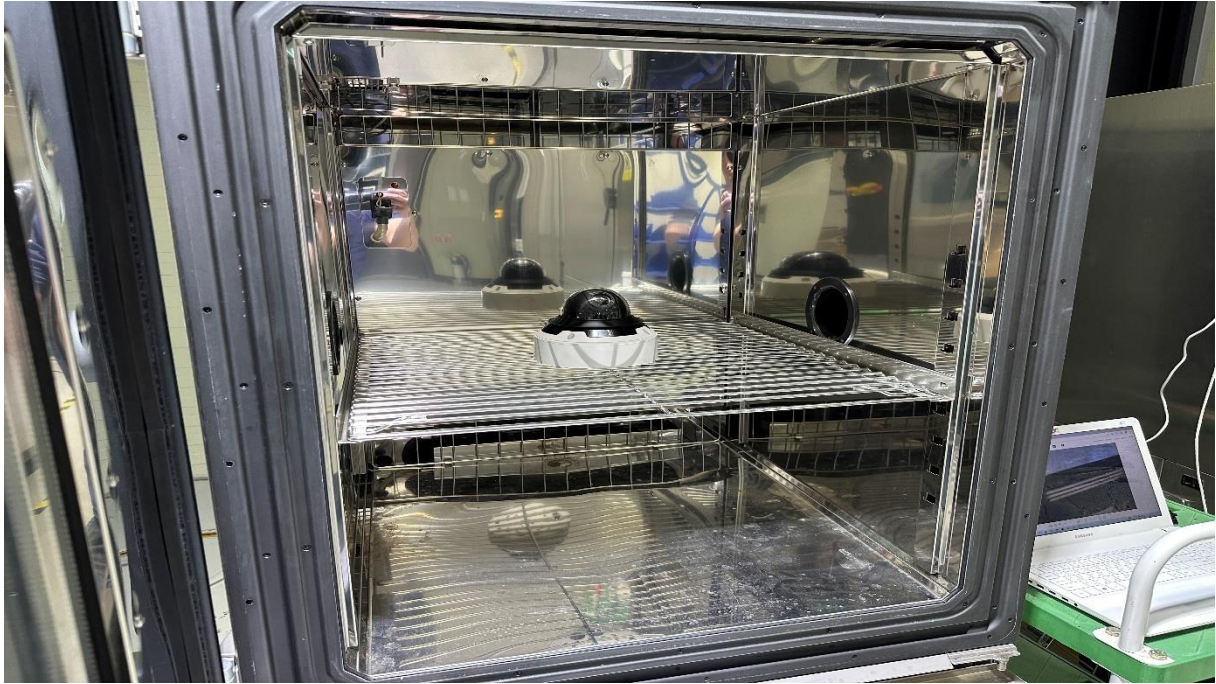
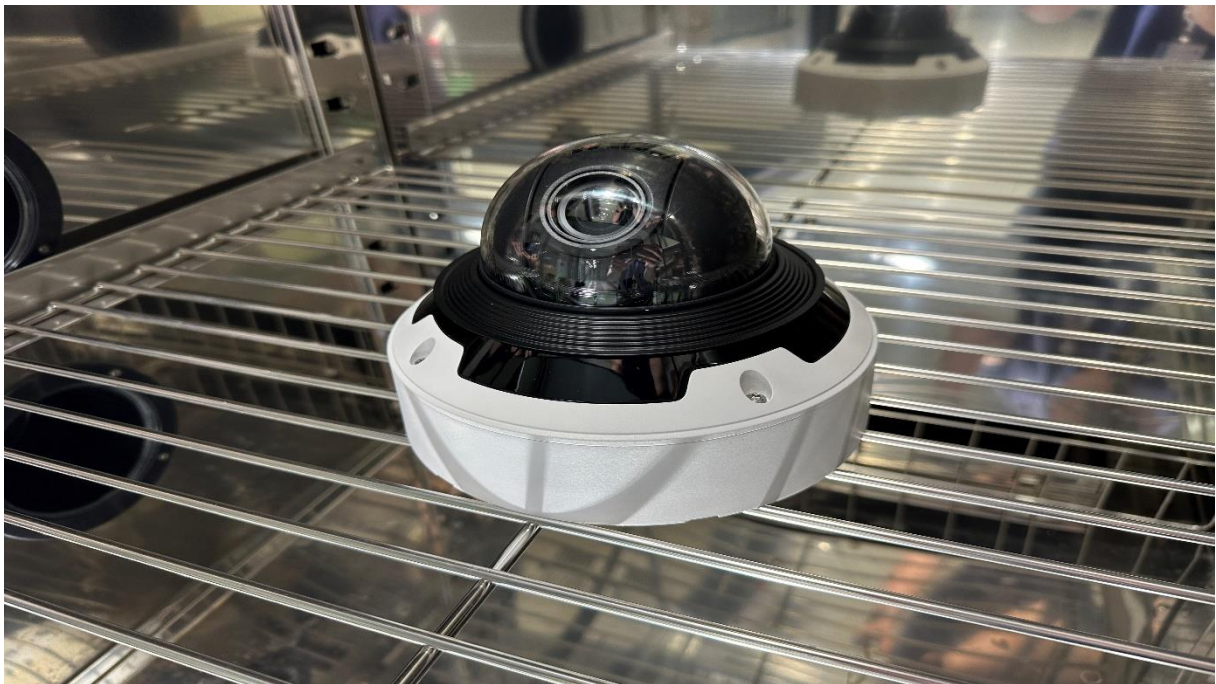
#### 4.3.1 Evidence of test setting

4.2.1 Sample status: Non-operation

4.2.2 Test temperature: 60 °C

4.2.3 Test time: 96 h

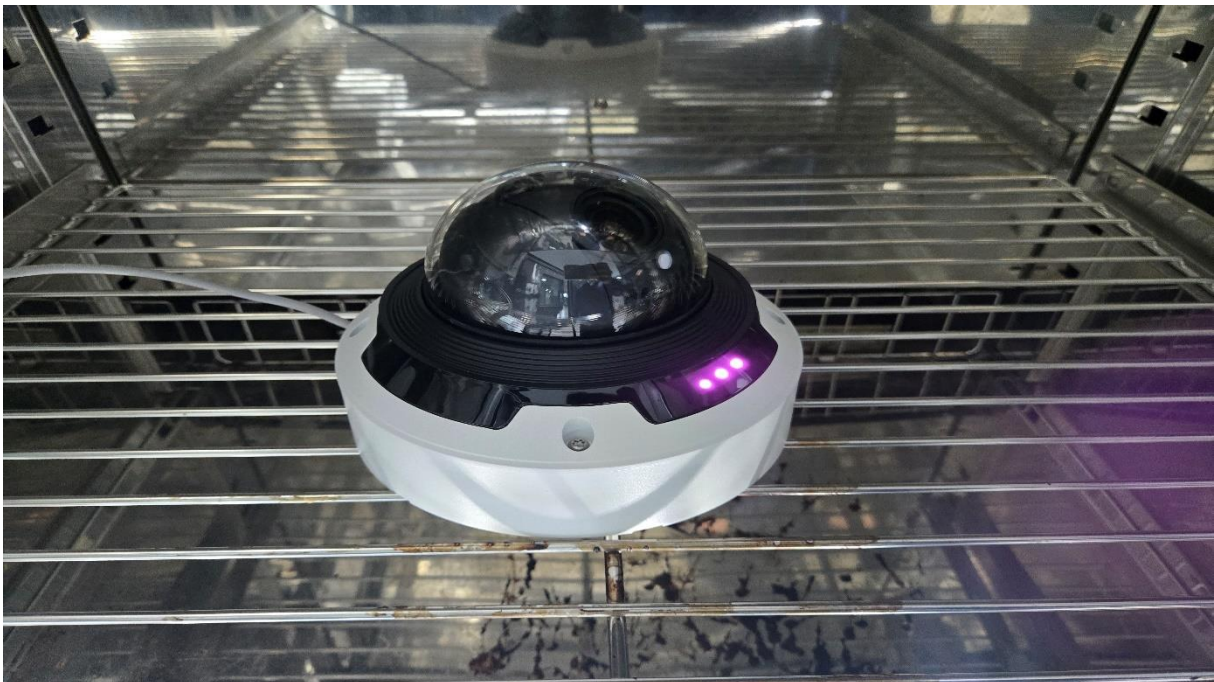
#### 5.3.1 Evidence of test setting

5.2.1 Sample status: operation

5.2.2 Test temperature: -50 °C, 55 °C

| Temp↵ | Temperature change rate(°C/min)↵ | t <sub>1</sub> (idle time)↵ | Cycles↵ |
| High↵ | 5 °C/min↵ | 3 h↵ | 3↵ |
| Low↵ | 1 °C/min↵ | 3 h↵ | 3↵ |

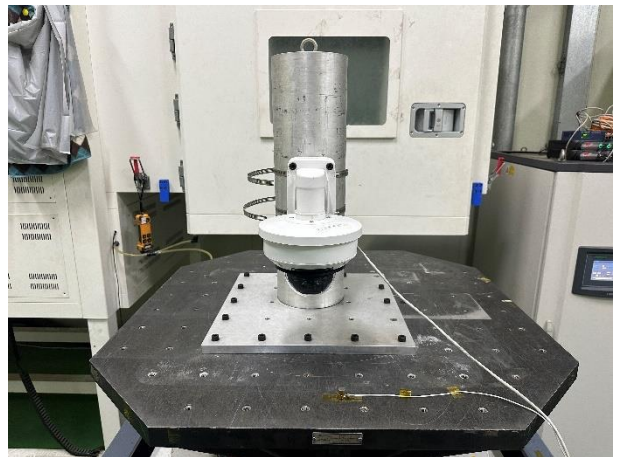
#### 6.3.1 Evidence of test setting

- Sample status: operation
- Frequency(Hz): 5 Hz ~ 200 Hz
- Acceleration(G): 1 G
- Sweep rate: 1 oct/min
- Test Axis: X, Y, Z
- Test time(h): Total 30 min (10 min. per each axis)

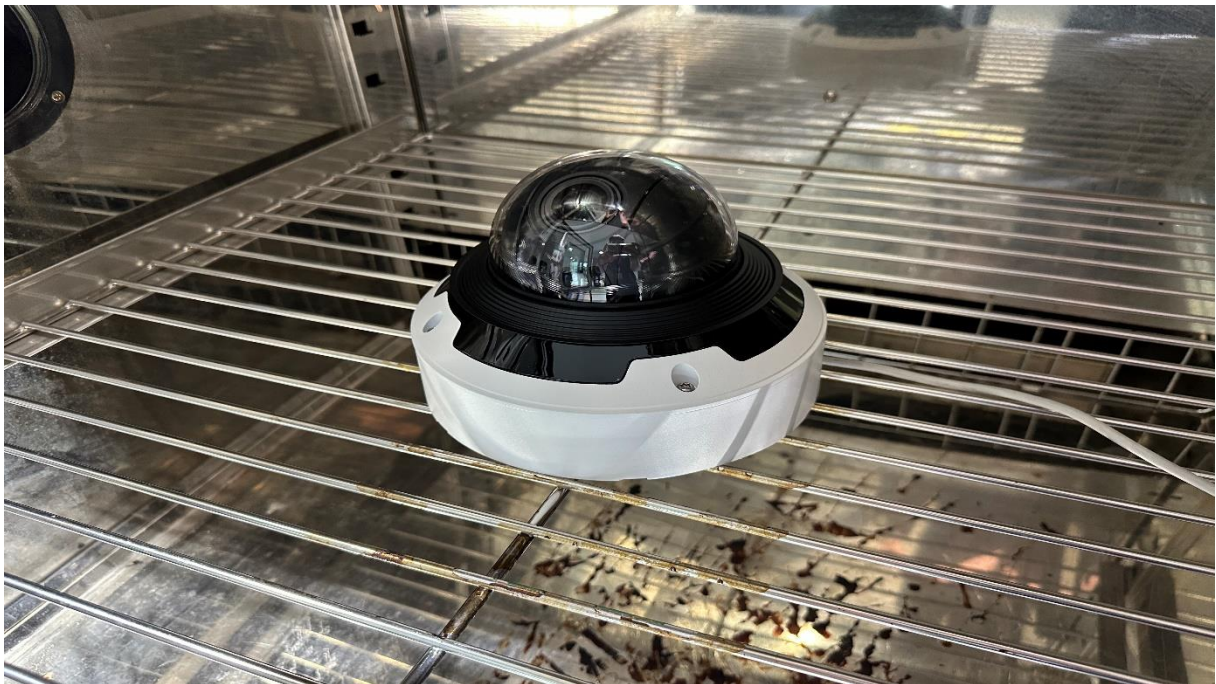
#### 8.3.1 Evidence of test setting

8.2.1 Sample status: operation

8.2.2 Test temperature:  $40 \pm 2$  °C

8.2.3 Test Humidity:  $93 \pm 3$  % R.H.

8.2.4 Test time: 240 h
