# TEST REPORT

REPORT No.:  
CTK-2025-01910  
Page (1) / (26) pages

NETWORK CAMERA / PNV-A9082RZ

NEMA TS 2-2013 2.2.7.3 Test C ~ 2.2.7.8 Test H,  
NEMA TS 2.2.8, NEMA TS 2.2.9

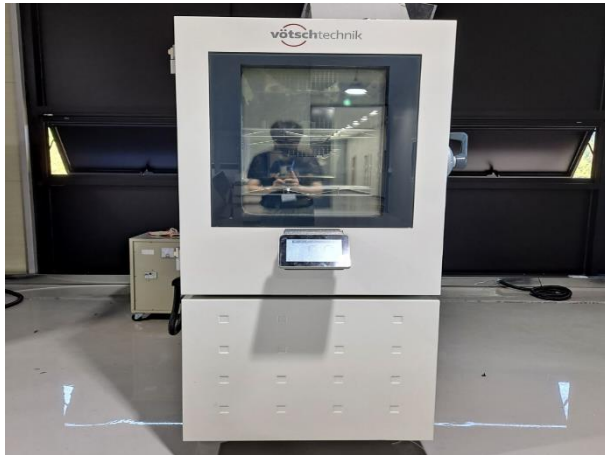
Temperature & Humidity Chamber

| Testing equipment | Model Name | Manufacturer | Manufacturing Number | Calibration Date |
|---|---|---|---|---|
| Temperature & Humidity Chamber | C4-340 | Weisstechnik | 54260023190010 | Feb 6, 2026 |

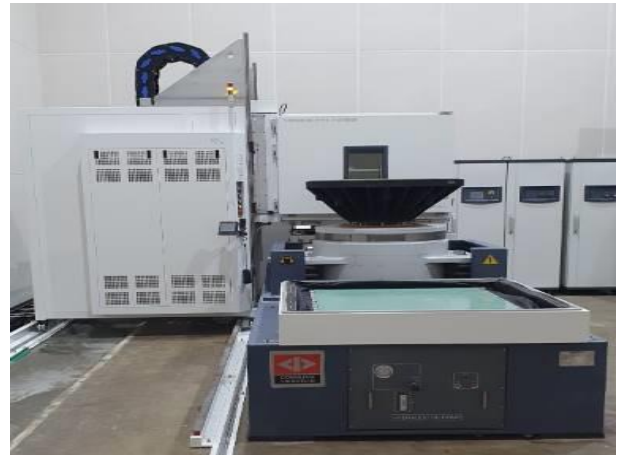
VIBRATION TESTING SYSTEM

| Testing equipment | Model Name | Manufacturer | Manufacturing Number | Calibration Date |
|---|---|---|---|---|
| VIBRATION TESTING SYSTEM | LT1010 | FAMTECH | D2012335 | N/A |

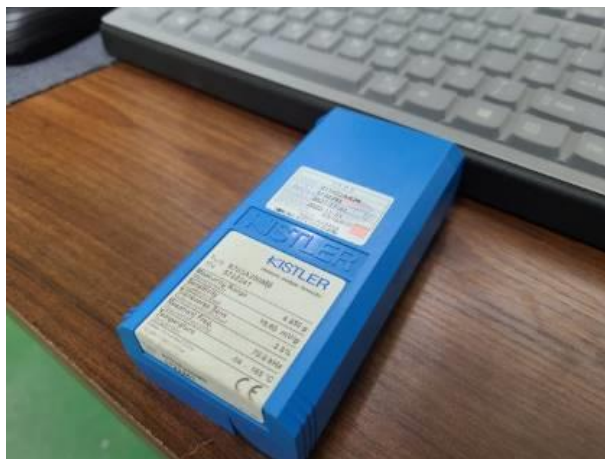
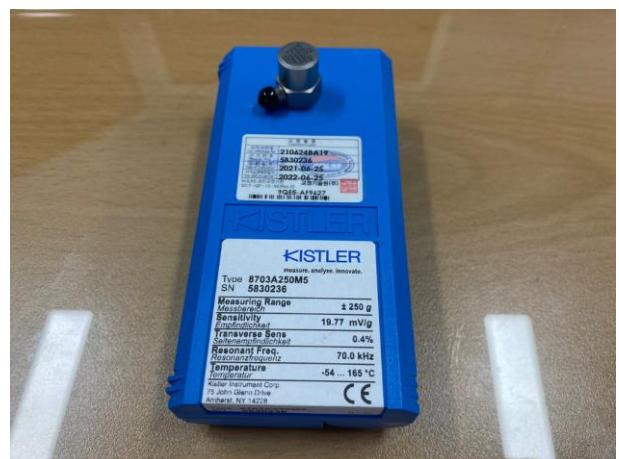
8703A250M5

| Testing equipment | Model Name | Manufacturer | Manufacturing Number | Calibration Date |
|---|---|---|---|---|
| Acceleration sensor | 8703A250M5 | KISTLER | 5830236 | Jan. 16, 2026 |
| Acceleration sensor | 8703A250M5 | KISTLER | 5722241 | Jan. 16, 2026 |

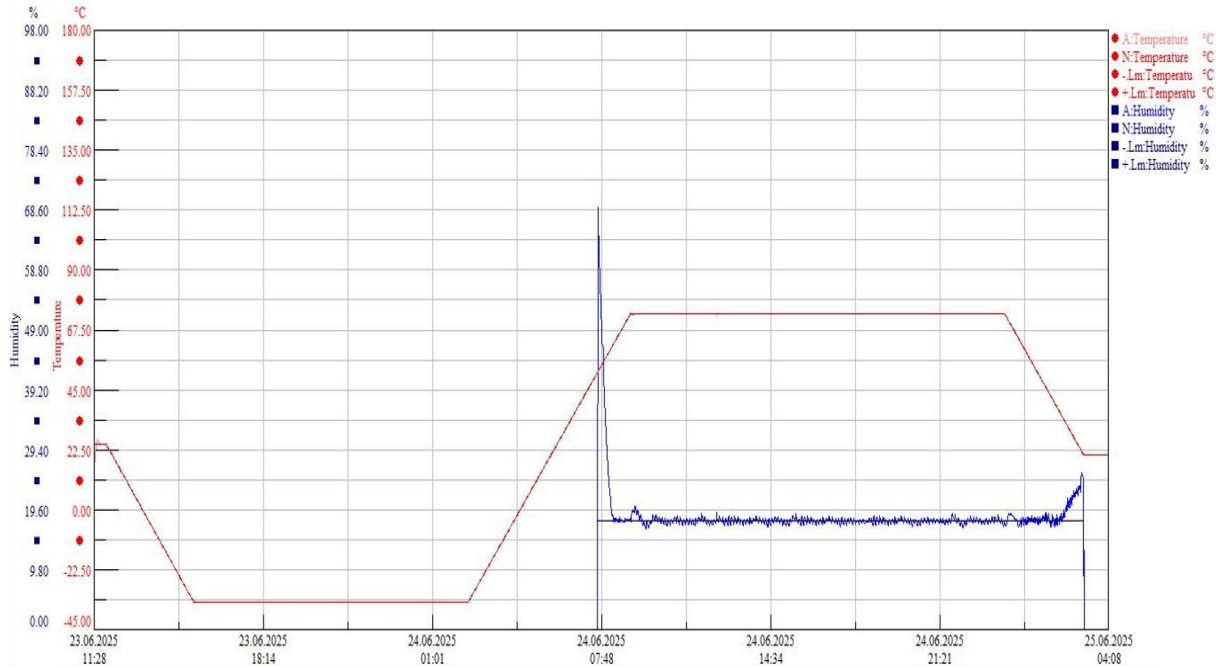
Temperature Data

- 3.2.1 2.2.7.3 Test C: - 34 °C, 89 Vac, 10 h (Check interim operation after 5 h and operation check after 10h)
- 3.2.2 2.2.7.4 Test D: - 34 °C, 135 Vac, 1 h (Operating state)
- 3.2.3 2.2.7.5 Test E: 74 °C, 18 %, 135 Vac, 15 h (Operating state)
- 3.2.4 2.2.7.6 Test F: 74 °C, 18 %, 89 Vac (Operation check after 2.2.7.5 Test E)
- 3.2.5 2.2.7.7 Test G: (21 ±6) °C, 120 Vac (Operating state)
- 3.2.6 2.2.7.8 Test H: Check for mechanical damage

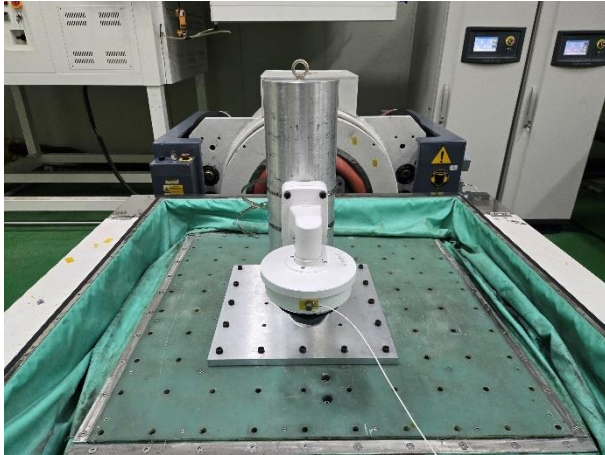
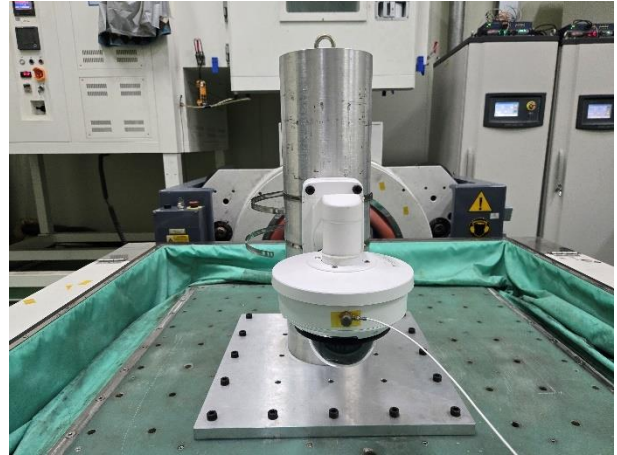
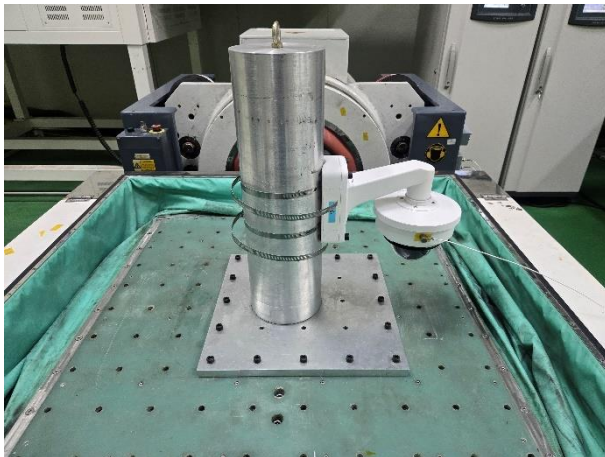
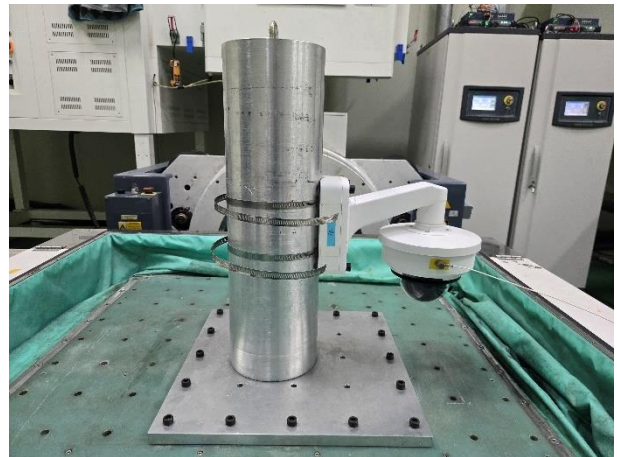
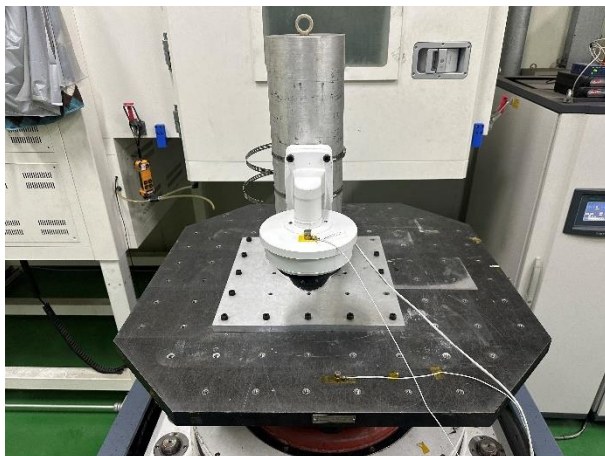
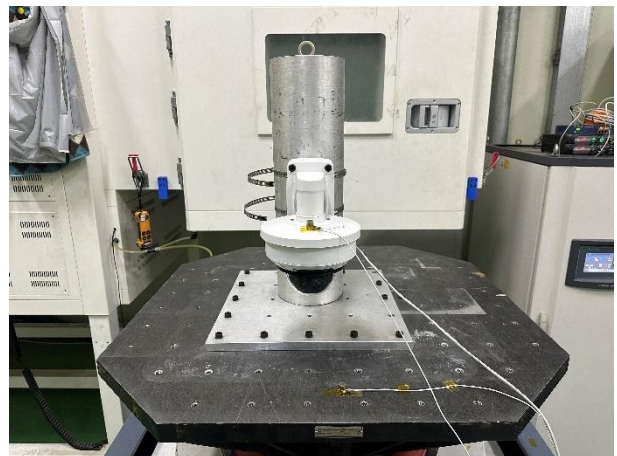
#### 4.3.1 Evidence of test setting (NEMA TS 2-2013 2.2.8)

- Sample status : unpackaged / not in operation
- Applied waveform : Sine
- Frequency(Hz) : 5 ~ 30
- Double amplitude displacement (inch) : 0.015
- Sweep rate(Sweep/min) : 12.5

- Applicable axis : X, Y, Z
- Test time(h) : 12.5
- Evaluation items
  - Check for mechanical damage before and after testing
- Test methods
  - With the test unit securely fastened to the test table, set the test table for a double amplitude displacement of 0.015 inch.

- Cycle the test table over a search range from 5 to 30 Hz and back within a period of 12.5 minutes.
  - Conduct the resonant frequency search in each of the three mutually perpendicular planes.

- Sample status : unpackaged / not in operation
- Applied waveform : Sine
- Frequency(Hz) : 30 or 3.2.2 Test results
- Acceleration(G) : 0.5
- Applicable axis : X, Y, Z
- Test time(h) : All 3(Each axis 1)
- Evaluation items
  - Check for mechanical damage before and after testing
- Test methods
  - Vibrate the test unit in each plane at its resonant frequency for a period of 1 hour at an amplitude resulting in 0.5 g acceleration. (test profile)
  - When more than one resonant frequency has been recorded in accordance with Section 1.2 Item 4, the test period of 1 hour shall be divided equally between the resonant frequencies.
  - The total time of the endurance test shall be limited to 3 hours, 1 hour in each of three mutually perpendicular planes.

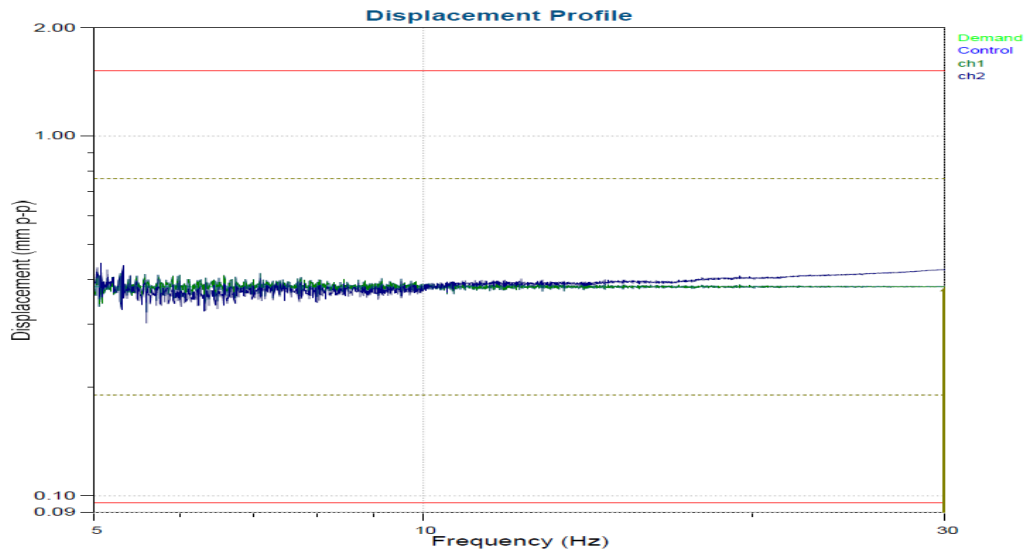
### Resonant search Test ( Z Axis )

6/27, 2025 10:19:41 Level 1) 100 % Output: 0 Volts peak NEMA TS-2 2.2.8 - search.  
Demand: 0.381 mm Level Time: 0:12:30 Frequency: 30 Hz  
Control: 0.0004265 mm Total Time: 0:12:36 End of Sweep Test

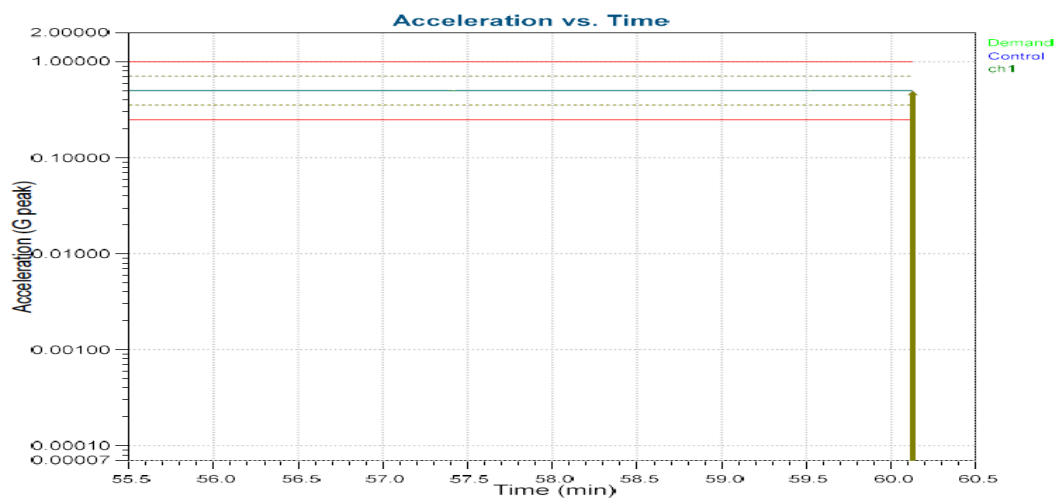
### Endurance Test ( Z Axis )

6/27, 2025 11:21:53 Level 1) 100 % Output: 0 Volts peak 한화비전 공진 L  
Demand: 0.5 G Level Time: 1:00:00 Frequency: 30 Hz  
Control: 8.122e-05 G Total Time: 1:00:08 End of Timed Test

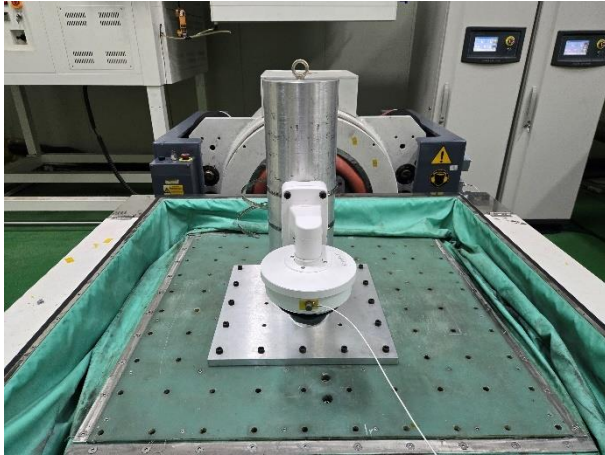
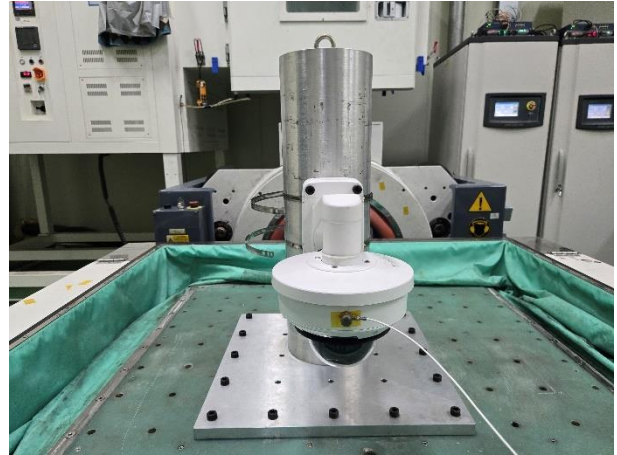
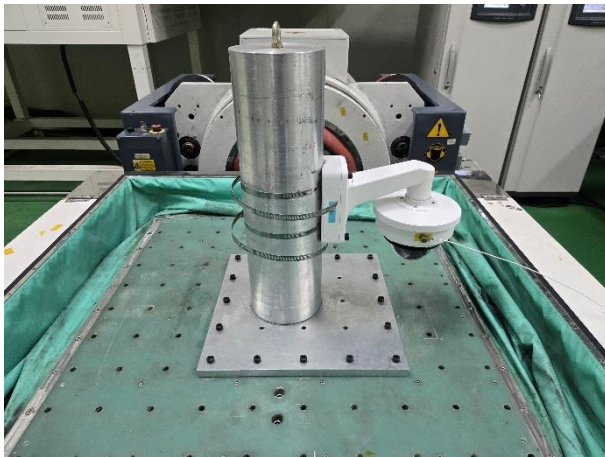
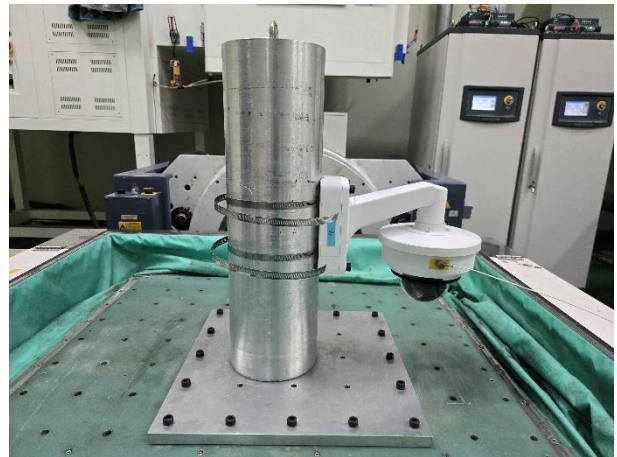
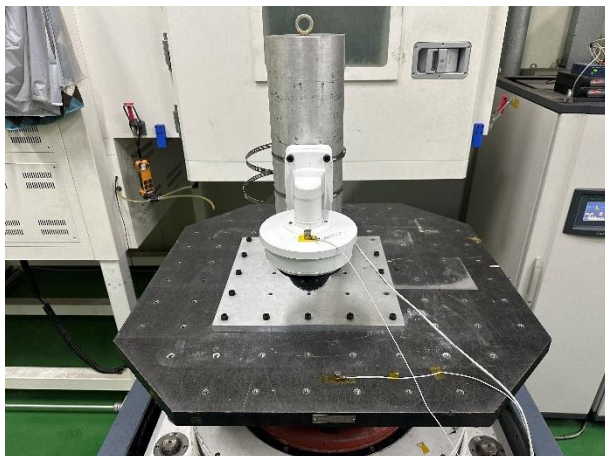
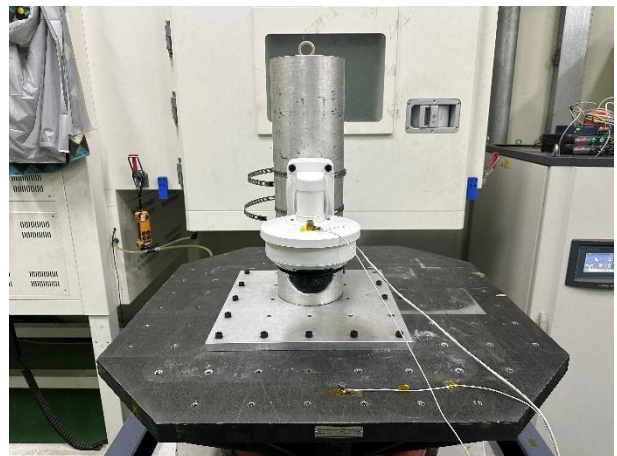
#### 5.3.1 Evidence of test setting (NEMA TS 2-2013 2.2.9)

5.2.1 Sample status: unpackaged / not in operation

5.2.2 Applied waveform: Half sine

5.2.3 Acceleration(G): 10 G

5.2.4 Nominal duration (ms): 11

5.2.5 Applicable axis : X, Y, Z

5.2.6 Number of impacts: 1 per direction (total 6)

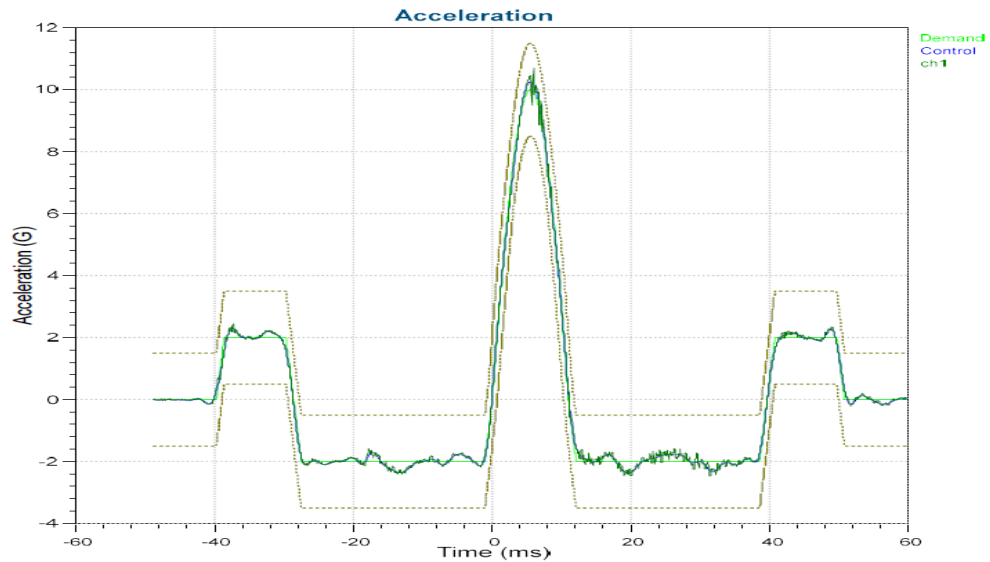
X+

6 25, 2025 15:36:19 Level 1) 100 % Output: 0.7255 Volts peak 2025-05-02 NEMA TS-2 2.2.5

Demand: 10 G

Control: 10.25 G Pulse: 1 of 1 Running

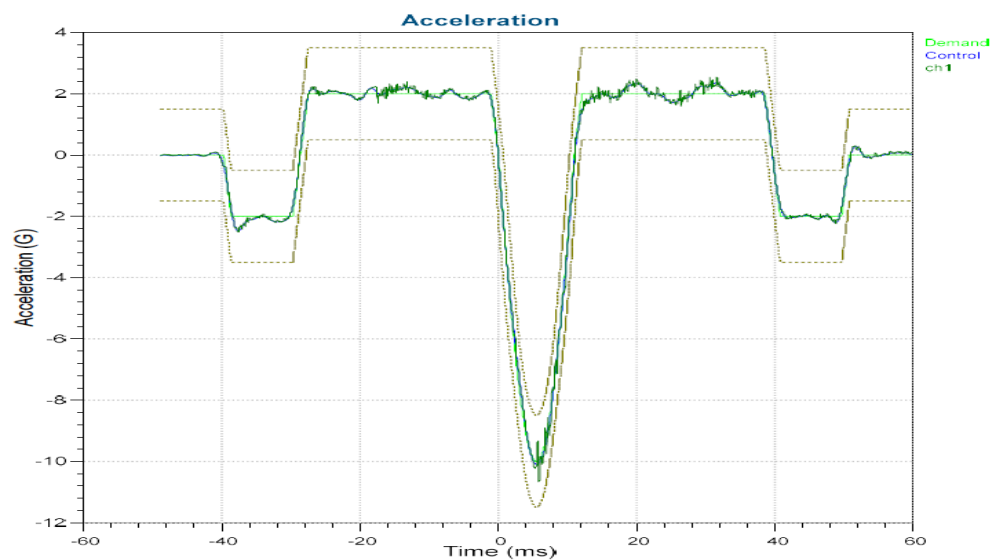
X-

6 25, 2025 15:36:24 Level 2) 100 % Output: 0.7279 Volts peak 2025-05-02 NEMA TS-2 2.2.5

Demand: 10 G

Control: 10.1 G Pulse: 1 of 1 End of Test

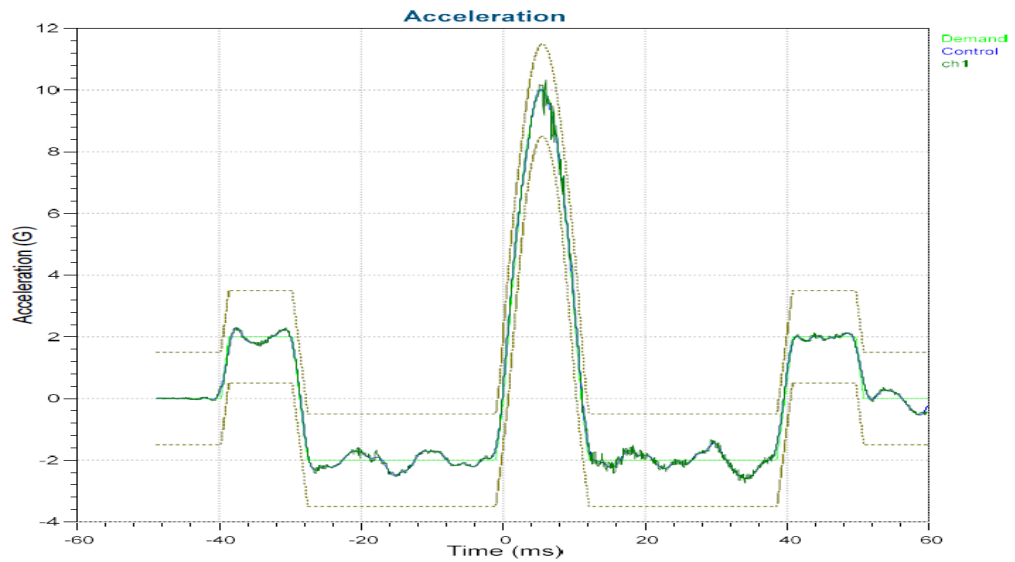
Y+

6 25, 2025 16:58:22 Level 1) 100 % Output: 0.7418 Volts peak 2025-05-02 NEMA TS-2 2.2.5

Demand: 10 G

Control: 10.02 G Pulse: 1 of 1 Running

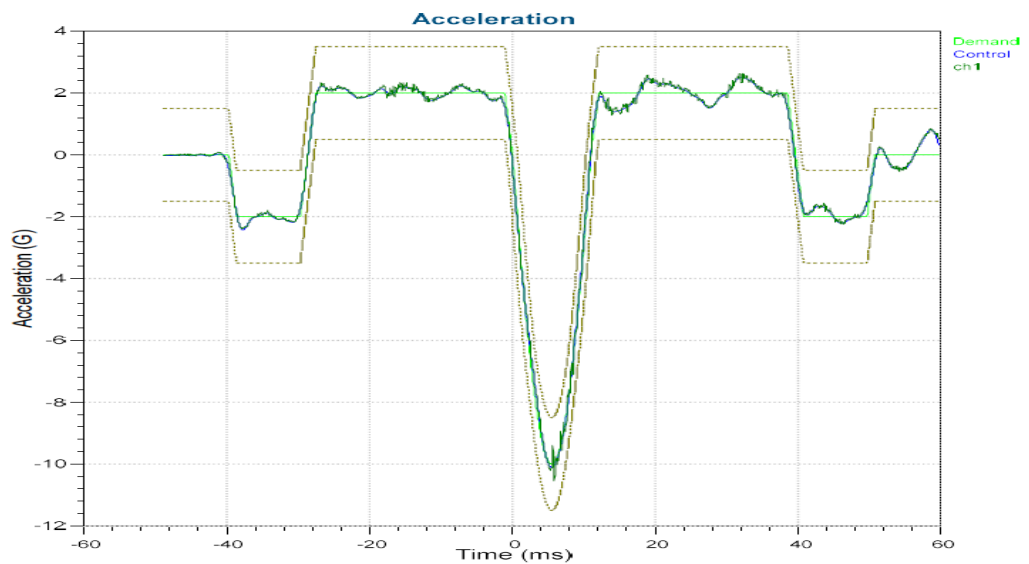
Y-

6 25, 2025 16:58:35 Level 2) 100 % Output: 0.746 Volts peak 2025-05-02 NEMA TS-2 2.2.5

Demand: 10 G

Control: 10.11 G Pulse: 1 of 1 End of Test
