# TEST REPORT

REPORT No.:  
CTK-2025-02841  
Page (1) / (39) pages

LENS MODULE / SLA-F2480BA

EN 60068-2-1, EN 60068-2-2, EN 60068-2-14, EN 60068-2-6, EN  
60068-2-27, EN 60068-2-78, IEC 60068-2-1, IEC 60068-2-2, IEC  
60068-2-14, IEC 60068-2-6, IEC 60068-2-27, IEC 60068-2-78

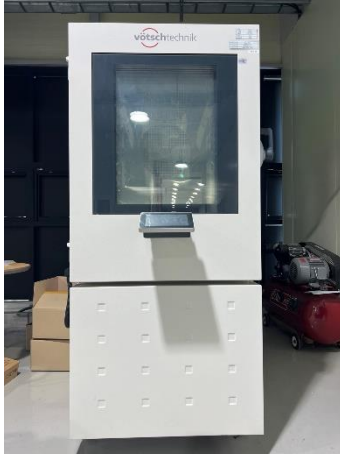
Temperature & Humidity Chamber

| Testing equipment | Model Name | Manufacturer | Manufacturing Number | Calibration Date |
|---|---|---|---|---|
| Temperature & Humidity Chamber | C4-340 | Weisstechnik | 54260023190010 | Feb. 6, 2026 |

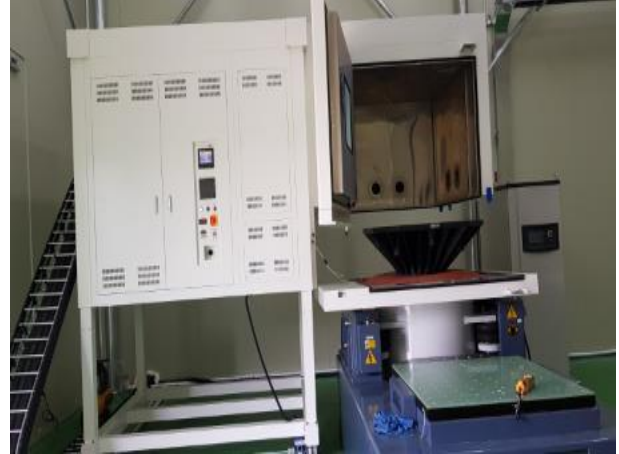
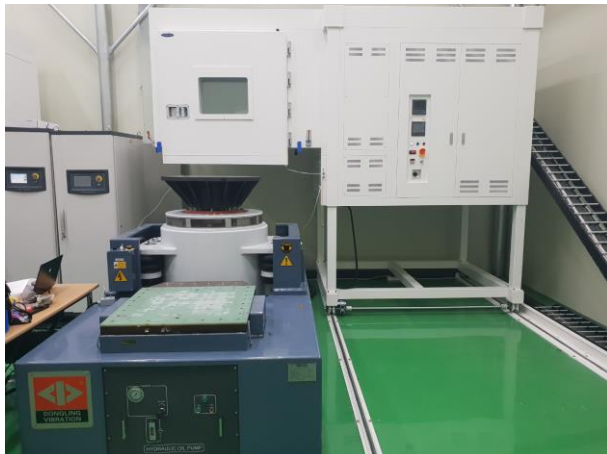
VIBRATION TESTING SYSTEM

| Testing equipment | Model Name | Manufacturer | Manufacturing Number | Calibration Date |
|---|---|---|---|---|
| VIBRATION TESTING SYSTEM (UH1 1000T) | GT1000M | FAMTECH | D1803072 | N/A |
| VIBRATION TESTING SYSTEM (UH1 800T) | GT1000M | FAMTECH | D1803072-1 | N/A |

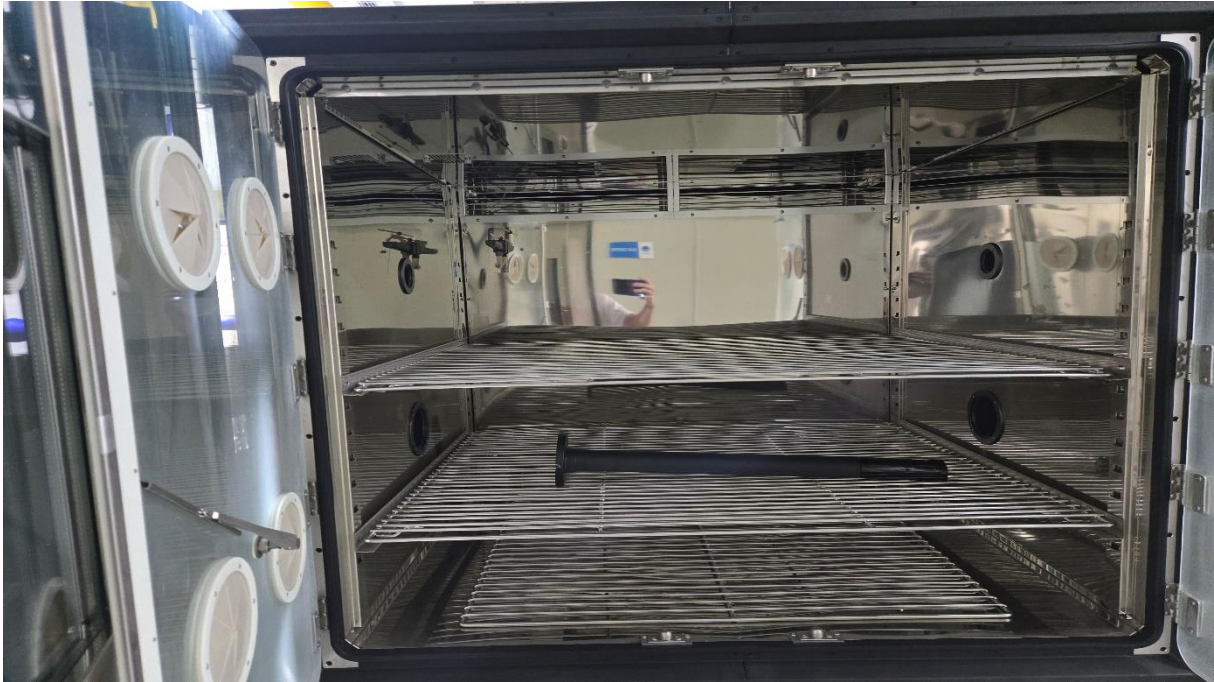
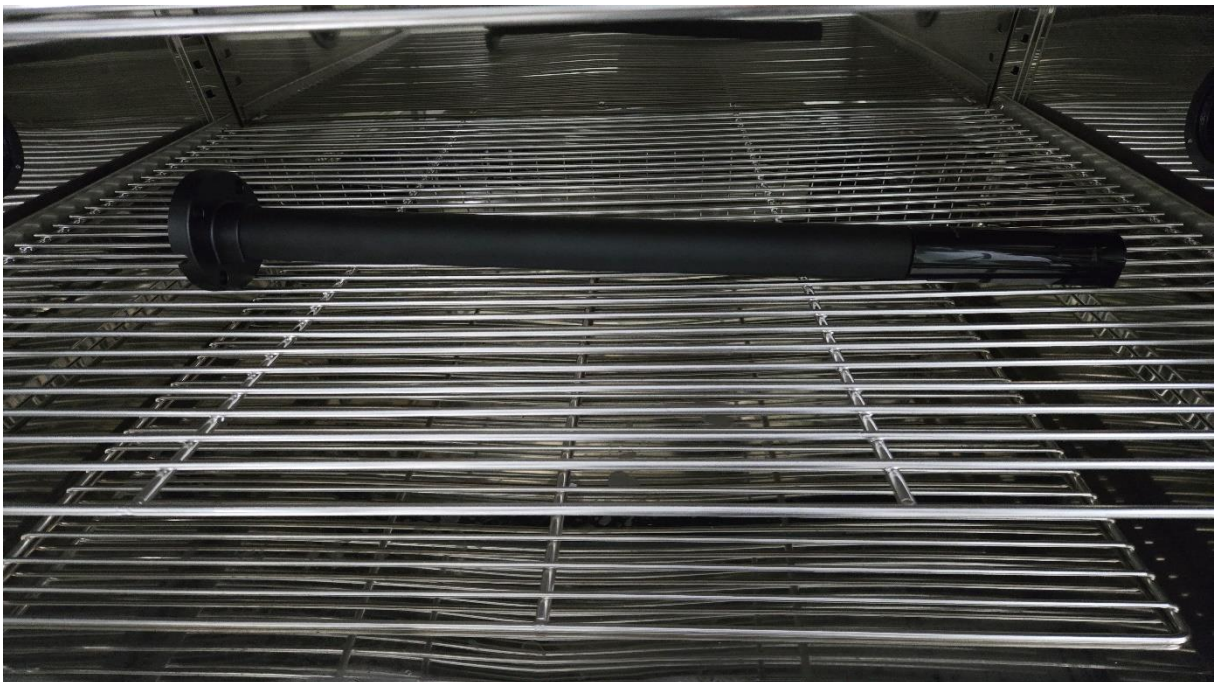
#### 3.3.1 Evidence of test setting

3.2.1 Sample status: Non-operation

3.2.2 Test temperature: -33 °C

3.2.3 Test time: 16 h

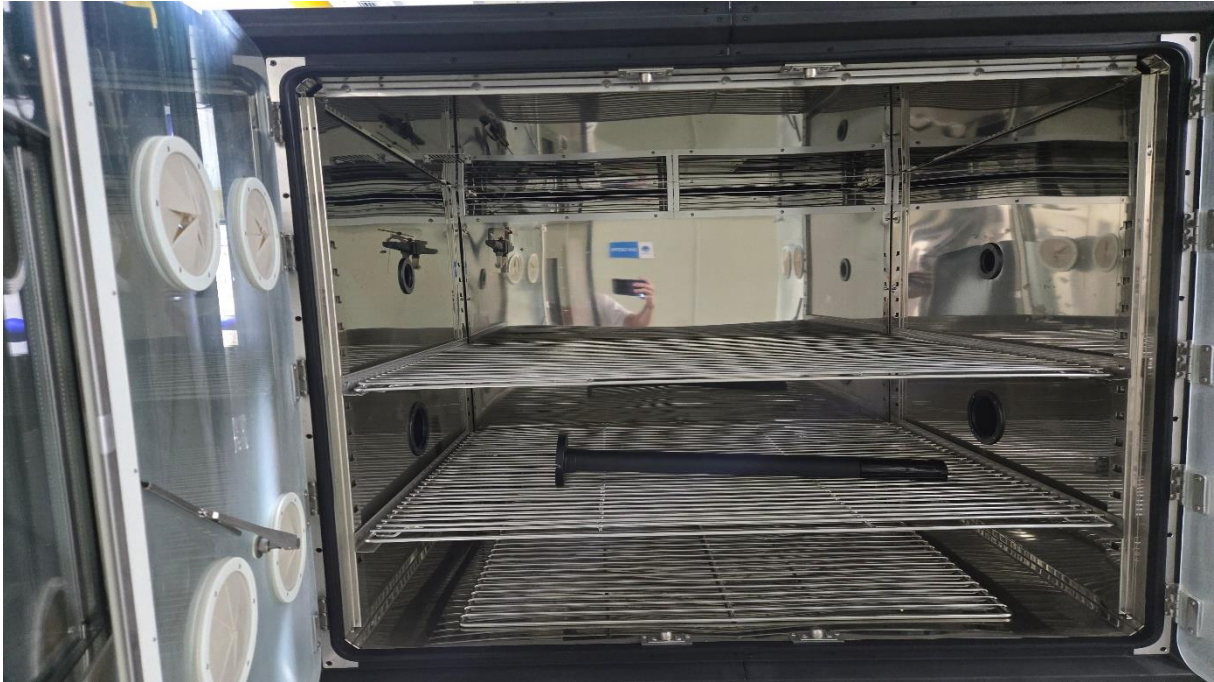
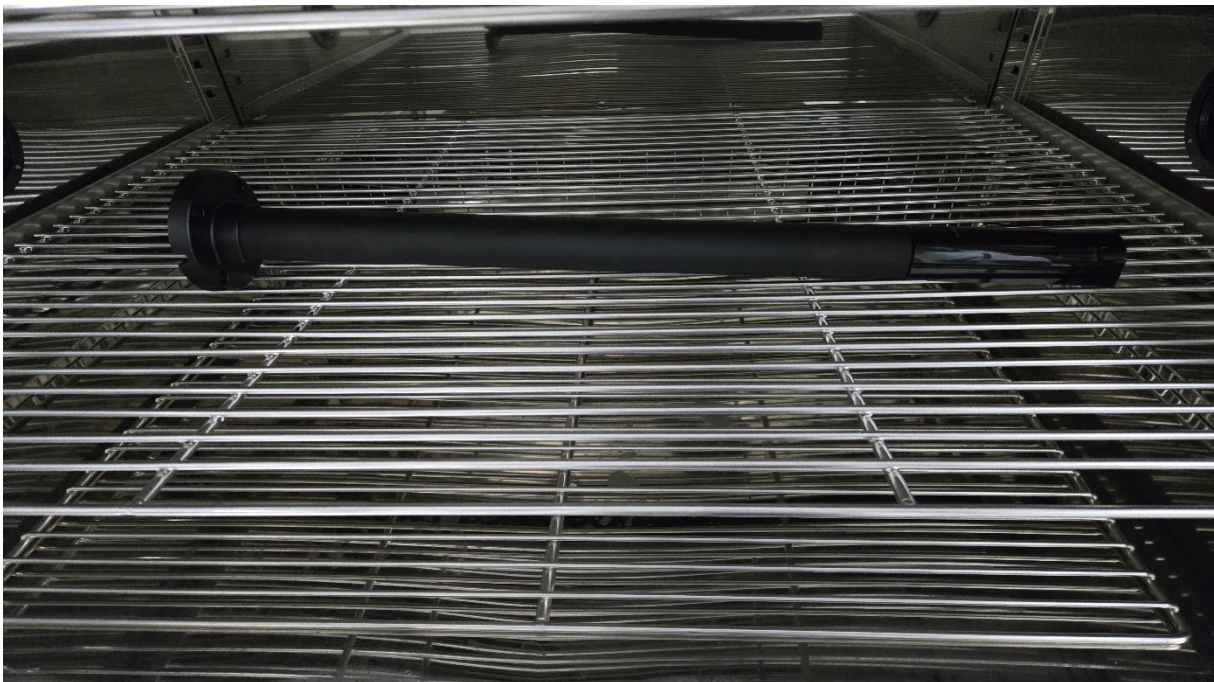
#### 4.3.1 Evidence of test setting

4.2.1 Sample status: Non-operation

4.2.2 Test temperature: 60 °C

4.2.3 Test time: 96 h

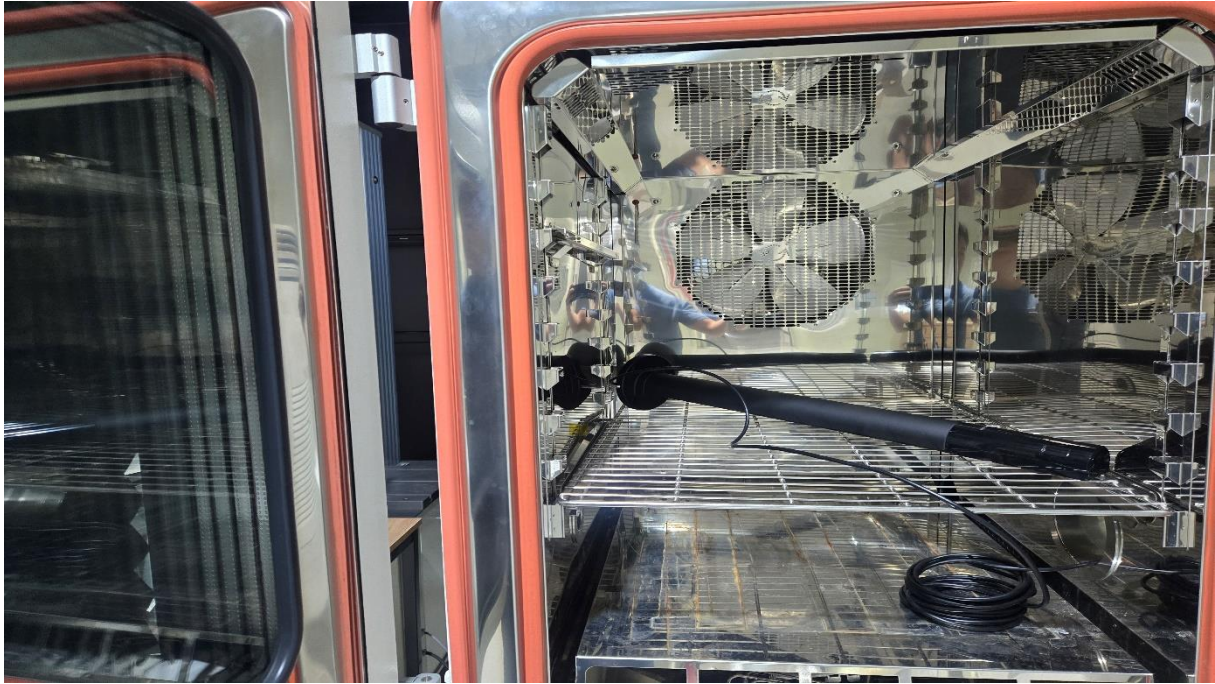
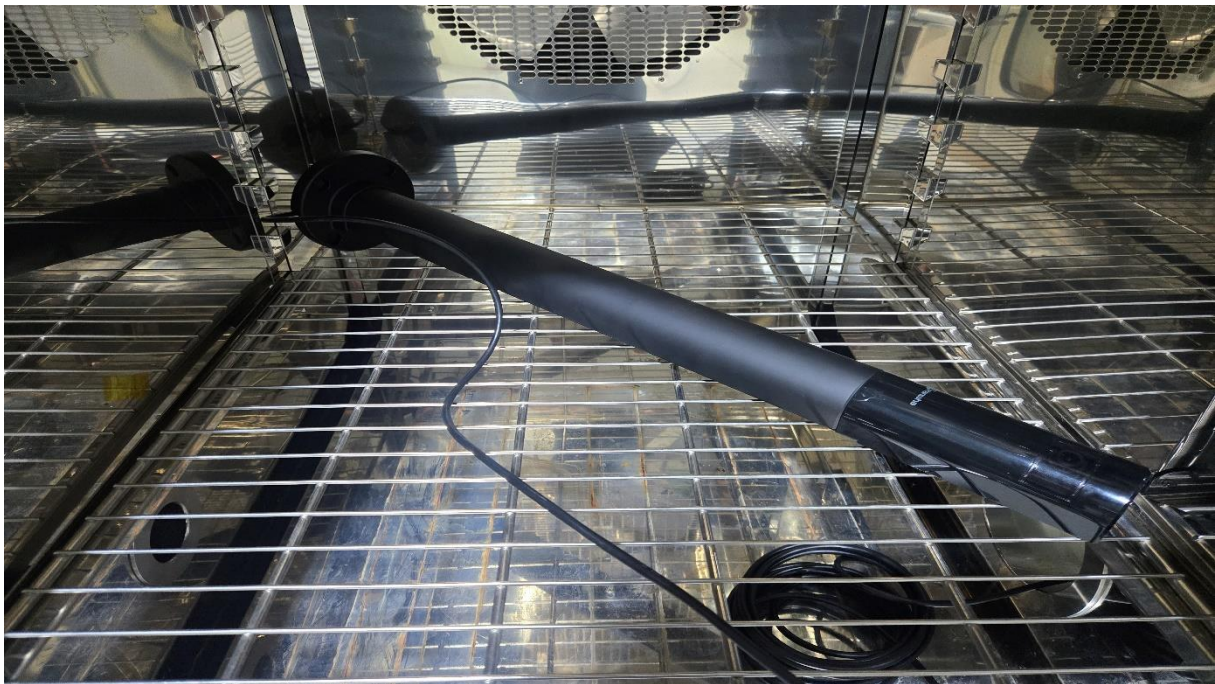
#### 5.3.1 Evidence of test setting

5.2.1 Sample status: operation

5.2.2 Test temperature: -10 °C, 55 °C

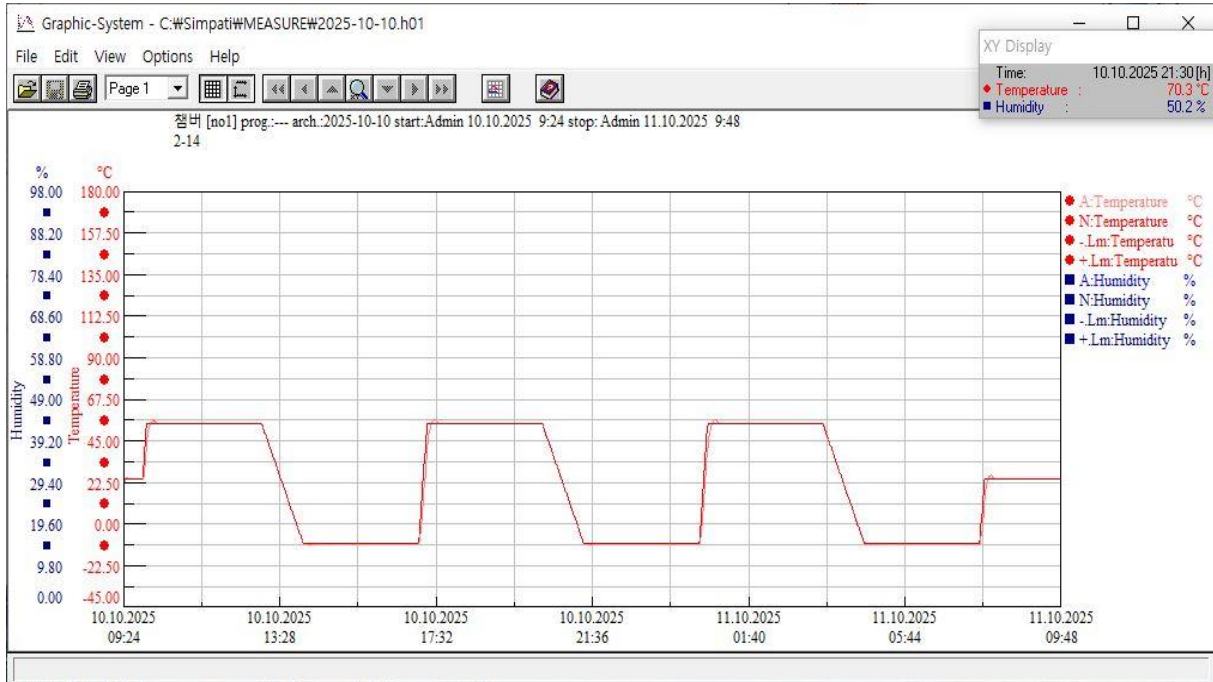
### 5.5.1 Test data and graph

| Temp↵ | Temperature change rate(°C/min)↵ | t <sub>1</sub> (idle time)↵ | Cycles↵ |
| High↵ | 5 °C/min↵ | 3 h↵ | 3↵ |
| Low↵ | 1 °C/min↵ | 3 h↵ | 3↵ |

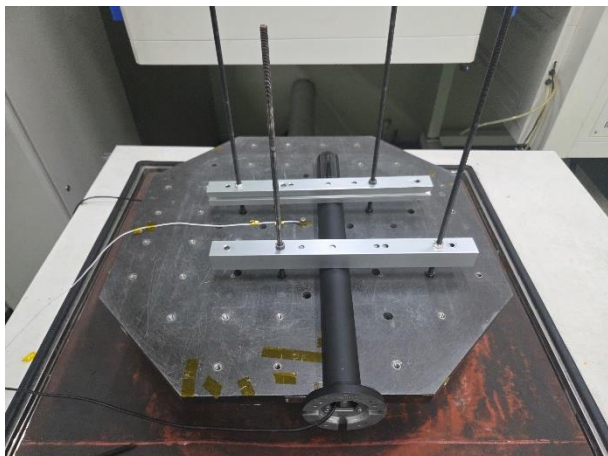
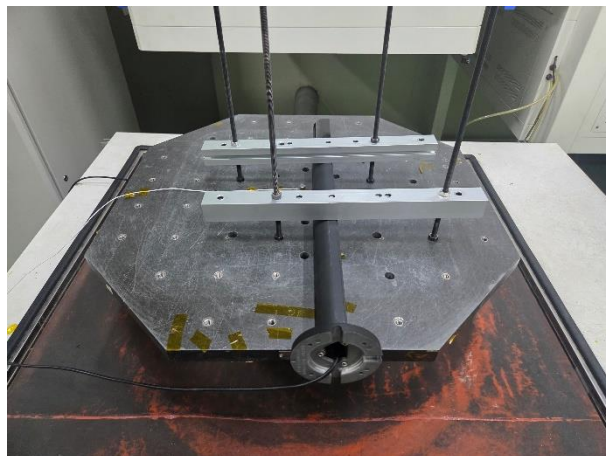
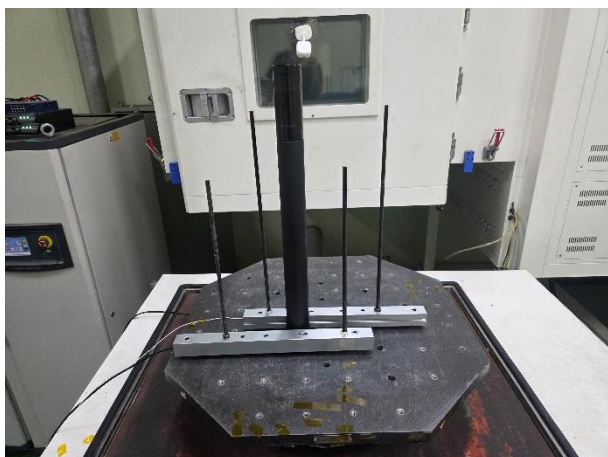
### 6.3.1 Evidence of test setting

- Sample status: operation
- Frequency(Hz): 5 Hz ~ 200 Hz
- Acceleration(G): 1 G
- Sweep rate: 1 oct/min
- Test Axis: X, Y, Z
- Test time(h): Total 30 min (10 min. per each axis)

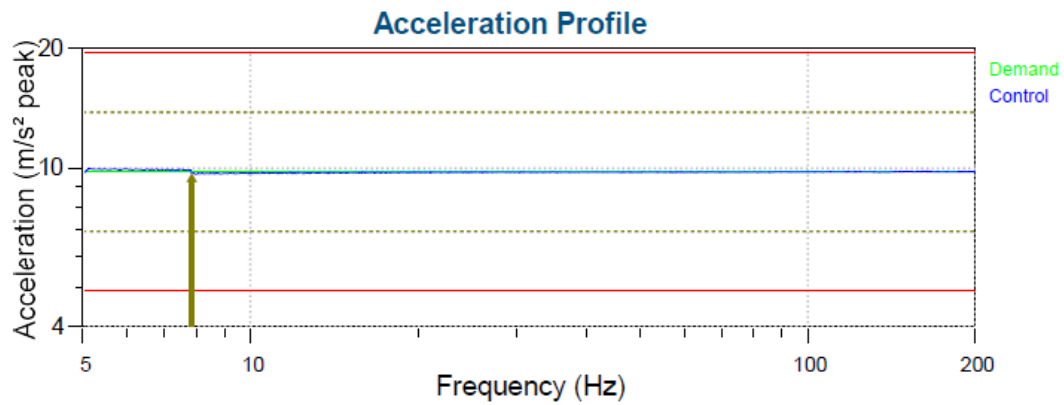
### 6.5.2 Test data and graph (Vibration Test Y Axis)

10 14, 2025 10:36:55 Level 1) 100 %    Output: 0.3608 Volts peak    60068-2-6  
Demand: 9.807 m/s<sup>2</sup>    Level Time: 0:10:00    Frequency: 7.846 Hz  
Control: 9.73 m/s<sup>2</sup>    Total Time: 0:10:12    End of Timed Test

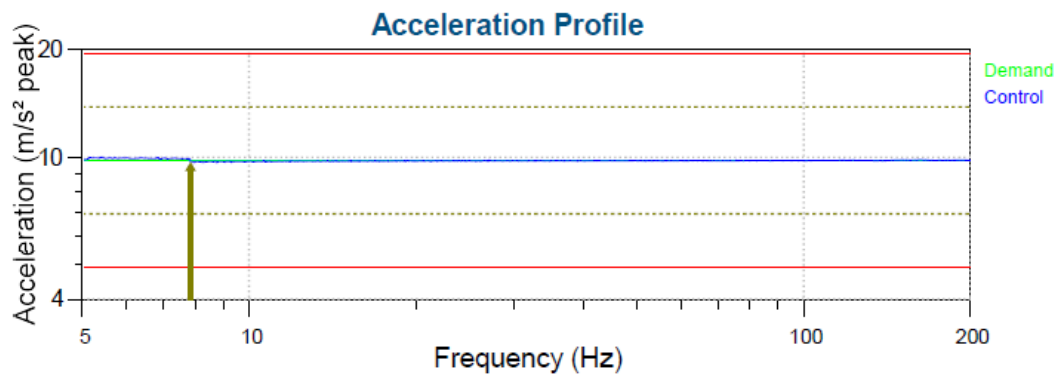
### 6.5.3 Test data and graph (Vibration Test Z Axis)

10 14, 2025 10:59:19 Level 1) 100 %    Output: 0.3601 Volts peak    60068-2-6  
Demand: 9.807  $\text{m/s}^2$     Level Time: 0:10:00    Frequency: 7.841 Hz  
Control: 9.715  $\text{m/s}^2$     Total Time: 0:10:12    End of Timed Test

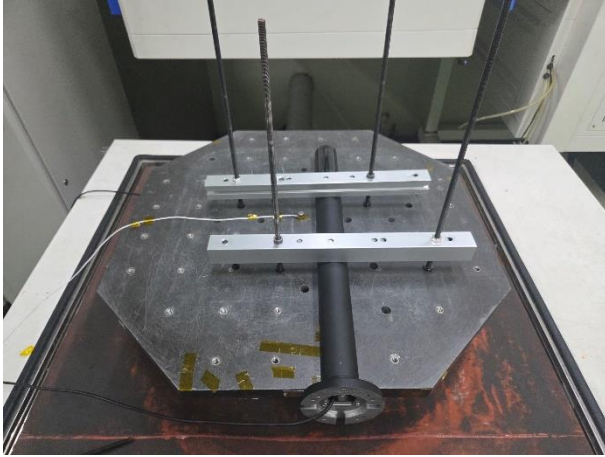
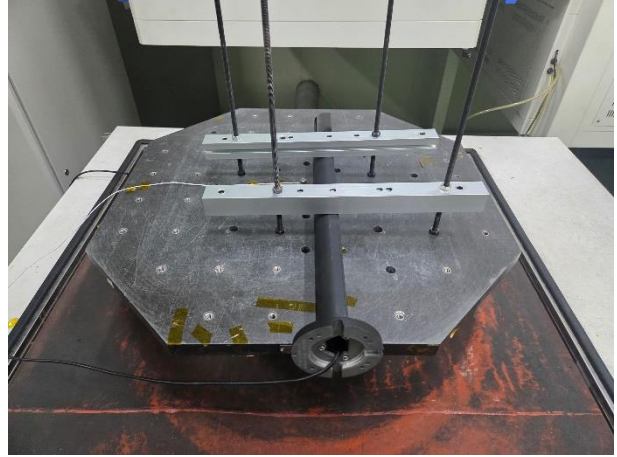
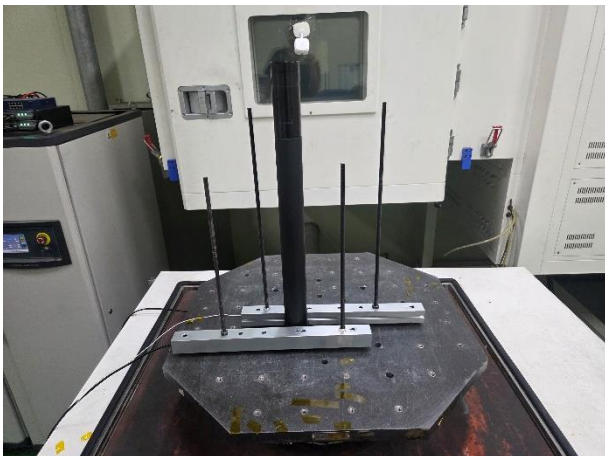
### 7.3.1 Evidence of test setting

7.2.1 Sample status: Non-operation

7.2.2 Acceleration( $\text{m/s}^2$ ):  $150 \text{ m/s}^2$

7.2.4 Test Axis: X, Y, Z

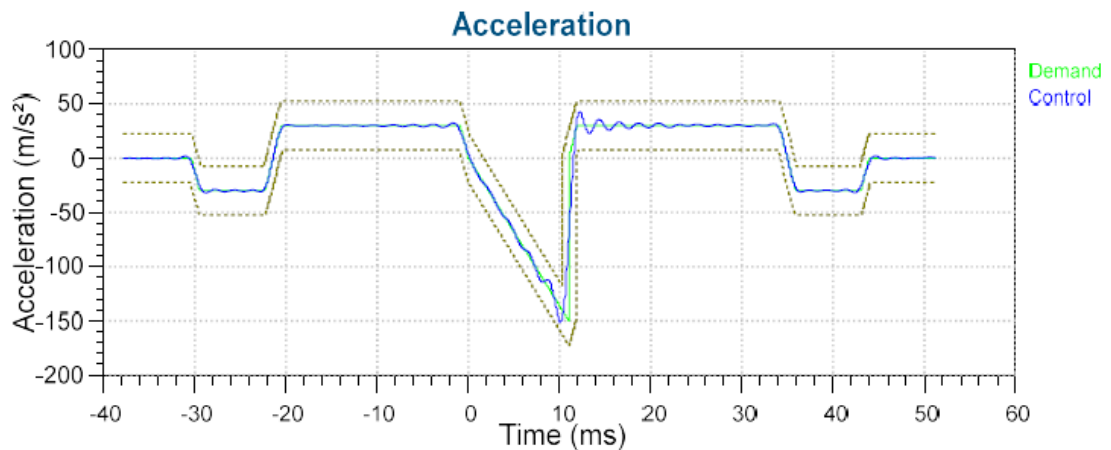
### 7.5.2 Test data and graph (Shock Test Y Axis)

10 14, 2025 10:37:50 Level 1) 100 % Output: 0.9411 Volts peak 60068-2-27  
Demand: 150 m/s<sup>2</sup>  
Control: 151.9 m/s<sup>2</sup> Pulse: 10 of 10 Running

10 14, 2025 10:38:20 Level 2) 100 % Output: 0.929 Volts peak 60068-2-27  
Demand: 150 m/s<sup>2</sup>  
Control: 151.2 m/s<sup>2</sup> Pulse: 10 of 10 End of Test

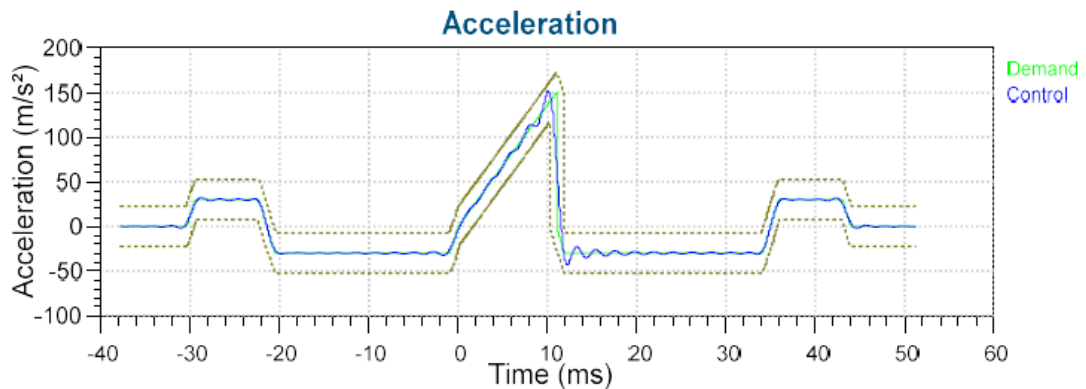
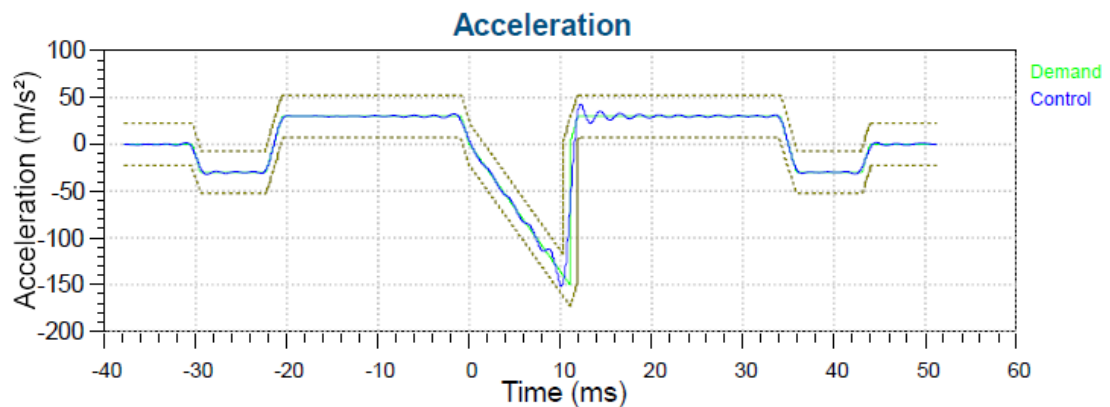
### 7.5.3 Test data and graph (Shock Test Z Axis)

10 14, 2025 11:00:25 Level 1) 100 % Output: 0.9227 Volts peak 60068-2-27

Demand: 150 m/s<sup>2</sup>

Control: 151.5 m/s<sup>2</sup> Pulse: 10 of 10 Running

10 14, 2025 11:00:55 Level 2) 100 % Output: 0.9207 Volts peak 60068-2-27

Control: 151.6 m/s<sup>2</sup> Pulse: 10 of 10 End of Test

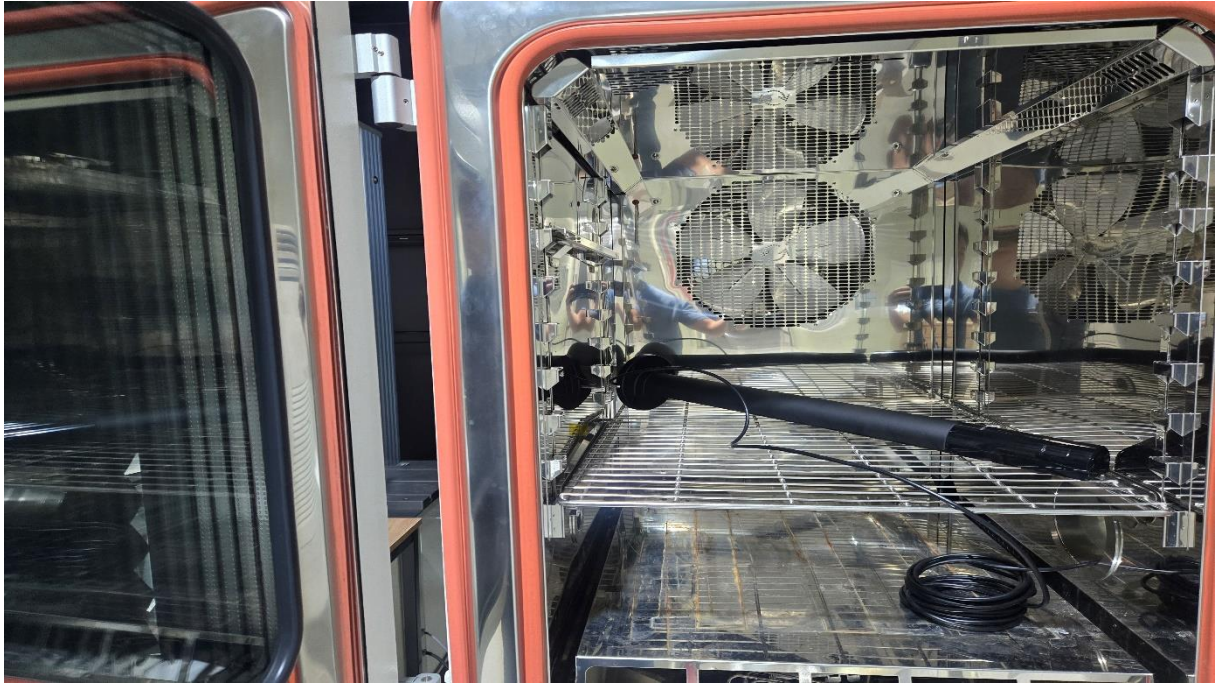
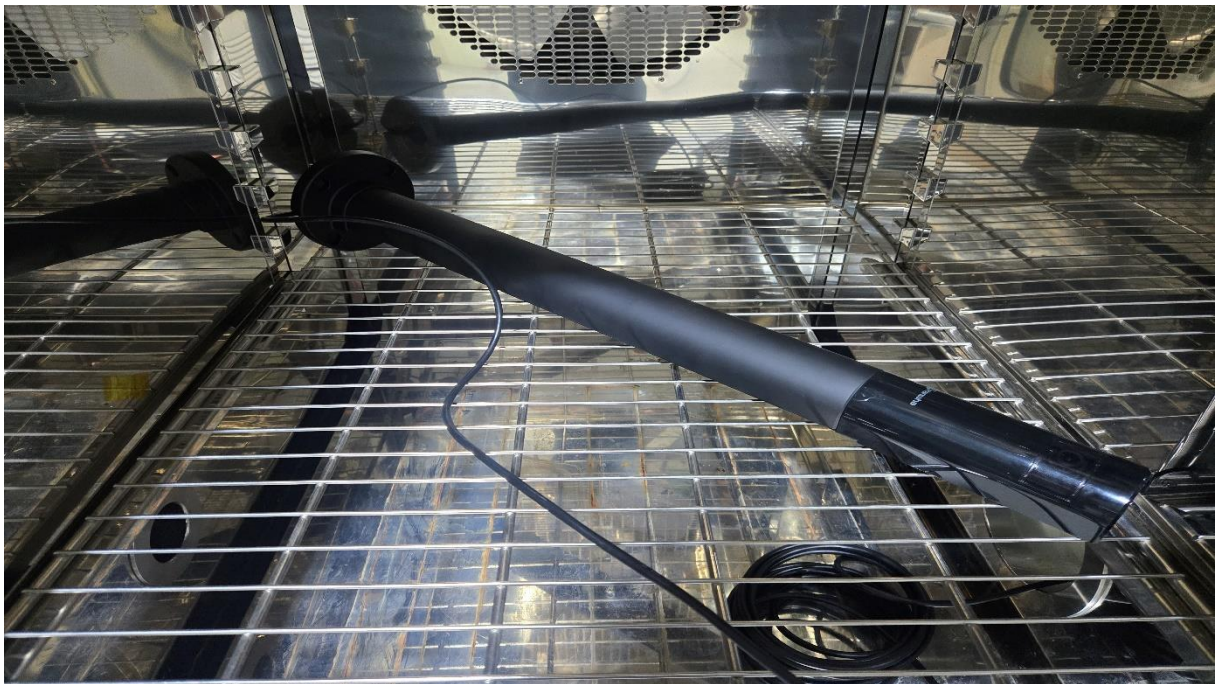
#### 8.3.1 Evidence of test setting

8.2.1 Sample status: operation

8.2.2 Test temperature:  $40 \pm 2$  °C

8.2.3 Test Humidity:  $93 \pm 3$  % R.H.

8.2.4 Test time: 240 h

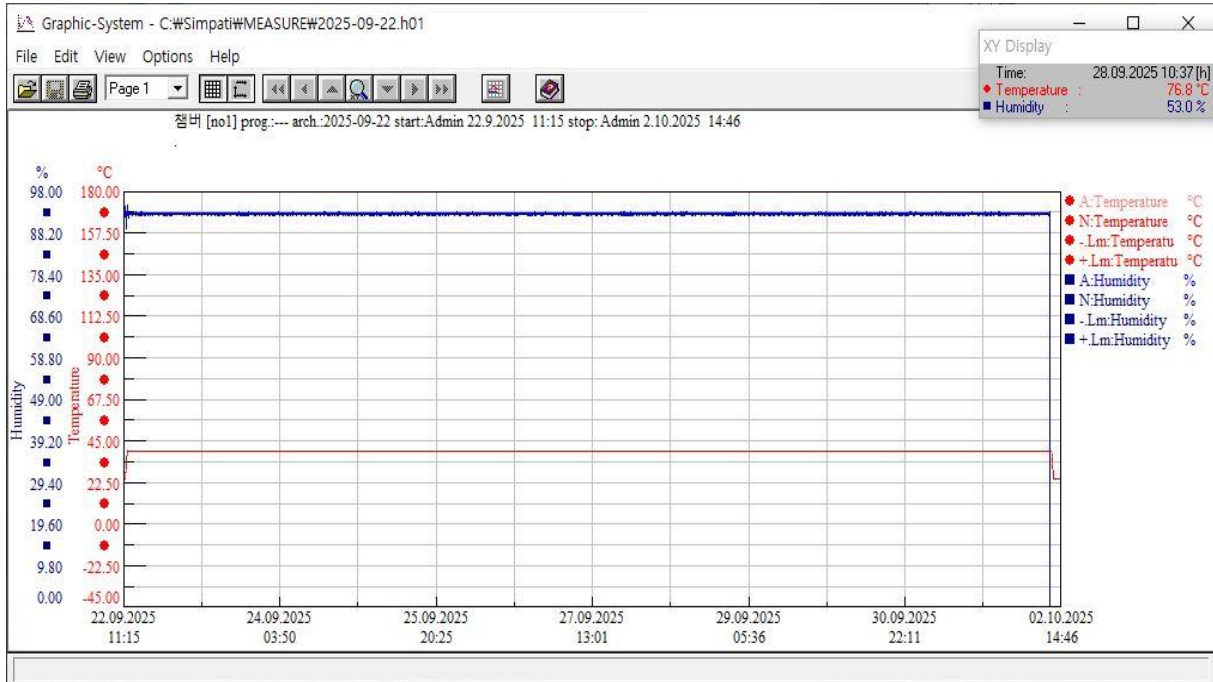
### 8.5.1 Test data and graph

Temperature Data

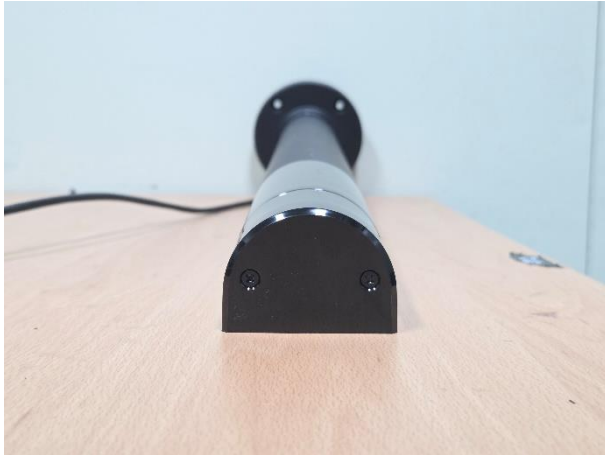
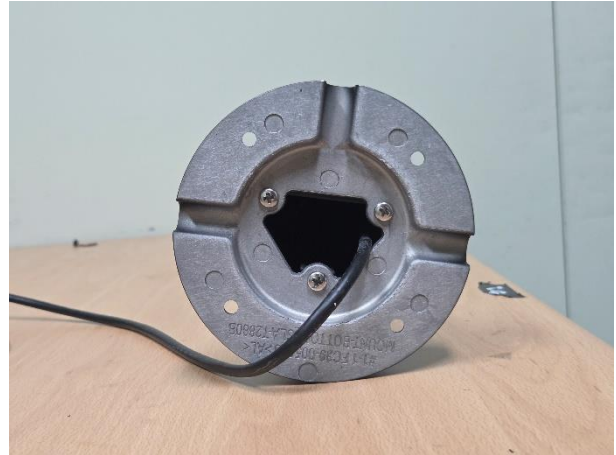
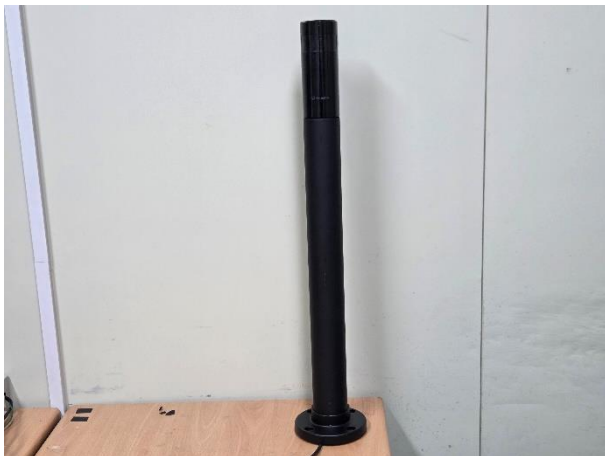
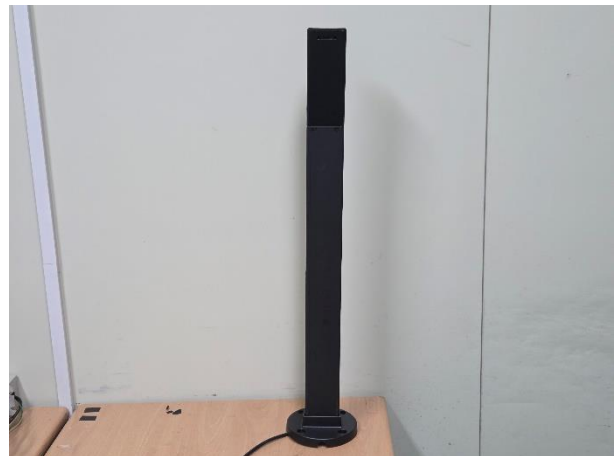
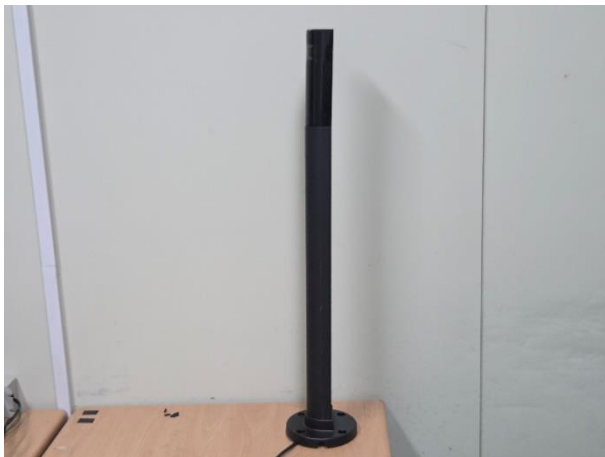
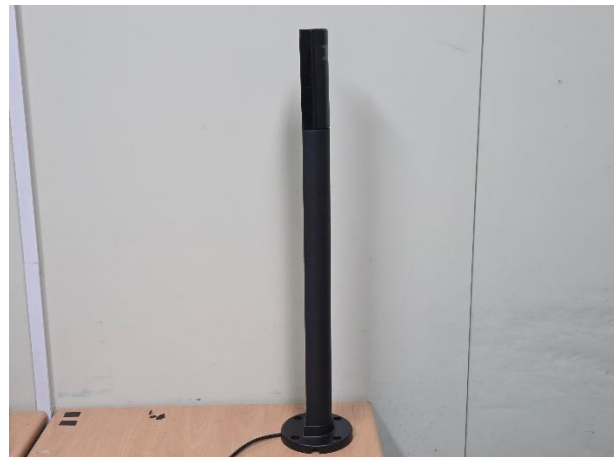
### 8.6.1 Test sample

| Evaluations Criteria | Test result | | 비고 |
|---|---|---|---|
| Sample | Visual Inspection | Normal | - |
