# TEST REPORT

REPORT No.:  
CTK-2025-02829  
Page (1) / (39) pages

LENS MODULE / SLA-F2480DA

EN 60068-2-1, EN 60068-2-2, EN 60068-2-14, EN 60068-2-6, EN  
60068-2-27, EN 60068-2-78, IEC 60068-2-1, IEC 60068-2-2, IEC  
60068-2-14, IEC 60068-2-6, IEC 60068-2-27, IEC 60068-2-78

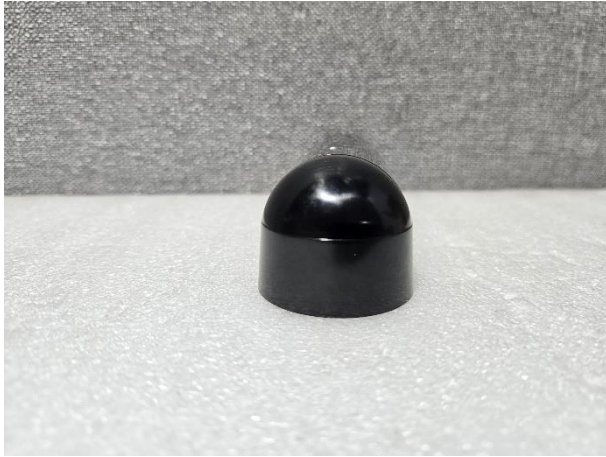
Top

## 2.3 Pre-test product images

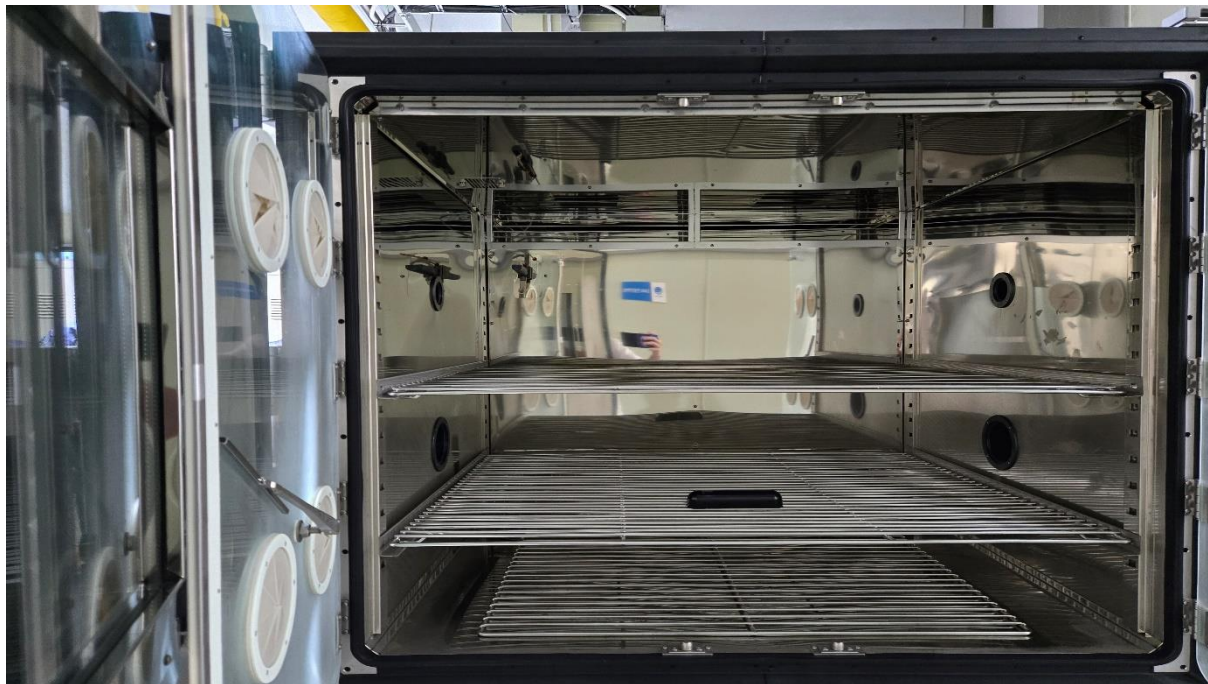
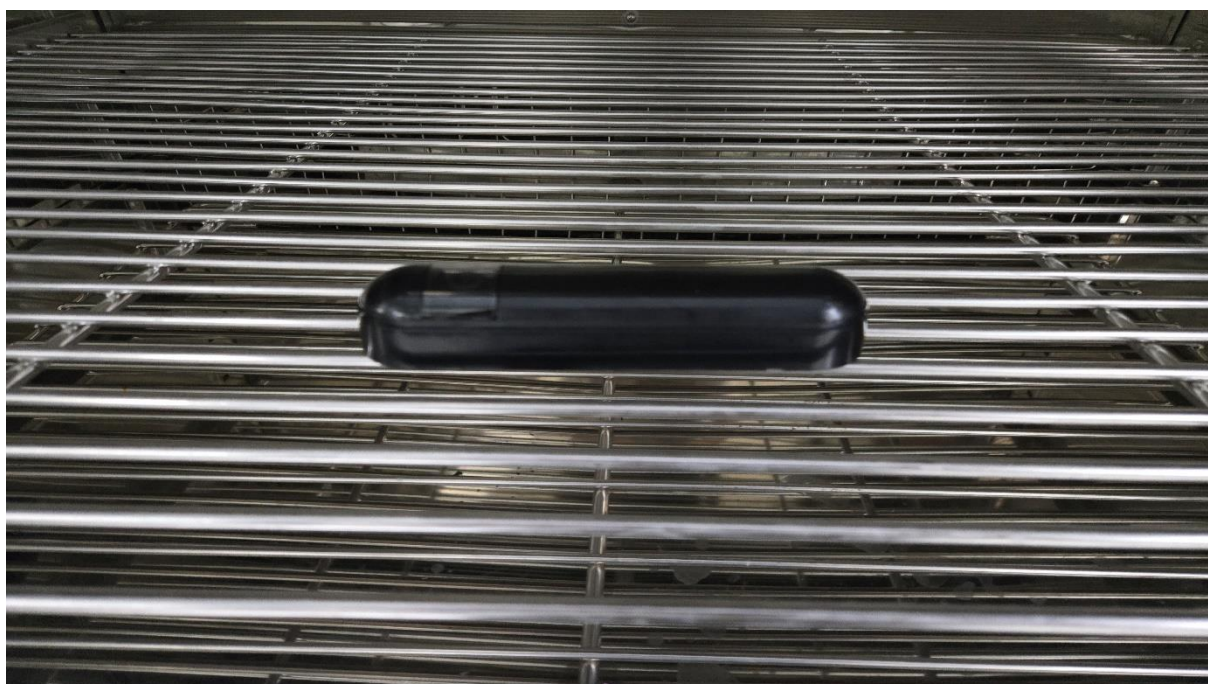
#### 3.3.1 Evidence of test setting

3.2.1 Sample status: Non-operation

3.2.2 Test temperature: -33 °C

3.2.3 Test time: 16 h

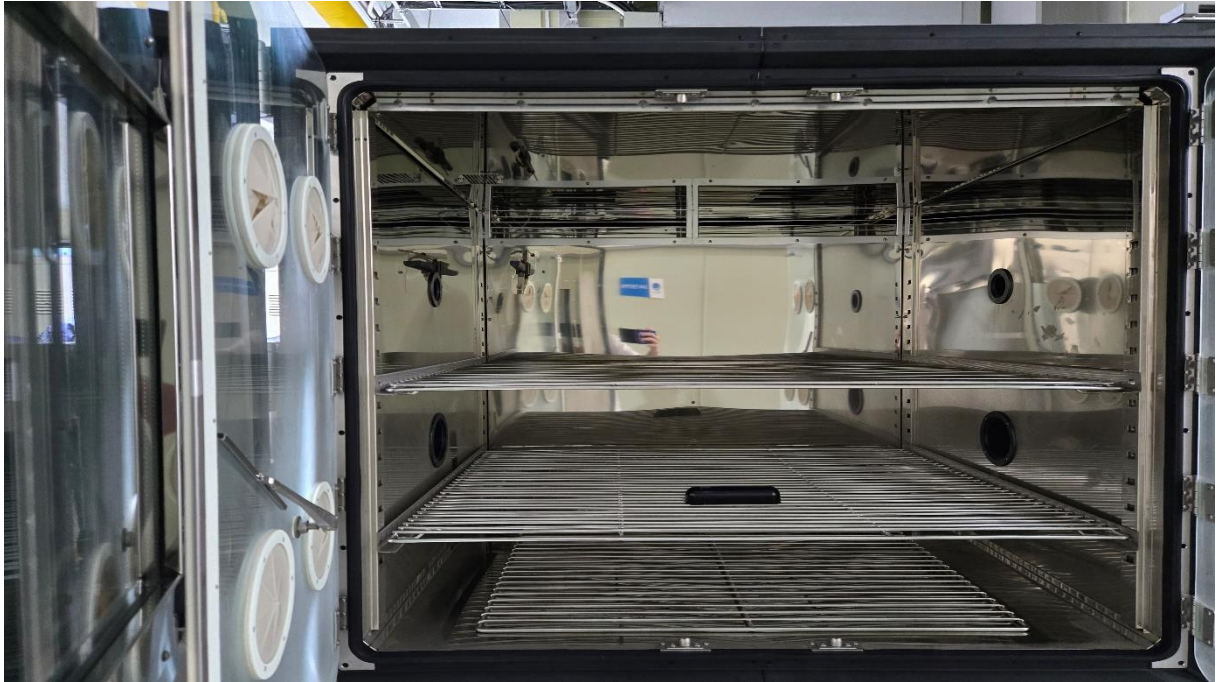
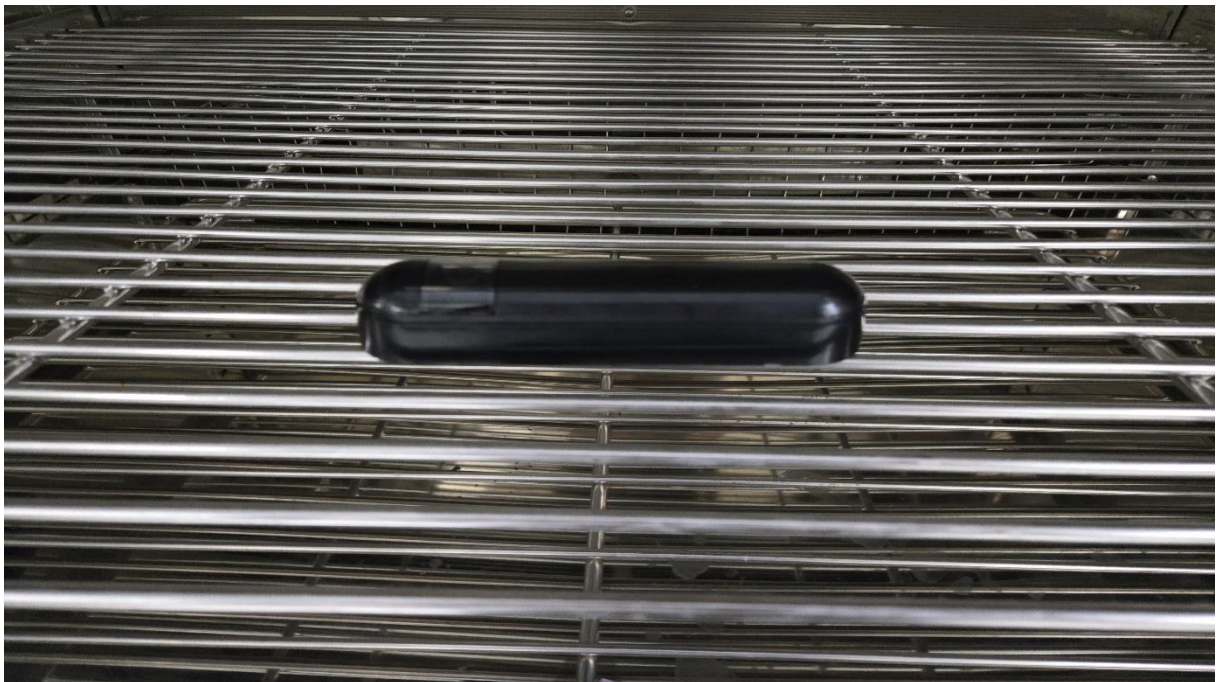
#### 4.3.1 Evidence of test setting

4.2.1 Sample status: Non-operation

4.2.2 Test temperature: 60 °C

4.2.3 Test time: 96 h

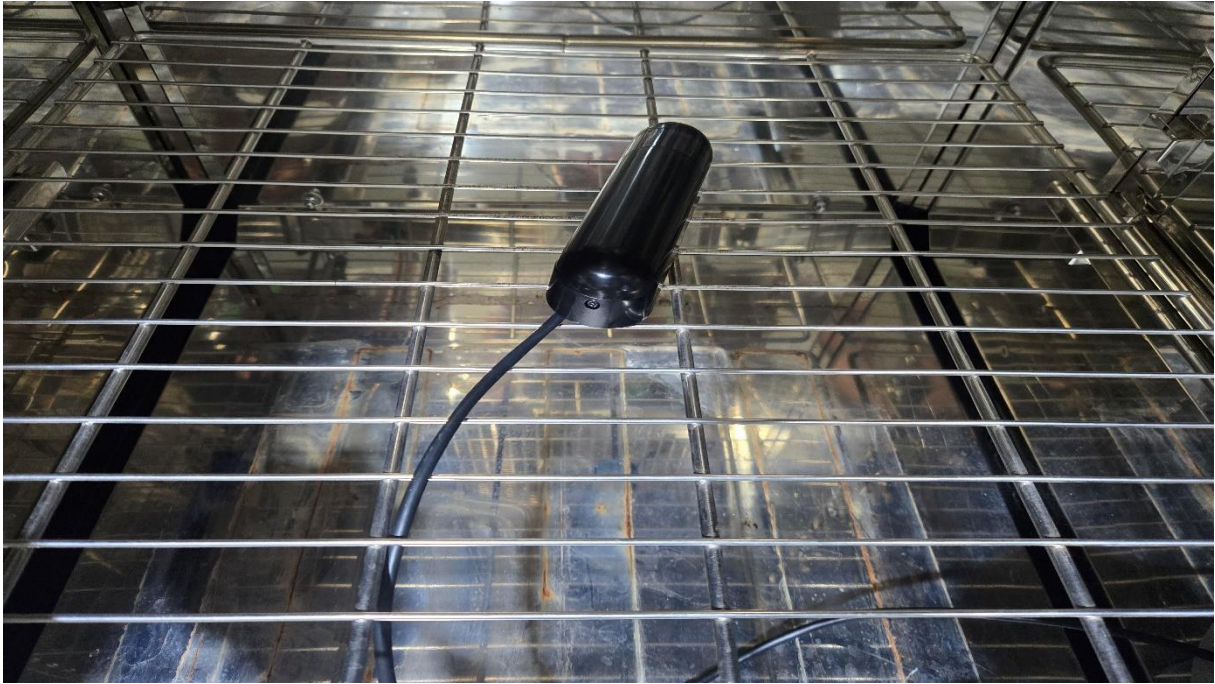
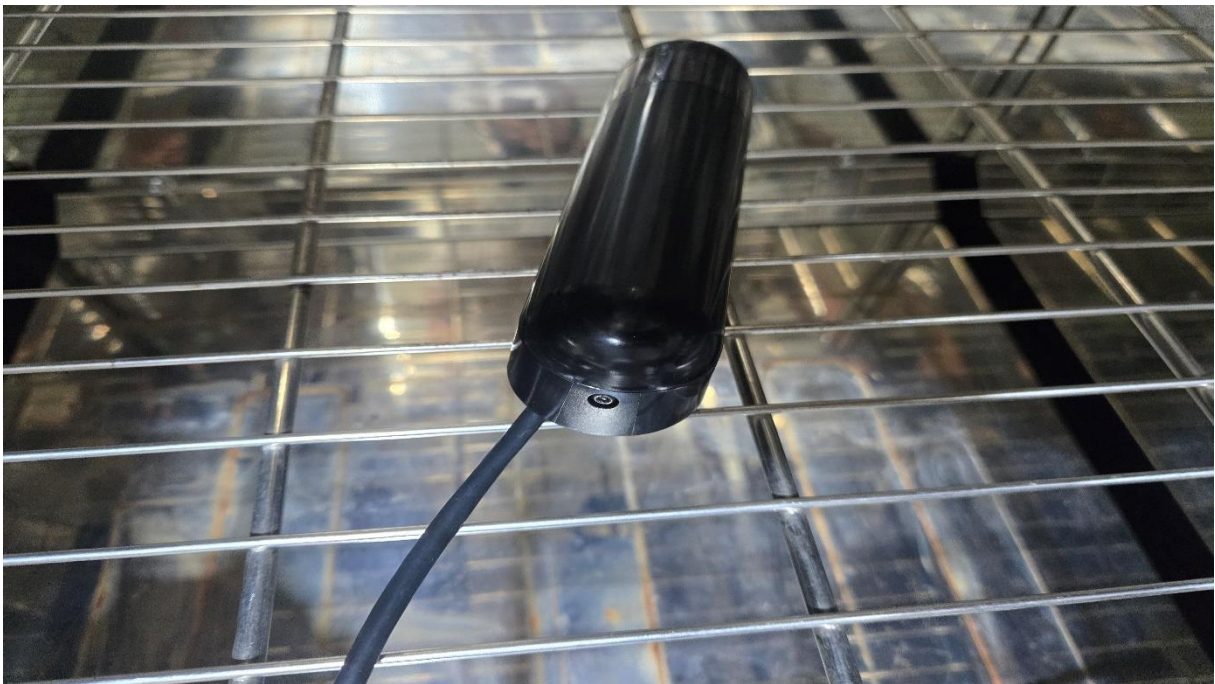
#### 5.3.1 Evidence of test setting

5.2.1 Sample status: operation

5.2.2 Test temperature: -10 °C, 55 °C

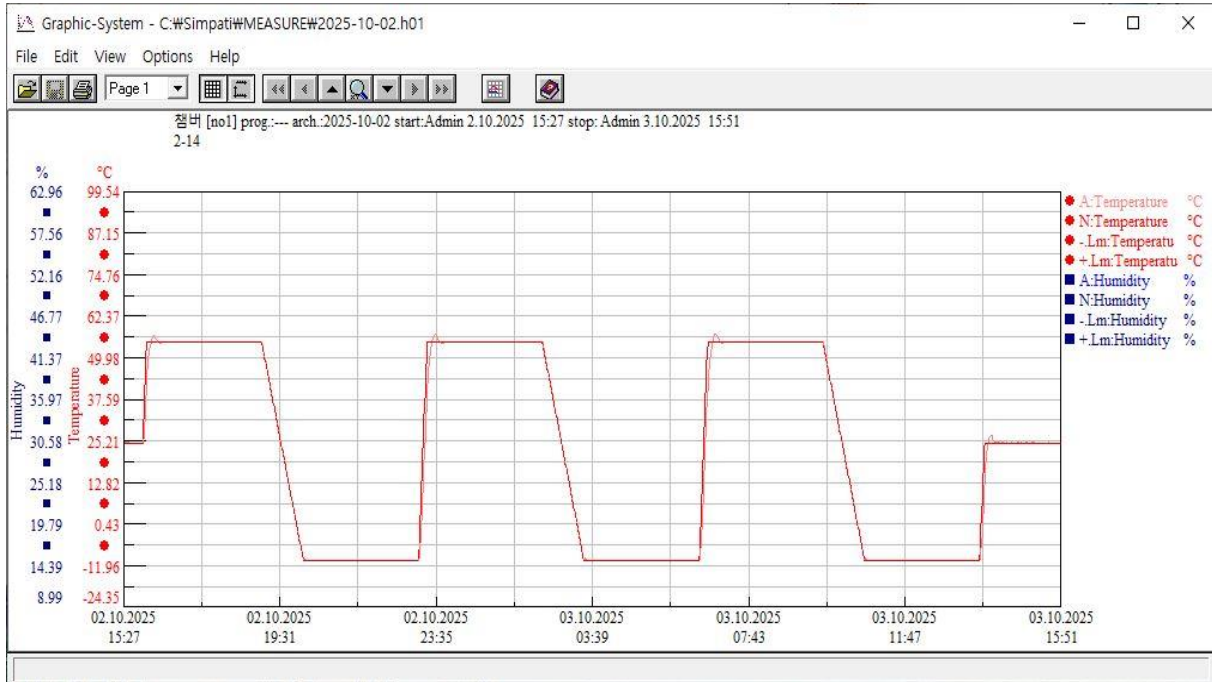
### 5.5.1 Test data and graph

| Temp↵ | Temperature change rate(°C/min)↵ | t <sub>1</sub> (idle time)↵ | Cycles↵ |
| High↵ | 5 °C/min↵ | 3 h↵ | 3↵ |
| Low↵ | 1 °C/min↵ | 3 h↵ | 3↵ |

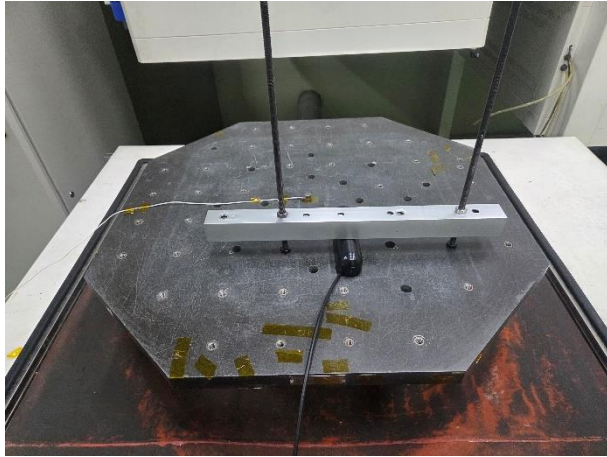
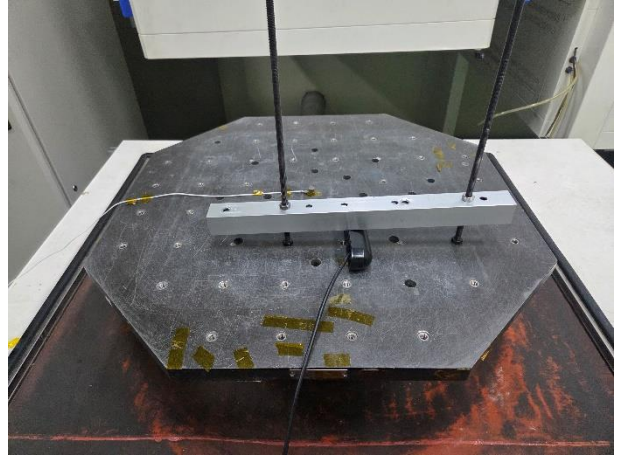
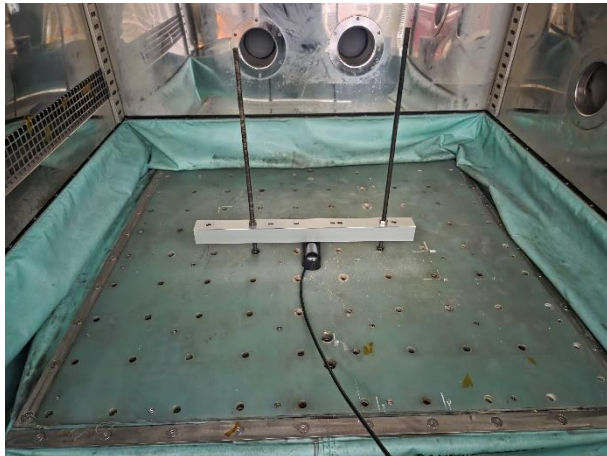
### 6.3.1 Evidence of test setting

- Sample status: operation
- Frequency(Hz): 5 Hz ~ 200 Hz
- Acceleration(G): 1 G
- Sweep rate: 1 oct/min
- Test Axis: X, Y, Z
- Test time(h): Total 30 min (10 min. per each axis)

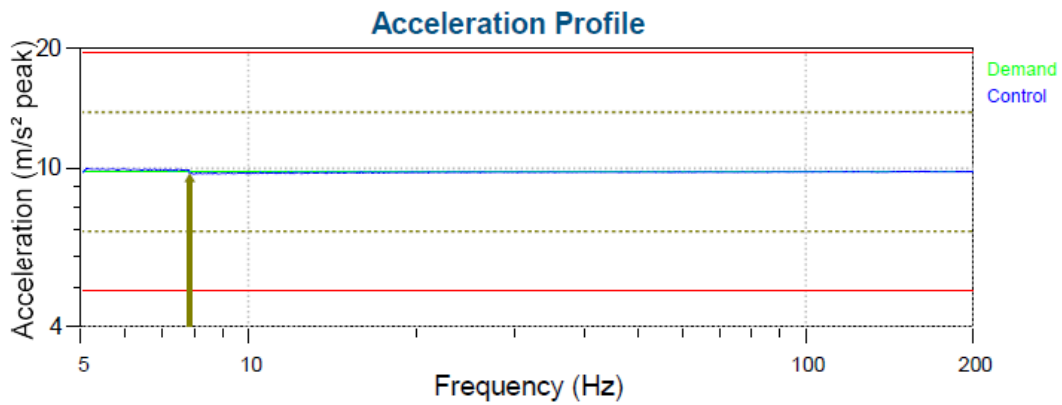
### 6.5.2 Test data and graph (Vibration Test Y Axis)

10 14, 2025 10:36:55 Level 1) 100 %    Output: 0.3608 Volts peak    60068-2-6  
Demand: 9.807 m/s<sup>2</sup>    Level Time: 0:10:00    Frequency: 7.846 Hz  
Control: 9.73 m/s<sup>2</sup>    Total Time: 0:10:12    End of Timed Test

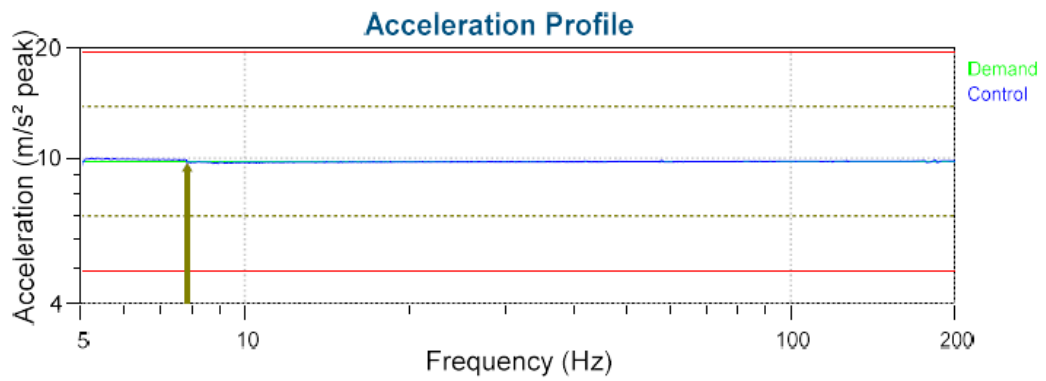
### 6.5.3 Test data and graph (Vibration Test Z Axis)

10 14, 2025 16:51:3: Level 1) 100 %      Output: 0.382 Volts peak      2025-05-07 한화비전 60068  
Demand: 9.807 m/s      Level Time: 0:10:01      Frequency: 7.841 Hz  
Control: 9.723 m/s      Total Time: 0:10:15      End of Timed Test

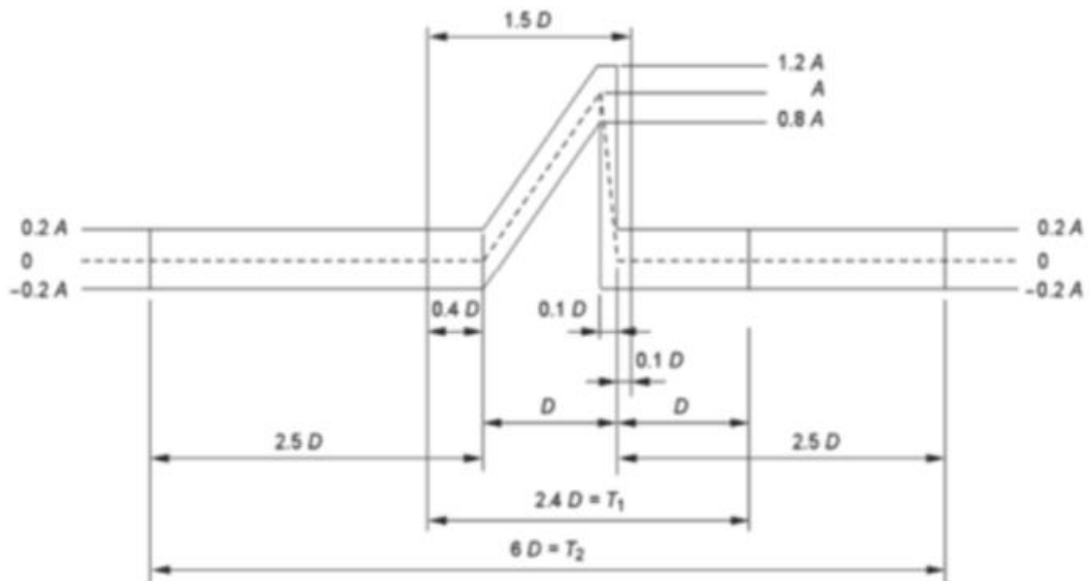
7.2.5 Profile

7.2.2 Acceleration( $\text{m/s}^2$ ): 150

7.2.3 Number of impacts: 10 per direction (total 60)

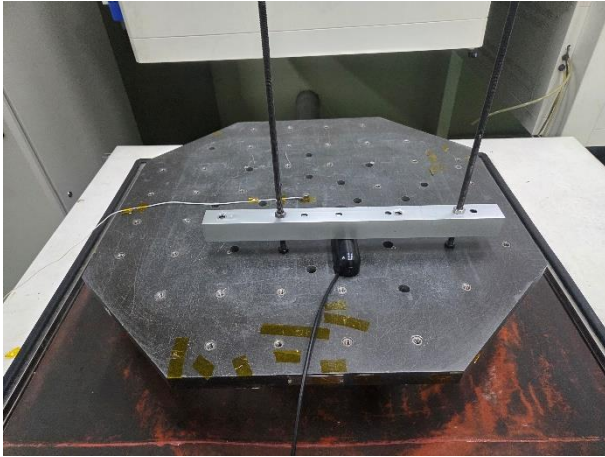
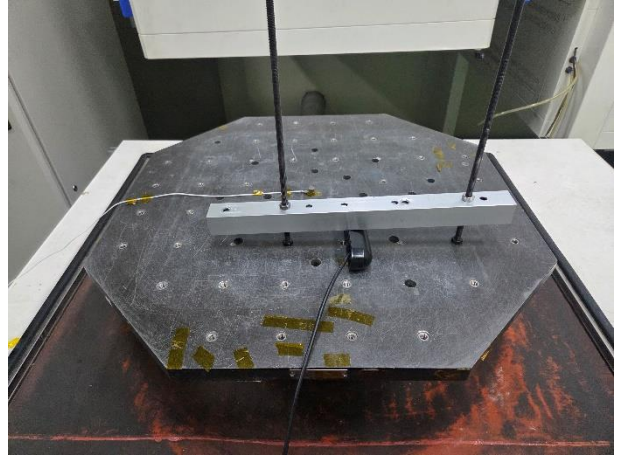
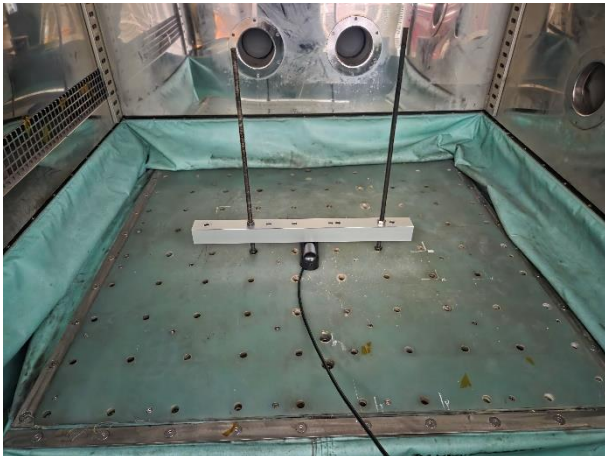
### 7.3.1 Evidence of test setting

7.2.1 Sample status: Non-operation

7.2.4 Test Axis: X, Y, Z

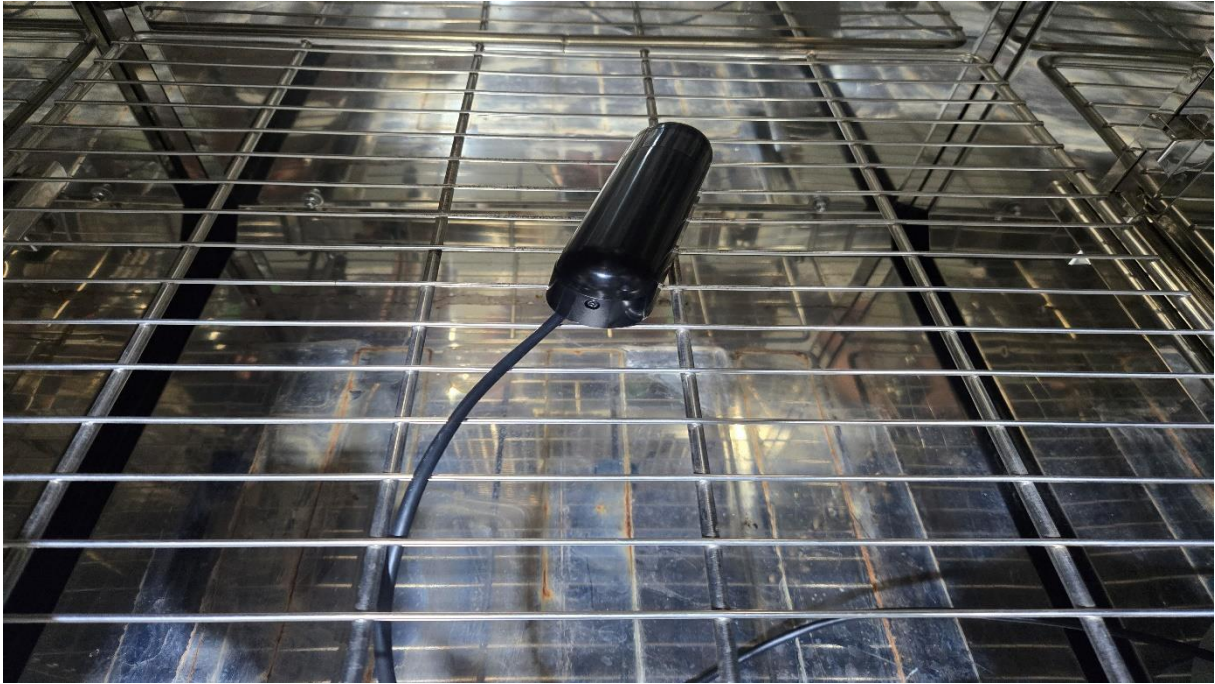
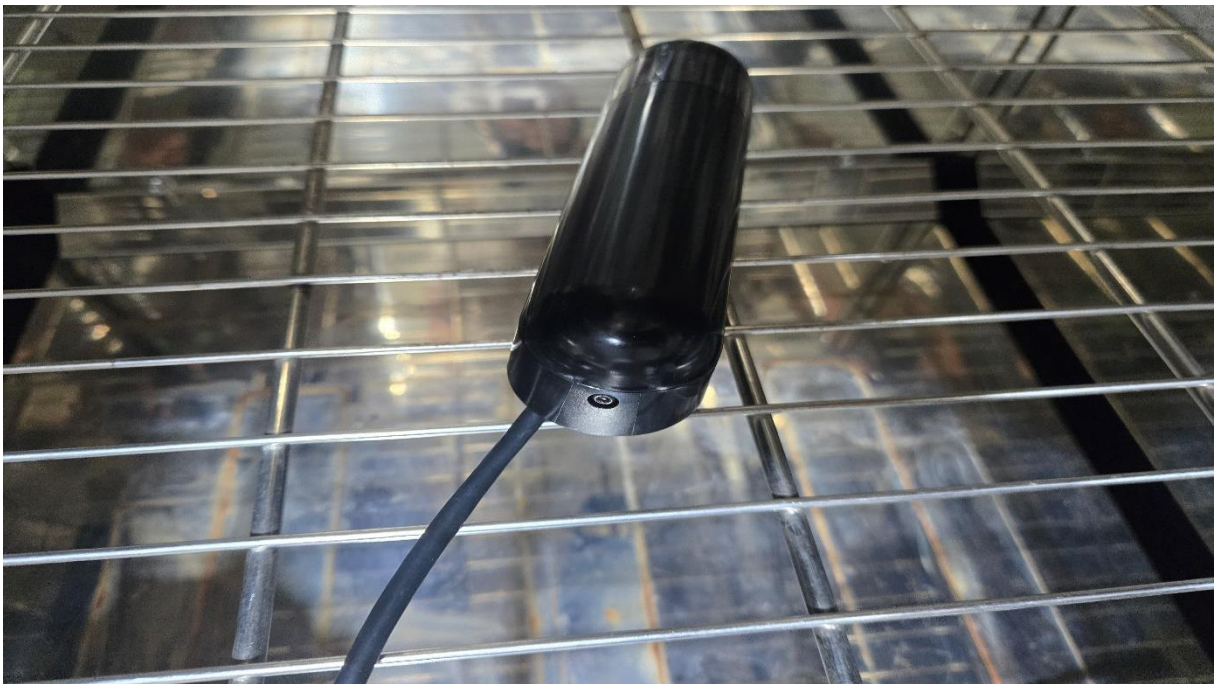
### 8.3.1 Evidence of test setting

8.2.2 Test temperature:  $40 \pm 2$  °C

8.2.3 Test Humidity:  $93 \pm 3$  % R.H.

8.2.4 Test time: 240 h
