# TEST REPORT

REPORT No.:  
CTK-2025-02830  
Page (1) / (39) pages

LENS MODULE / SLA-F2480WA

EN 60068-2-1, EN 60068-2-2, EN 60068-2-14, EN 60068-2-6, EN  
60068-2-27, EN 60068-2-78, IEC 60068-2-1, IEC 60068-2-2, IEC  
60068-2-14, IEC 60068-2-6, IEC 60068-2-27, IEC 60068-2-78

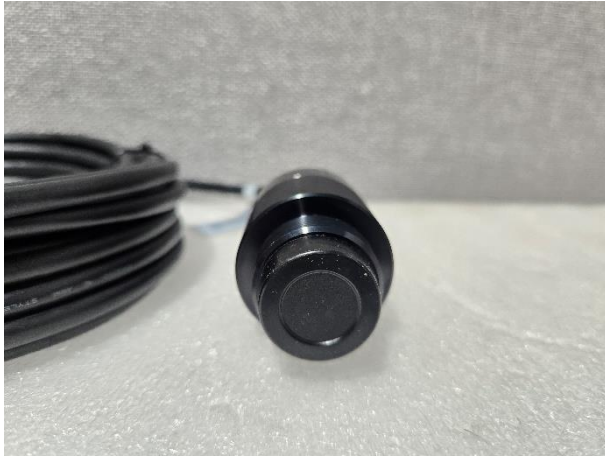
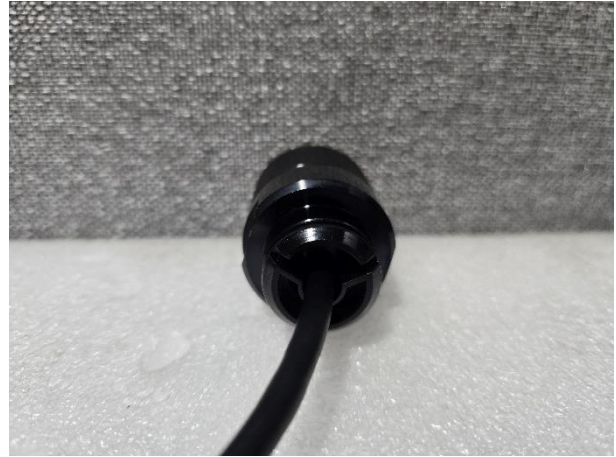
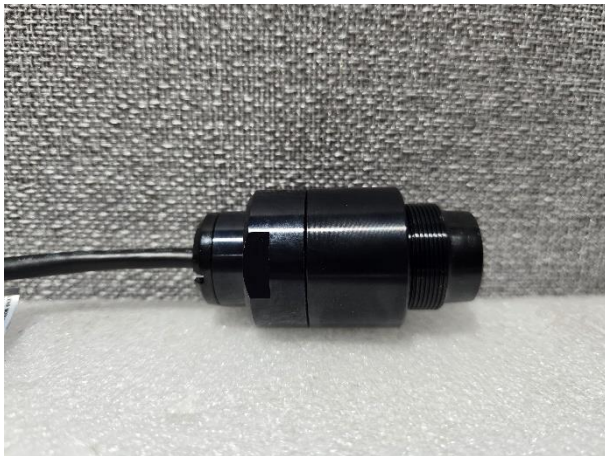
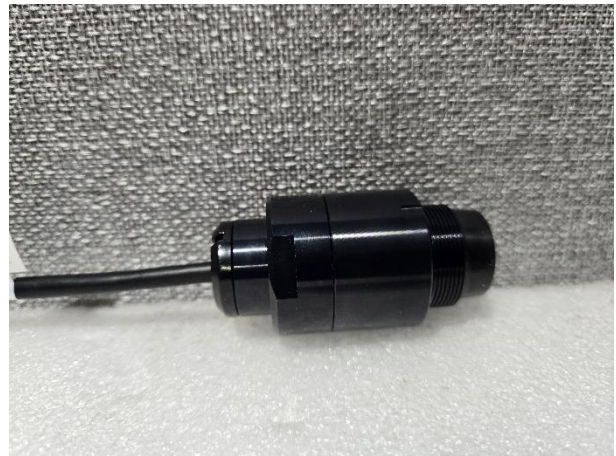
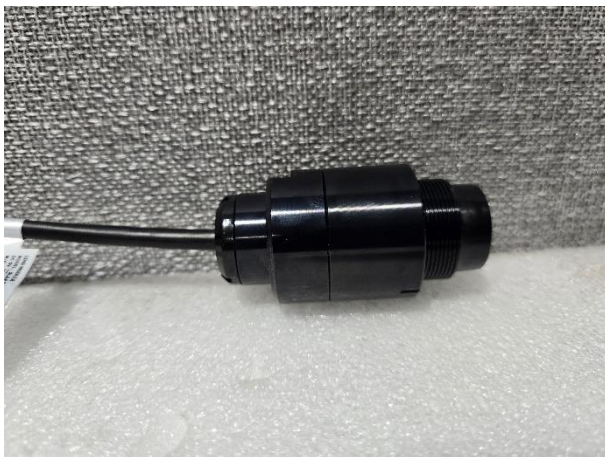
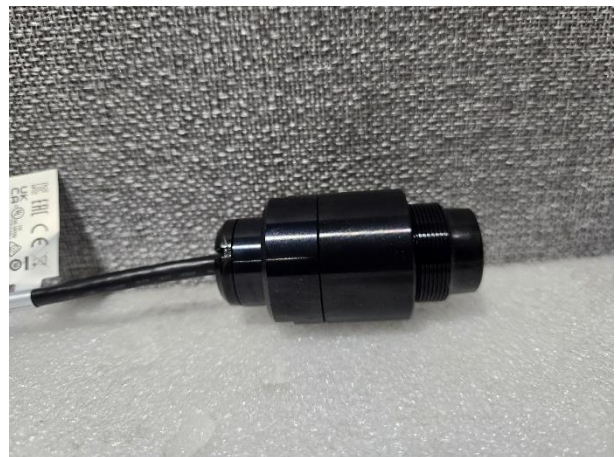
### 2.3.1 Test sample

Top

Bottom

Front

Rear

Left side

Right side

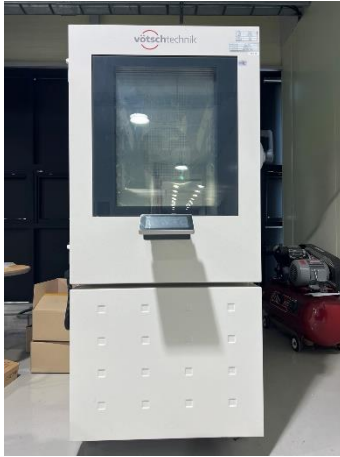
Temperature & Humidity Chamber

| Testing equipment | Model Name | Manufacturer | Manufacturing Number | Calibration Date |
|---|---|---|---|---|
| Temperature & Humidity Chamber | C4-340 | Weissstechnik | 54260023190010 | Feb. 6, 2026 |

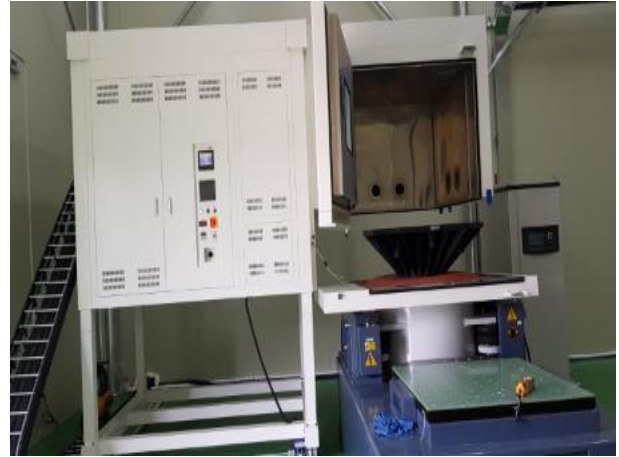
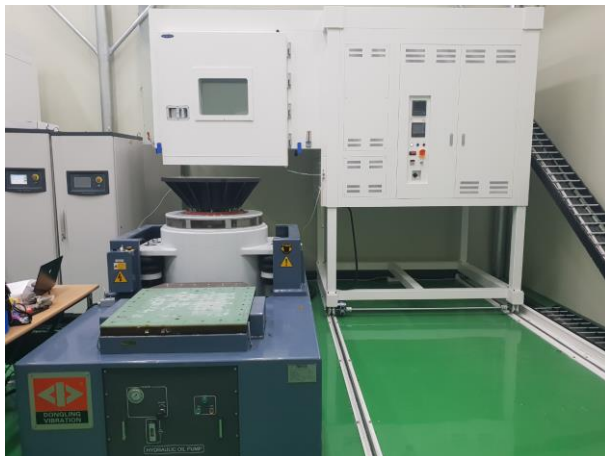
VIBRATION TESTING SYSTEM

| Testing equipment | Model Name | Manufacturer | Manufacturing Number | Calibration Date |
|---|---|---|---|---|
| VIBRATION TESTING SYSTEM (UH1 1000T) | GT1000M | FAMTECH | D1803072 | N/A |
| VIBRATION TESTING SYSTEM (UH1 800T) | GT1000M | FAMTECH | D1803072-1 | N/A |

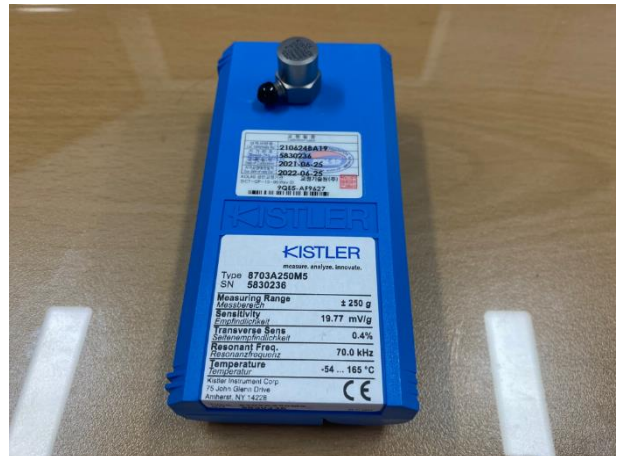
8703A250M5

| Testing equipment | Model Name | Manufacturer | Manufacturing Number | Calibration Date |
|---|---|---|---|---|
| Acceleration sensor | 8703A250M5 | KISTLER | 5241941 | Jan. 05, 2026 |

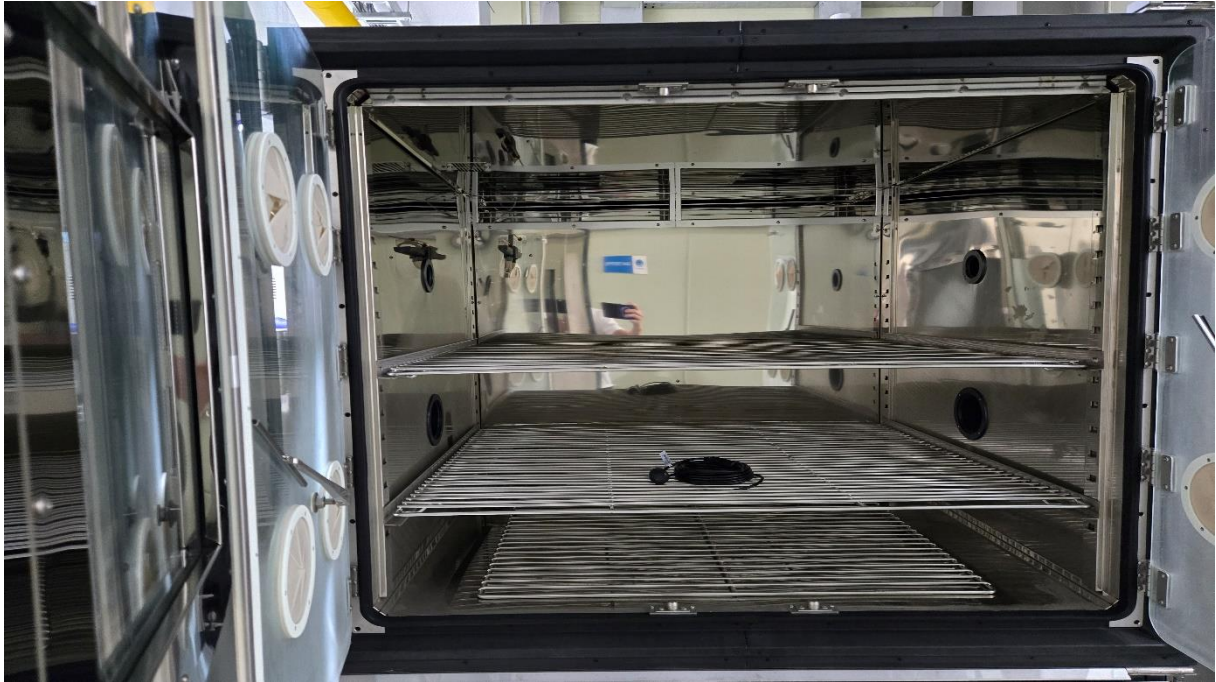
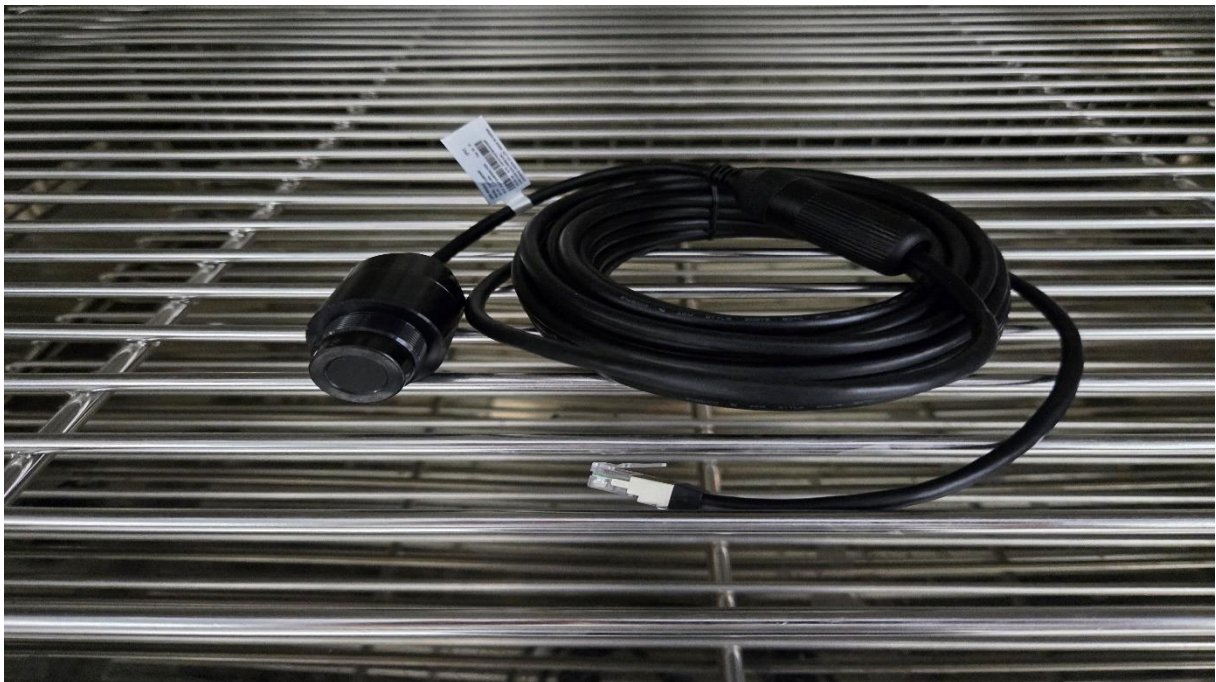
#### 3.3.1 Evidence of test setting

3.2.1 Sample status: Non-operation

3.2.2 Test temperature: -33 °C

3.2.3 Test time: 16 h

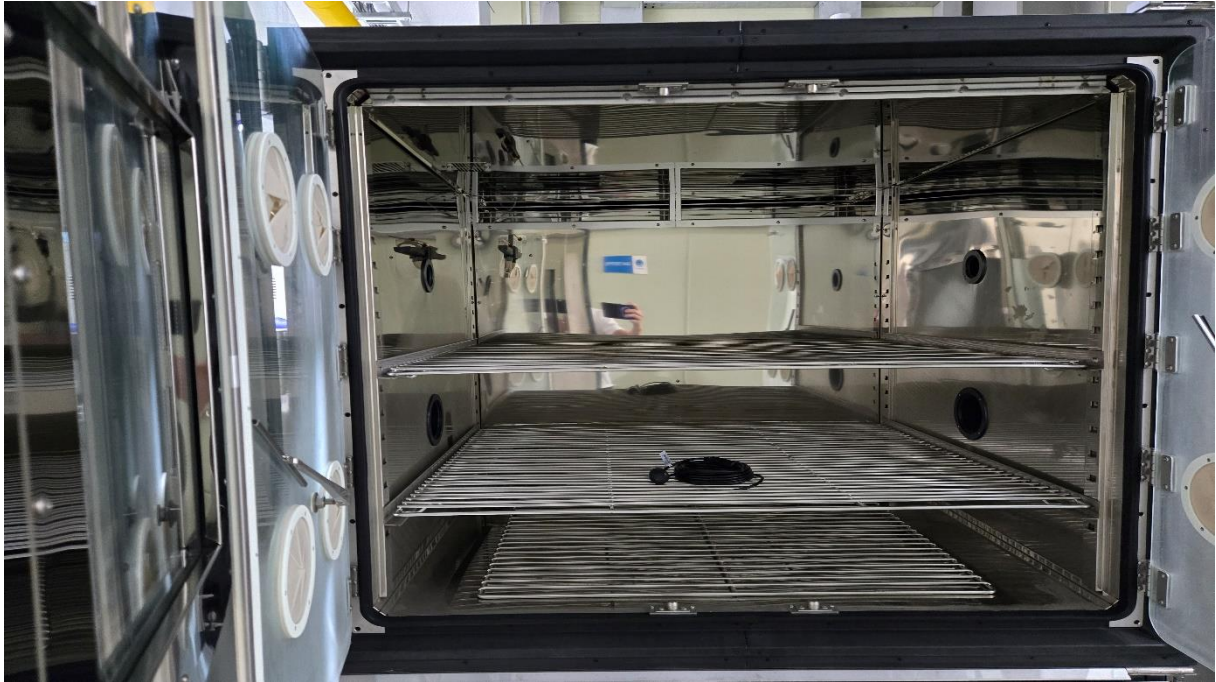
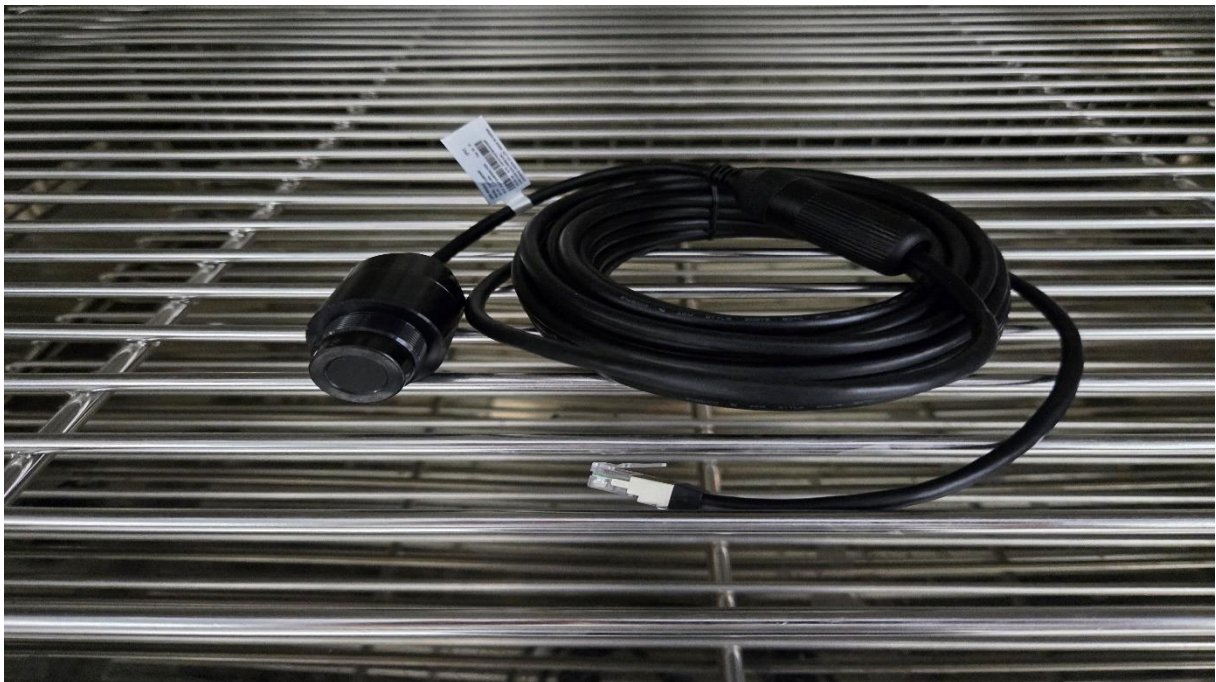
#### 4.3.1 Evidence of test setting

4.2.1 Sample status: Non-operation

4.2.2 Test temperature: 60 °C

4.2.3 Test time: 96 h

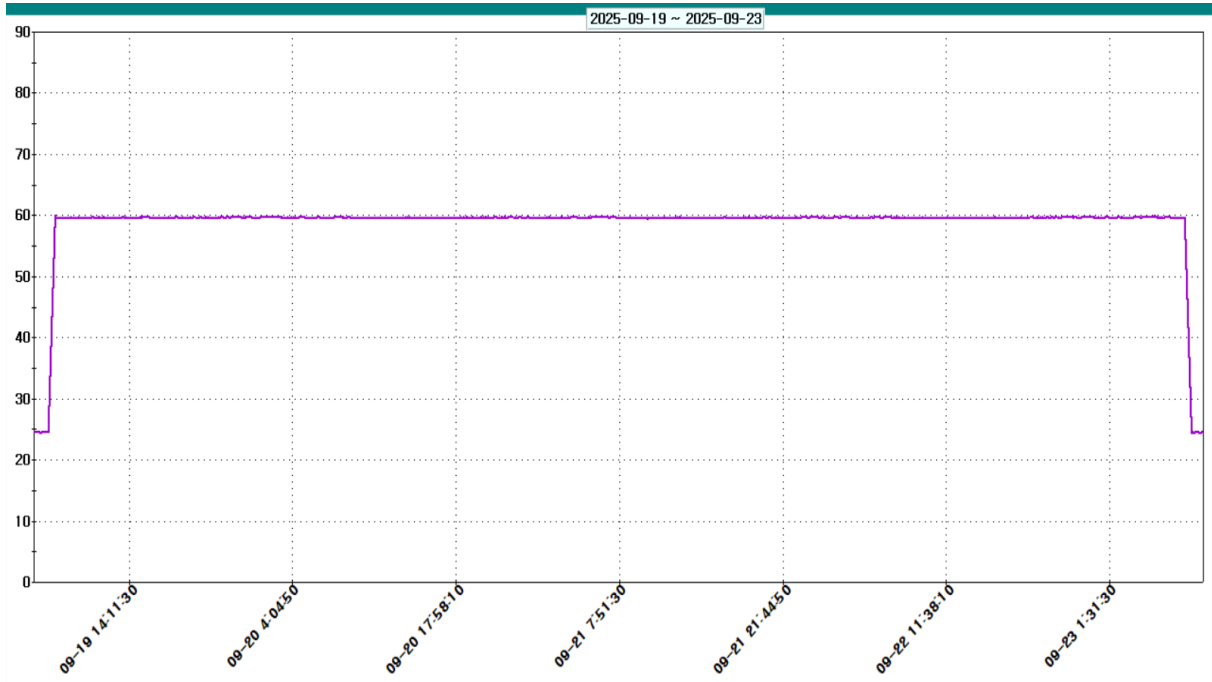
#### 4.5.1 Test data and graph

Temperature Data

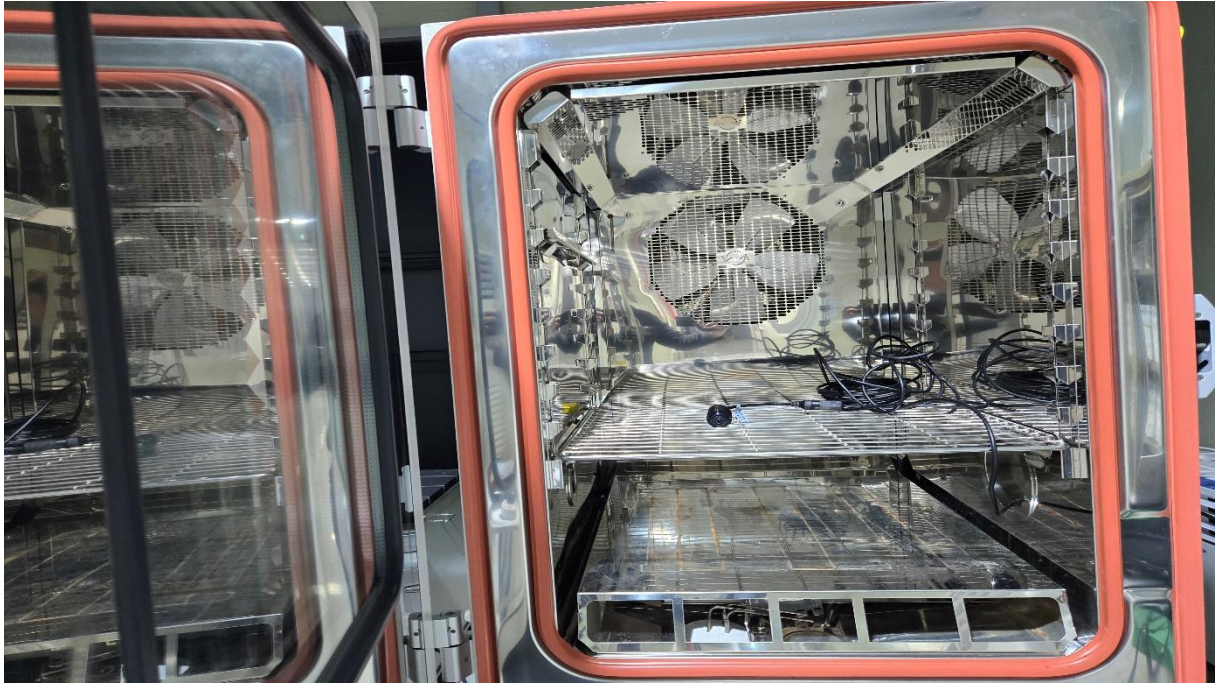
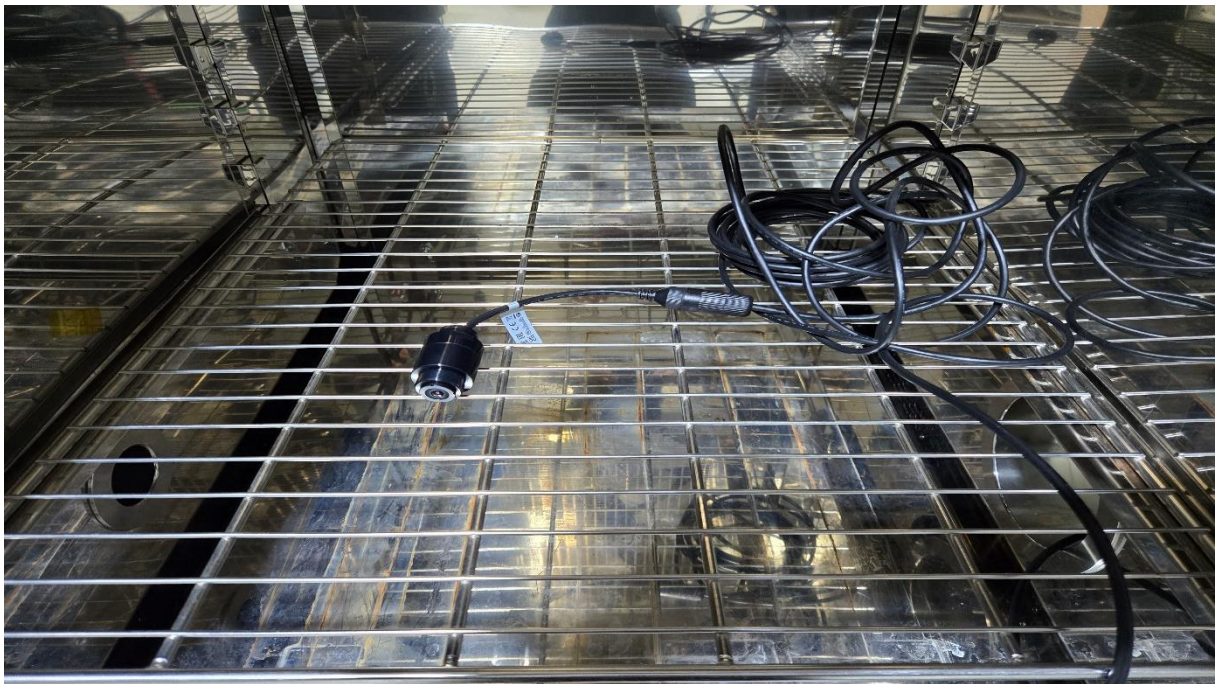
#### 5.3.1 Evidence of test setting

5.2.1 Sample status: operation

5.2.2 Test temperature: -33 °C, 55 °C

| Temp↵ | Temperature change rate(°C/min)↵ | t <sub>1</sub> (idle time)↵ | Cycles↵ |

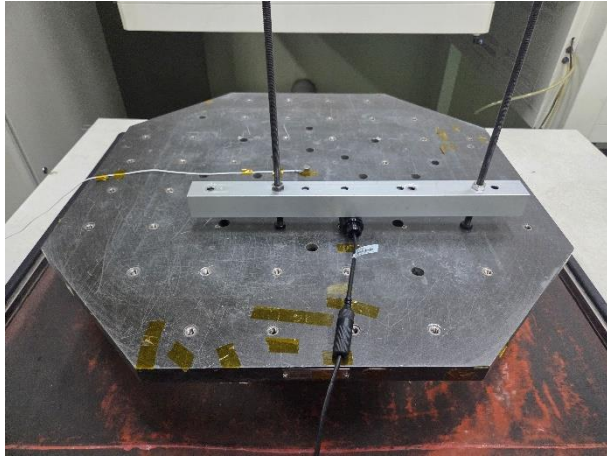
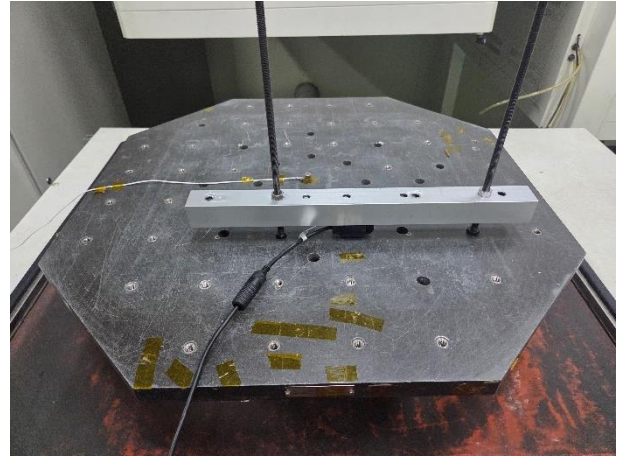
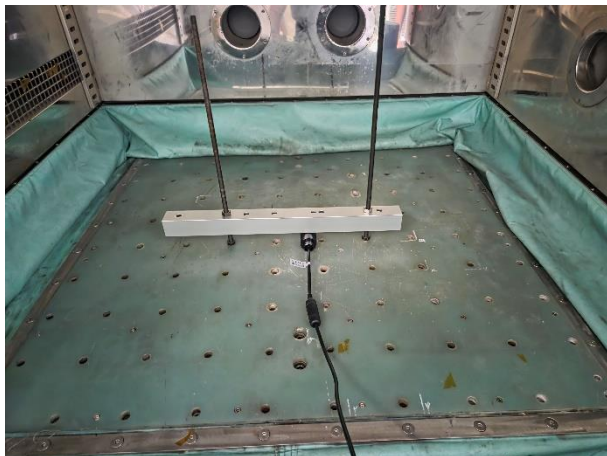
### 6.3.1 Evidence of test setting

- Sample status: operation
- Frequency(Hz): 5 Hz ~ 200 Hz
- Acceleration(G): 1 G
- Sweep rate: 1 oct/min
- Test Axis: X, Y, Z
- Test time(h): Total 30 min (10 min. per each axis)

X axis

Y axis

Z axis

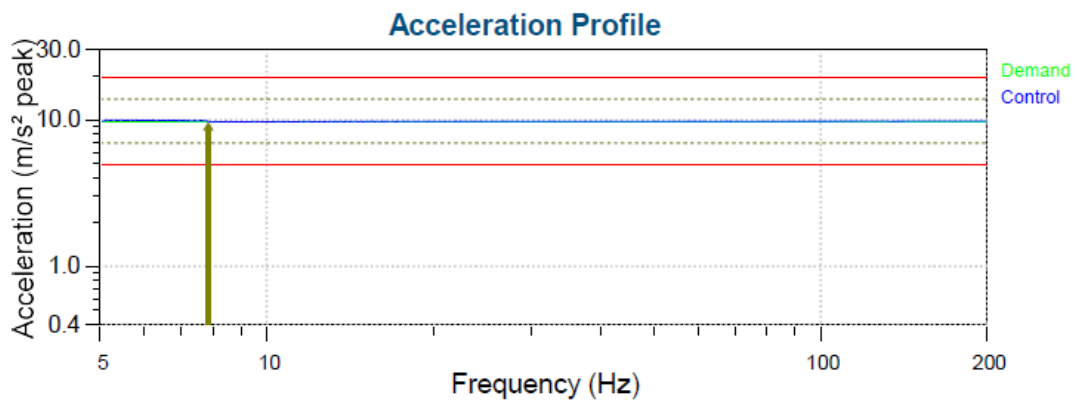
#### 6.5.1 Test data and graph (Vibration Test X Axis)

10 14, 2025 10:12:18 Level 1) 100 %    Output: 0.3614 Volts peak    60068-2-6  
Demand: 9.807 m/s<sup>2</sup>    Level Time: 0:10:00    Frequency: 7.841 Hz  
Control: 9.731 m/s<sup>2</sup>    Total Time: 0:10:12    End of Timed Test

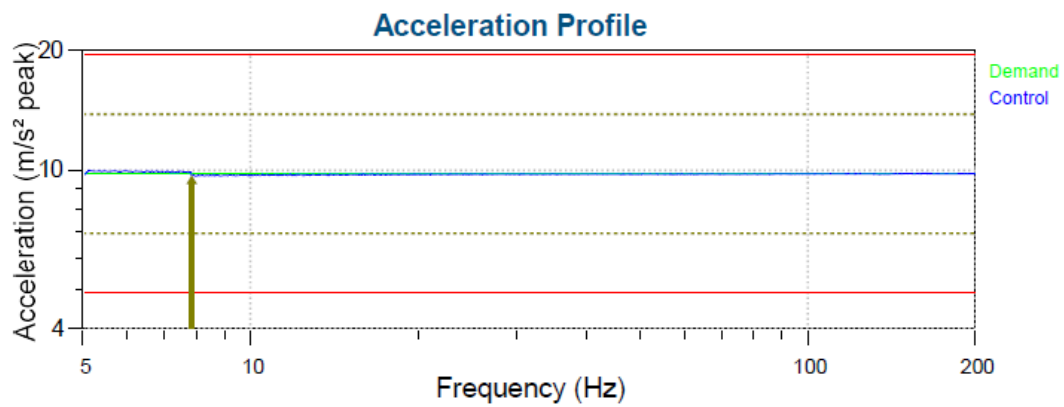
### 6.5.2 Test data and graph (Vibration Test Y Axis)

10 14, 2025 10:36:55 Level 1) 100 %    Output: 0.3608 Volts peak    60068-2-6  
Demand: 9.807 m/s<sup>2</sup>    Level Time: 0:10:00    Frequency: 7.846 Hz  
Control: 9.73 m/s<sup>2</sup>    Total Time: 0:10:12    End of Timed Test

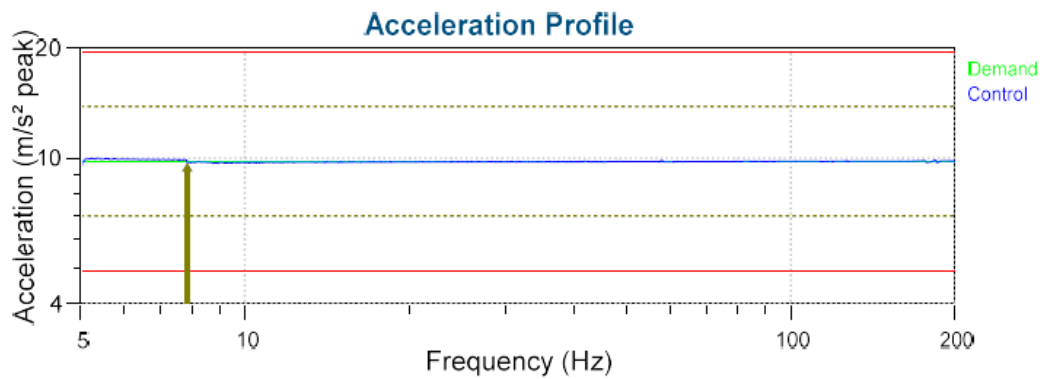
### 6.5.3 Test data and graph (Vibration Test Z Axis)

10 14, 2025 16:51:3: Level 1) 100 %      Output: 0.382 Volts peak      2025-05-07 한화비전 60068  
Demand: 9.807 m/s      Level Time: 0:10:01      Frequency: 7.841 Hz  
Control: 9.723 m/s      Total Time: 0:10:15      End of Timed Test

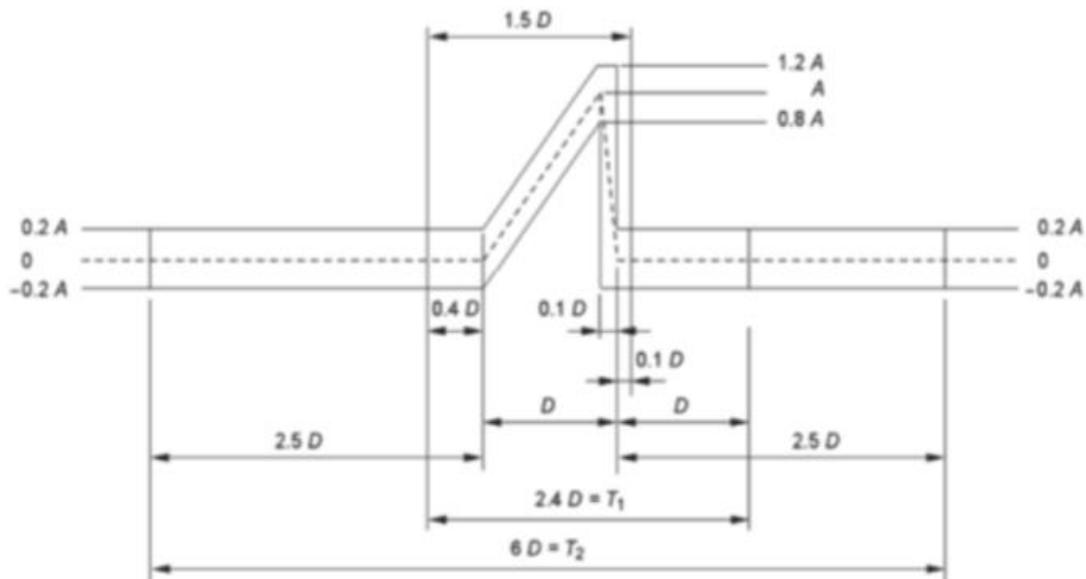
7.2.5 Profile

7.2.2 Acceleration( $m/s^2$ ):  $150 m/s^2$

7.2.3 Number of impacts: 10 per direction (total 60)

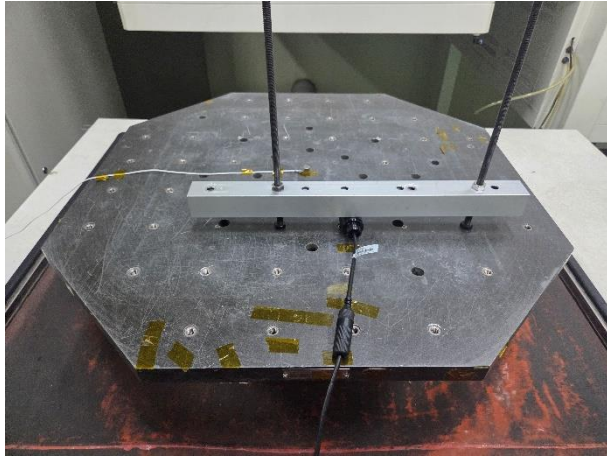
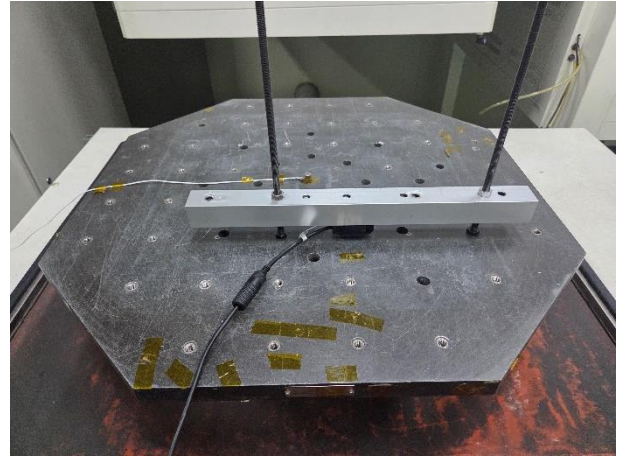
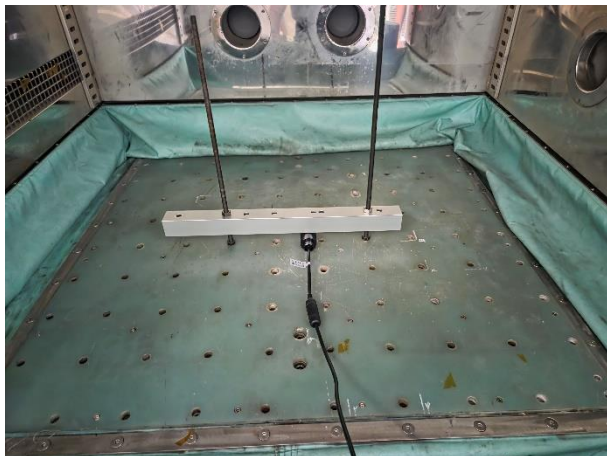
### 7.3.1 Evidence of test setting

X axis

Y axis

Z axis

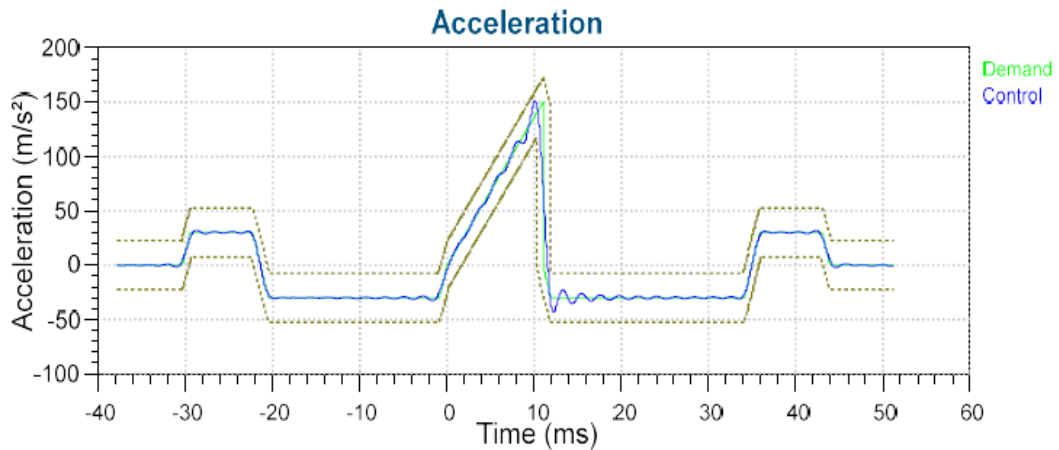
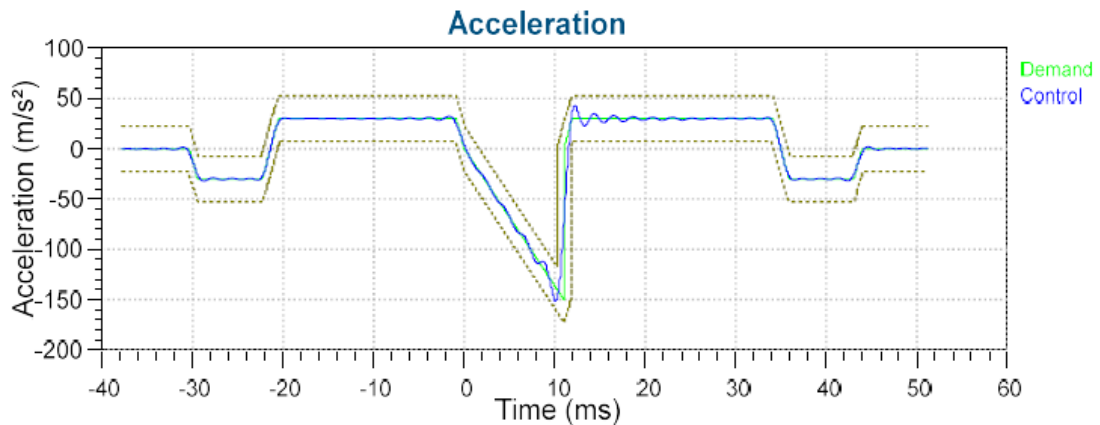
#### 7.5.1 Test data and graph (Shock Test X Axis)

10 14, 2025 10:16:51 Level 1) 100 % Output: 0.93 Volts peak 60068-2-27  
Demand: 150 m/s<sup>2</sup>  
Control: 151.4 m/s<sup>2</sup> Pulse: 10 of 10 Running

10 14, 2025 10:17:21 Level 2) 100 % Output: 0.9344 Volts peak 60068-2-27  
Demand: 150 m/s<sup>2</sup>  
Control: 151.5 m/s<sup>2</sup> Pulse: 10 of 10 End of Test

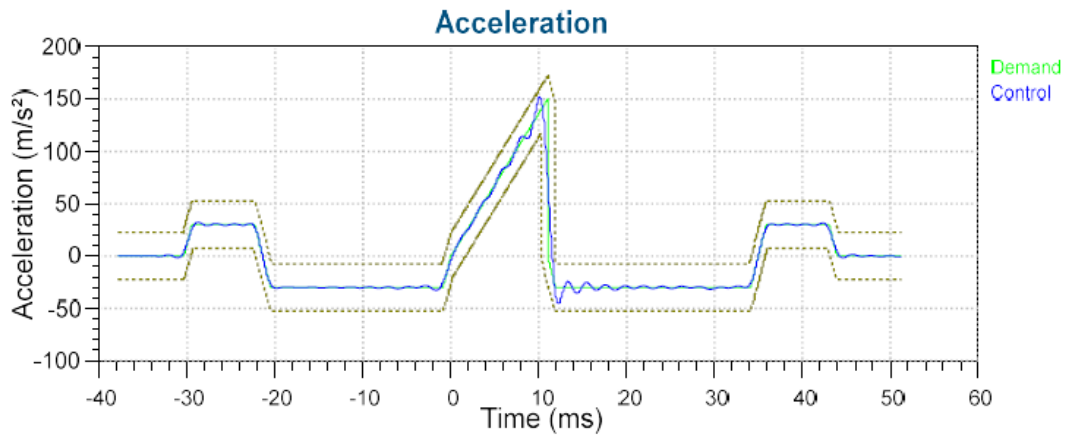
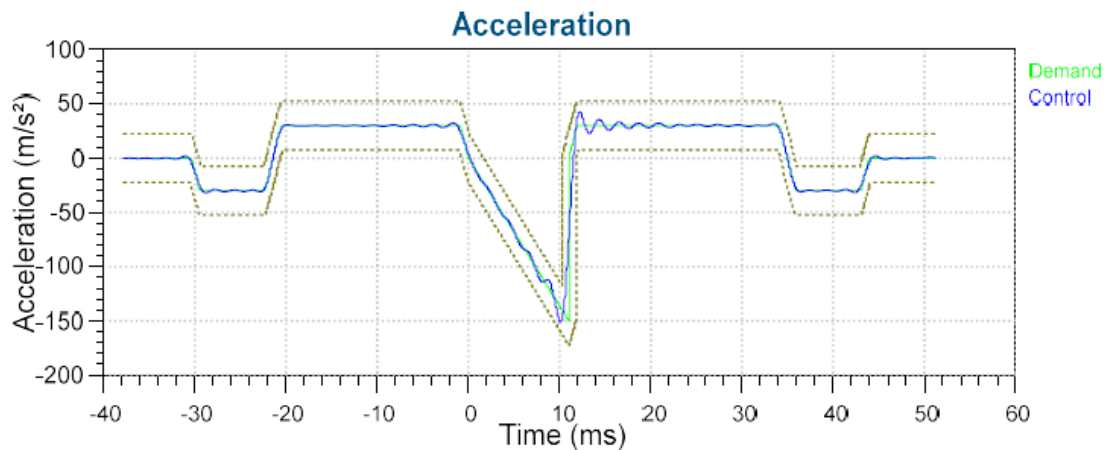
### 7.5.2 Test data and graph (Shock Test Y Axis)

10 14, 2025 10:37:50 Level 1) 100 % Output: 0.9411 Volts peak 60068-2-27  
Demand: 150 m/s<sup>2</sup>  
Control: 151.9 m/s<sup>2</sup> Pulse: 10 of 10 Running

10 14, 2025 10:38:20 Level 2) 100 % Output: 0.929 Volts peak 60068-2-27  
Demand: 150 m/s<sup>2</sup>  
Control: 151.2 m/s<sup>2</sup> Pulse: 10 of 10 End of Test

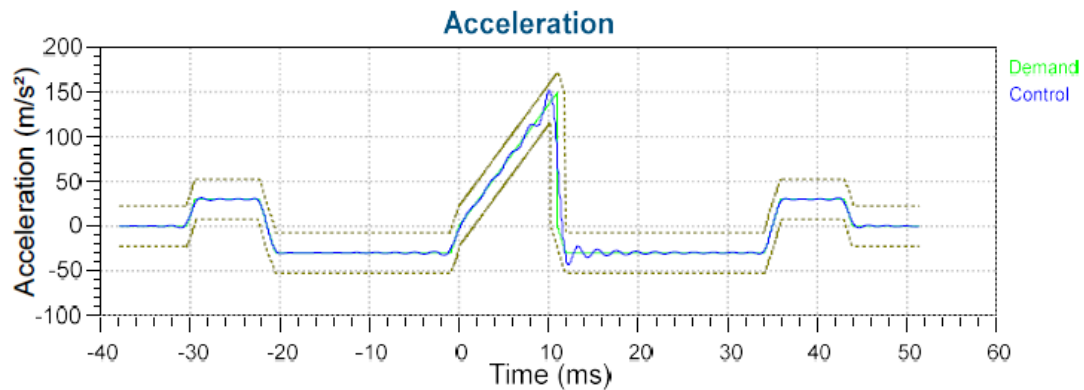
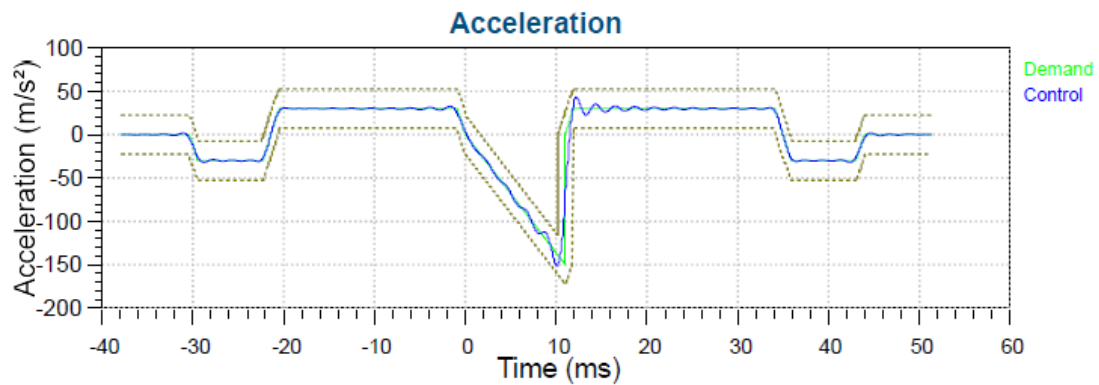
### 7.5.3 Test data and graph (Shock Test Z Axis)

10 14, 2025 16:56:1: Level 1) 100 %  
Demand: 150 m/s  
Control: 151.5 m/s Pulse: 10 of 10

Output: 1.138 Volts peak 한화비전 60068-2  
Running

10 14, 2025 16:56:4 Level 2) 100 %  
Demand: 150 m/s  
Control: 151.4 m/s Pulse: 10 of 10

Output: 1.148 Volts peak 한화비전 60068-2  
End of Test

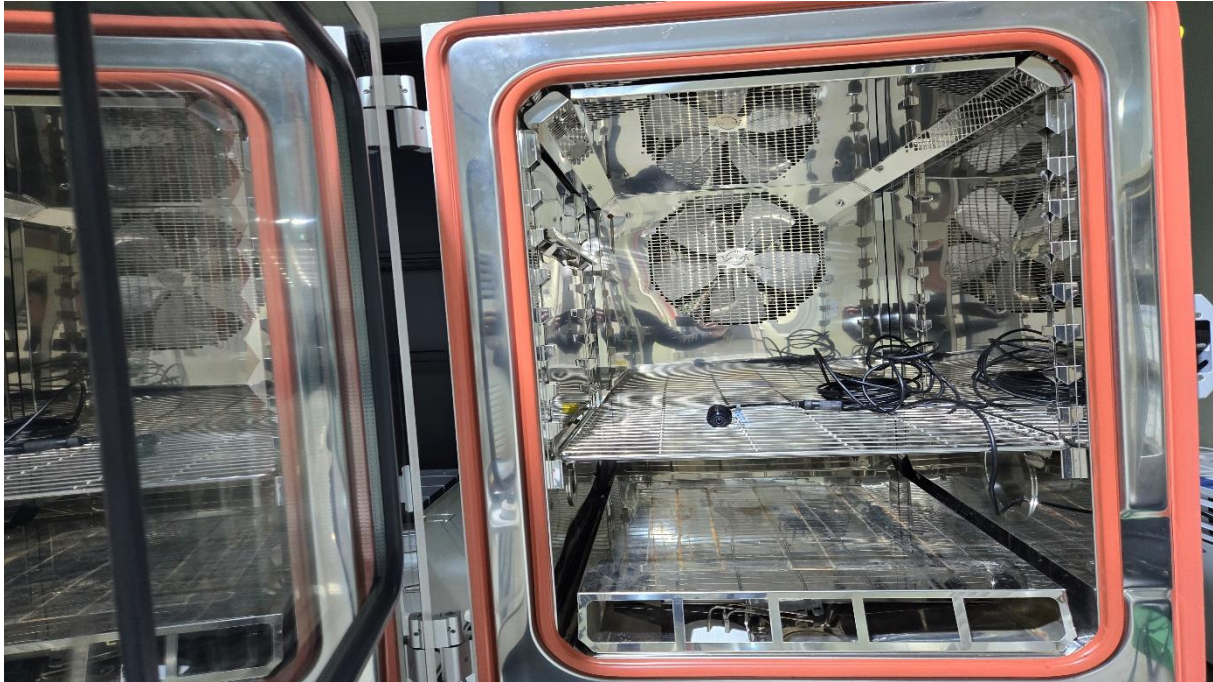
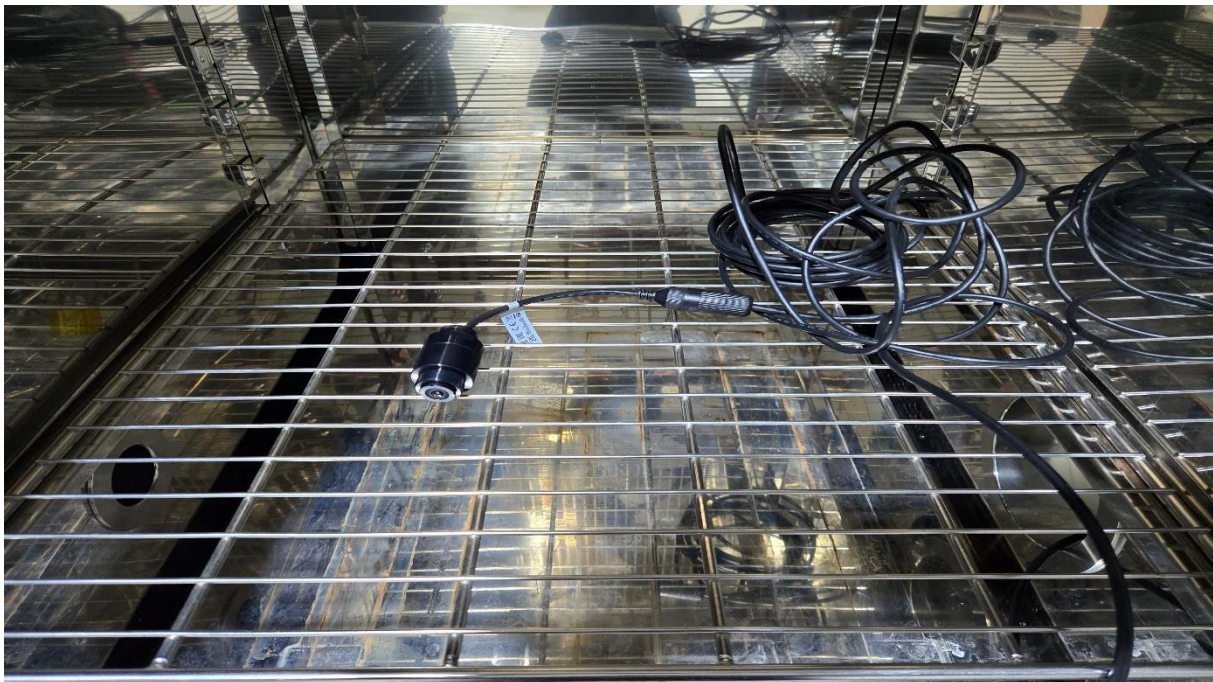
#### 8.3.1 Evidence of test setting

8.2.2 Test temperature:  $40 \pm 2$  °C

8.2.3 Test Humidity:  $93 \pm 3$  % R.H.

8.2.4 Test time: 240 h

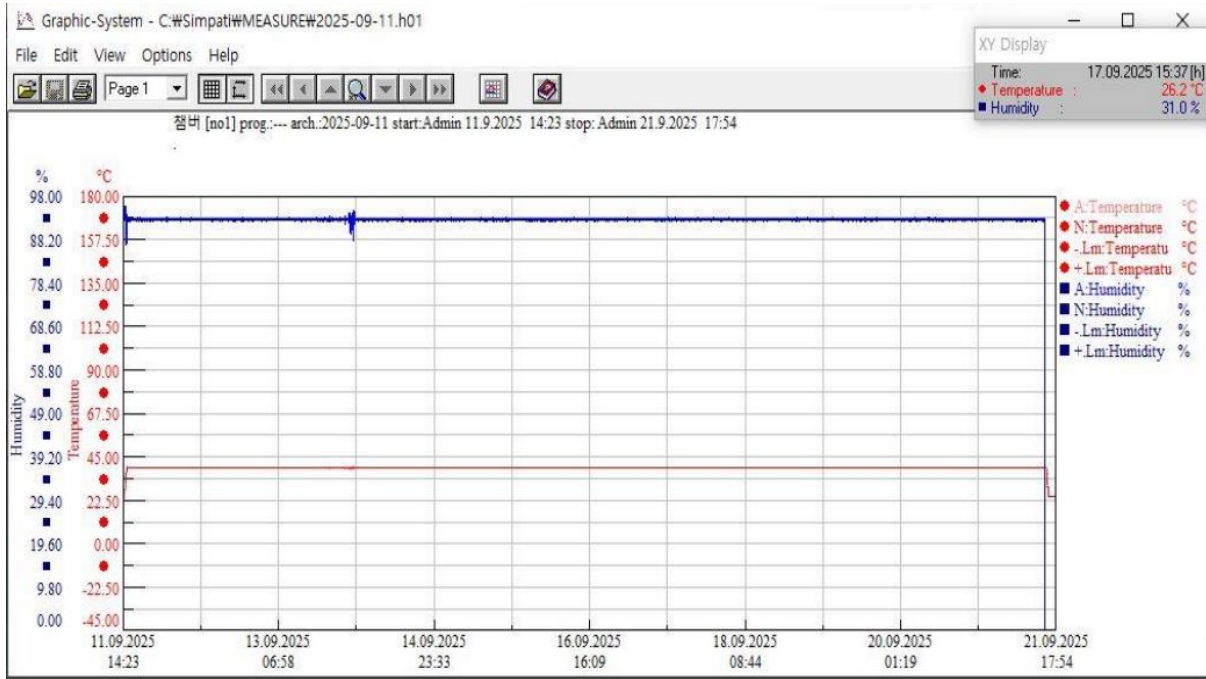
### 8.5.1 Test data and graph

Temperature Data
