# TEST REPORT

REPORT No.:  
CTK-2025-02837  
Page (1) / (39) pages

LENS MODULE / SLA-F2480WDA

EN 60068-2-1, EN 60068-2-2, EN 60068-2-14, EN 60068-2-6, EN 60068-2-27, EN 60068-2-78, IEC 60068-2-1, IEC 60068-2-2, IEC 60068-2-14, IEC 60068-2-6, IEC 60068-2-27, IEC 60068-2-78

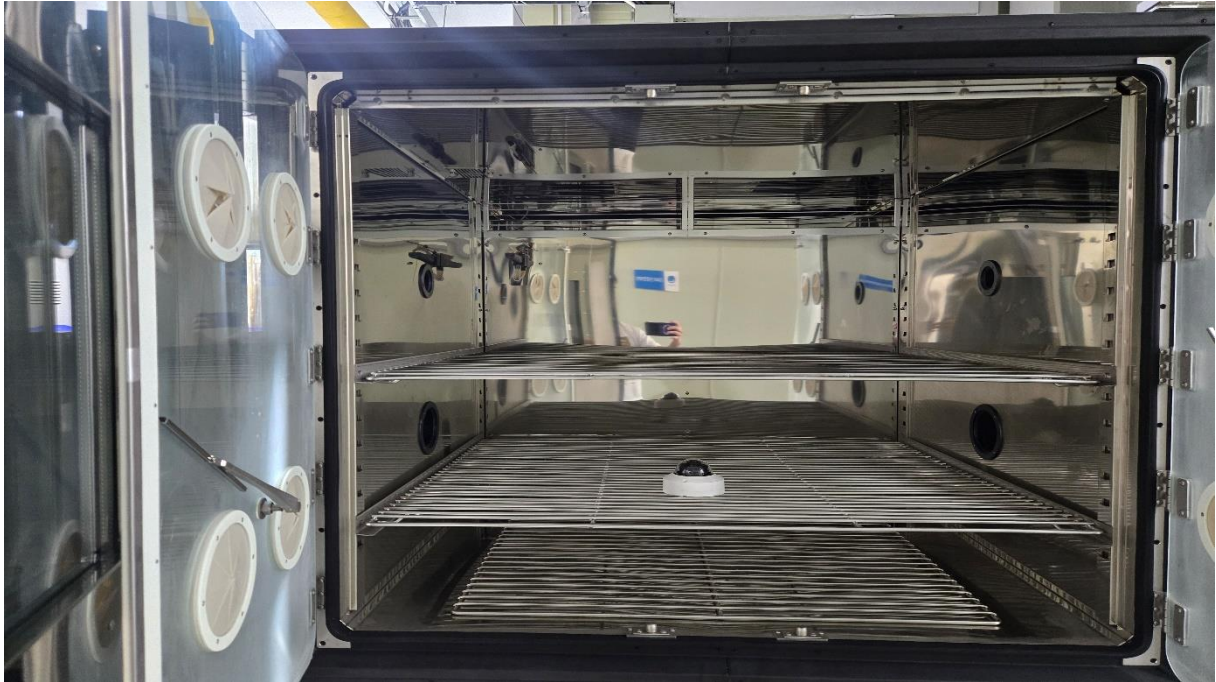
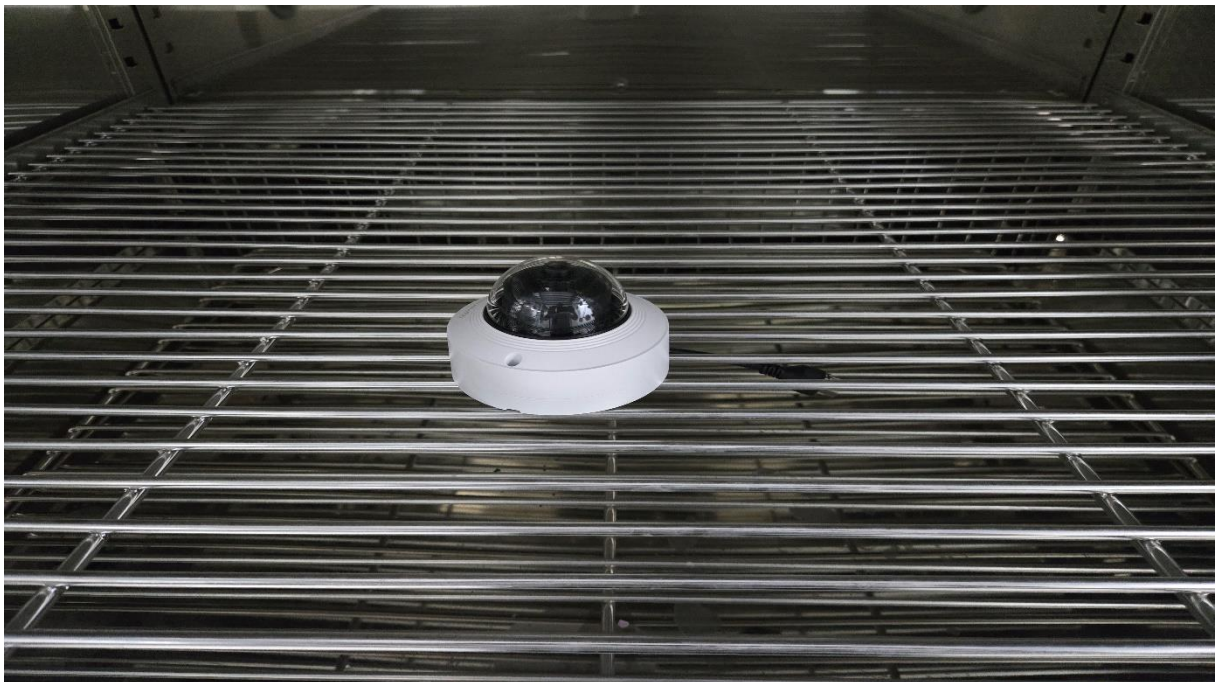
#### 3.3.1 Evidence of test setting

3.2.1 Sample status: Non-operation

3.2.2 Test temperature: -33 °C

3.2.3 Test time: 16 h

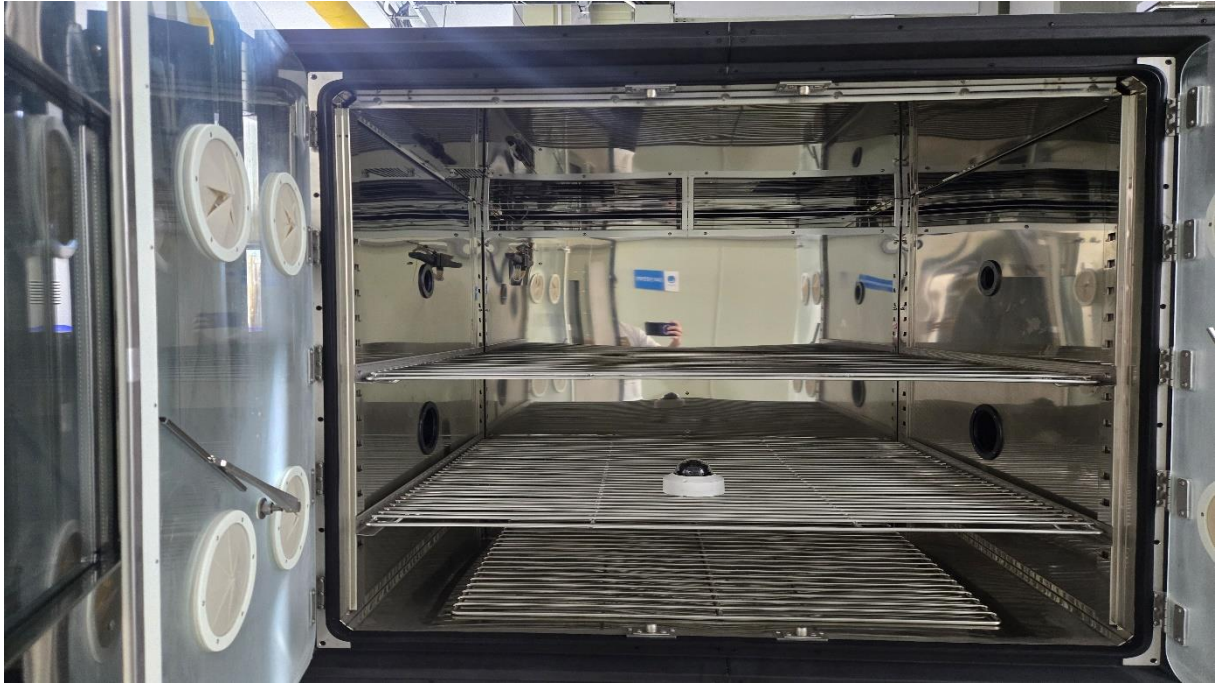
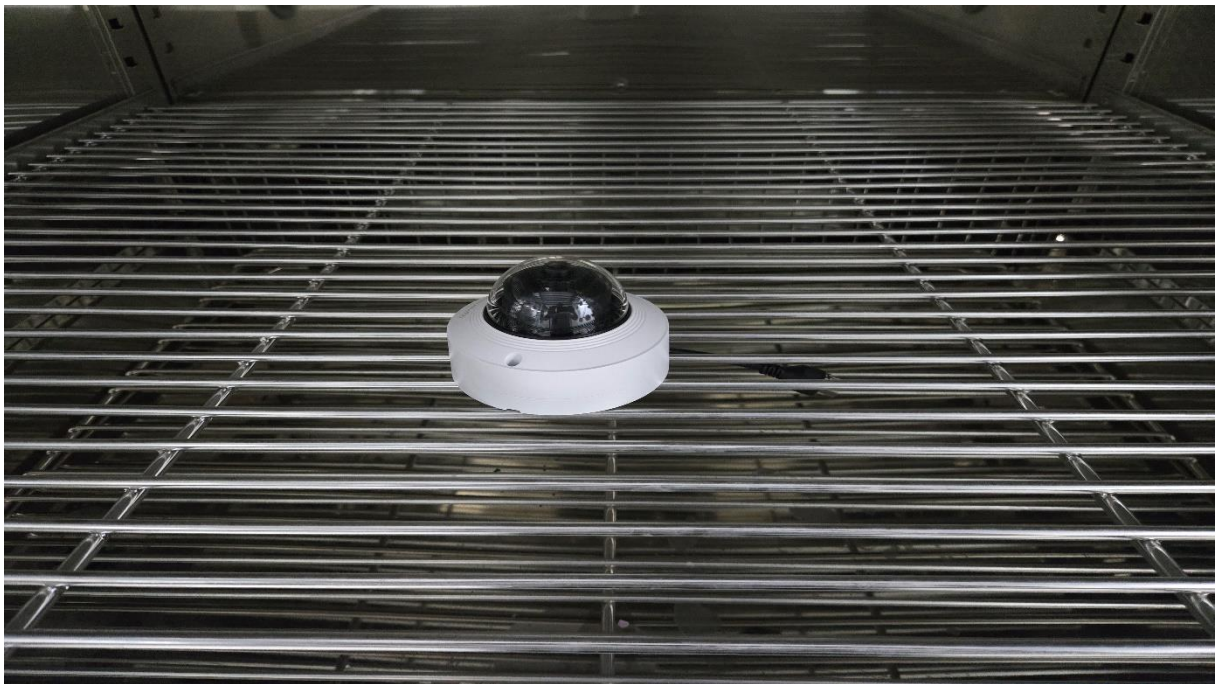
#### 4.3.1 Evidence of test setting

4.2.1 Sample status: Non-operation

4.2.2 Test temperature: 60 °C

4.2.3 Test time: 96 h

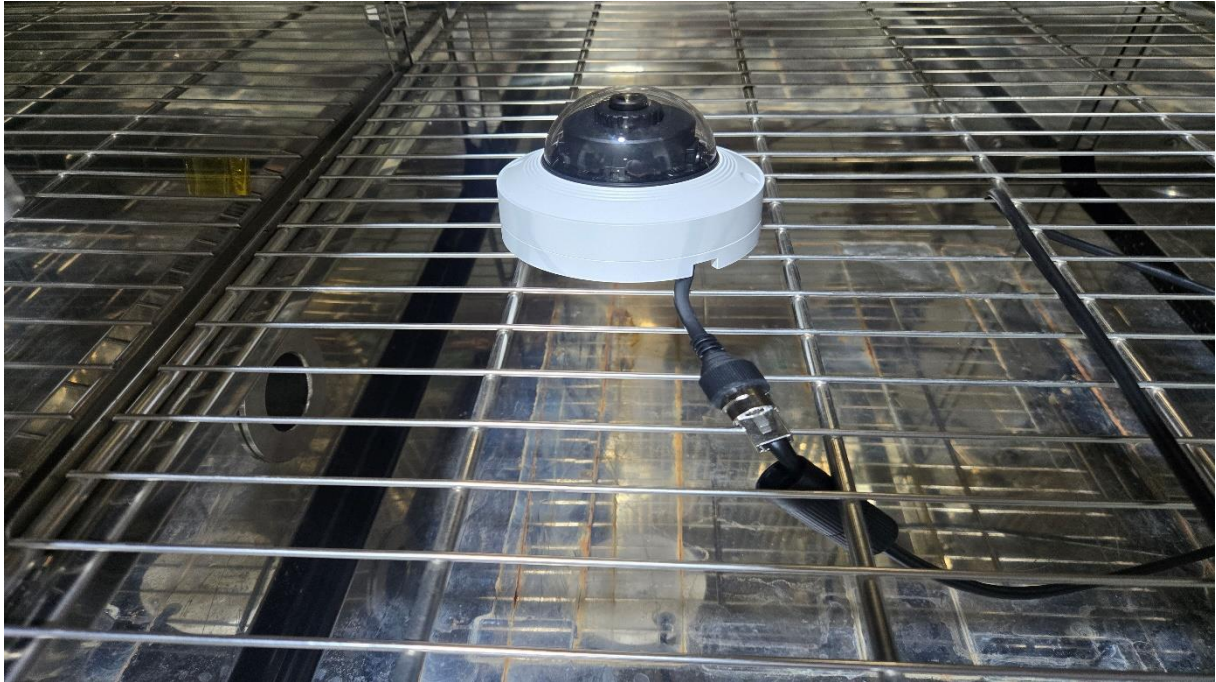
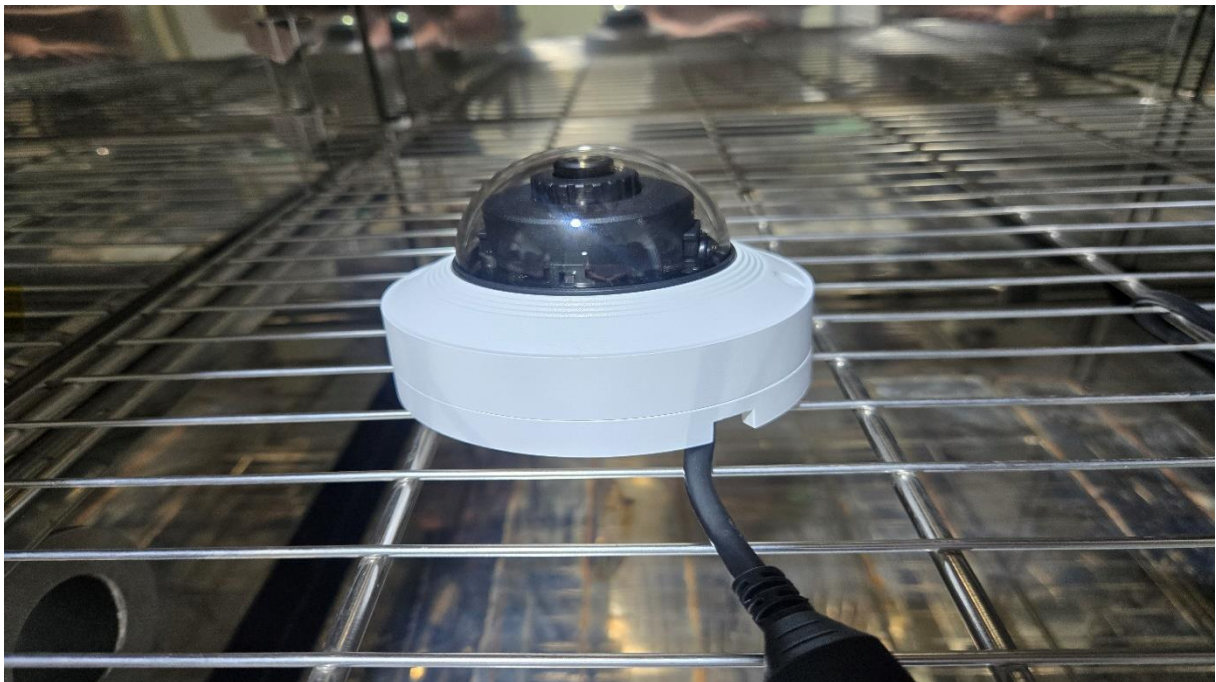
#### 5.3.1 Evidence of test setting

5.2.1 Sample status: operation

5.2.2 Test temperature: -33 °C, 55 °C

| Temp↵ | Temperature change rate(°C/min)↵ | t <sub>1</sub> (idle time)↵ | Cycles↵ |
| High↵ | 5 °C/min↵ | 3 h↵ | 3↵ |
| Low↵ | 1 °C/min↵ | 3 h↵ | 3↵ |

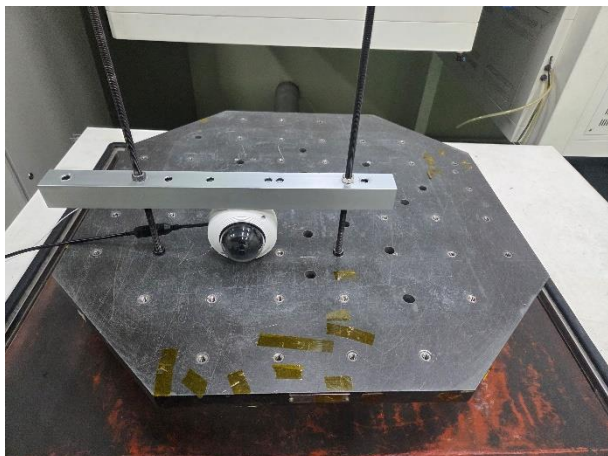
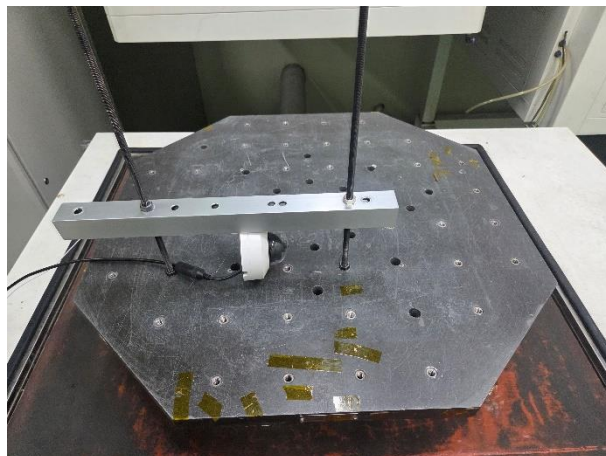
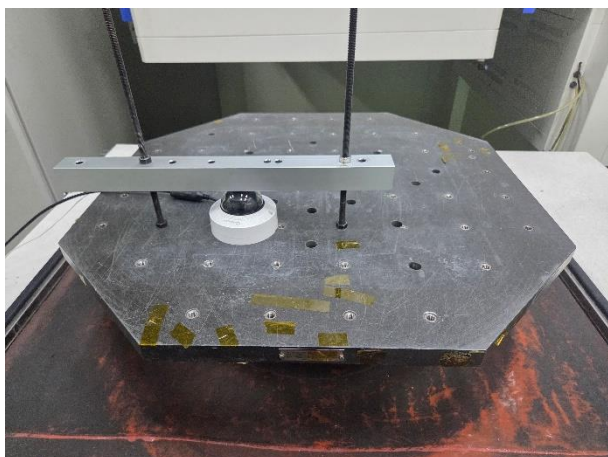
### 6.3.1 Evidence of test setting

- Sample status: operation
- Frequency(Hz): 5 Hz ~ 200 Hz
- Acceleration(G): 1 G
- Sweep rate: 1 oct/min
- Test Axis: X, Y, Z
- Test time(h): Total 30 min (10 min. per each axis)

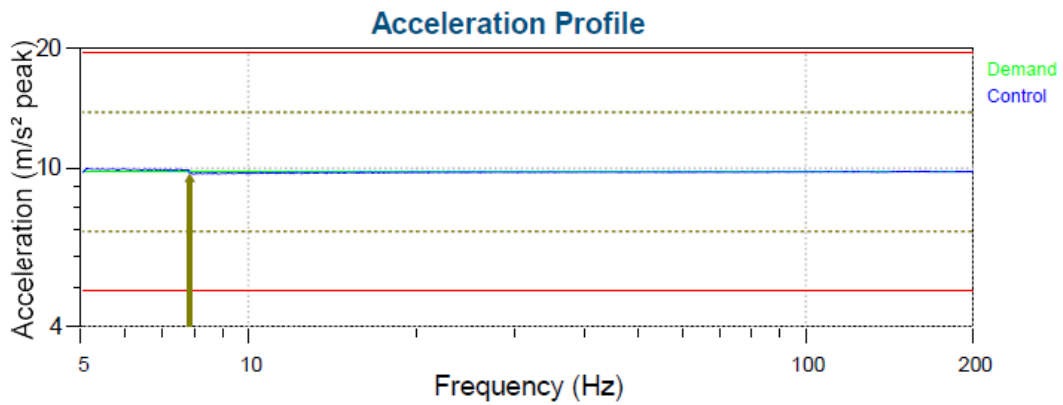
### 6.5.2 Test data and graph (Vibration Test Y Axis)

10 14, 2025 10:36:55 Level 1) 100 % Output: 0.3608 Volts peak 60068-2-6  
Demand: 9.807 m/s<sup>2</sup> Level Time: 0:10:00 Frequency: 7.846 Hz  
Control: 9.73 m/s<sup>2</sup> Total Time: 0:10:12 End of Timed Test

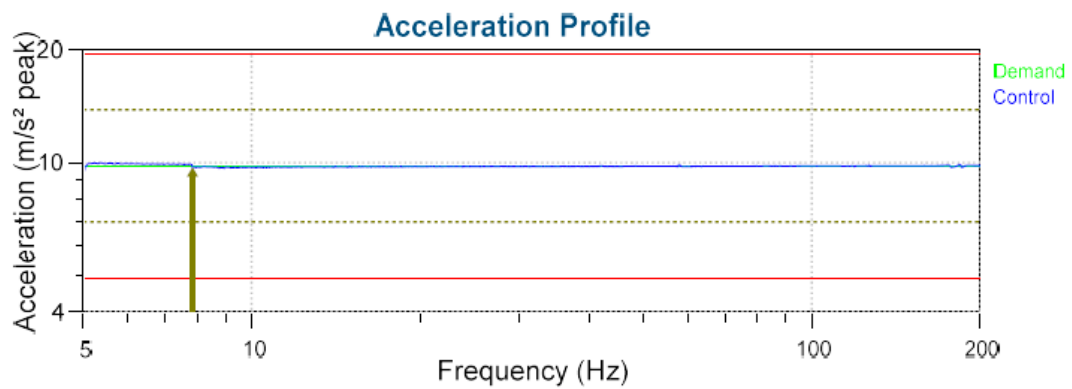
### 6.5.3 Test data and graph (Vibration Test Z Axis)

10 14, 2025 16:51:31 Level 1) 100 %  
Demand: 9.807 m/s<sup>2</sup> Level Time: 0:10:01  
Control: 9.723 m/s<sup>2</sup> Total Time: 0:10:15

Output: 0.382 Volts peak 2025-05-07 한화비전 60068  
Frequency: 7.841 Hz  
End of Timed Test

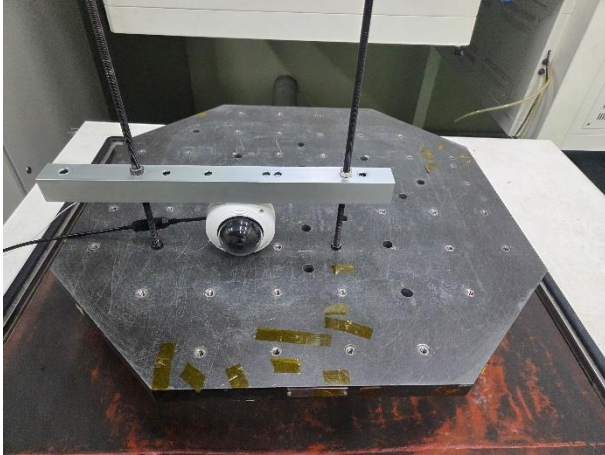
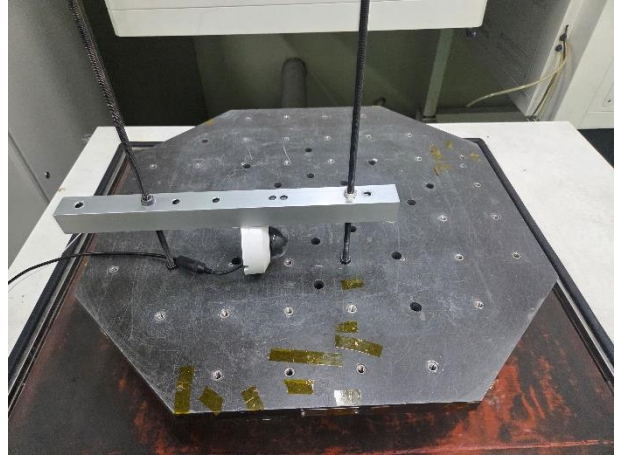
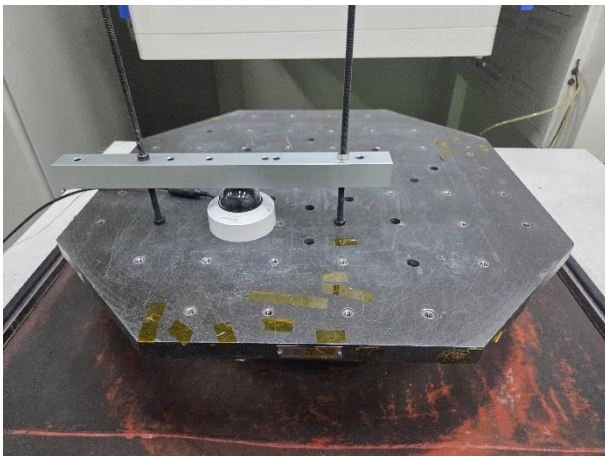
### 7.3.1 Evidence of test setting

7.2.1 Sample status: Non-operation

7.2.2 Acceleration( $\text{m/s}^2$ ):  $150 \text{ m/s}^2$

7.2.3 Number of impacts: 10 per direction (total 60)

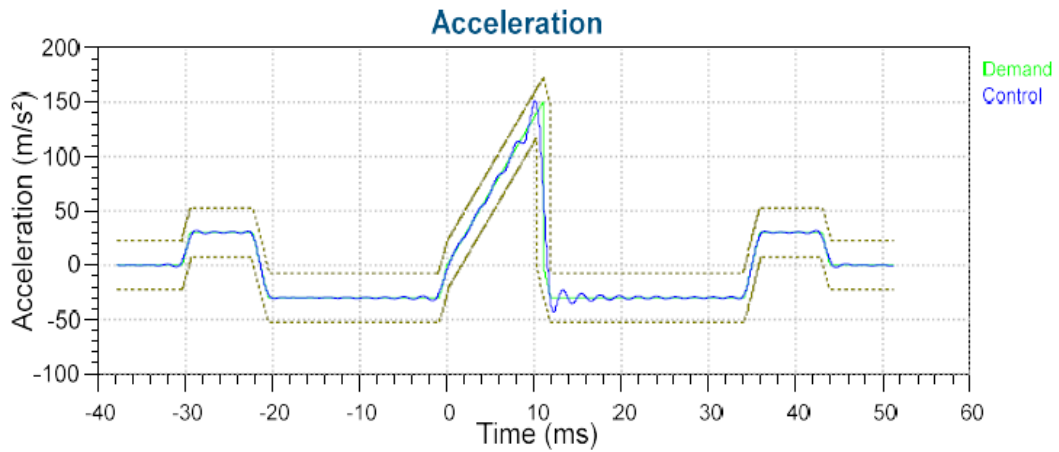
X+

10 14, 2025 10:16:51 Level 1) 100 % Output: 0.93 Volts peak 60068-2-27  
Demand: 150 m/s<sup>2</sup>  
Control: 151.4 m/s<sup>2</sup> Pulse: 10 of 10 Running

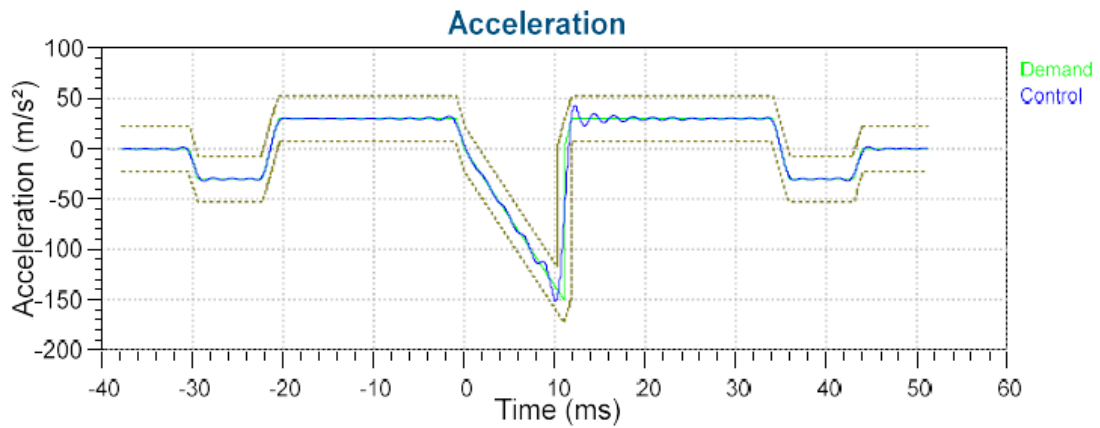
X-

10 14, 2025 10:17:21 Level 2) 100 % Output: 0.9344 Volts peak 60068-2-27  
Demand: 150 m/s<sup>2</sup>  
Control: 151.5 m/s<sup>2</sup> Pulse: 10 of 10 End of Test

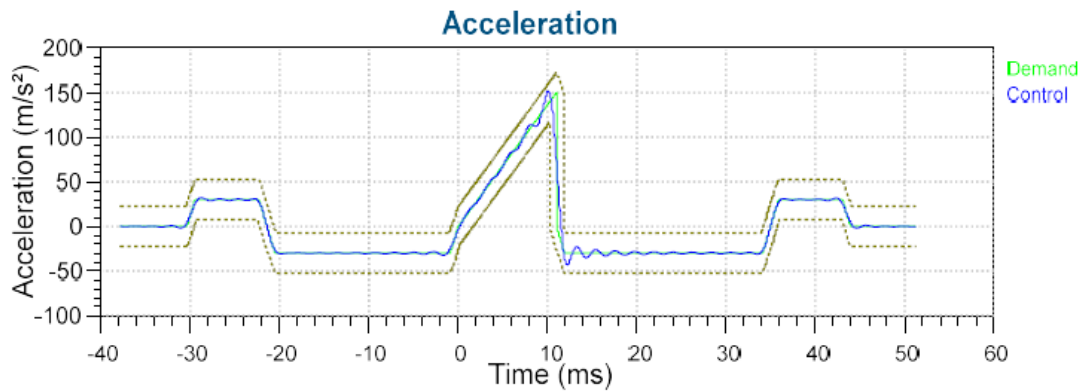
Z+

10 14, 2025 11:00:25 Level 1) 100 % Output: 0.9227 Volts peak 60068-2-27

Demand: 150 m/s<sup>2</sup>

Control: 151.5 m/s<sup>2</sup> Pulse: 10 of 10 Running

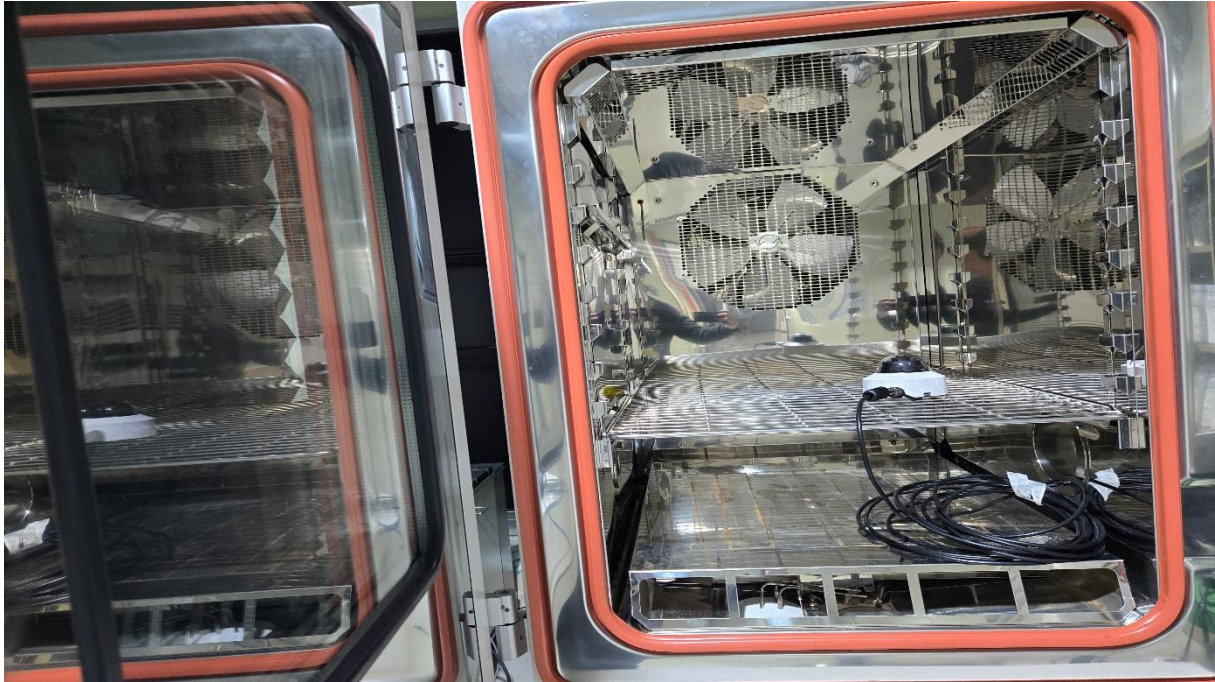
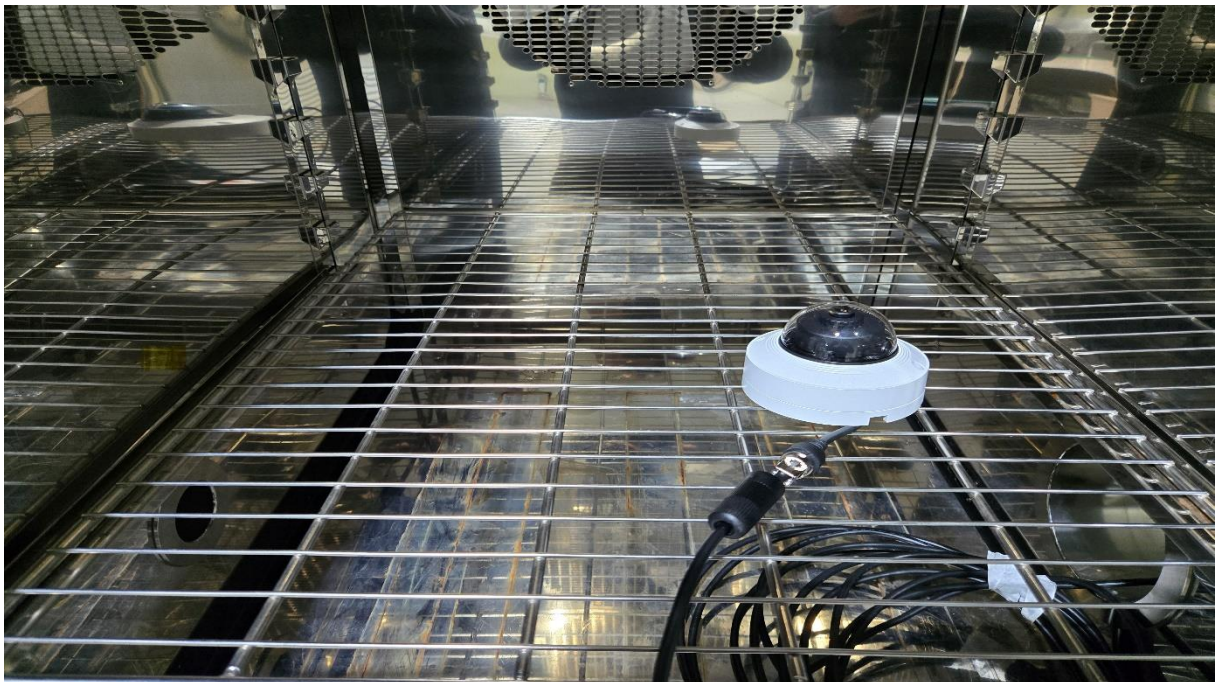
#### 8.3.1 Evidence of test setting

8.2.1 Sample status: operation

8.2.2 Test temperature:  $40 \pm 2$  °C

8.2.3 Test Humidity:  $93 \pm 3$  % R.H.

8.2.4 Test time: 240 h
