# TEST REPORT

REPORT No.:  
CTK-2025-02235  
Page (1) / (39) pages

LENS MODULE / SLA-F4780A

EN 60068-2-1, EN 60068-2-2, EN 60068-2-14, EN 60068-2-6, EN 60068-2-27, EN 60068-2-78, IEC 60068-2-1, IEC 60068-2-2, IEC 60068-2-14, IEC 60068-2-6, IEC 60068-2-27, IEC 60068-2-78

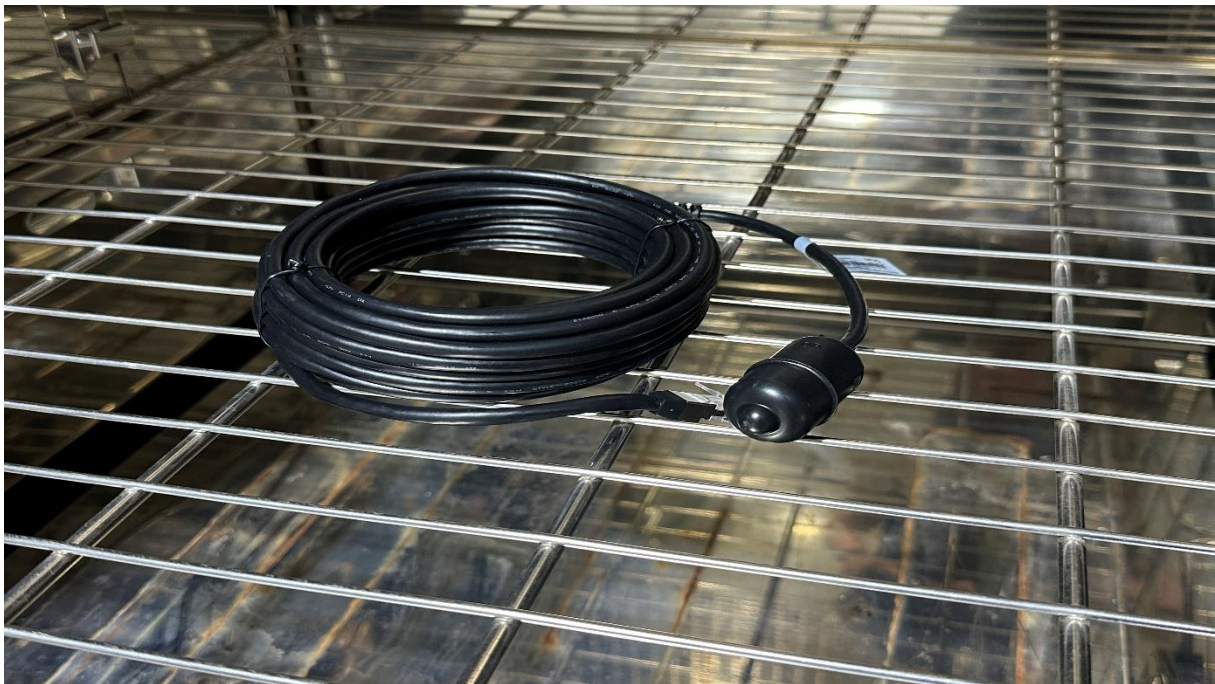
#### 3.3.1 Evidence of test setting

3.2.1 Sample status: Non-operation

3.2.2 Test temperature: -33 °C

3.2.3 Test time: 16 h

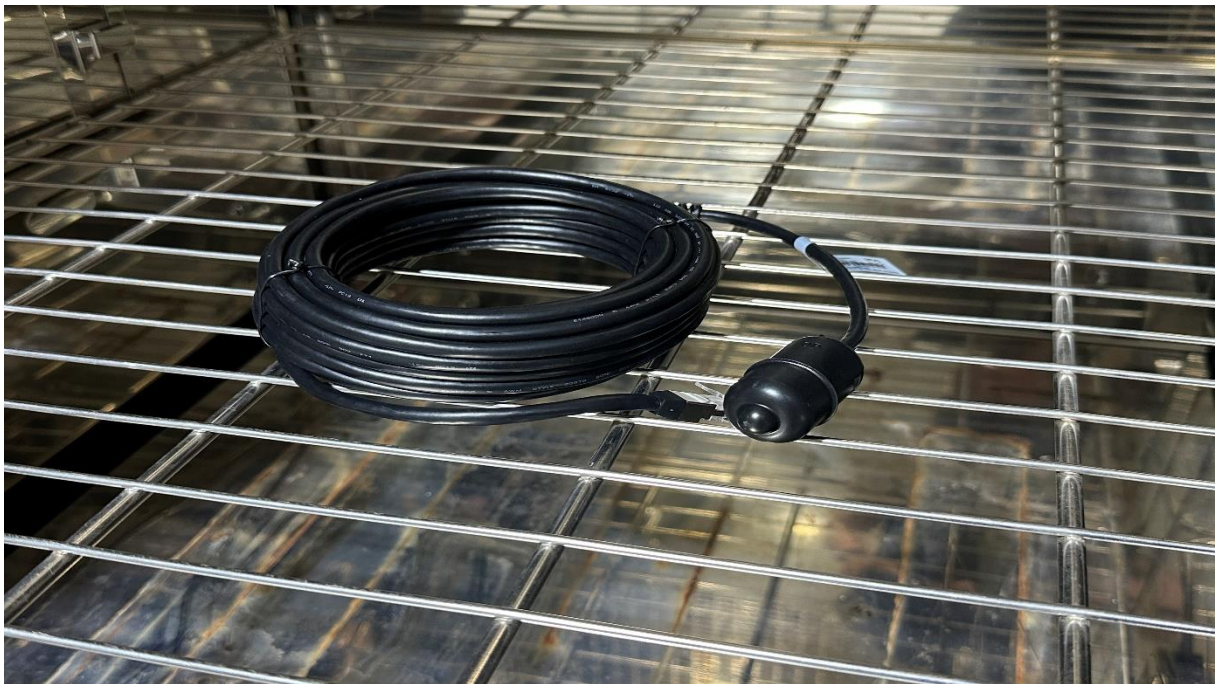
#### 4.3.1 Evidence of test setting

4.2.1 Sample status: Non-operation

4.2.2 Test temperature: 60 °C

4.2.3 Test time: 96 h

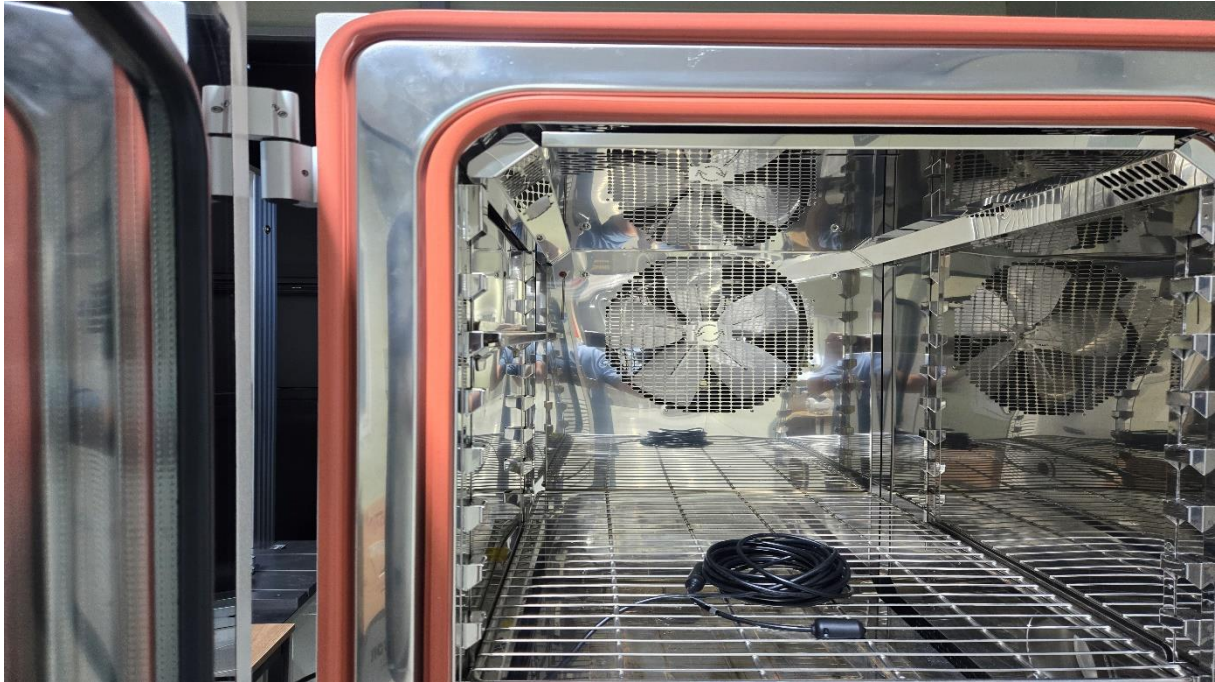
#### 5.3.1 Evidence of test setting

5.2.1 Sample status: operation

5.2.2 Test temperature: -10 °C, 55 °C

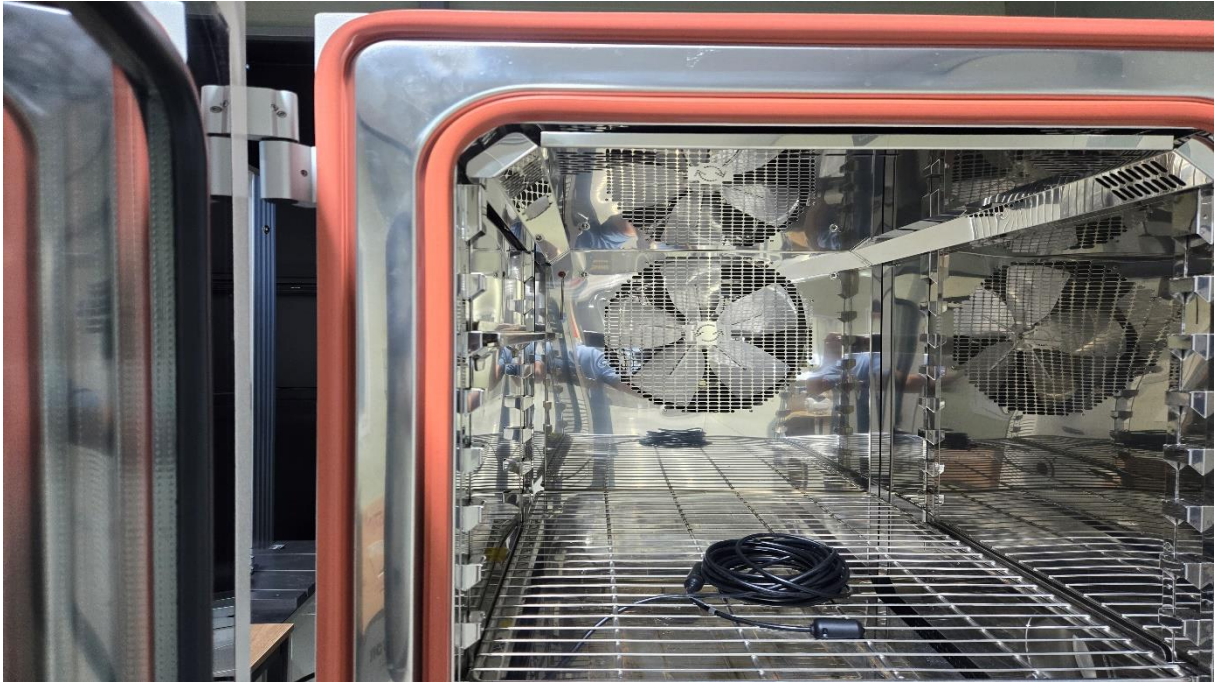
#### 8.3.1 Evidence of test setting

8.2.1 Sample status: operation

8.2.2 Test temperature:  $40 \pm 2$  °C

8.2.3 Test Humidity:  $93 \pm 3$  % R.H.

8.2.4 Test time: 240 h
