# TEST REPORT

REPORT No.:  
CTK-2026-00018  
Page (1) / (39) pages

LENS MODULE / SLA-T16080WA

EN 60068-2-1, EN 60068-2-2, EN 60068-2-14, EN 60068-2-6, EN  
60068-2-27, EN 60068-2-78, IEC 60068-2-1, IEC 60068-2-2, IEC  
60068-2-14, IEC 60068-2-6, IEC 60068-2-27, IEC 60068-2-78

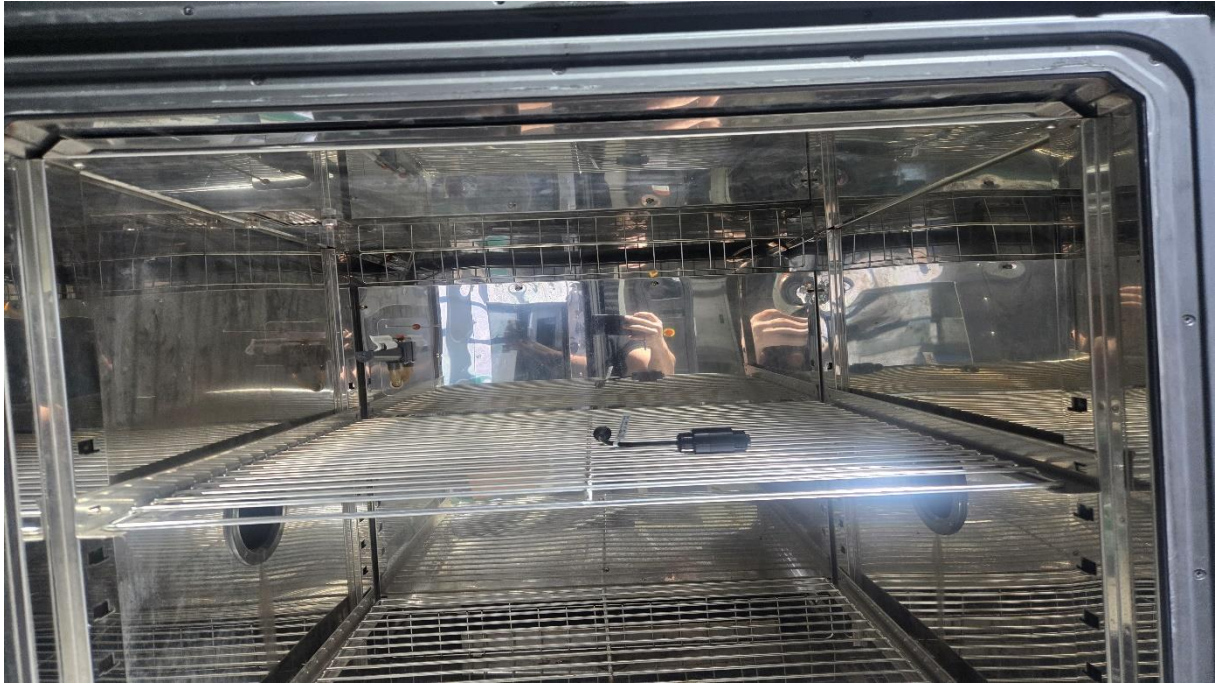
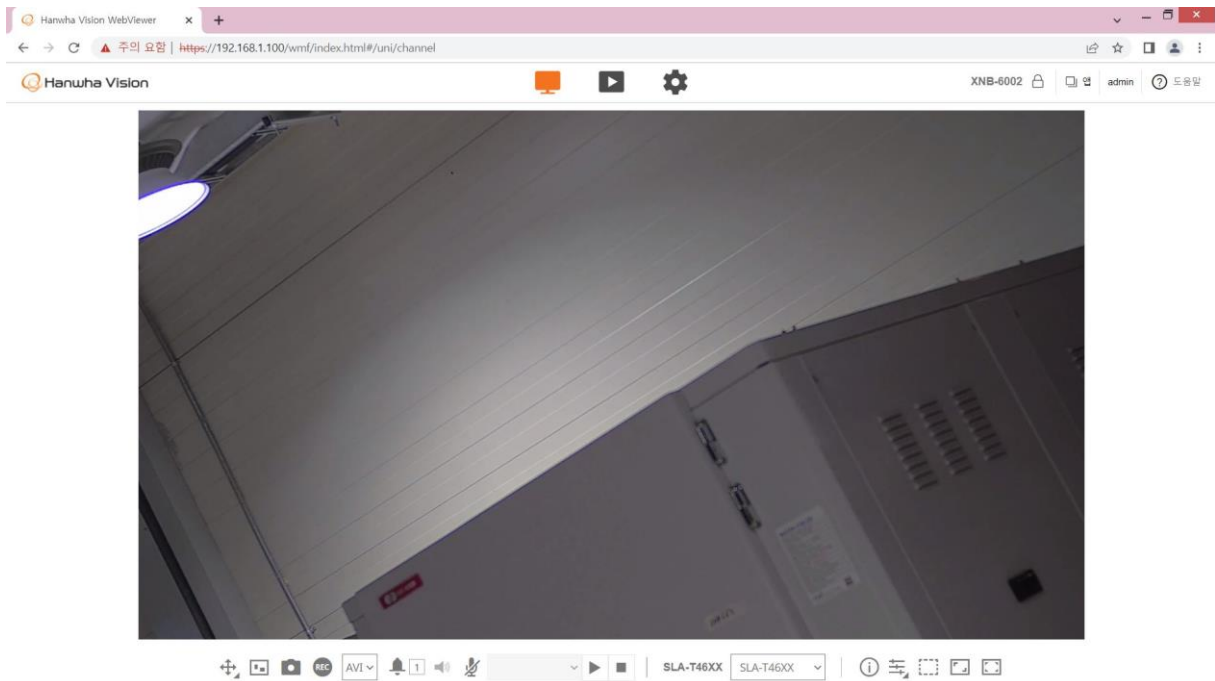
#### 3.3.1 Evidence of test setting

3.2.1 Sample status: Non-operation

3.2.2 Test temperature: -33 °C

3.2.3 Test time: 16 h

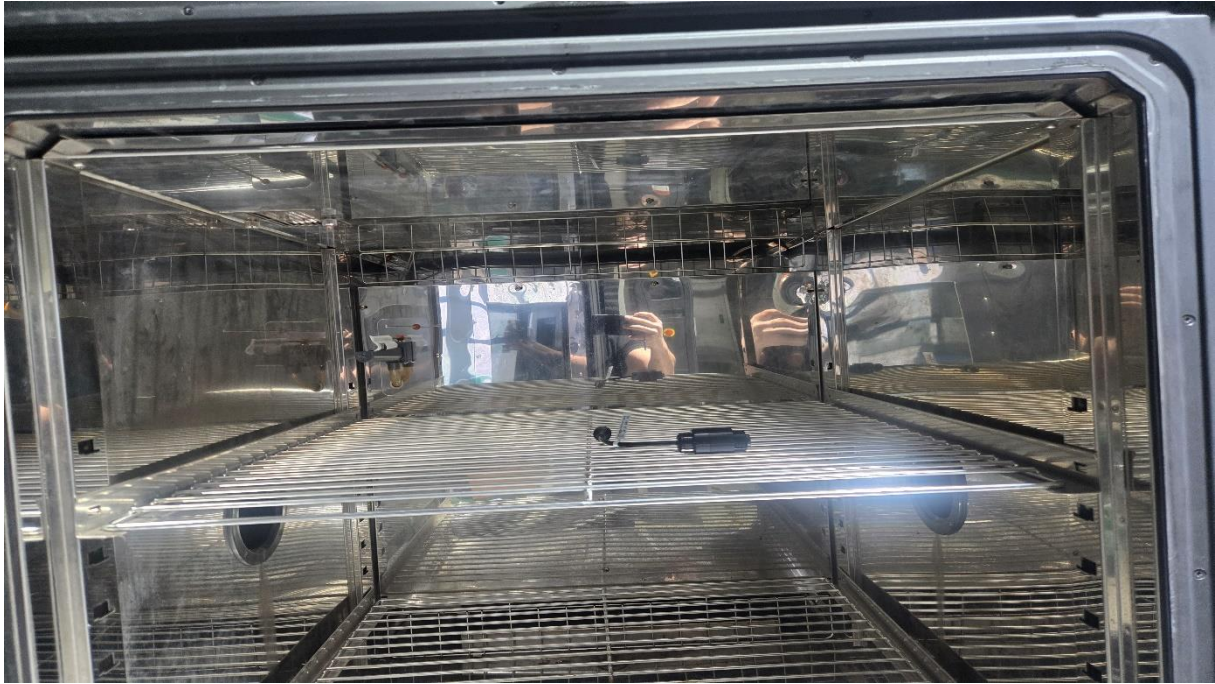
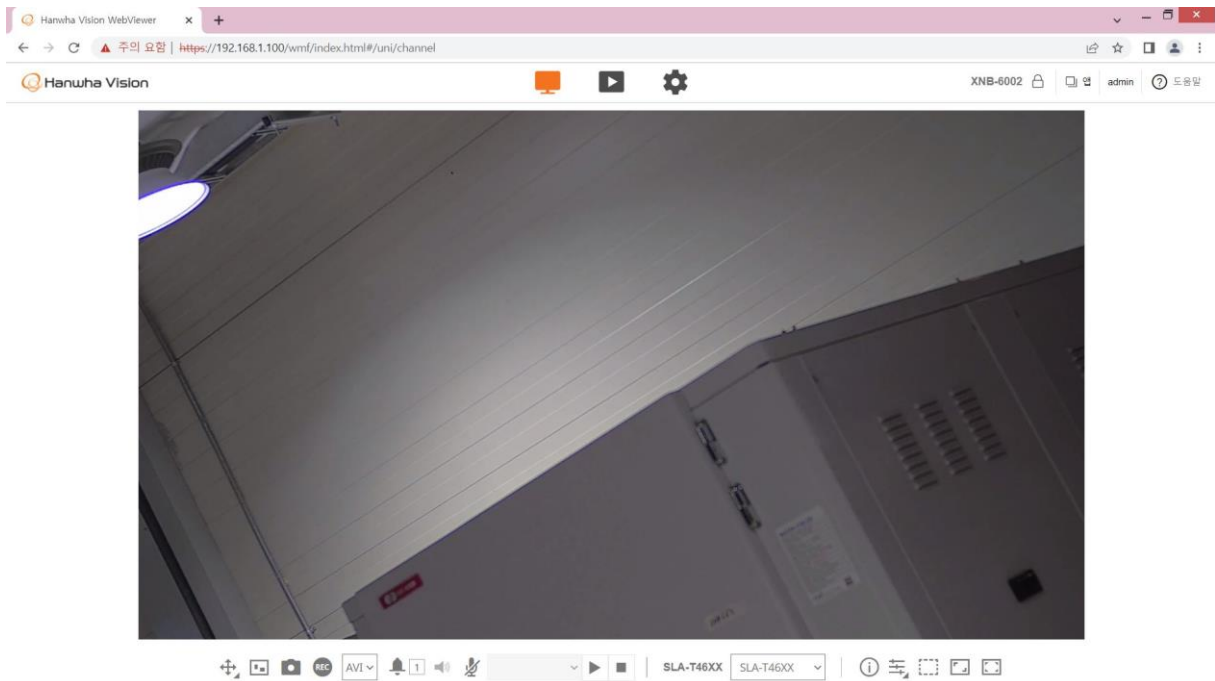
#### 4.3.1 Evidence of test setting

4.2.1 Sample status: Non-operation

4.2.2 Test temperature: 60 °C

4.2.3 Test time: 96 h

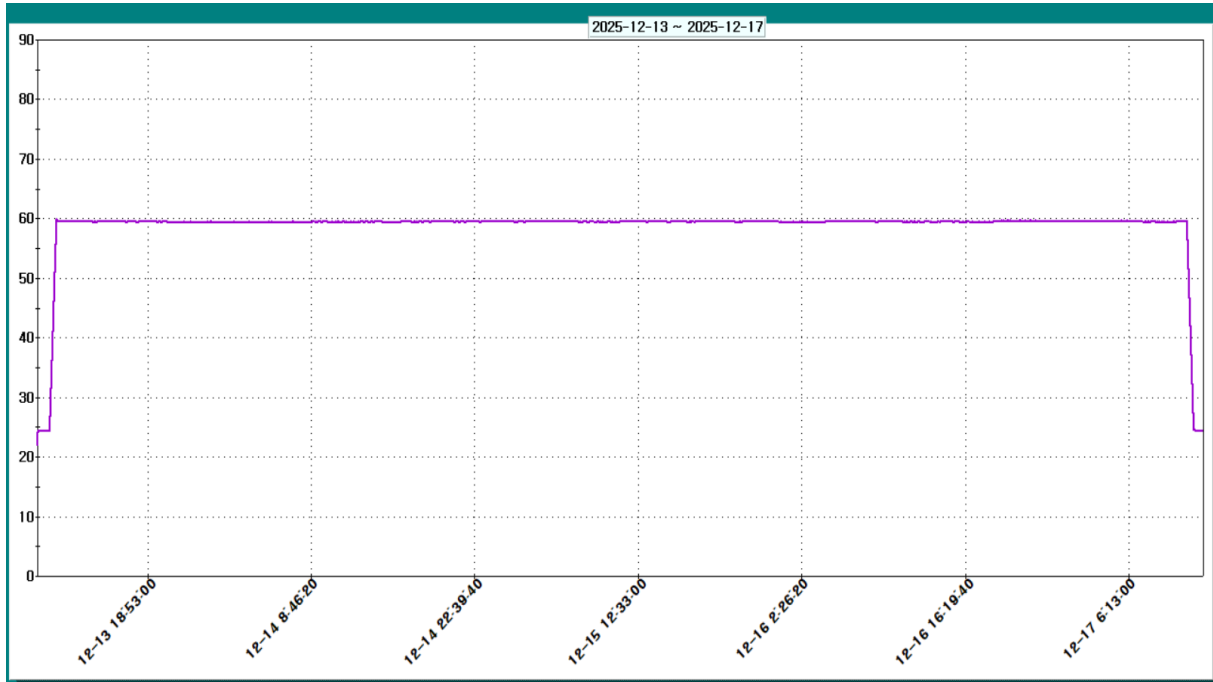
#### 4.5.1 Test data and graph

Temperature Data

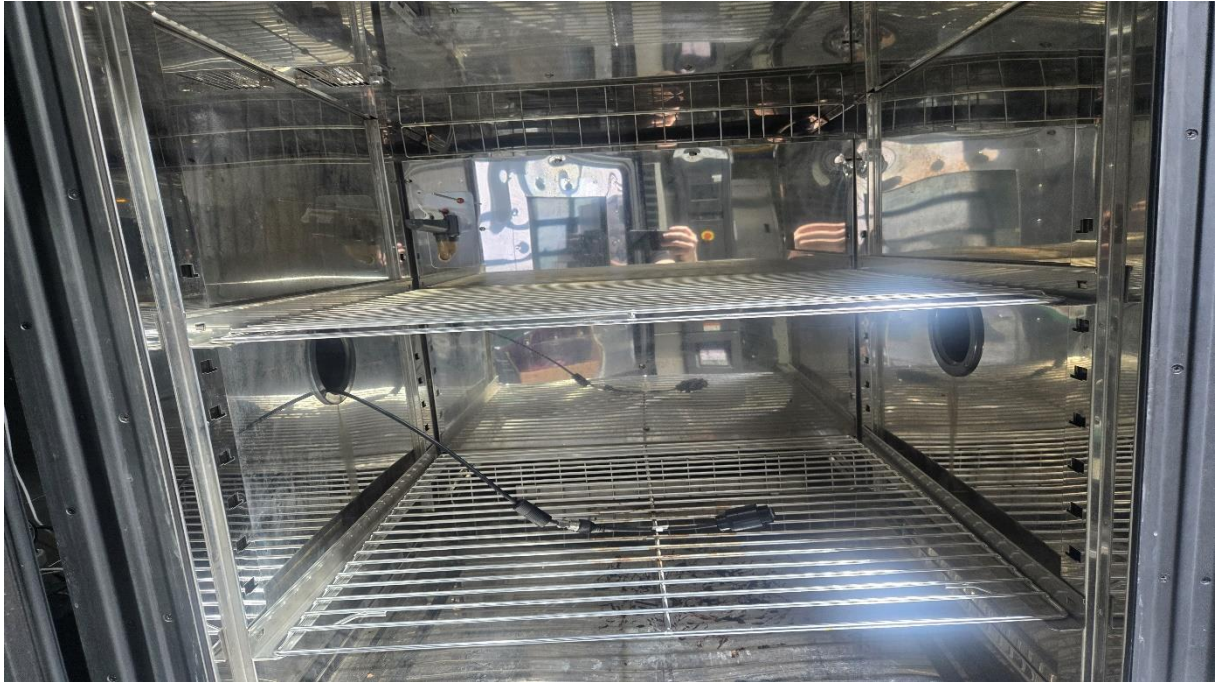
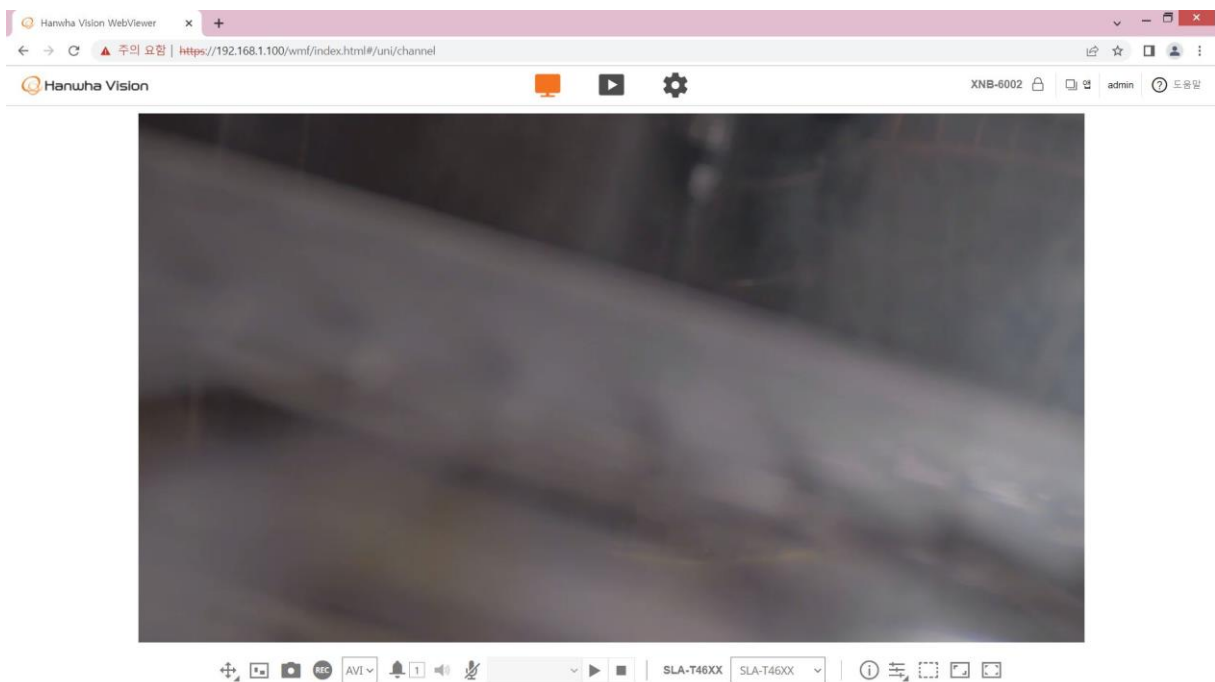
#### 5.3.1 Evidence of test setting

5.2.1 Sample status: operation

5.2.2 Test temperature: -33 °C, 55 °C

| Temp↵ | Temperature change rate(°C/min)↵ | t <sub>1</sub> (idle time)↵ | Cycles↵ |
| High↵ | 5 °C/min↵ | 3 h↵ | 3↵ |
| Low↵ | 1 °C/min↵ | 3 h↵ | 3↵ |

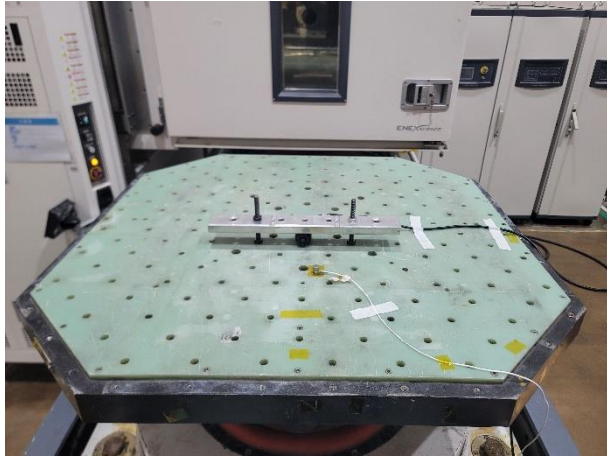
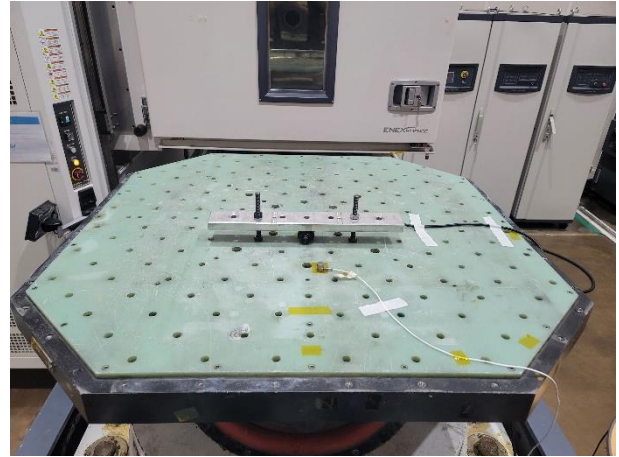
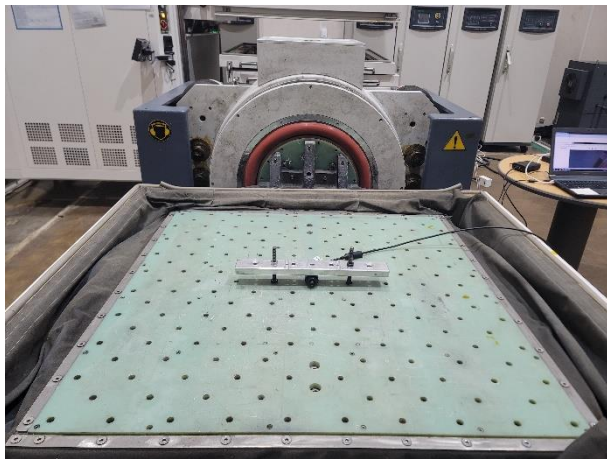
#### 6.3.1 Evidence of test setting

- Sample status: operation
- Frequency(Hz): 5 Hz ~ 200 Hz
- Acceleration(G): 1 G
- Sweep rate: 1 oct/min
- Test Axis: X, Y, Z
- Test time(h): Total 30 min (10 min. per each axis)

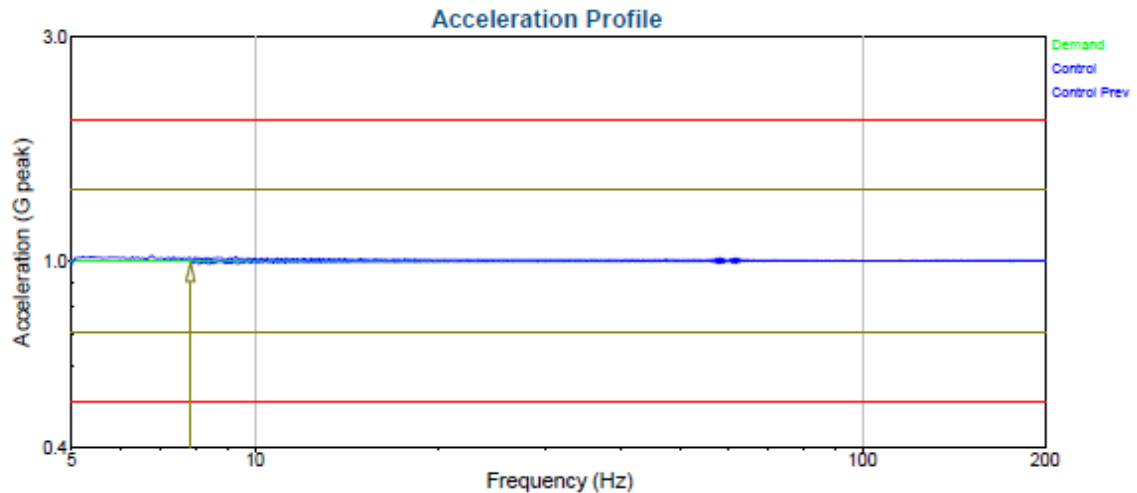
#### 6.5.1 Test data and graph (Vibration Test X Axis)

| 12 29, 2025 15:10:16 | Level 1) 100 % | Output: 0.2589 Volts peak | 한화비전 60068-2-6 |
| Demand: 1 G | Level Time: 0:10:00 | Frequency: 7.846 Hz | |
| Control: 0.9895 G | Total Time: 0:10:12 | End of Timed Test | |

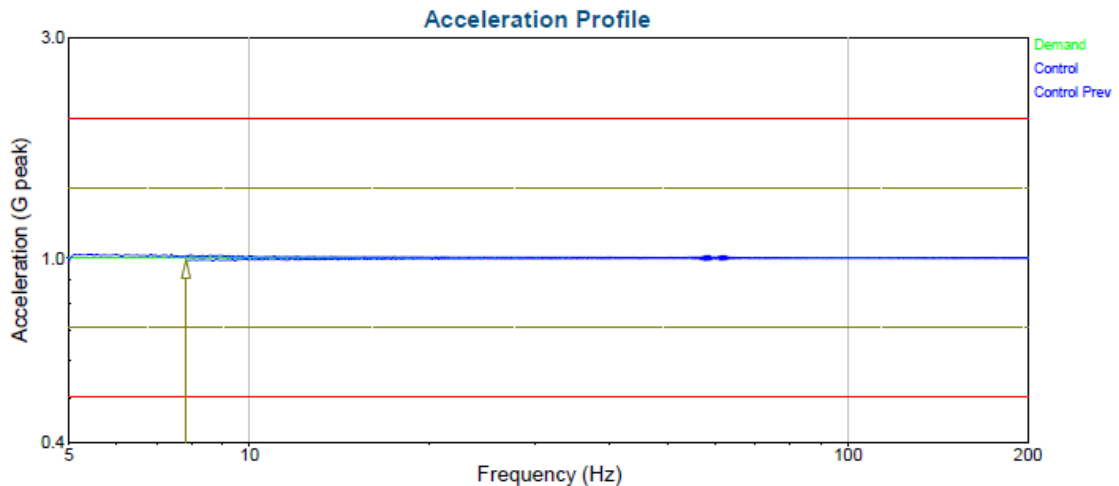
### 6.5.2 Test data and graph (Vibration Test Y Axis)

Output: 0.2593 Volts peak

Demand: 1 G

Frequency: 7.841 Hz

Control: 0.9899 G

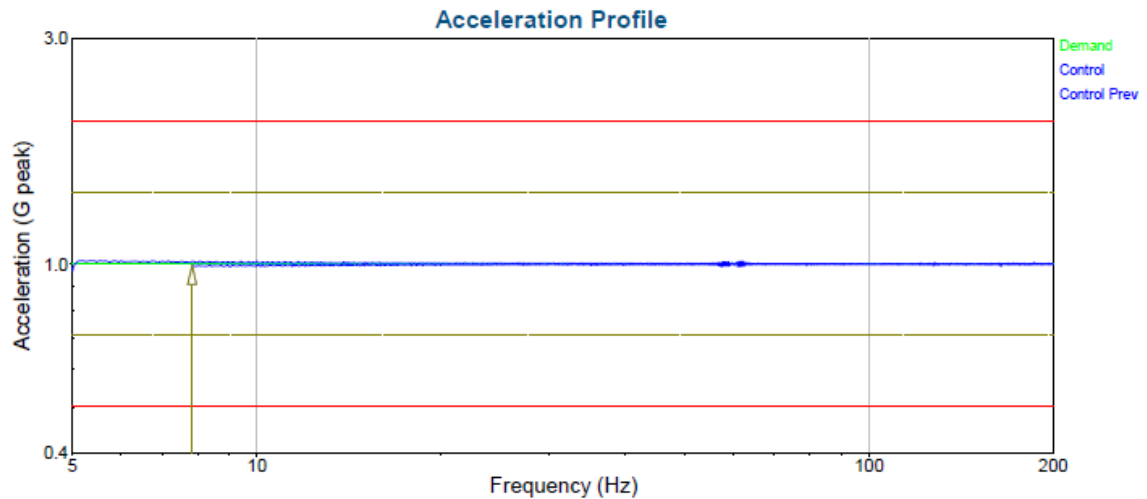
### 6.5.3 Test data and graph (Vibration Test Z Axis)

12 29, 2025 16:16:48    Level 1) 100 %    Output: 0.2581 Volts peak    한화비전 60068-2-6  
Demand: 1 G    Level Time: 0:10:00    Frequency: 7.841 Hz  
Control: 0.9925 G    Total Time: 0:10:12    End of Timed Test

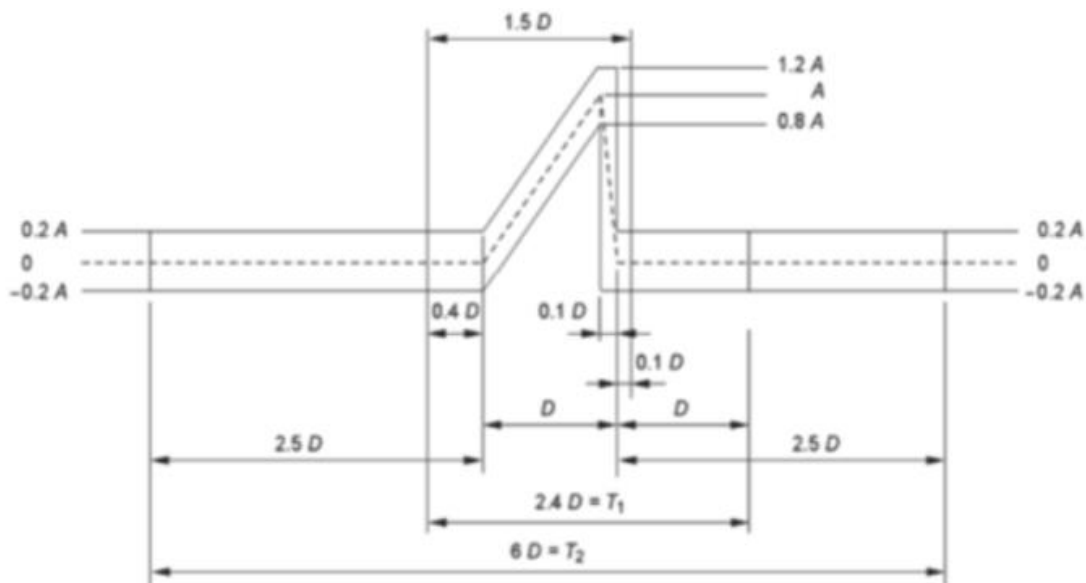
7.2.5 Profile

7.2.2 Acceleration( $\text{m/s}^2$ ): 100  $\text{m/s}^2$

7.2.3 Number of impacts: 10 per direction (total 60)

7.2.4 Test Axis: X, Y, Z

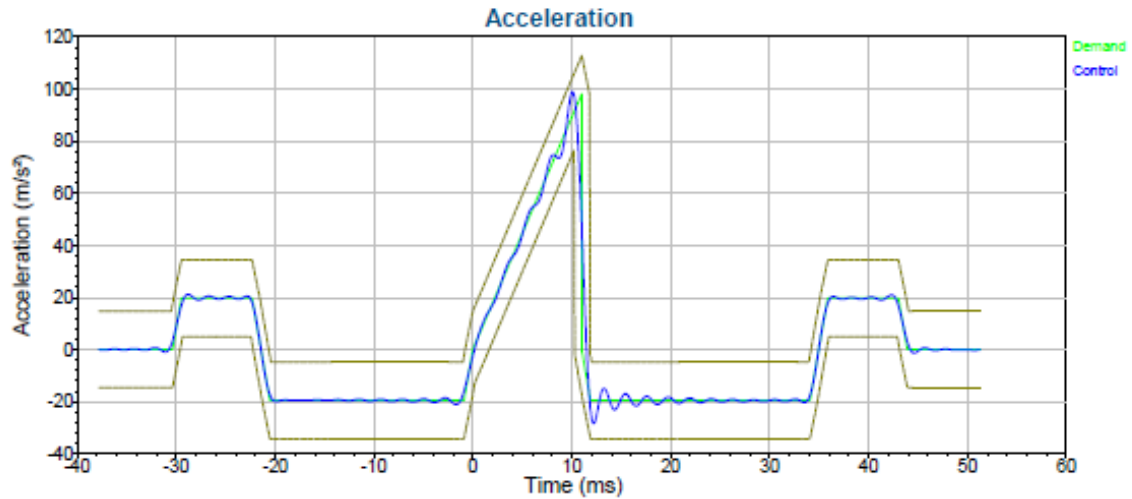
#### 7.5.1 Test data and graph (Shock Test X Axis)

Output: 0.566 Volts peak 한화비전 60068-2-27

Demand: 100 m/s<sup>2</sup>

Control: 98.88 m/s<sup>2</sup> Pulse: 10 of 10

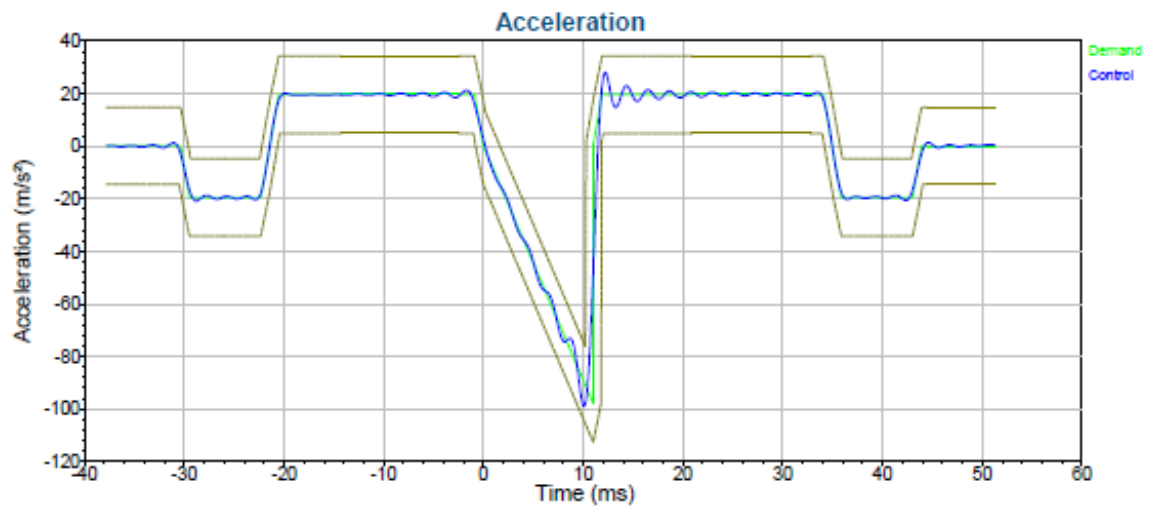
X-

Output: 0.5612 Volts peak 한화비전 60068-2-27

Demand: 100 m/s<sup>2</sup>

Control: 99.07 m/s<sup>2</sup> Pulse: 10 of 10

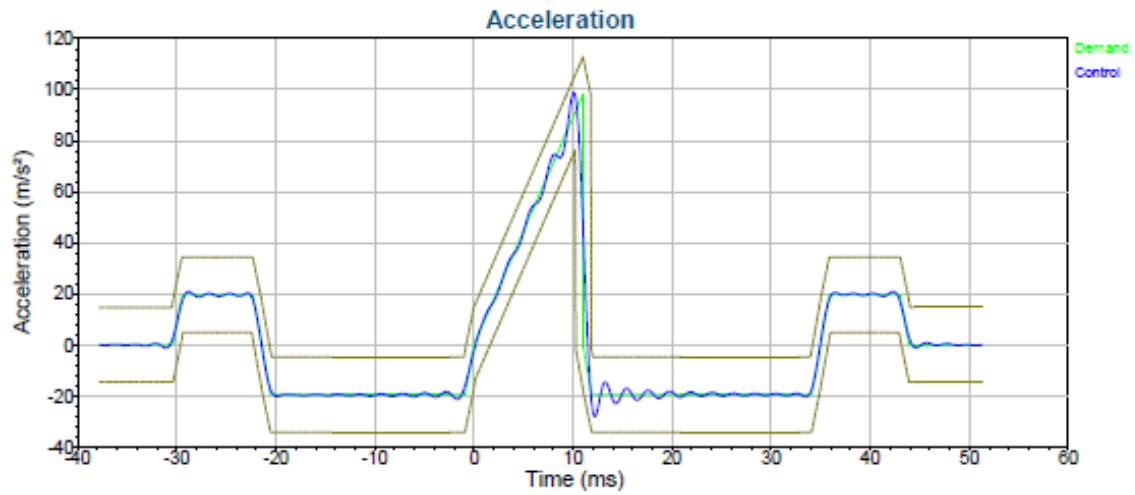
### 7.5.2 Test data and graph (Shock Test Y Axis)

Output: 0.5633 Volts peak 한화비전 60068-2-27

Demand: 100 m/s²

Control: 98.85 m/s² Pulse: 10 of 10

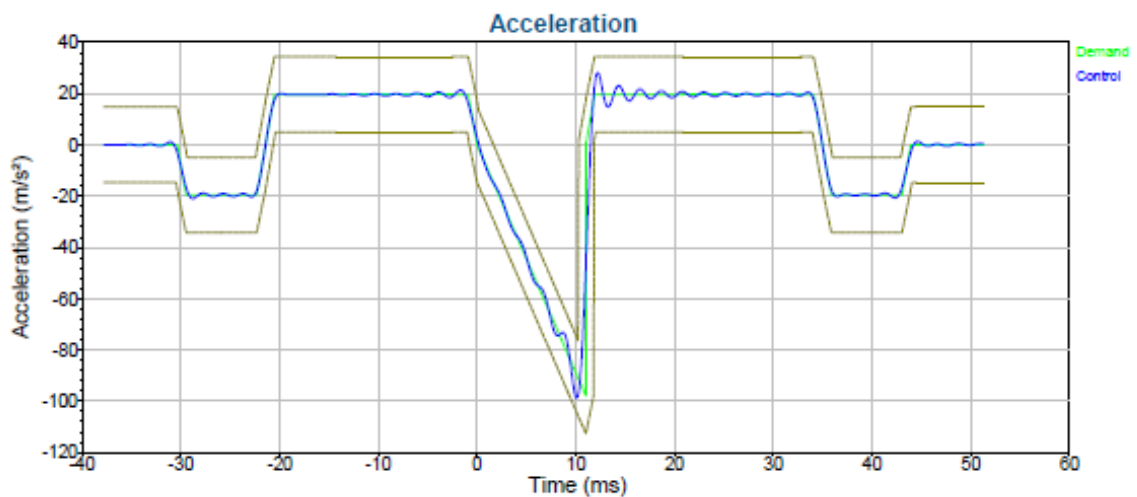
Y-

Output: 0.5055 Volts peak 한화비전 60068-2-27

Demand: 100 m/s²

Control: 98.9 m/s² Pulse: 10 of 10

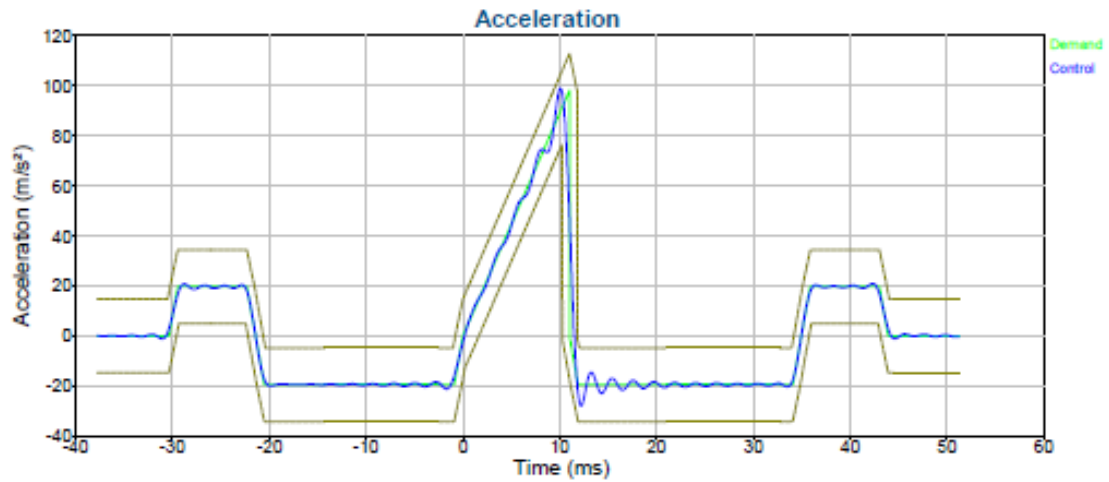
### 7.5.3 Test data and graph (Shock Test Z Axis)

Output: 0.5041 Volts peak 한화비전 60068-2-27

Demand: 100 m/s<sup>2</sup>

Control: 98.89 m/s<sup>2</sup> Pulse: 10 of 10

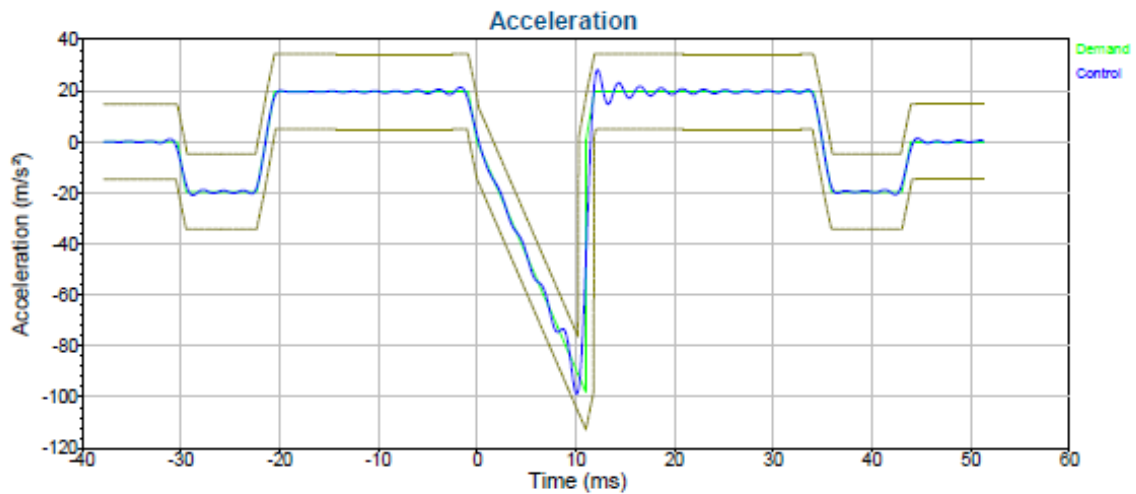
Z-

Output: 0.5055 Volts peak 한화비전 60068-2-27

Demand: 100 m/s<sup>2</sup>

Control: 98.9 m/s<sup>2</sup> Pulse: 10 of 10

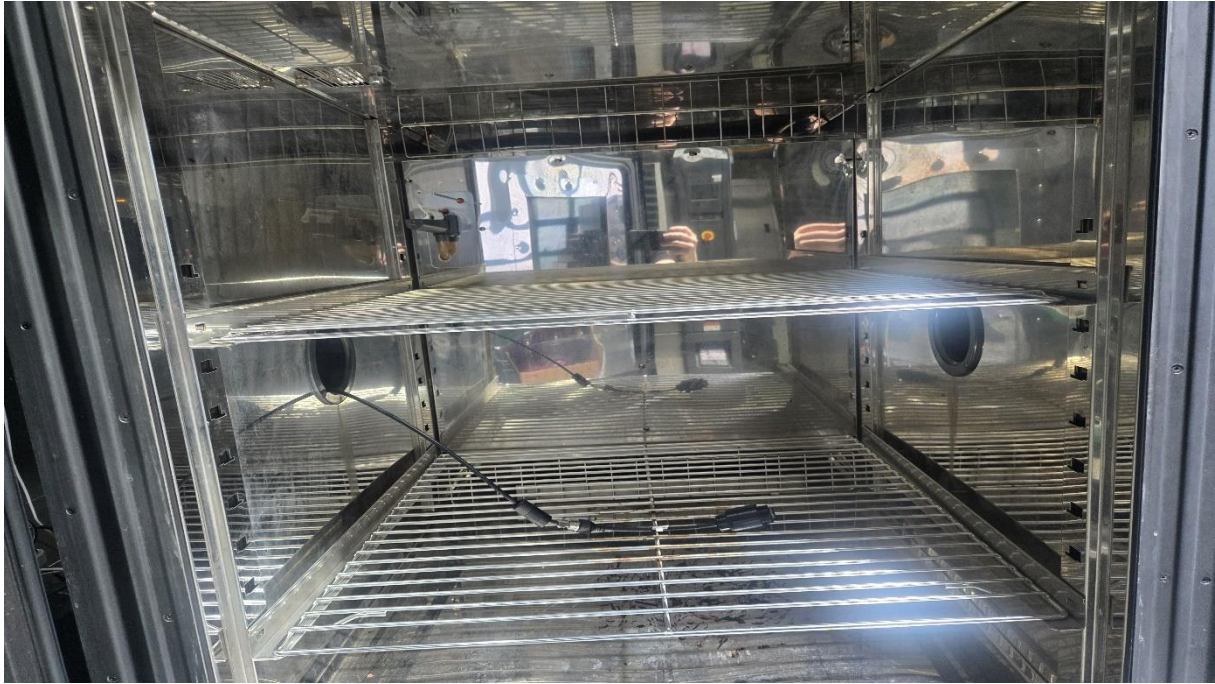
#### 8.3.1 Evidence of test setting

8.2.2 Test temperature:  $40 \pm 2$  °C

8.2.3 Test Humidity:  $93 \pm 3$  % R.H.

8.2.4 Test time: 240 h

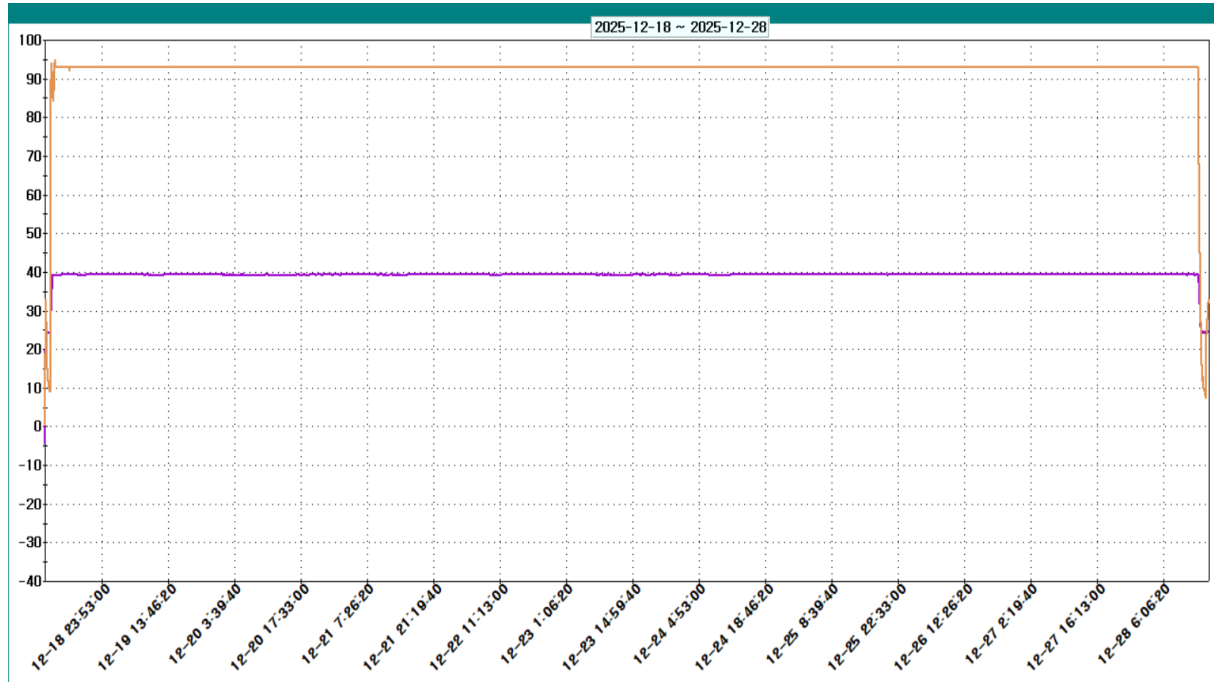
### 8.5.1 Test data and graph

Temperature Data
