# TEST REPORT

**Report No.** : SGS-R14-0666-EN  
**Applicant** : SAMSUNG TECHWIN Co., Ltd.  
**Address** : SAMSUNG TECHWIN R&D Center, #6 319 beongil,  
Pangyo-ro, Bundang-gu, Seongnam-si, Gyeonggi-do  
**Product** : NETWORK CAMERA  
**Model** : SNF-8010VM(Basic), SNF-8010V  
**Environment** : (27 ± 3) °C, (42 ± 8) % R.H.  
**Test Date** : May 28, 2014 ~ June 4, 2014  
**Standard** : EN 50155: 2007  
Section 12.2.11 Vibration, Shock and bump test  
Section 12.2.3 Cooling test(T3)  
Section 12.2.4 Dry heat test(T2, TX)  
IEC 60529: 2001(IP66)  
**Test Result** : Refer to the attached document  
**Use of report** : Validation

## Summary of Test Results

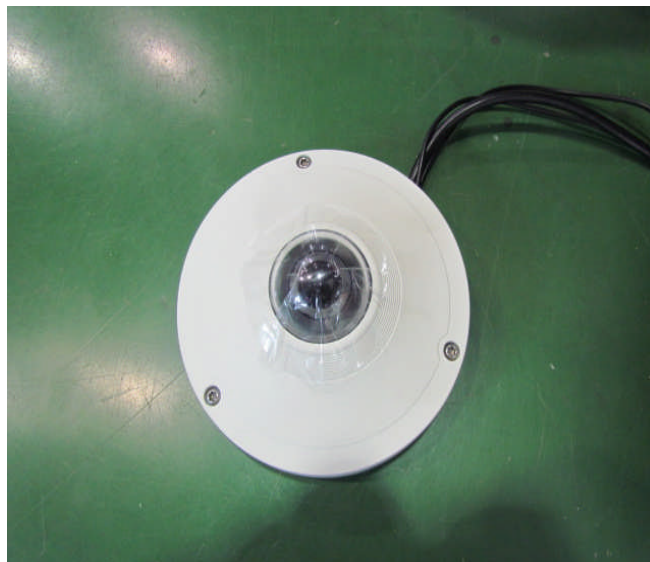
### 2.3 Photograph

Other models (SNF-8010V) are identical to figuration of basic model.

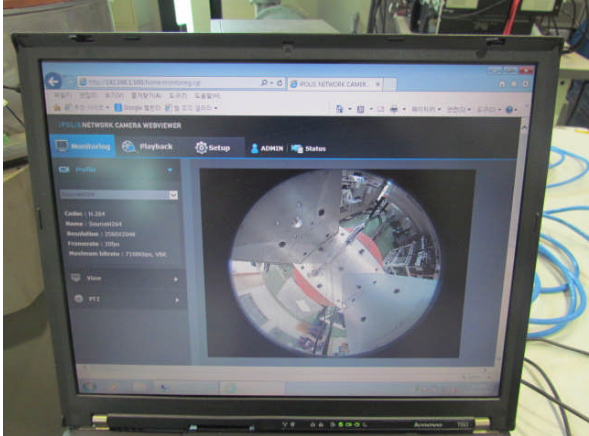
| No. | Display output |
|---|---|
| Z axis | |

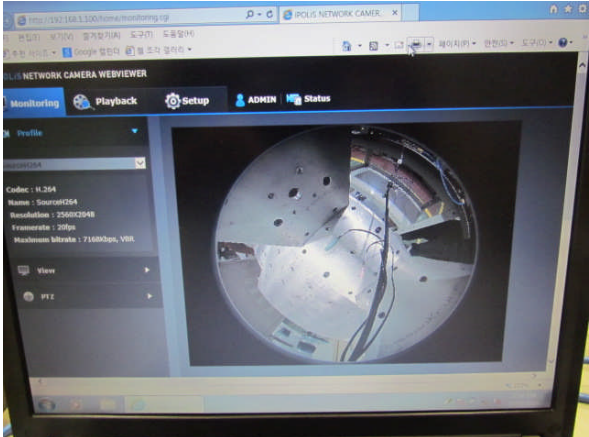
| No. | Display output |
|---|---|
| X axis | |

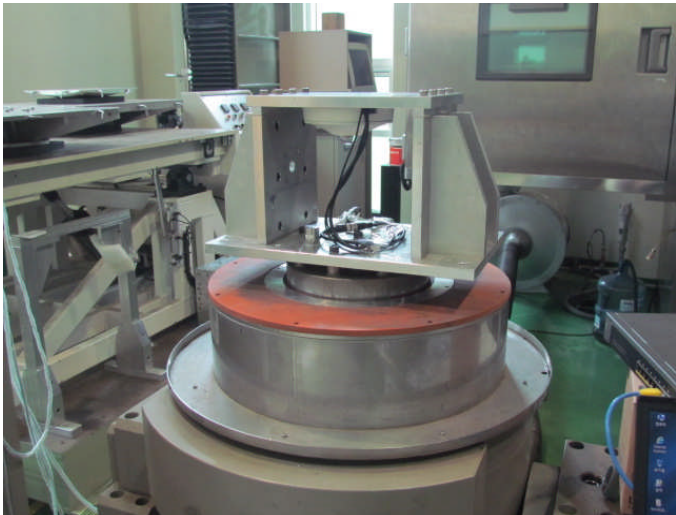
| Test axis | Test photograph |
|---|---|
| Vertical<br>(Z) | |

- 1) Test type : Half sine
- 2) Acceleration : Z - 30 m/s<sup>2</sup>, X - 30 m/s<sup>2</sup>, Y - 50 m/s<sup>2</sup>
- 3) Duration : 30 ms
- 4) Test time : 18 times in total  
(6 times in each axis : positive 3 / negative 3)
- 5) Test axis : Vertical (Z), Transverse (X), Longitudinal (Y)
- 6) Check time : After the test
- 7) Sample condition : Unpackaged product / Non-operation
- 8) Sample quantity : 1 EA

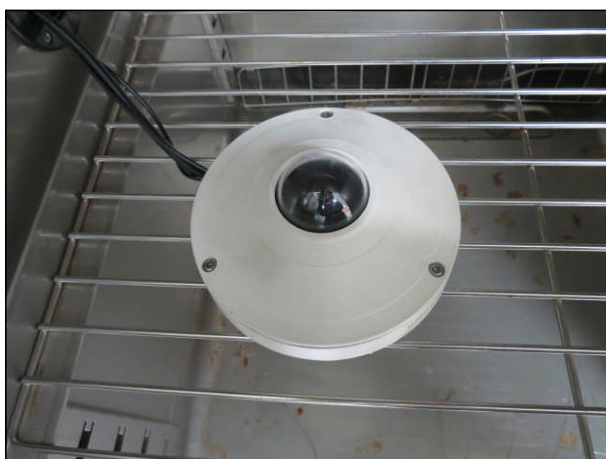
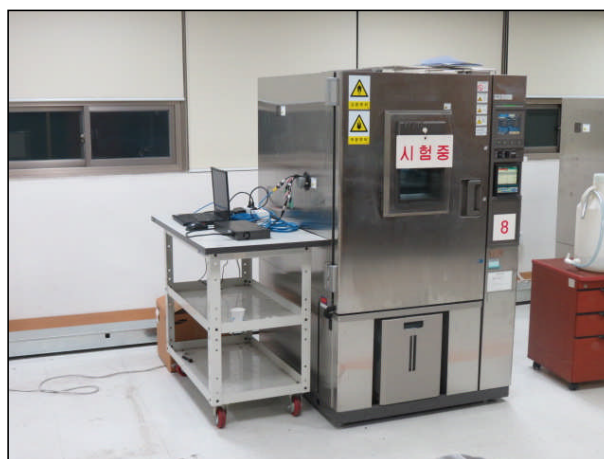
### (3) Test photograph

| Check list | Test result |
|---|---|
| 1. Operation check<br>-. Video output check | No abnormal was found.<br>(Refer to the appendix 1.) |
| 2. Visual inspection | No abnormal was found. |

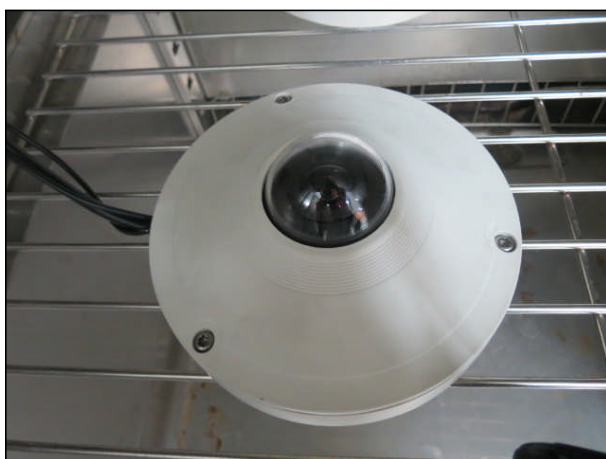
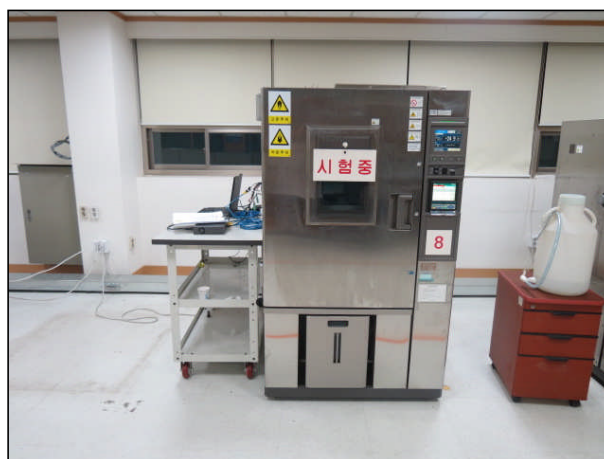
### (3) Test photograph

| Check list | Test result |
|---|---|
| 1. Operation check<br>-. Video output check | No abnormal was found.<br>(Refer to the appendix 1.) |
| 2. Visual inspection | No abnormal was found. |

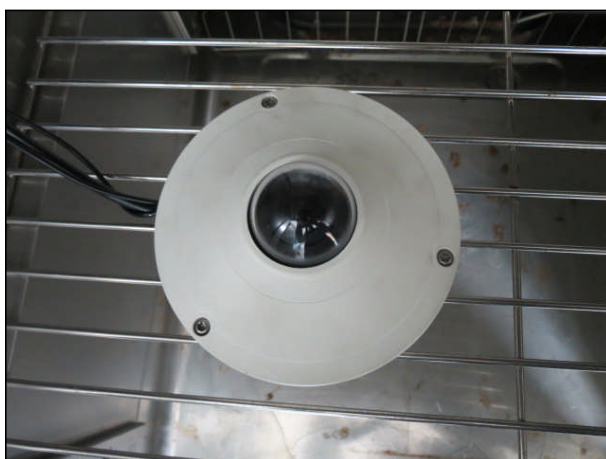
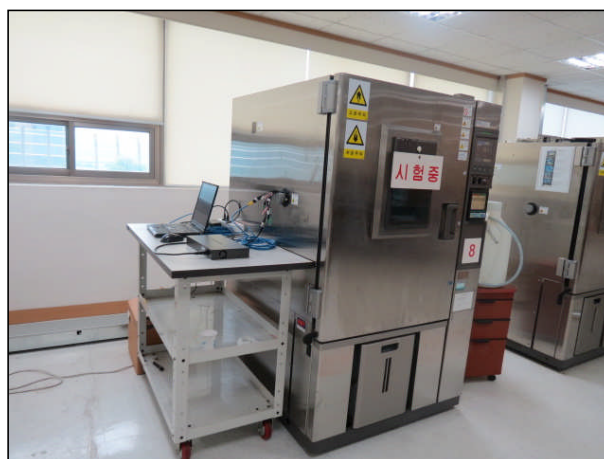
### (3) Test photograph

| Check list | Test result |
|---|---|
| 1. Operation check<br>-. Video output check | No abnormal was found.<br>(Refer to the appendix 1.) |
| 2. Visual inspection | No abnormal was found. |

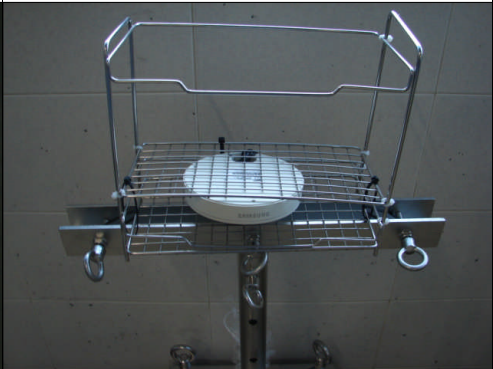
| | Photograph | |
|---|---|---|
| Before<br>The Test | | |

| Check list | Test result |
|---|---|
| - Confirmation of water resistance | No water penetration was found. |

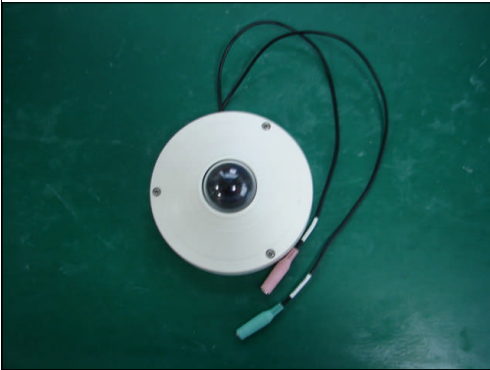
| | Photograph | |
|---|---|---|
| Before<br>The Test | | |

| NETWORK CAMERA / SNF-8010VM(Basic), SNF-8010V | |
|---|---|
| IP6X | No dust penetration was found. |
