# ***ENVIRONMENTAL TEST REPORT***

**Product: Network Camera**

**“MODEL NAME(S): SNO-L6083R”**

**Standard**..... : KS C IEC 60529:2006 / IP66

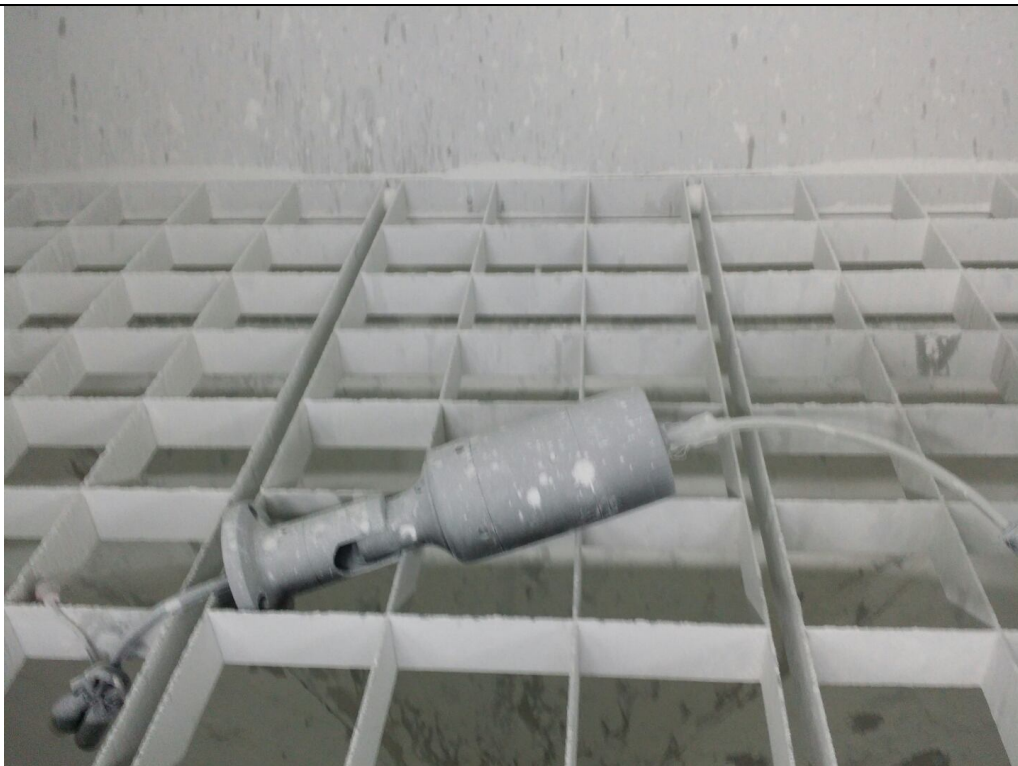
IP6X

| Items | | Descriptions |
|---|---|---|
| Test Condition | | -Wire diameter: 50 $\mu\text{m}$<br>-Width between wires: 75 $\mu\text{m}$<br>-Amount of talcum powder of the test chamber: 2 kg/m <sup>3</sup> |
| Method | Category 1 | <input type="checkbox"/> If an extraction rate of 40 to 60 volumes per hour is obtained the duration of the test is 2 h.<br><input checked="" type="checkbox"/> If, with a maximum depression of 2 kPa(20 mbar), the extraction rate is less than 40 volumes per hour, the test is continued until 80 volumes have been drawn, or a period of 8 h has elapsed. |
| Acceptance Conditions | | The protection is satisfactory if no deposit of dust is observable inside the enclosure at the end of the test. |

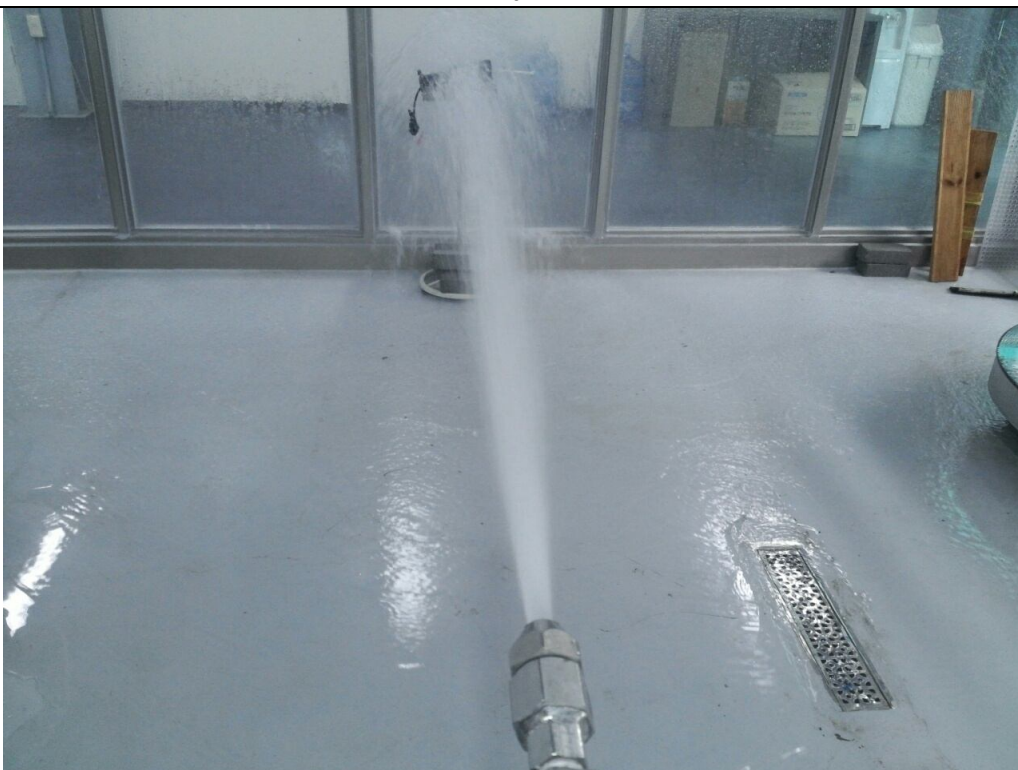
IPX6

| Items | Descriptions |
|---|---|
| Test Condition | <ul style="list-style-type: none"> <li>-Internal diameter of the nozzle: 12.5 mm</li> <li>-Delivery rate: 100 l/min <math>\pm</math> 5 %</li> <li>-Distance nozzle to enclosure surface: Between 2.5 m &amp; 3 m</li> <li>-The duration of the test: 3 min</li> </ul> |
| Acceptance Conditions | <ul style="list-style-type: none"> <li>-In general, if any water has entered, it shall not;</li> <li>-Be sufficient to interfere with the correct operation of the equipment or impair safety.</li> <li>-Deposit on insulation parts where it could lead to tracking along the creepage distances</li> <li>-Reach live parts or windings not designed to operate when wet.</li> <li>-Accumulate near the cable end or enter the cable if any.</li> </ul> |

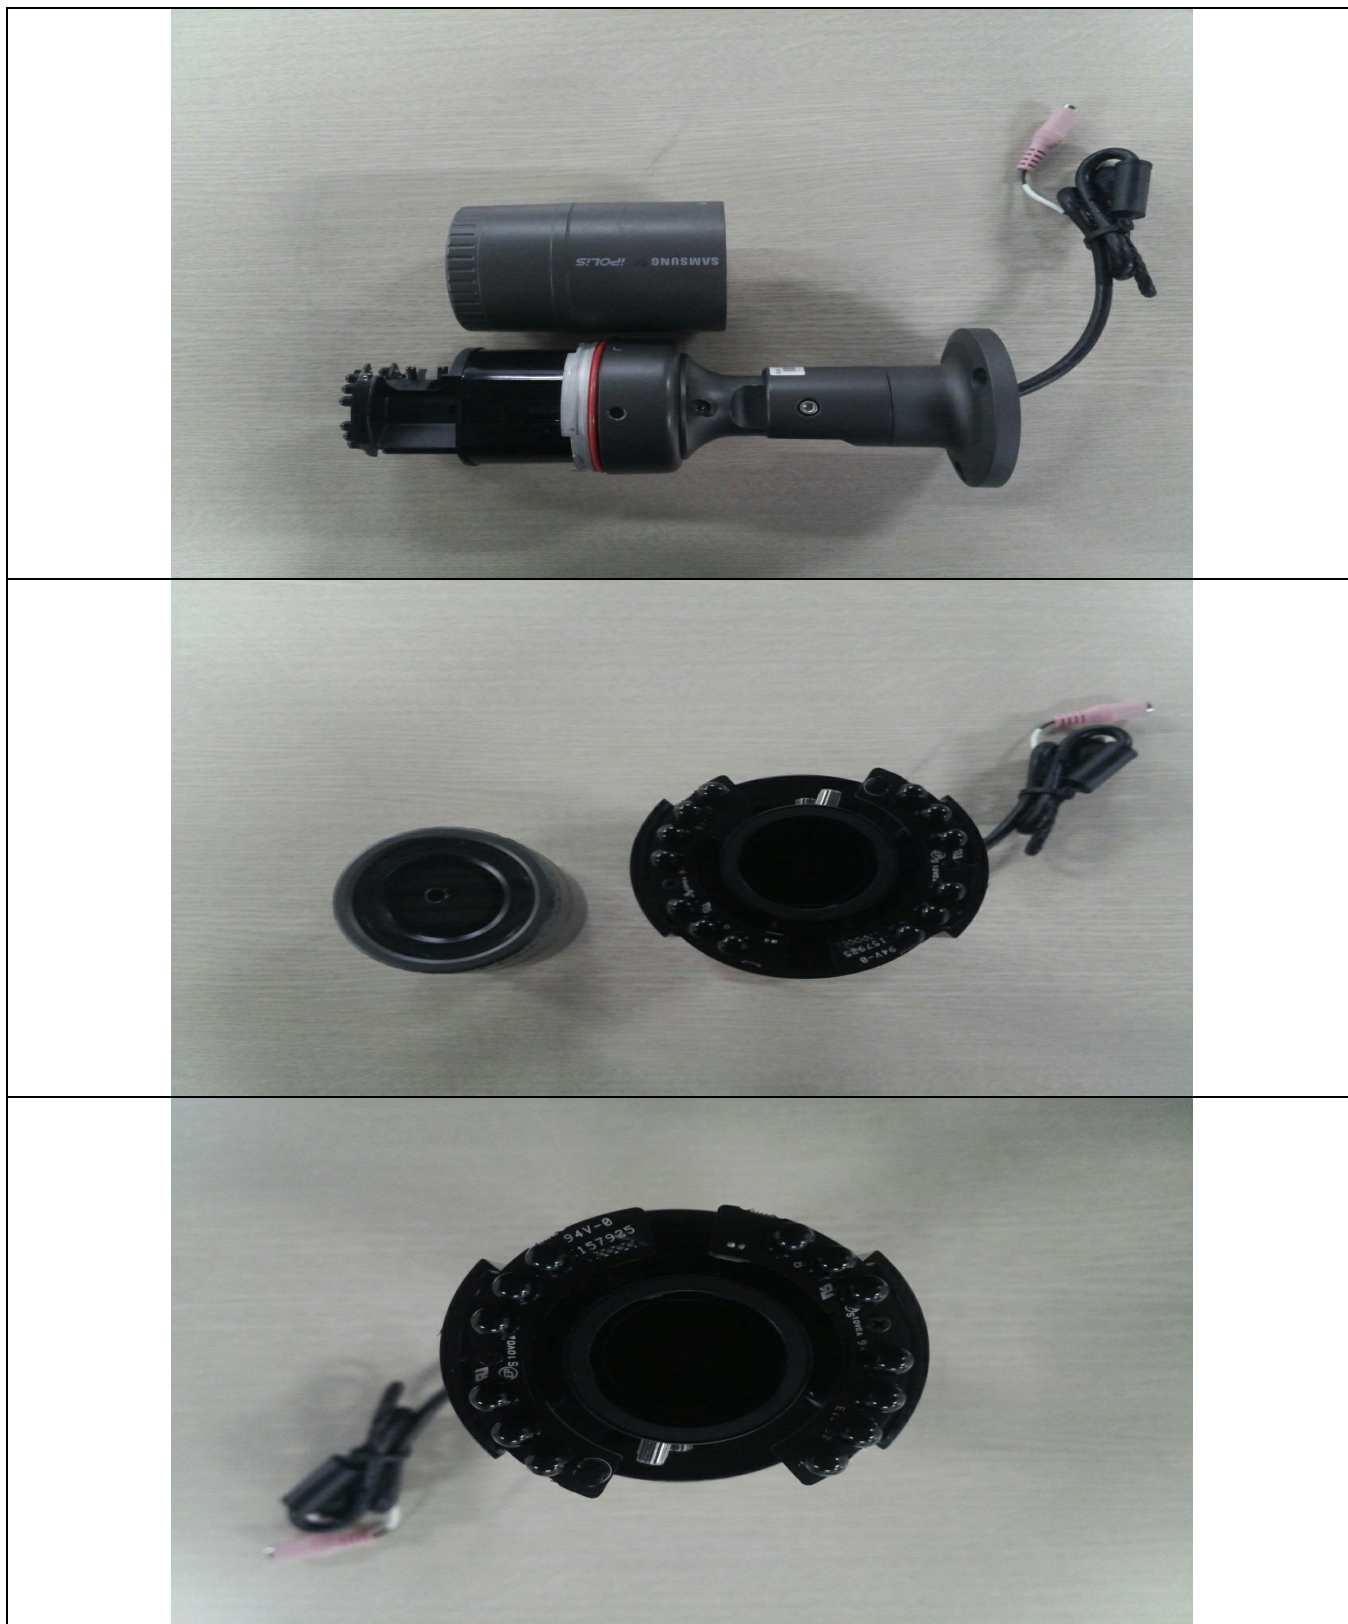
### APPENDIX III - PHOTO OF INSIDE AFTER IP66 TEST

| Item | IP Code | Result |
|---|---|---|
| SNO-L6083R | IP66 | Pass |
