# TEST REPORT

**Report No.** : SGS-R11-0621

**Product** : Network Camera

**Model** : SNV-5010P

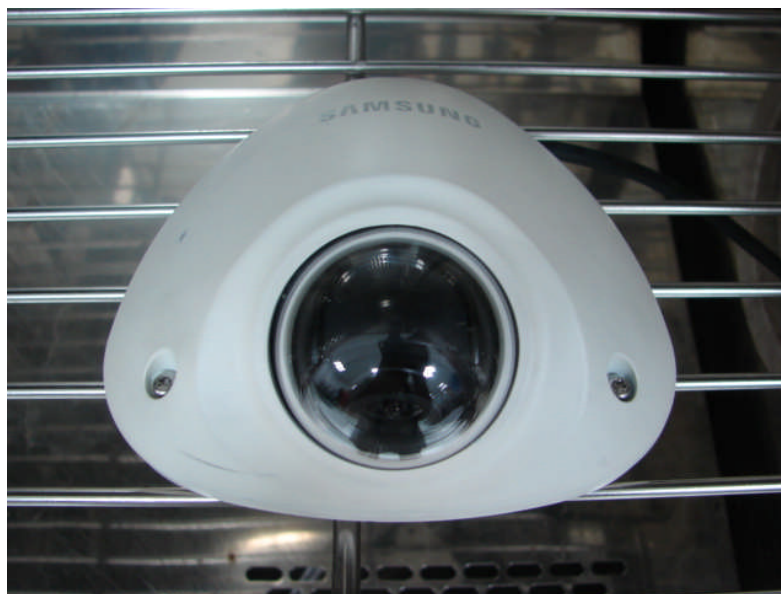
### 2.2 Photograph

Applicant : SAMSUNG TECHWIN Co., Ltd.  
Manufacturer : SAMSUNG TECHWIN Co., Ltd.  
Product : Network Camera  
Model : SNV-5010P  
S/N : N/A

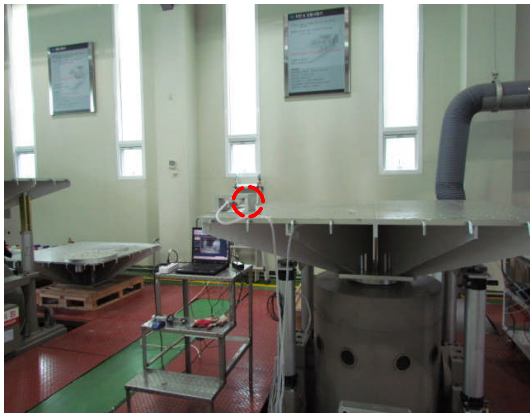
## (4) Test photograph

- 1) Test Type : Sweep sine
- 2) Acceleration : 5 m/s<sup>2</sup> (0.51 g<sub>n</sub>)
- 3) Frequency : (5 ~ 150 ~ 5) Hz
- 4) Sweep Cycle : 1 Cycle
- 5) Test time : 15 min in total (Each axis 5 min)
- 6) Test axis : Vertical (Z), Transverse (X), Longitudinal (Y)
- 7) Check time : After the test
- 8) Sample state : Unpackaged product / Non-operation
- 9) Sample quantity : 1 EA

| No. | Check point | Test result |
|---|---|---|
| | - Resonance search | - Z : 150 Hz, 10.309 m/s <sup>2</sup> (1.051 g <sub>n</sub> )<br>- X : No resonance<br>- Y : No resonance |

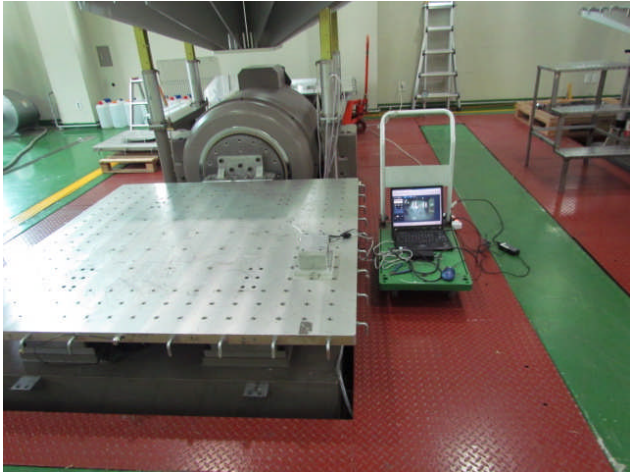
| Test axis | Photograph |
|---|---|
| Transverse<br>(X) | |

- 1) Test type : Random
- 2) Acceleration : Z-0.75 m/s<sup>2</sup> r.m.s. (0.07 g<sub>n</sub> r.m.s.)→ Reference to (5) PSD Levels  
X-0.37 m/s<sup>2</sup> r.m.s. (0.03 g<sub>n</sub> r.m.s.)→ Reference to (5) PSD Levels  
Y-0.5 m/s<sup>2</sup> r.m.s. (0.05 g<sub>n</sub> r.m.s.)→ Reference to (5) PSD Levels
- 3) Frequency : (5 ~ 150) Hz
- 4) Test time : 30 min in total (**10** min in each axis)
- 5) Test axis : Vertical (Z), Transverse (X), Longitudinal (Y)
- 6) Check time : During the test
- 7) Sample condition : Unpackaged product / Operation
- 8) Sample quantity : 1 EA

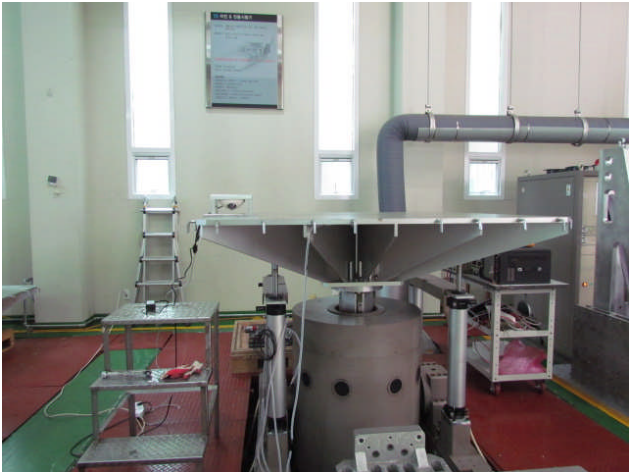
| Test axis | Photograph |
|---|---|
| Vertical<br>(Z) | |

- 1) Test type : Random
- 2) Acceleration : Z-5.9 m/s<sup>2</sup> r.m.s. (0.06 g<sub>n</sub> r.m.s.)→ Reference to (5) PSD Levels  
X-2.9 m/s<sup>2</sup> r.m.s. (0.29 g<sub>n</sub> r.m.s.)→ Reference to (5) PSD Levels  
Y-3.9 m/s<sup>2</sup> r.m.s. (0.39 g<sub>n</sub> r.m.s.)→ Reference to (5) PSD Levels
- 3) Frequency : (5 ~ 150) Hz
- 4) Test time : 15 min in total (5 h in each axis)
- 5) Test axis : Vertical (Z), Transverse (X), Longitudinal (Y)
- 6) Check time : After the test
- 7) Sample condition : Unpackaged product / Non-operation
- 8) Sample quantity : 1 EA

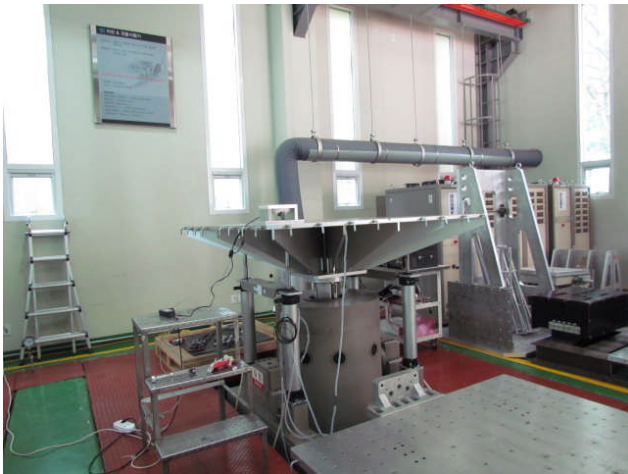
| Test axis | Photograph |
|---|---|
| Vertical<br>(Z) | |

- 1) Test type : Random
- 2) Peak acceleration of nominal pulse : Z-30 m/s<sup>2</sup> (3.061g<sub>n</sub>)  
X-30 m/s<sup>2</sup> (3.061 g<sub>n</sub>)  
Y-50 m/s<sup>2</sup> (5.102 g<sub>n</sub>)
- 3) Duration of nominal pulse : 30 ms
- 4) Number of shock : 18 times in each axis (3 times in total)
- 5) Test axis : Vertical (Z), Transverse (X), Longitudinal (Y)
- 6) Check time : After the test
- 7) Sample condition : Unpackaged product / Non-operation
- 8) Sample quantity : 1 EA
